NASA/TM-2011-217072/Volume I  
NESC-RP-09-00506

# Space Shuttle Program (SSP) Orbiter Main Propulsion System (MPS) Gaseous Hydrogen ( $\text{GH}_2$ ) Flow Control Valve (FCV) Poppet Eddy Current (EC) Inspection Probability of Detection (POD) Study

<b>NASA Engineering and Safety Center Technical Assessment Report</b>	Document #: <b>NESC-RP- 09-00506</b>	Version: <b>1.1</b>
Title: <b>STS-126 MPS#2 GH<sub>2</sub> Flow Control Valve Broken Poppet</b>			Page #: 1 of 59

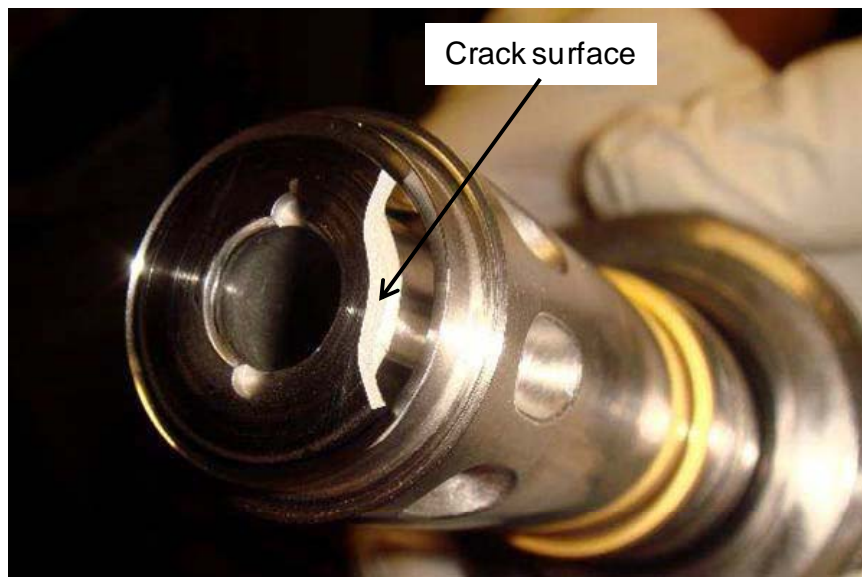
*Figure 5.0-1. Cracked STS-126 GH<sub>2</sub> FCV*

Flight controllers identified that GH<sub>2</sub> was flowing from one FCV at a higher than commanded rate during the STS-126 mission in November 2008. The flow rates in the other two FCVs were automatically reduced and no unusual ET pressurization issues were observed during ascent. The MPS was inspected after landing and the FCV poppet was observed to have a segment missing, as shown in Figure 5.0-1. The damaged FCV was removed from OV-105, disassembled, and fractographic examination determined that the crack was caused by fatigue.

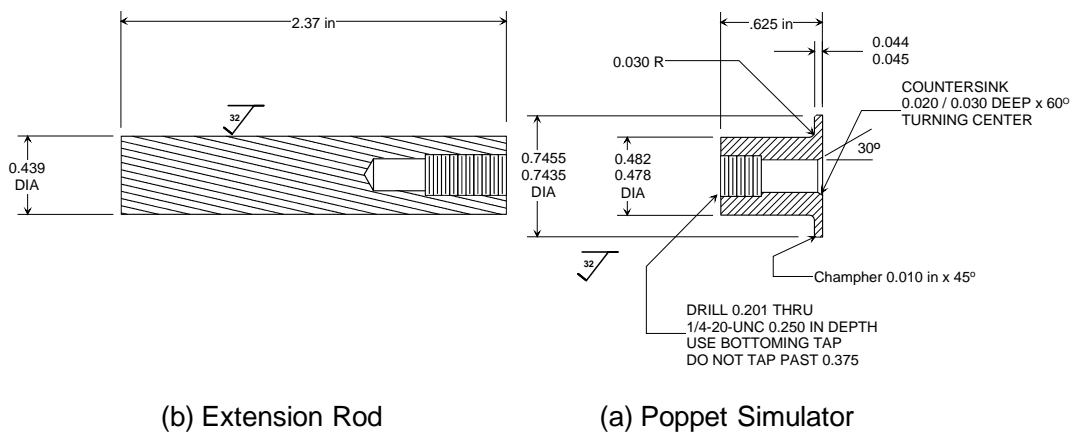
**Figure 5.3-1. A Schematic of the Poppet Simulators and Extension Rods that were used in the NDE Study**

The flange fillet radius of each poppet simulator was polished after machining to enhance crack detection. The poppet was rotated at about 90 revolutions per minute (rpm) and a diamond paste polishing grit was applied to the end of a sharpened wooden stick that was wrapped with a piece of cotton. Five different levels of polishing grit were used (9, 6, 3, 1, and ¼ micron) for 3 minutes each. An optical inspection was performed to verify that no remnant machining marks or scratches were present on the poppet simulator flange fillet radius which could have influenced the NDE inspections.

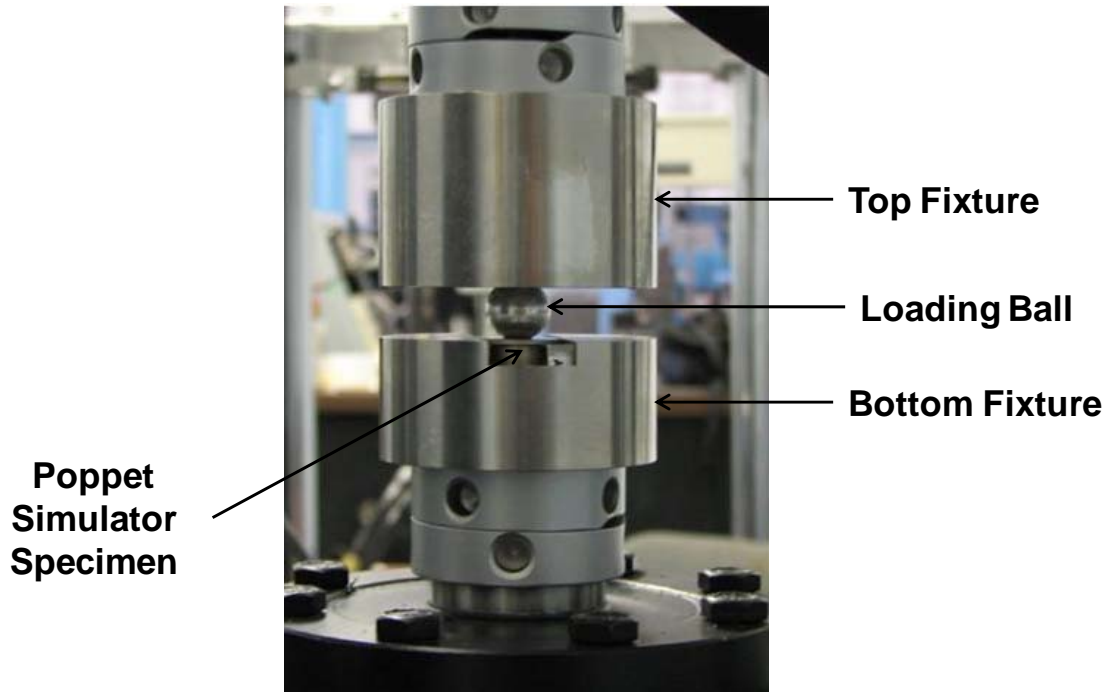
*Figure 5.3-3. Image of Poppet Simulator Loaded in a Test Fixture*

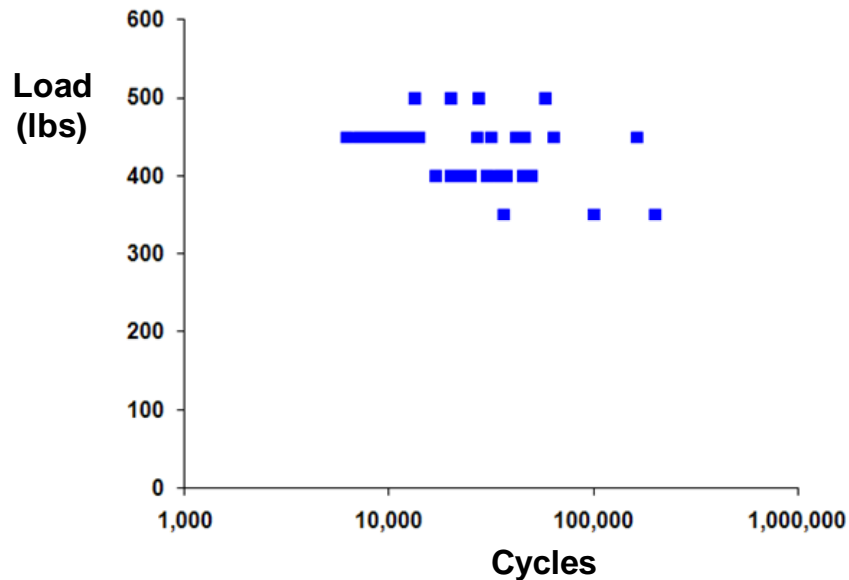
*Figure 5.3-4. The Number of Cycles required to Initiate Fatigue Cracks as a Function of the maximum Compressive Load*

compressive load and the number of cycles required to initiate a fatigue crack is shown in Figure 5.3-4.

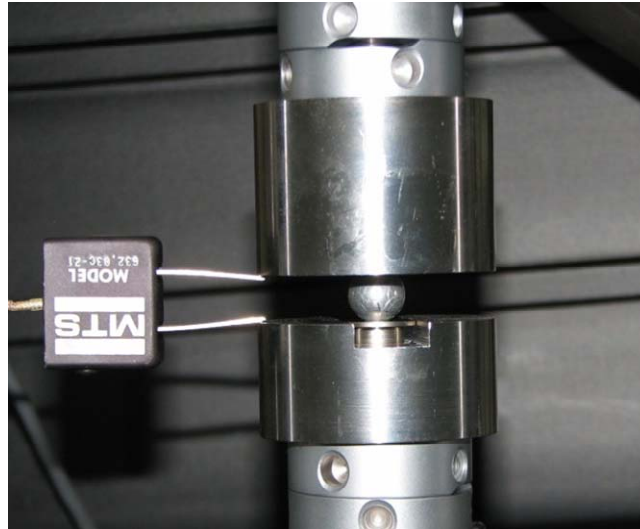
*Figure 5.3-5. Test Fixture with Displacement Gage for Detecting Cracking using the Compliance Method*

compliance of growing cracks and a rapid increase in overall compliance was observed. The resulting crack length in the poppet simulator could be adjusted, somewhat successfully, by stopping the tests at different magnitudes of compliance change. The poppet simulators were examined by SEM after each compliance cutoff and always had a crack with a surface length between 0.012 and 0.05 inches (0.3 to 1.3 mm).

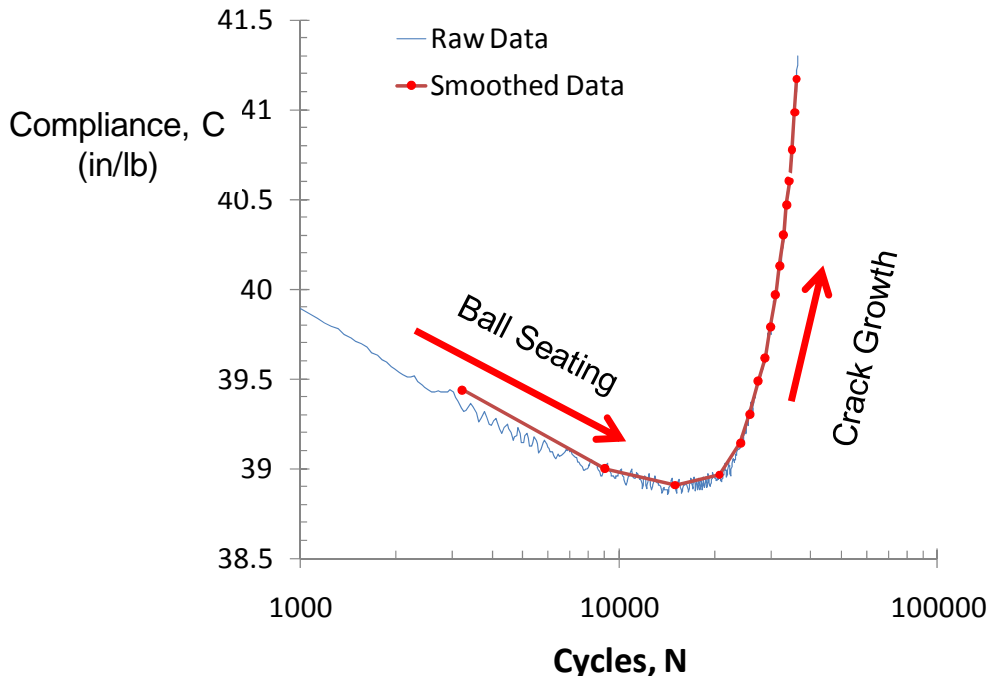
*Figure 5.3-6. Example of a Compliance Curve used to Detect Crack Growth in a Poppet Simulator Test*

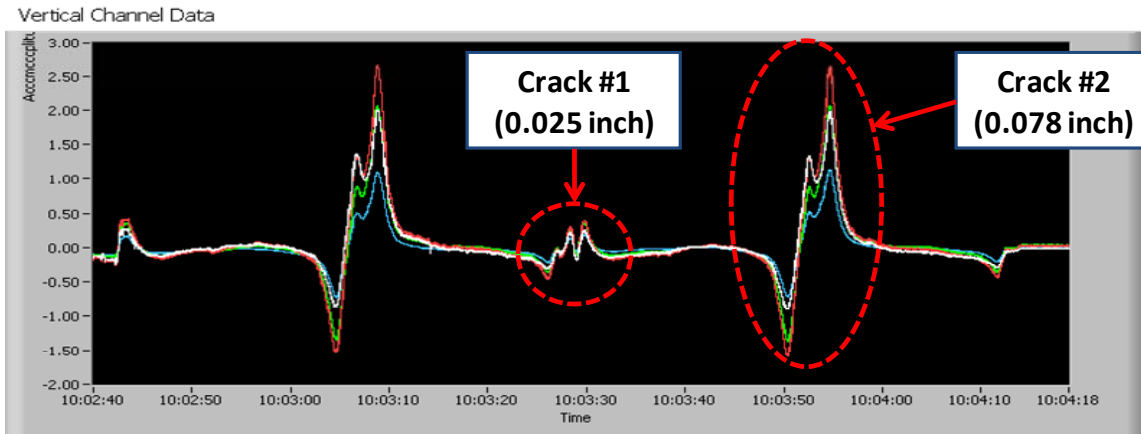
*Figure 5.3-8. EC Scan Result for a Poppet Simulator with Two Distinct Fatigue Cracks*

with an initial decrease as the probe first encounters the crack and an increase as the probe clears the crack, as shown in Figure 5.3-8. The magnitude of the voltage deviation is proportional to the size of the crack. The first signal of Figure 5.3-8 had a voltage deviation of about 1 volt and a 0.025 inch (0.64 mm) long crack was observed in the indicated location. The second signal of Figure 5.3-8 had a voltage deviation of about 4 volts and a 0.078 inch (2 mm) long crack was observed 180 degrees from the first indication. Fatigue cracks (~0.005 inches (0.13 mm)) exhibited a subtle voltage change that was barely larger than the background noise, so false calls were often observed when trying to generate small cracks. The laboratory EC inspection results were not included in the POD study because the device was not a controlled, field inspection system.

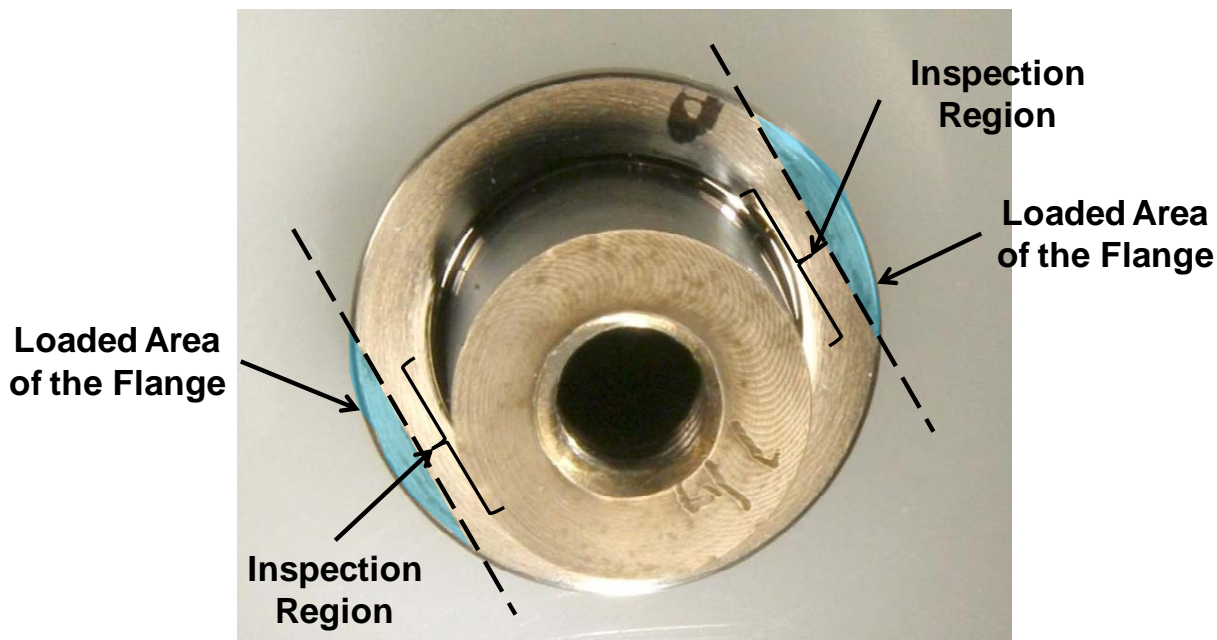
*Figure 5.3-9. Illustration of the High Stress Regions of the Poppet Simulators that were examined during the SEM Inspections*

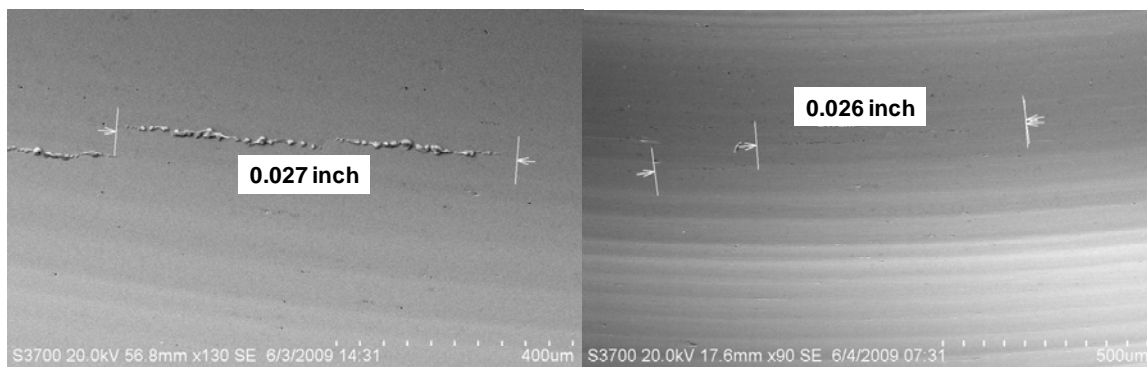
**(a) With repliset (130x)**

**(b) After polishing to remove repliset (90x)**

*Figure 5.3-10. SEM Images of a Crack in a Poppet Simulator with Repliset and after the Repliset has Been Removed*

A SEM was used to characterize the surface length, location, and number of fatigue cracks in each poppet. The poppets were polished, removing most of the manufacturing scratches, to aid in the location of the cracks. The SEM examination only considered the regions of the poppet simulator flange radius that were  $\pm 15$  degrees around the two primary loaded regions (0 and 180 degrees), as shown in Figure 5.3-9. The fatigue cracks exhibited small crack mouth openings in the unloaded state, making detection using the SEM difficult at low magnifications ( $< 100\times$ ). Examination at higher magnification ( $> 500\times$ ) was required to detect the fatigue cracks, which increased the inspection time by an order of magnitude. A repliset mold of the surface was made while the poppet simulator was loaded to 50 to 80 percent of the peak cyclic load. The repliset left a small amount of residual material at the crack mouth after the mold was removed and this residual material increased the crack detectability (due to surface charging), as shown in Figure 5.3-10. A low magnification examination was used to identify the location, number, and approximate crack size, and the remnant repliset material was removed by a  $\frac{1}{4}$  micron polish. The re-polished poppet simulators were examined with a high magnification SEM inspection of the known crack locations. SEM inspections of failed poppet simulators that were polished to remove the residual repliset material did not find any evidence of repliset on the fracture surfaces.

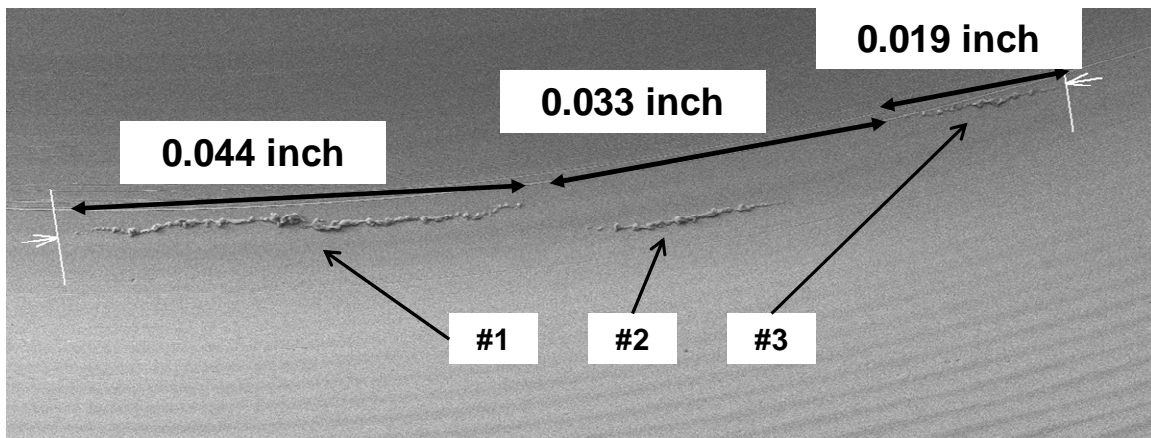
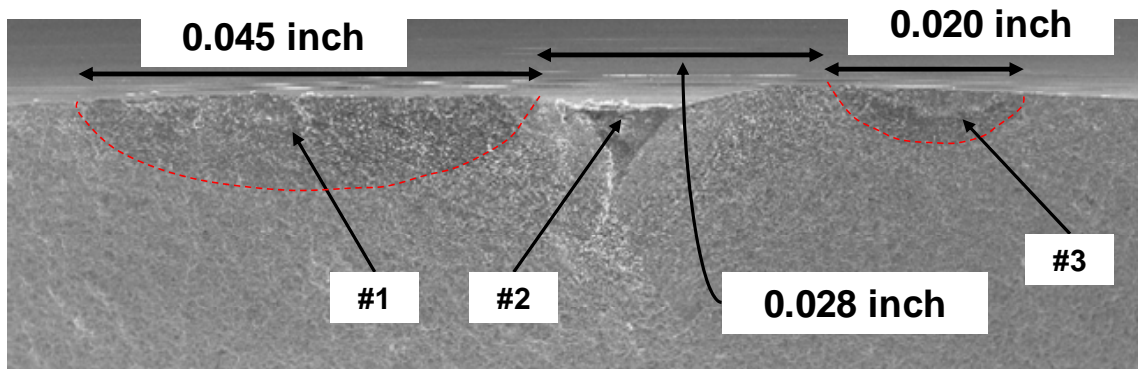
(a) Surface SEM examination of the intact poppet simulator

(b) Fracture surface SEM examination of the broken poppet simulator

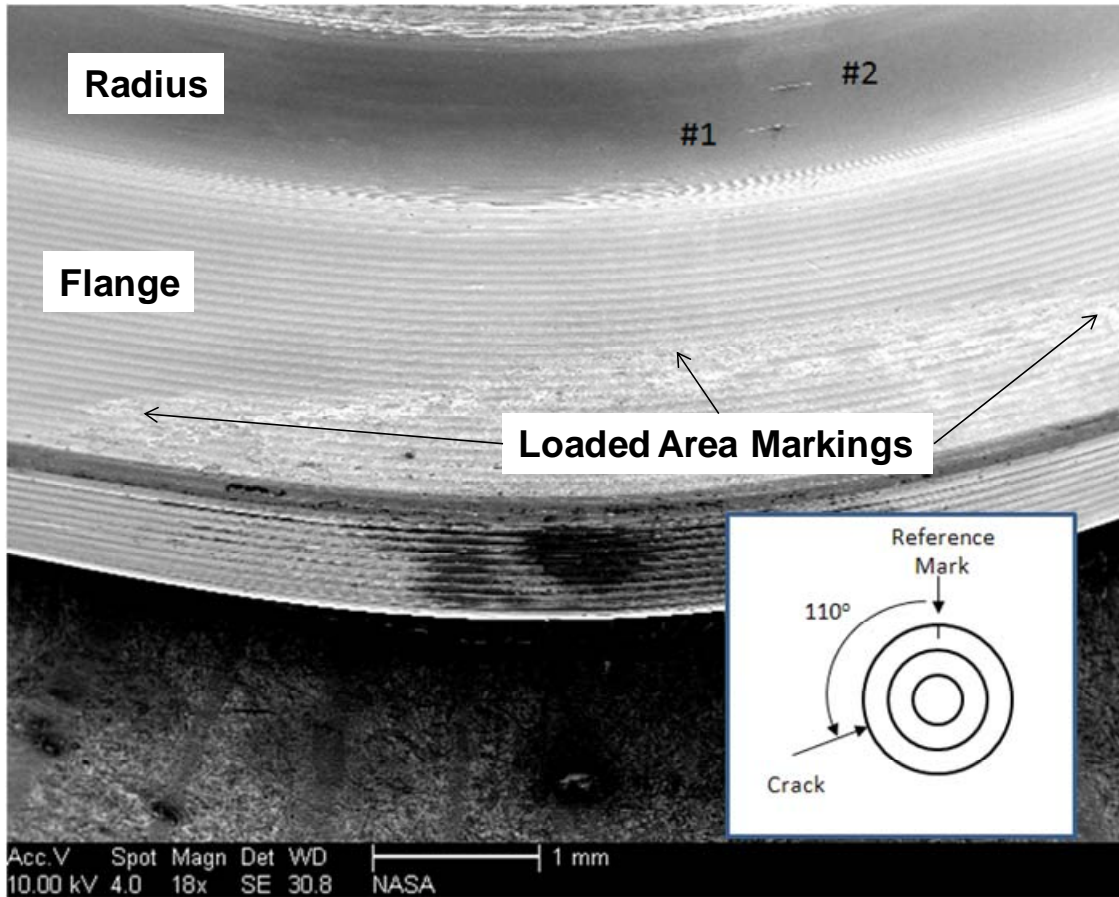
*Figure 5.4-1. Example of an SEM Image that shows the Location of Two Cracks*

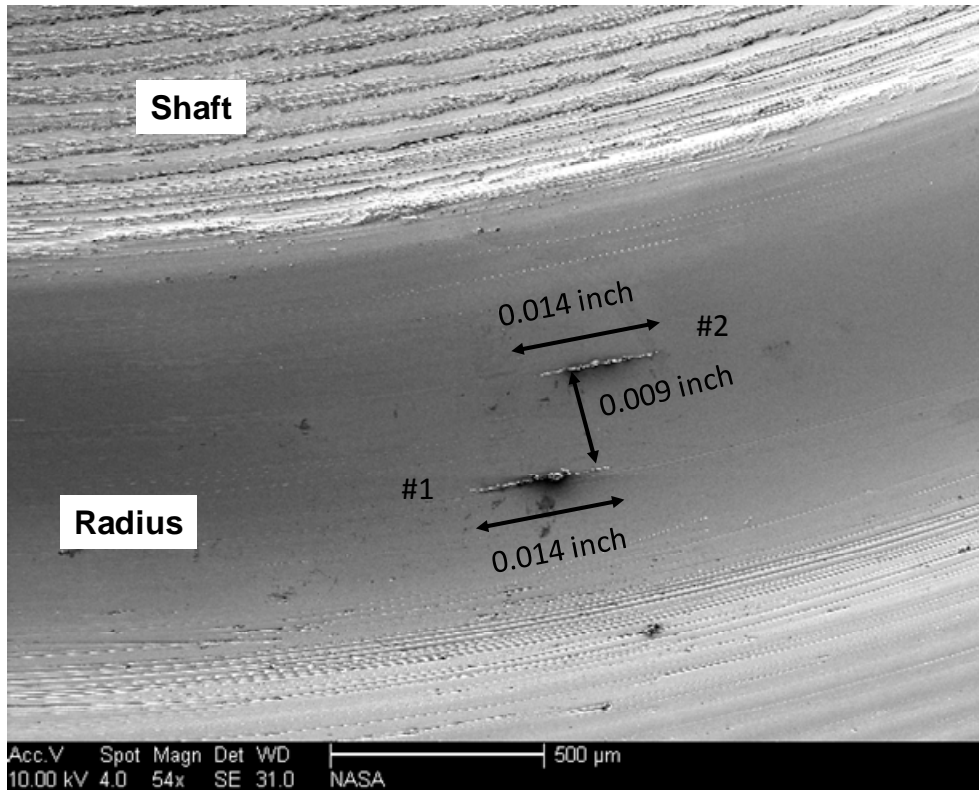
Figure 5.4-2. Example of an SEM image that shows Sufficient Details to Measure the Lengths and Relative Positions of Two Cracks

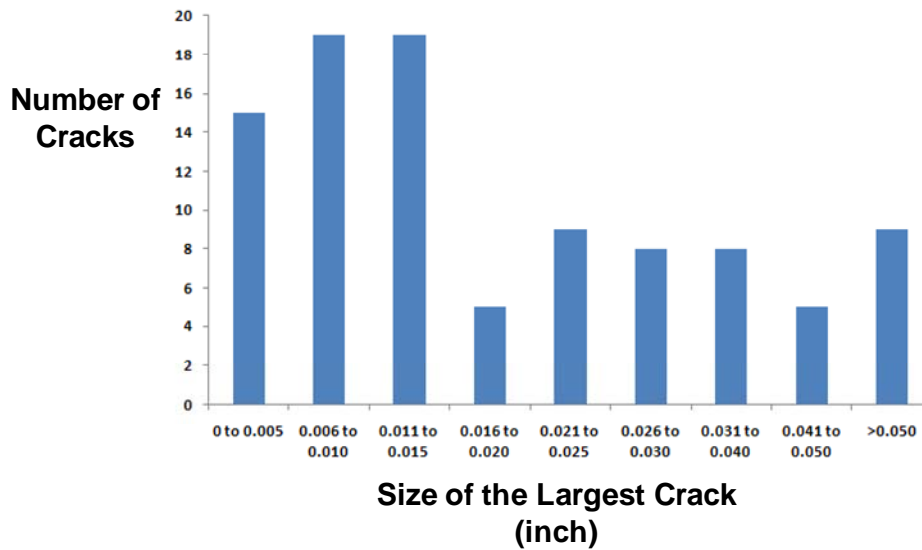
Figure 5.4-3. Distribution of the Largest Crack per Loaded Region of the Poppet Simulators Tested

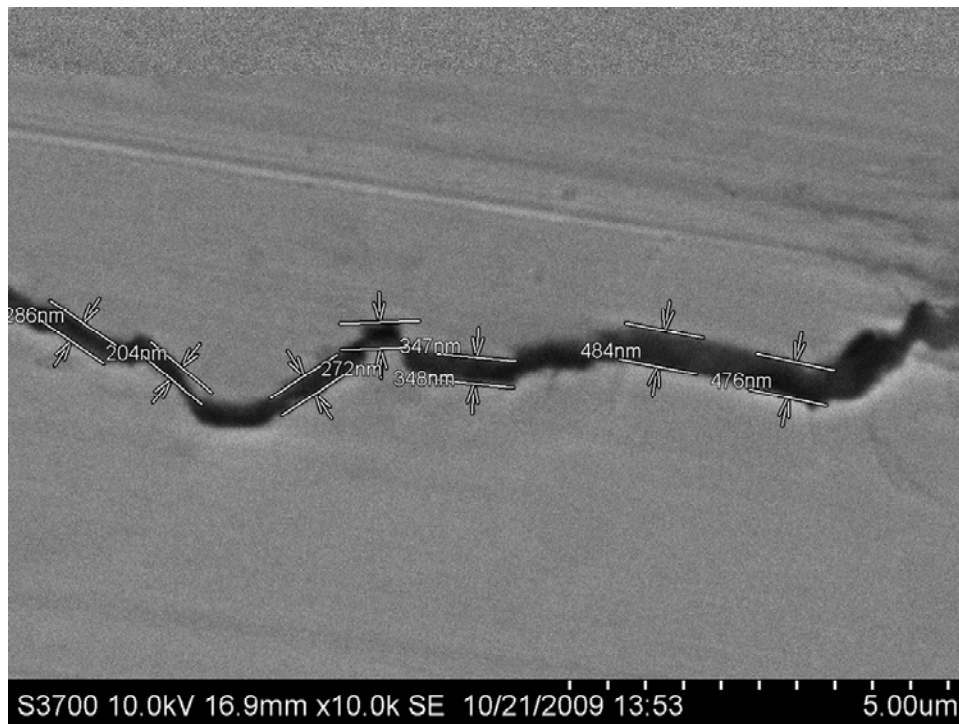
*Figure 5.4-4. Image of a Poppet Crack at 10,000x Magnification with Crack Openings Measured at Several Locations*

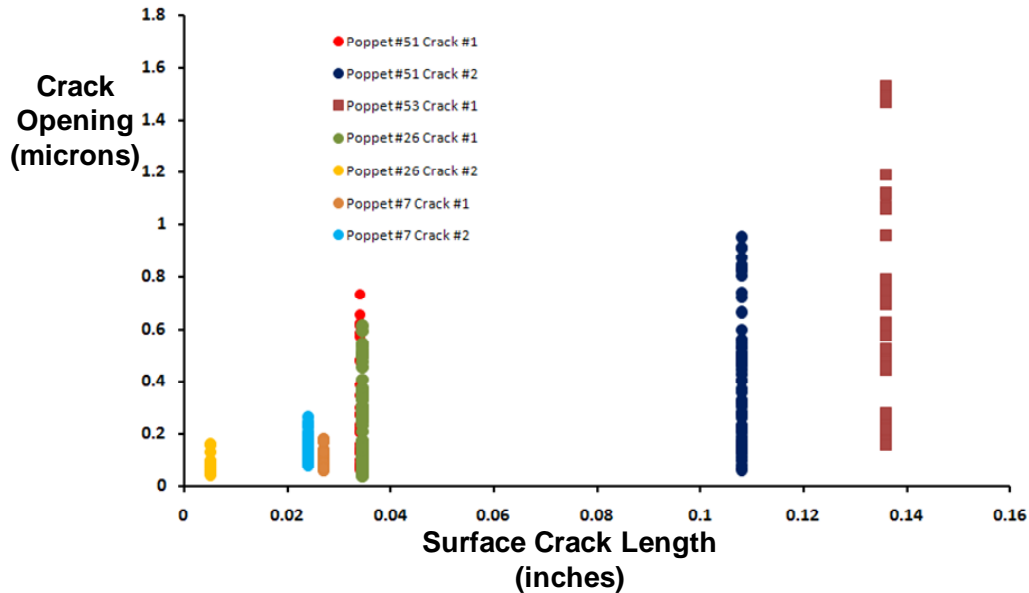
Figure 5.4-5. Crack Opening Displacement for Several Poppets

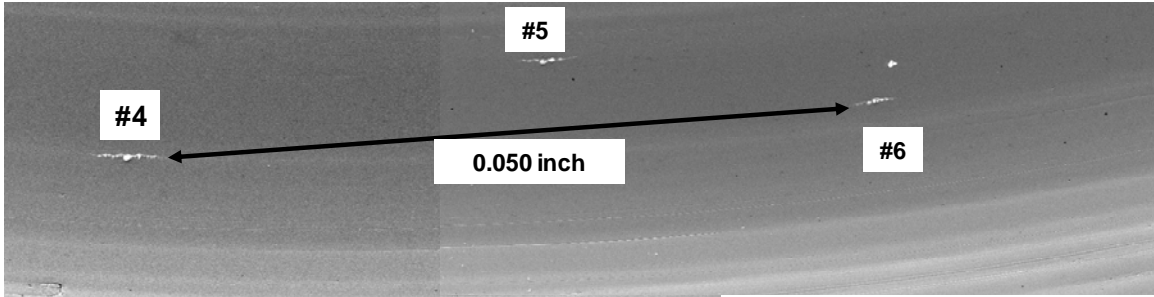
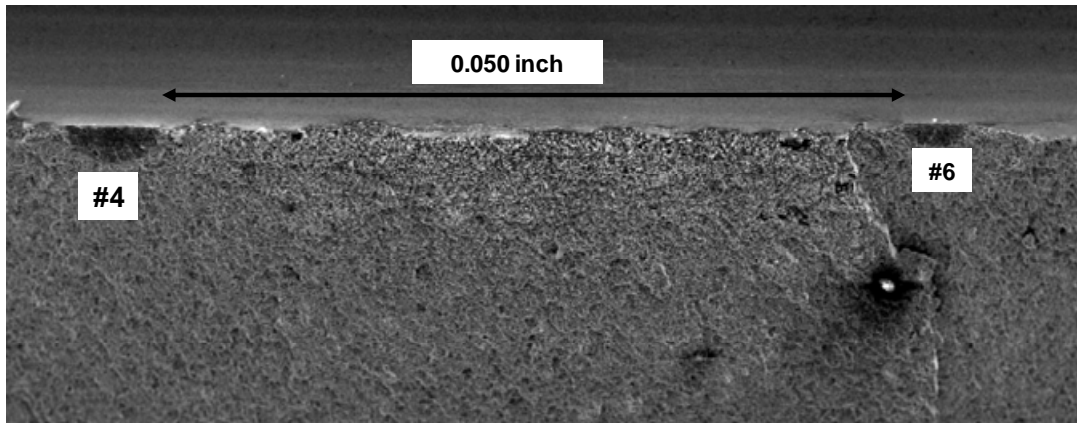
(a) Surface SEM examination of the intact poppet simulator

(b) Fracture surface SEM examination of the broken poppet simulator

*Figure 5.4-6. Images of a Fracture Surface from a Poppet Simulator and the Cracks observed on the Surface prior to Destructive Examination*

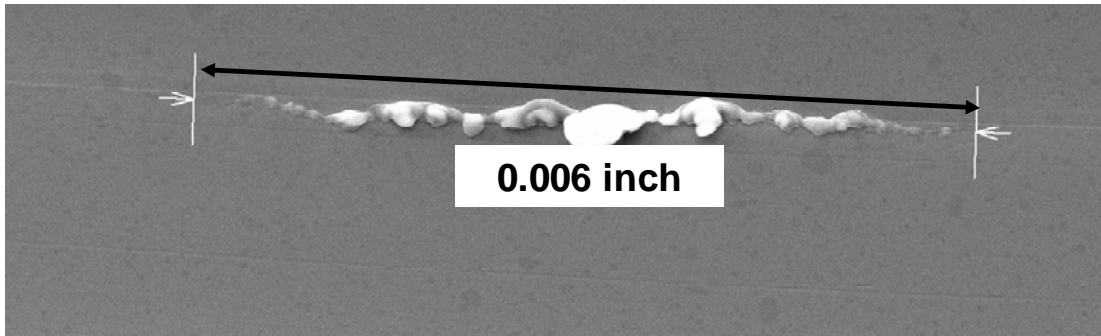
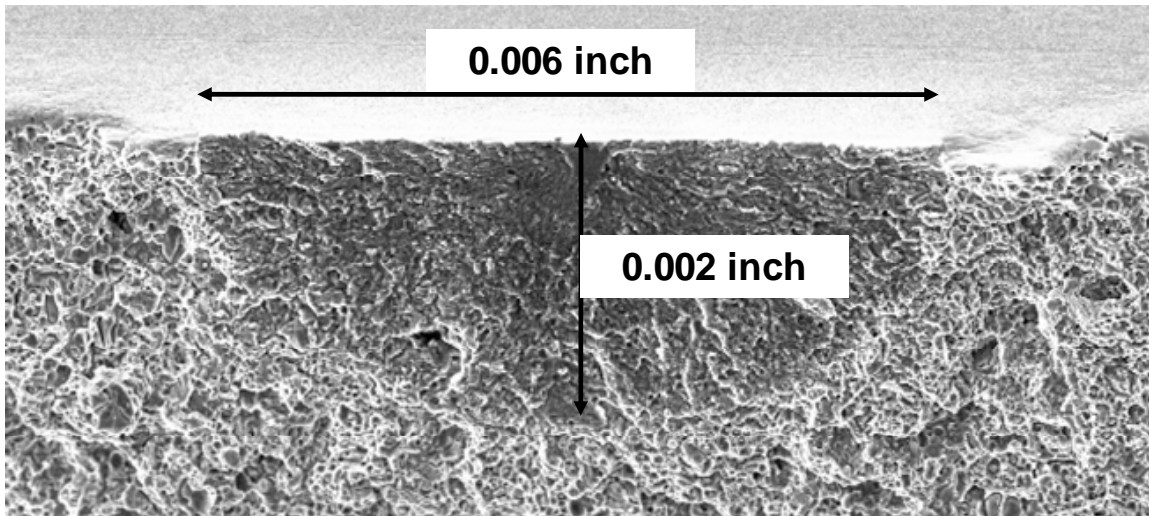
**(a) Surface SEM examination of the intact poppet simulator**

**(b) Fracture surface SEM examination of the broken poppet simulator**

*Figure 5.4-7. Comparison of the Surface Crack Length Measured and after Destructive Examination of crack #4 from Figure 5.4-6*

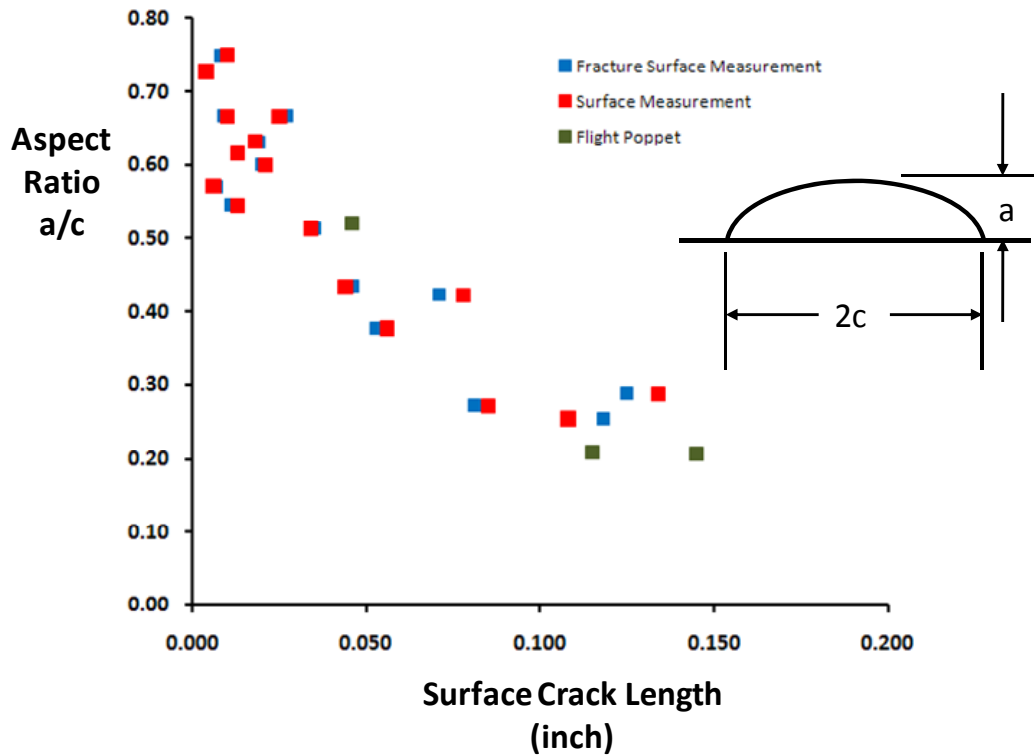
*Figure 5.4-9. Aspect Ratio of several Cracks from Poppet Simulators and Flight Poppets obtained from the Destructive Examinations*

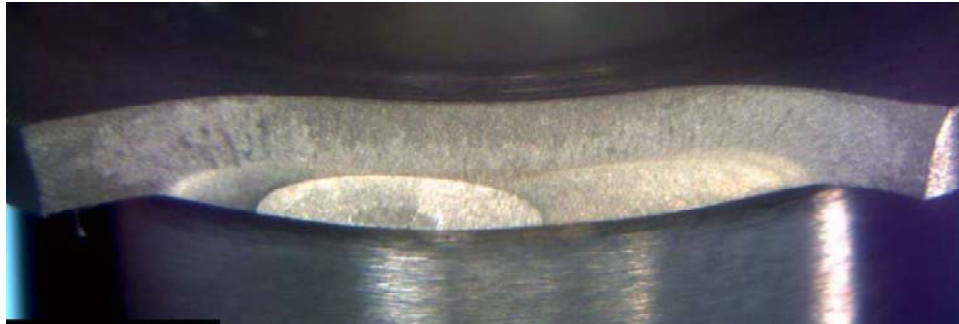
*Figure 5.4-10. Image of the Crack Detected in Flight Poppet from STS-126*

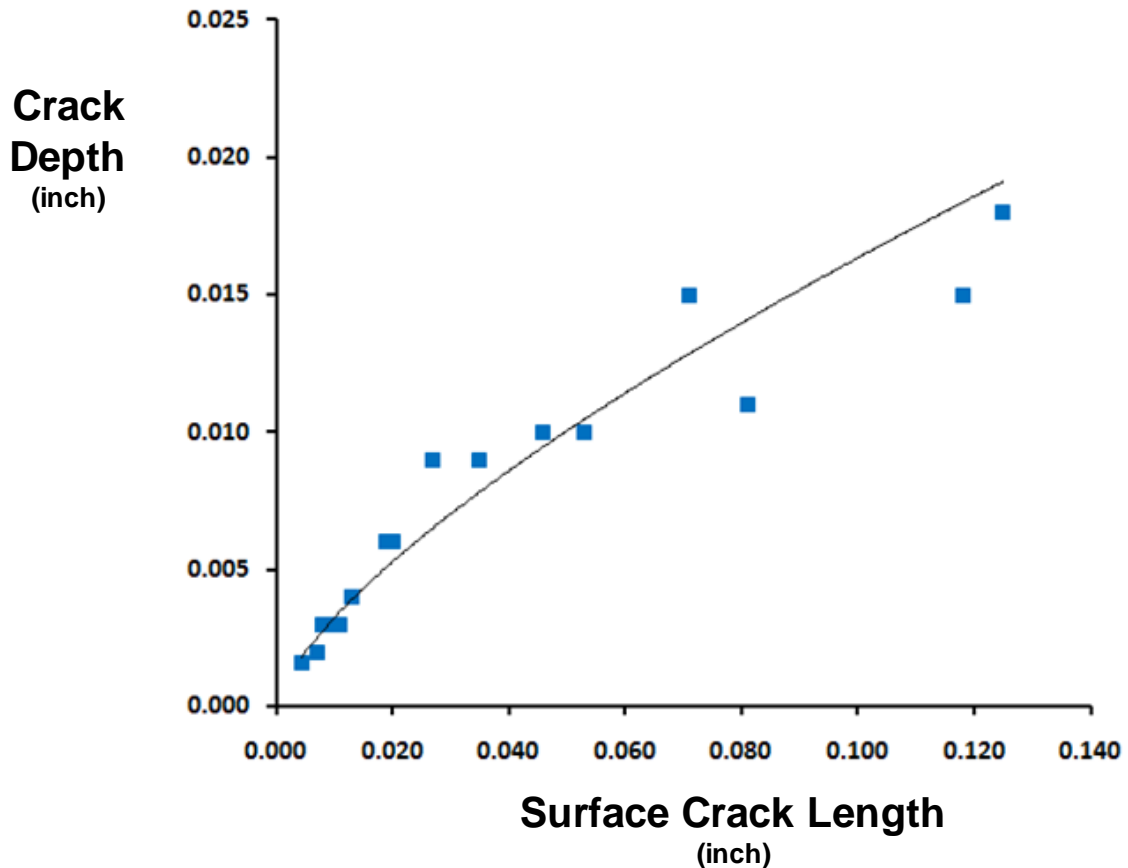
*Figure 5.4-11. Measured Crack Depth from the Destructive Examinations as a Function of the Surface Crack Length*

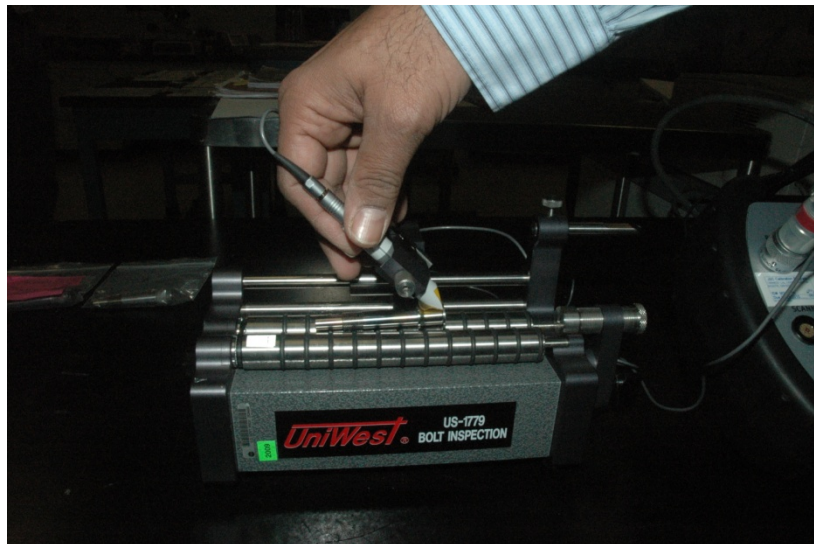
*Figure 5.5-1. US 1779 (UniWest) Bolt Inspection Scanner*

A poppet rotation device and a probe holder with controlled degrees of freedom were needed to establish a repeatable EC data acquisition process. A UniWest US 1779 bolt rotation device (Figures 5.5-1 and 5.5-2) and probe holder was the selected for this purpose. This configuration used a model US 1779 bolt rotation device/scanner and a model US 1839 probe (Figure 5.5-3). The probe tip has an included angle of 60 degree and a radius of 0.03125 inch (0.8 mm). The design allows the probe to contact the root of a bolt thread for detection of cracks at the thread root. The probe has two coils in a driver pick-up arrangement and their centers are separated by approximately 0.1 inch (2.54 mm). This configuration was used to inspect flight poppets and the popper simulators in the POD study.

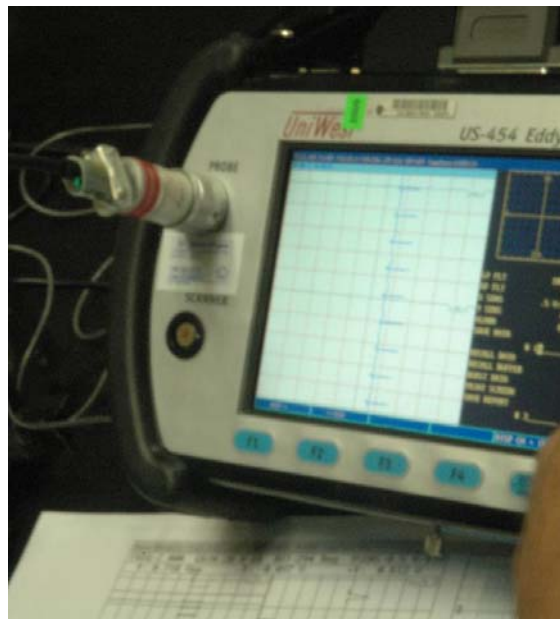
*Figure 5.5-2. US 454 (UniWest) EC Crack Detector*

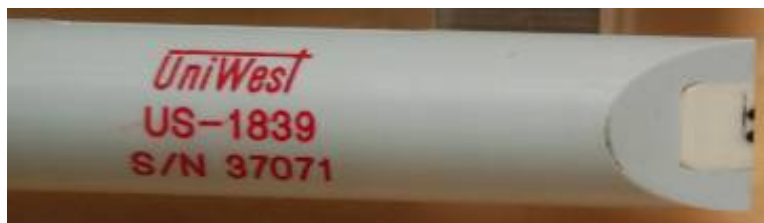
*Figure 5.5-3. EC Bolt Thread Root Inspection Probe US 1839*

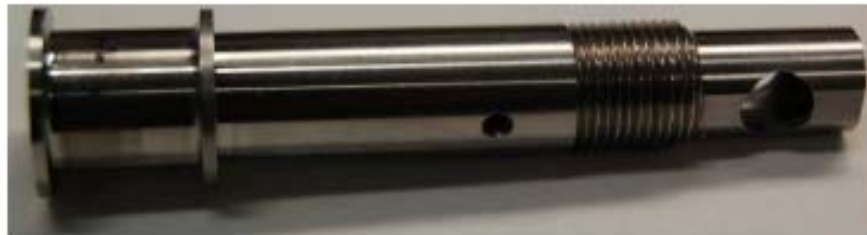
*Figure 5.5-4. S/N 33 Poppet Standard*

A frequency of 2 MHz was selected to optimize the detection of shallow cracks (0.005 inches (0.13 mm)). An electro-discharged machined (EDM) notch standard was fabricated from flight S/N 33-361 poppet (Figure 5.5-4). Note that any change in the magnetic permeability at notches due to the EDM process was not characterized. The notch dimensions were 0.030 long x 0.015 deep x 0.005 inch wide (0.76 x 0.38 x 0.13 mm). Three circumferential notches of the same size were machined in poppet S/N 33-361; the first notch was located at the center of the radius, the second was located at the radius tangential point with the shank, and the third notch was located at the radius tangential point with the flange.

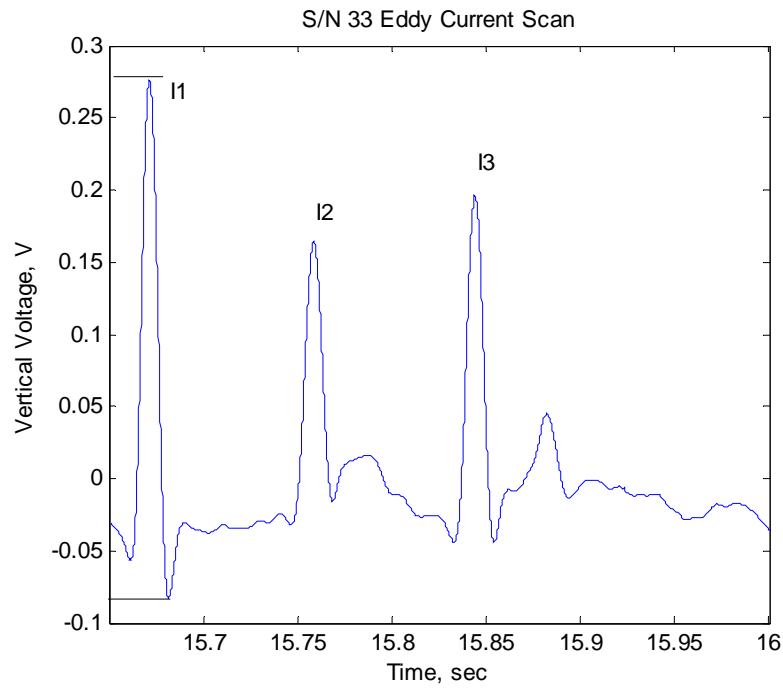
*Figure 5.5-5. EC Voltage Scan of S/N 33-361 Standard*

The voltage scan and phase diagrams were obtained from the EC responses for the three EDM notches of poppet S/N 33-361, as shown in Figures 5.5-5 and 5.5-6, respectively. The peak-to-peak voltage ( $V_{pp}$ ) was the difference (0.36  $V_{pp}$ ) between the two horizontal lines that bracket the I1 indication in Figure 5.5-5. Scanning of the EC probe causes a slight back and forth movement that causes lift-off of the probe coil relative to the contact surface. The EC response changes along a particular direction in the phase diagram due to this lift off, as indicated by the double arrow in phase diagram of Figure 5.5-6. Crack indications will appear as a sharp increase in the voltage scan and will have tight phase loops that point towards 1 to 2 o'clock on the phase diagram. Poppet S/N 33-361 also has a smaller crack-like indication to the right of the I3 peak and a non-crack-like indication between the I2 and I3 peaks in the voltage scan of Figure 5.5-5. However, the magnitude of these additional signals is small in relation to the typical background noise level and they have not been associated with additional detected cracks or defects.

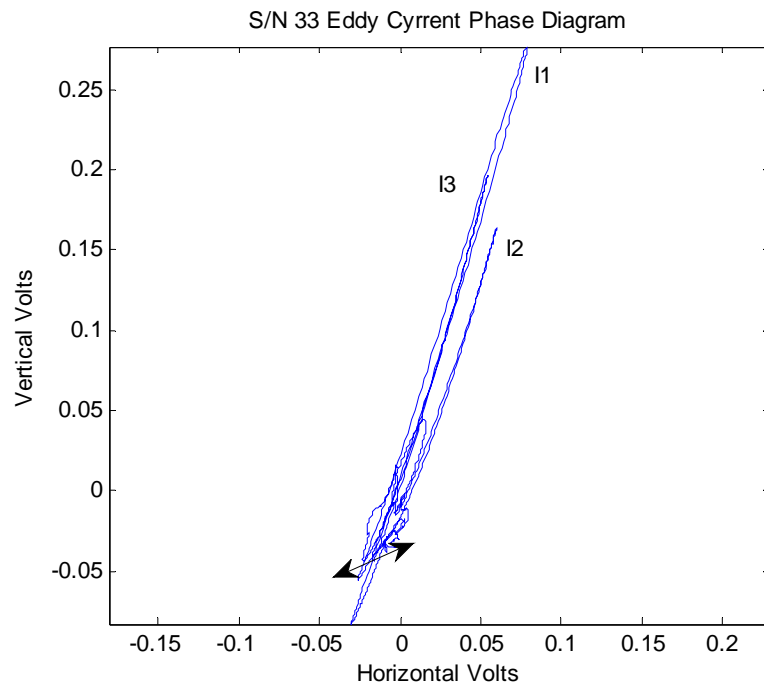
*Figure 5.5-6. EC Phase Diagram of S/N 33-361 Standard*

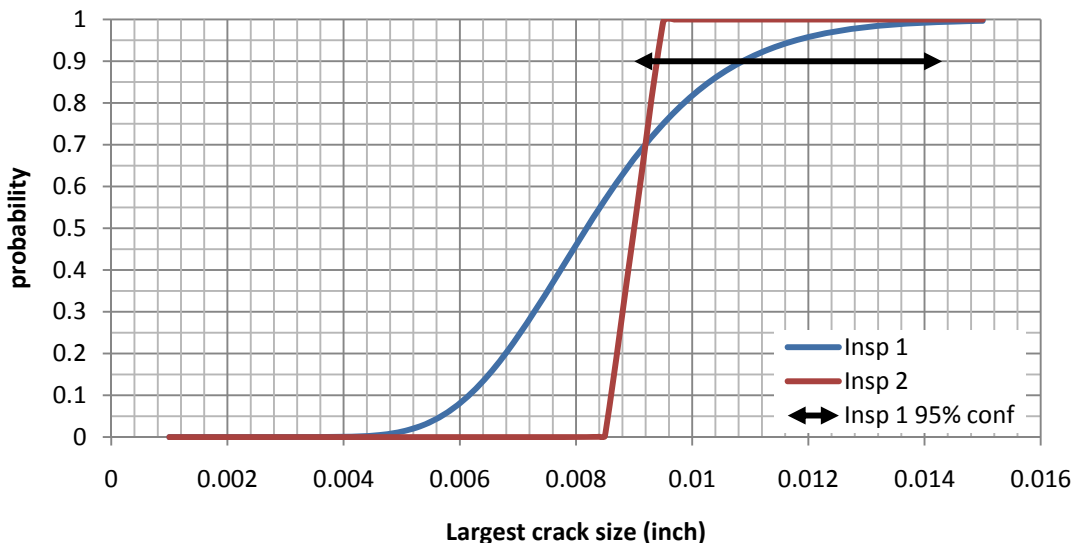
**Figure 5.5-7. Estimated POD Curves from Hit/Miss Data. 95 Percent Confidence on Crack Size yielding a POD of 0.90 is shown for Inspector 1**

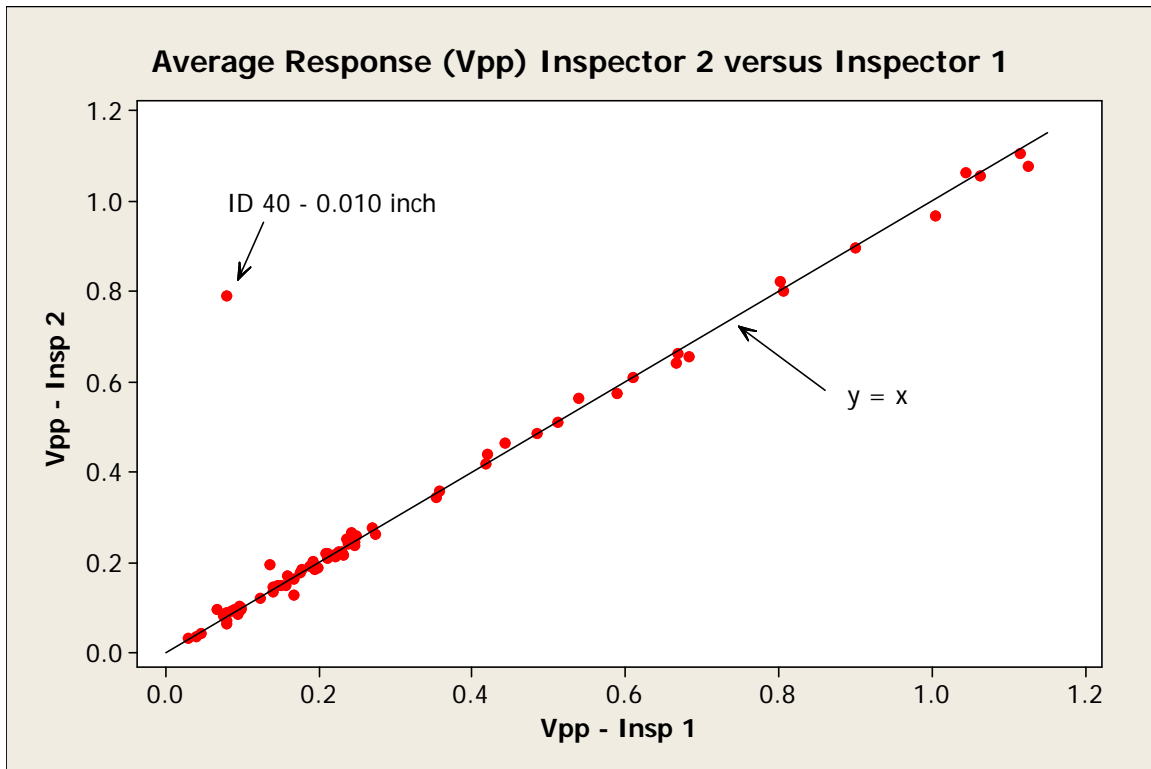
*Figure 5.5-8. The Vpp Response of Inspector 2 versus Inspector 1*

The initial analysis of the response signal data was to ascertain if the data exhibited an influence due to the individual inspector. The Vpp responses reported from individual poppet simulators by the two inspectors were compared, as shown in Figure 5.5-8, and nearly all of the measurements fall on a line with a slope of 1. The only exception was on poppet simulator #40, where the recorded Vpp value from Inspector 1 was an order of magnitude lower than that from Inspector 2. A re-examination of the recorded signals indicated that a clerical error had occurred and Inspector 2 had examined poppet simulator ID41 twice and had skipped poppet simulator ID40. Thus, only the one correct value for ID40 was carried through the analysis.

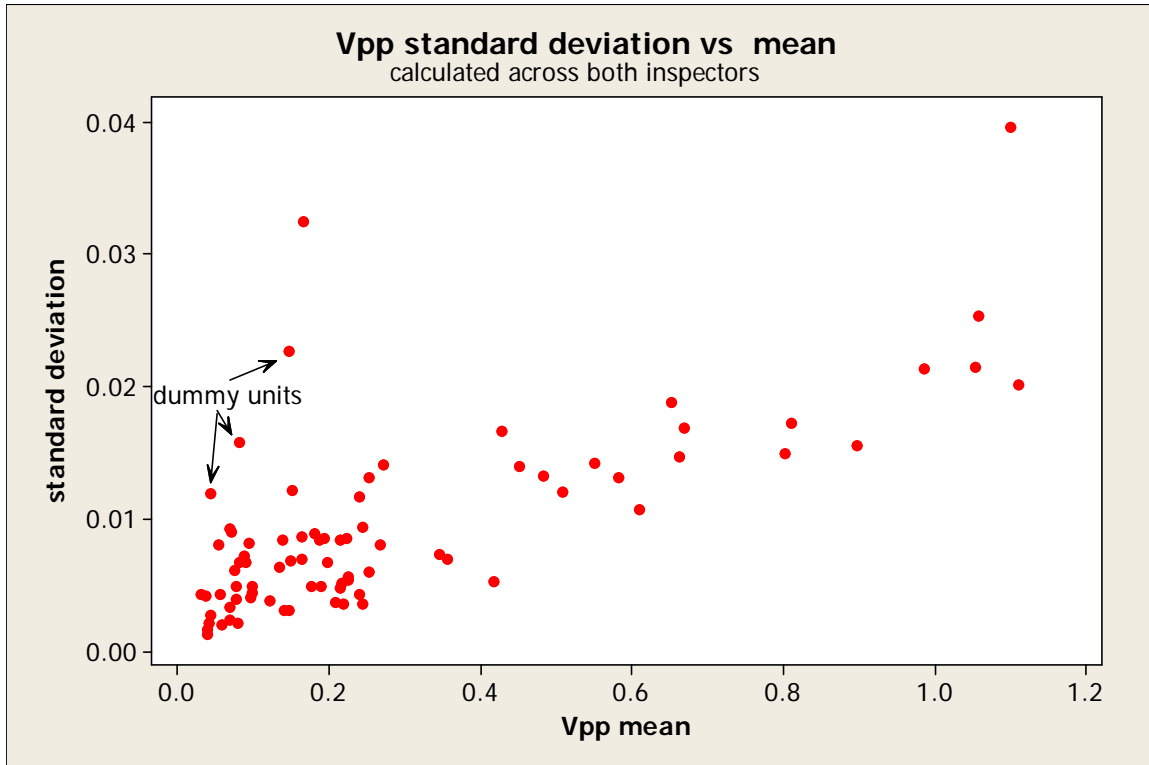
Figure 5.5-9. Standard Deviation versus Mean of the Vpp Responses (combined for both inspectors) for Individual Poppet Simulator Inspections

against the log crack size in an “a-hat” versus “a” analysis. However, the log response transformation overly compensates for a standard deviation that increases with increasing crack size and undercompensates for a standard deviation that decreases with increasing crack size. The family of power transforms (that includes the log transform as a special case) was chosen as candidates to stabilize the uncertainty across the crack size range.

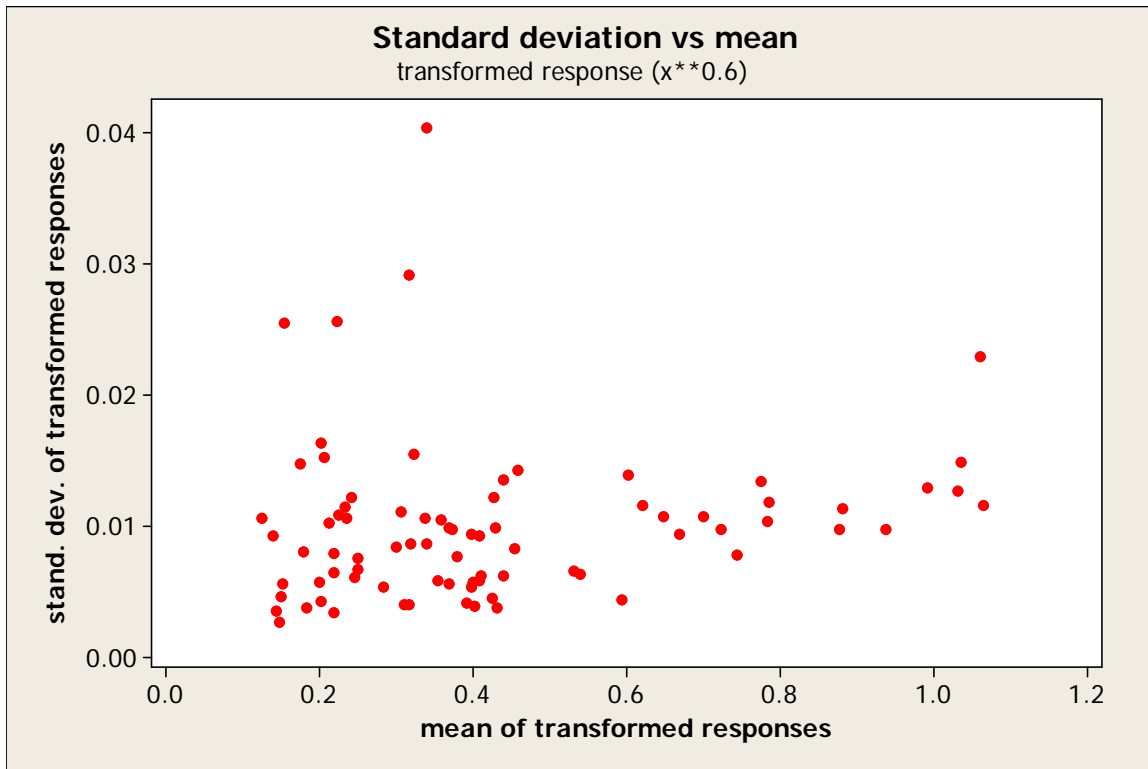
Figure 5.5-10. Standard Deviation versus Mean of the Vpp Responses Transformed by a Power of 0.6 (combined for both inspectors) for Individual Poppet Simulator Inspections

A power of 0.6 ( $x^{0.6}$ ) was found to provide the best stabilization of the variances for the entire crack size range, as shown in Figure 5.5-10. Note that, aside from a few extreme values, the tendency for standard deviation to increase with increasing crack sizes has been diminished. Three of the five points with largest standard deviations in Figure 5.5-10 were from inspections of the uncracked (control) poppet simulators. The remaining two points were from poppet simulators where the averages from the individual inspectors had the greatest difference. In other words, the higher standard deviations result from a combination of repeatability within inspector, and an inspector-to-inspector increase in variation.
