NASA/TM-2011-217072/Volume I  
NESC-RP-09-00506

# Space Shuttle Program (SSP) Orbiter Main Propulsion System (MPS) Gaseous Hydrogen ( $\text{GH}_2$ ) Flow Control Valve (FCV) Poppet Eddy Current (EC) Inspection Probability of Detection (POD) Study

<b>NASA Engineering and Safety Center Technical Assessment Report</b>	Document #: <b>NESC-RP- 09-00506</b>	Version: <b>1.1</b>
Title: <b>STS-126 MPS#2 GH<sub>2</sub> Flow Control Valve Broken Poppet</b>			Page #: 1 of 59

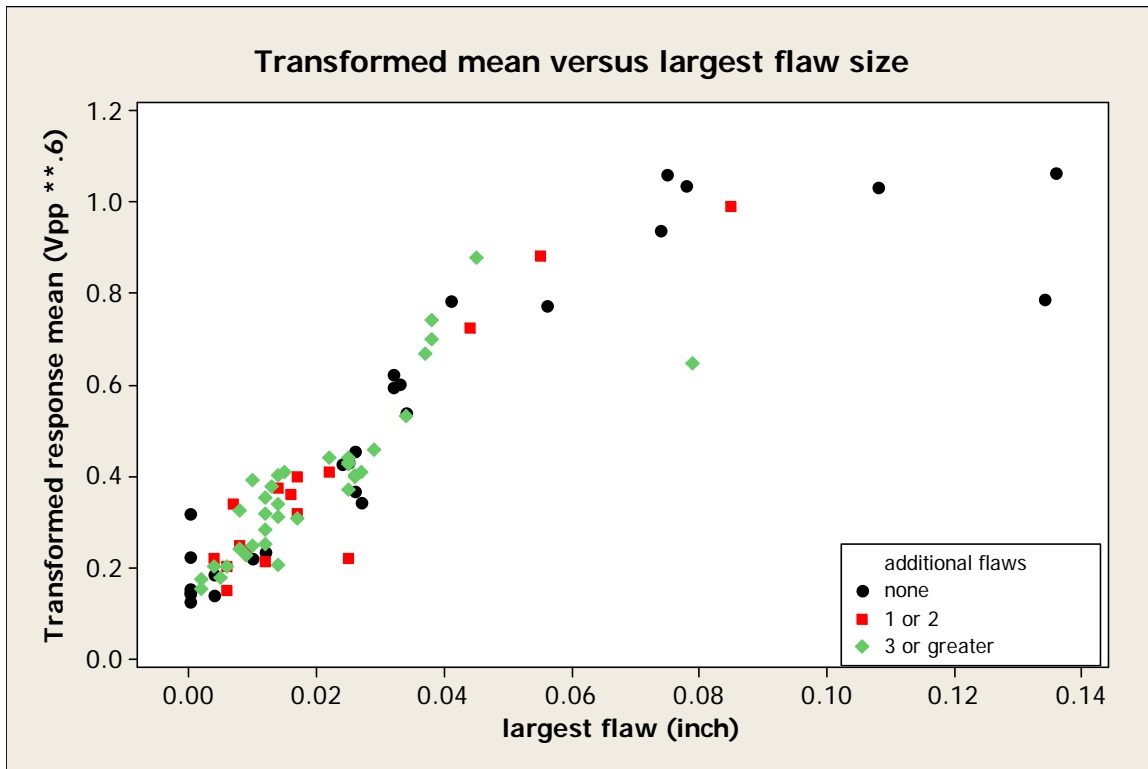
Figure 5.5-11. Transformed Response versus Largest Crack Length for Individual Poppet Simulator Inspections

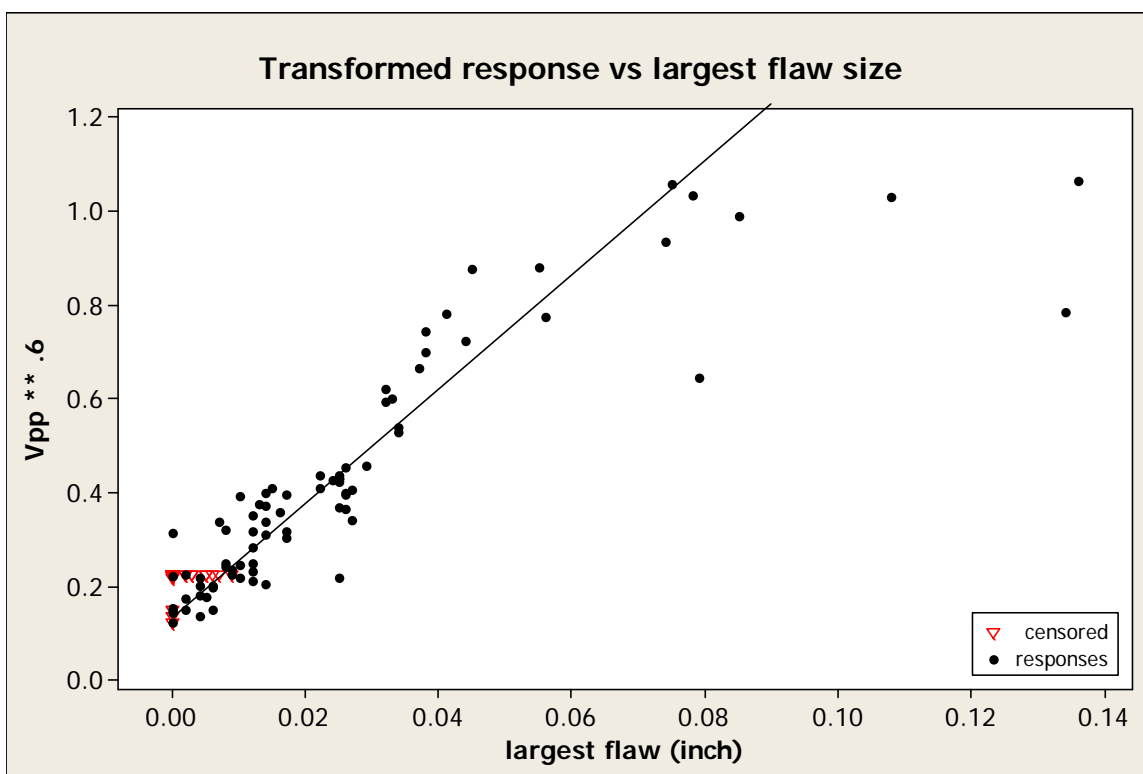
*Figure 5.5-12. Linear Fit in the Transform Scale with Censored Data Shown*

The variation of points around the mean characterized by a standard deviation estimate of  $\hat{\sigma} = 0.0711$ . This linear fit, overlaid with the observed and censored responses, is shown Figure 5.5-12.

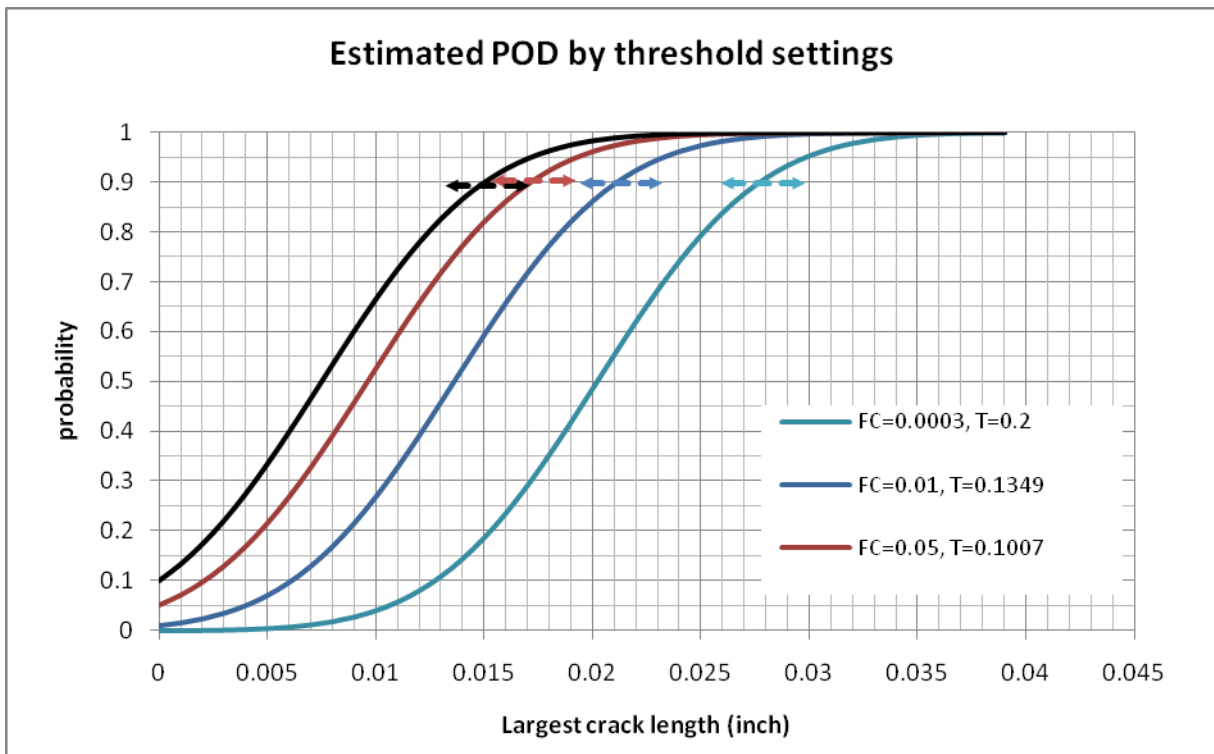
**Figure 5.5-13. Estimated POD Curves from Signal Strength ( $V_{pp}$ ) versus size of Longest Crack. The 95 percent confidence on Crack Length Yielding a POD of 0.90 is shown for Threshold Level.**

The threshold level of 0.20 (probability) was included in Figure 5.5-13 because that level had been previously proposed for the screening of flight poppets. The estimated false call rate associated with the 0.20 threshold level was small (< 0.03 percent) based on the analysis that used the longest crack length as the explanatory variable.

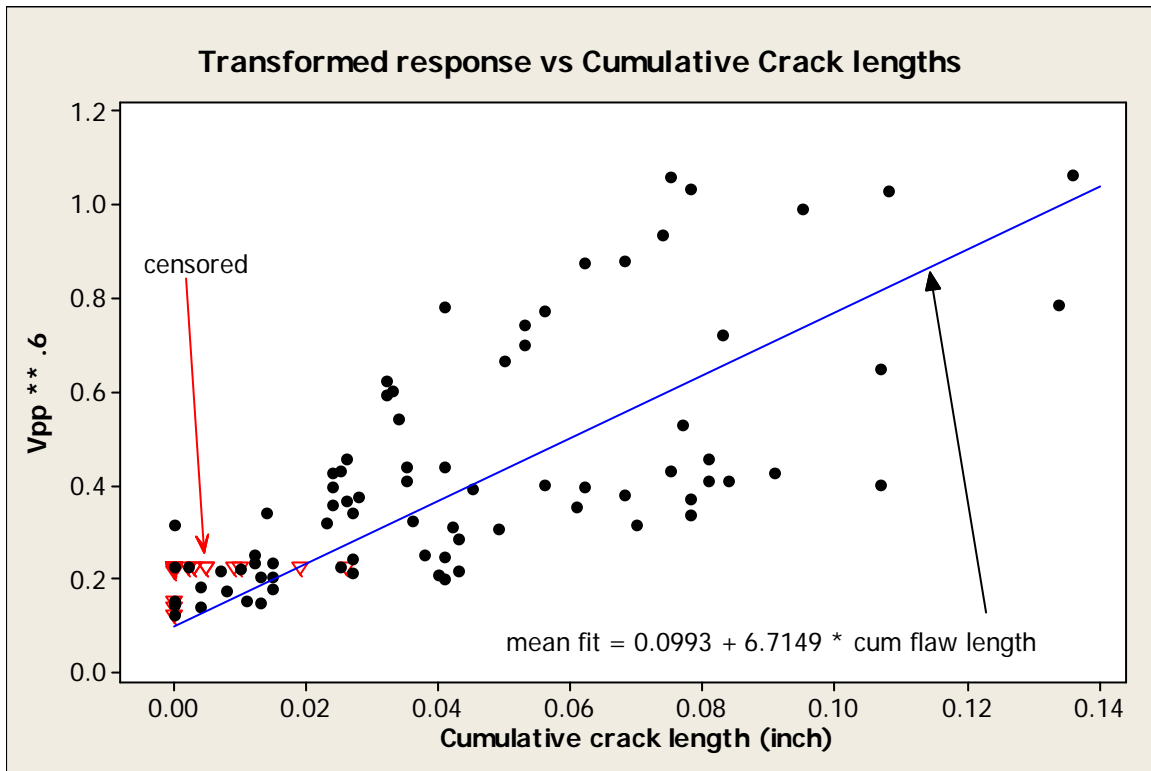
*Figure 5.5-14. Transformed Response versus Cumulative Crack Lengths*

variation about the mean line likely increased as the total crack lengths increased. However, as indicated with the response versus the longest crack length, it may be the case that the signal response would eventually flatten out. The data with respect to the cumulative crack length variable are not sufficient to estimate if and where this might occur.

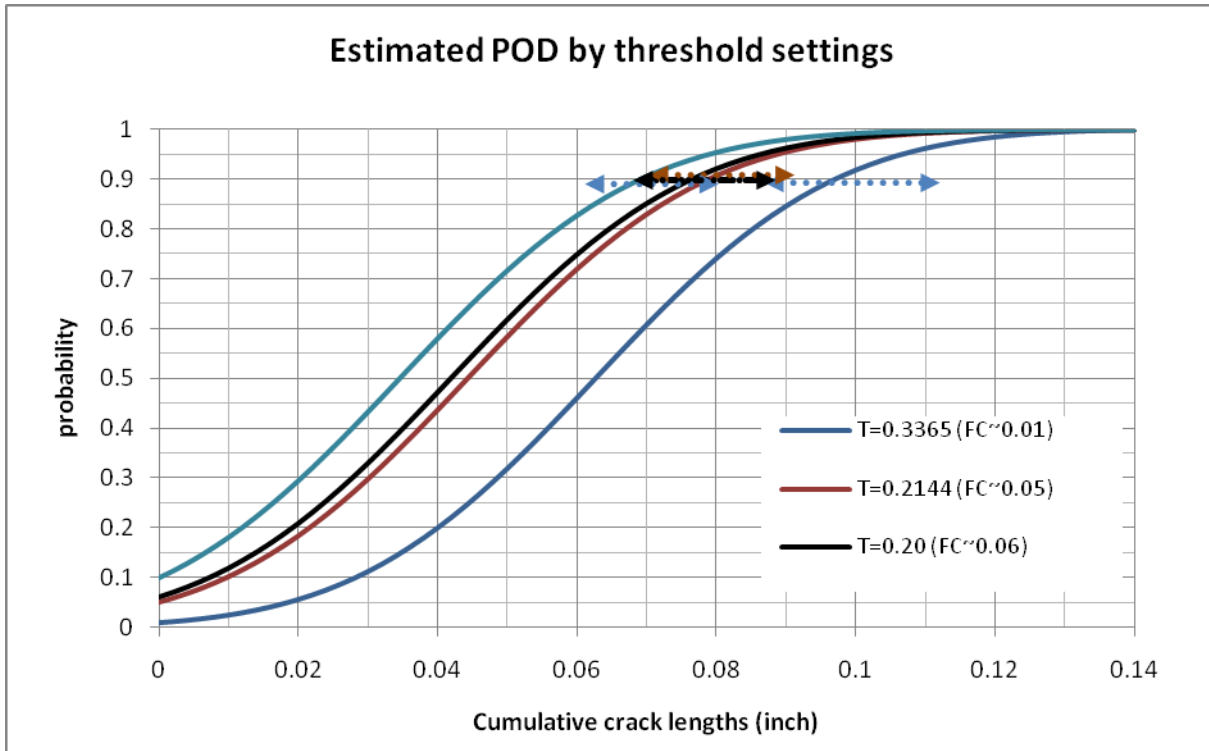
Figure 5.5-15. Estimated POD curves from signal strength ( $V_{pp}$ ) versus sum of all crack lengths in loaded region. The 95 percent confidence on crack length yielding a POD of 0.90 is shown for threshold level.

The POD curves were estimated for different threshold levels, as shown in Figure 5.5-15. The large variation around the mean line calculated using the cumulative crack length as the explanatory variable, resulted in the estimated false call rate for the proposed threshold level of 0.20 volts to be approximately 6 percent.

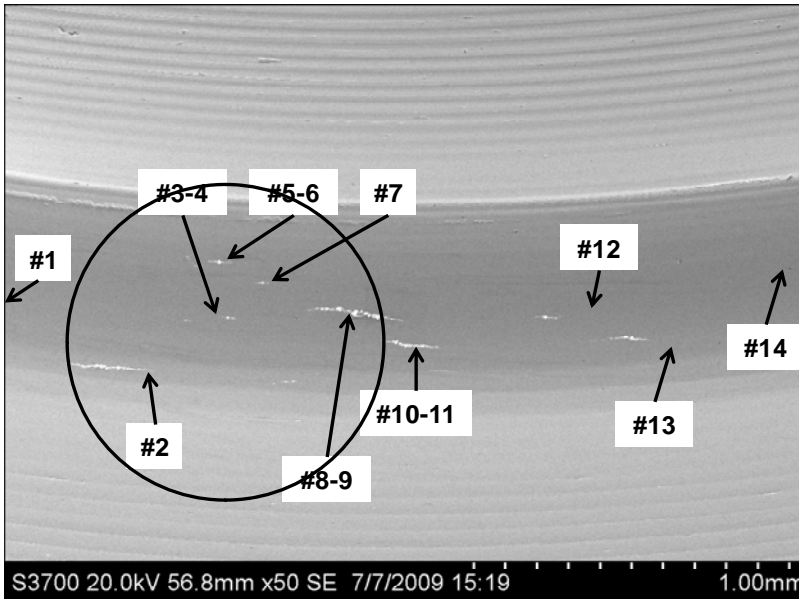
Cracks 2, 3, 4, 5, 6, 7, 8, and 9 are within the 0.04" circle

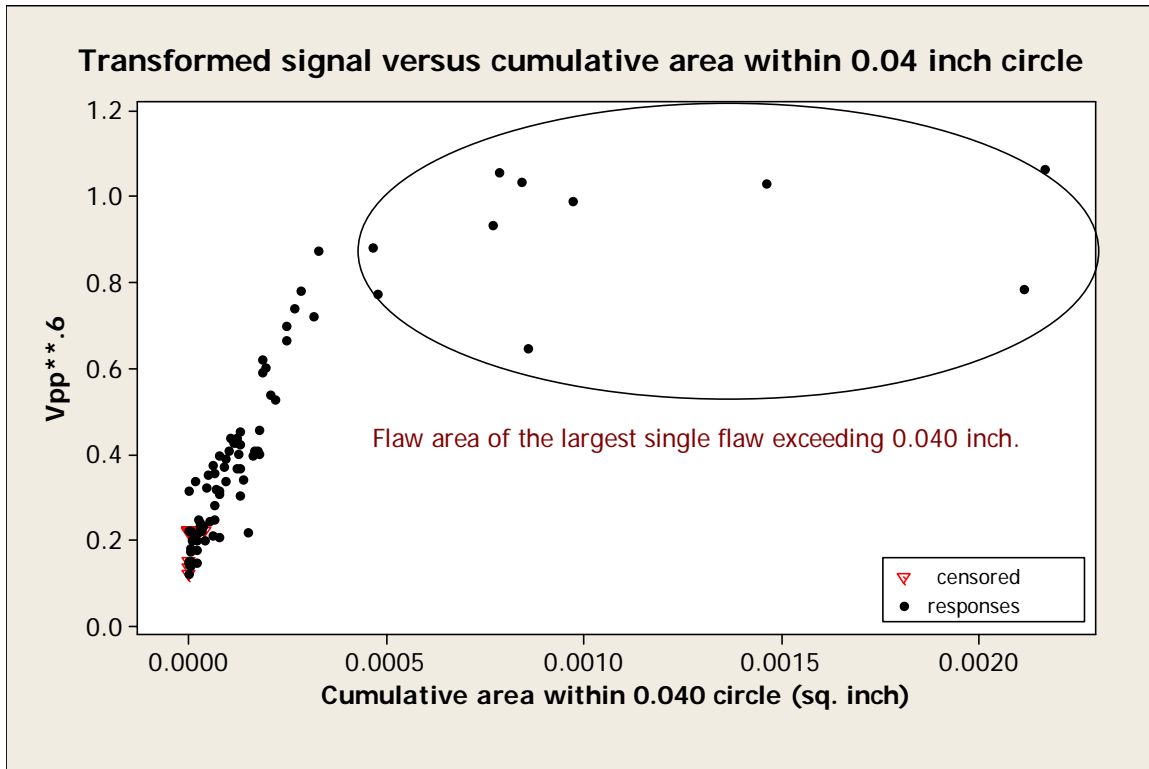
*Figure 5.5-17. Transformed signal versus maximum cumulative area within 0.04 inch (1.0 mm) circle. Regions containing single cracks larger than 0.040 inch (1.0 mm) are shown with cross sectional area from the largest single crack.*

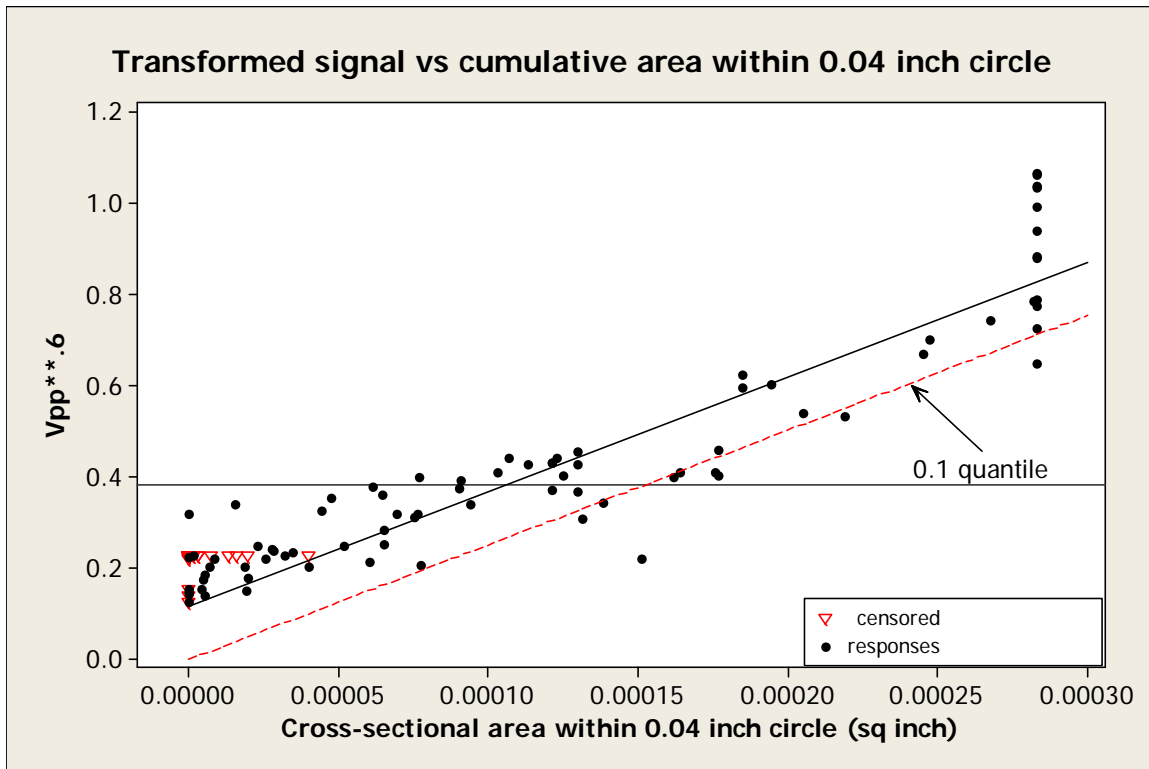
Figure 5.5-18. Transformed signal versus maximum cumulative area within 0.04 inch (1.0 mm) circle. Regions containing single cracks larger than 0.040 inch (1.0 mm) are shown with cross sectional area from the largest single crack.

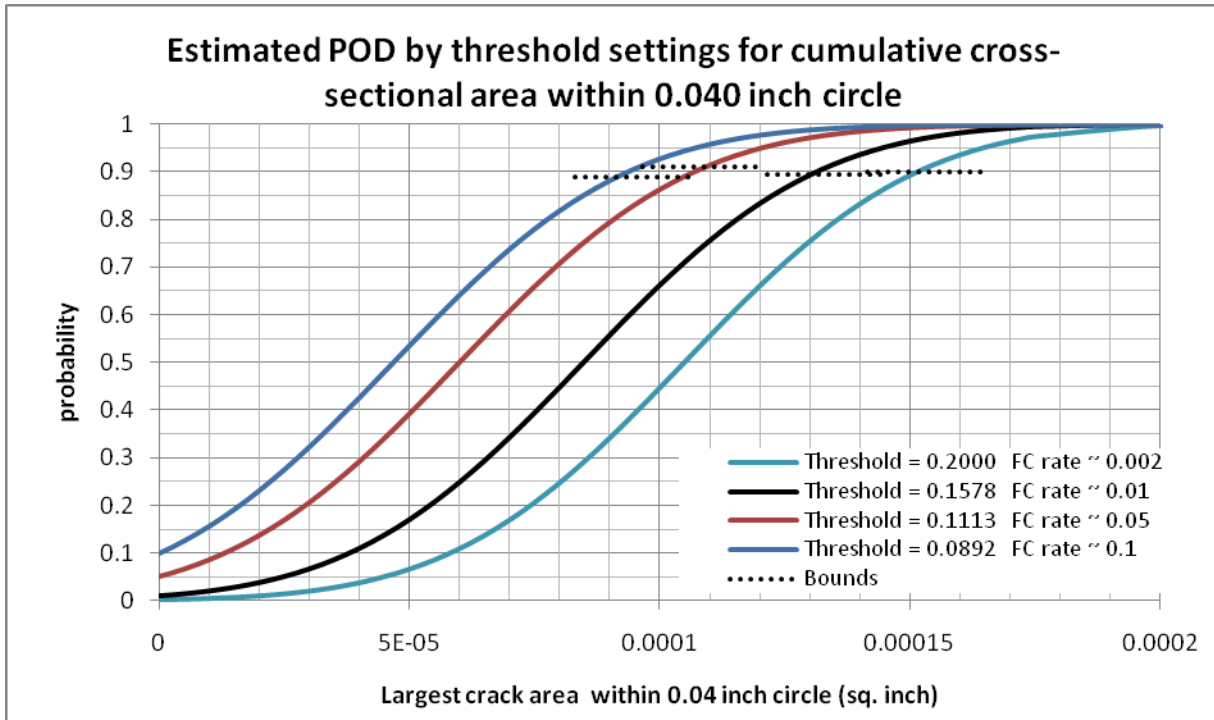
Figure 5.5-19. Estimated POD curves from signal strength ( $V_{pp}$ ) versus Cumulative Cross-Sectional area of Flaws within 0.04 inch (1.0 mm) Circle

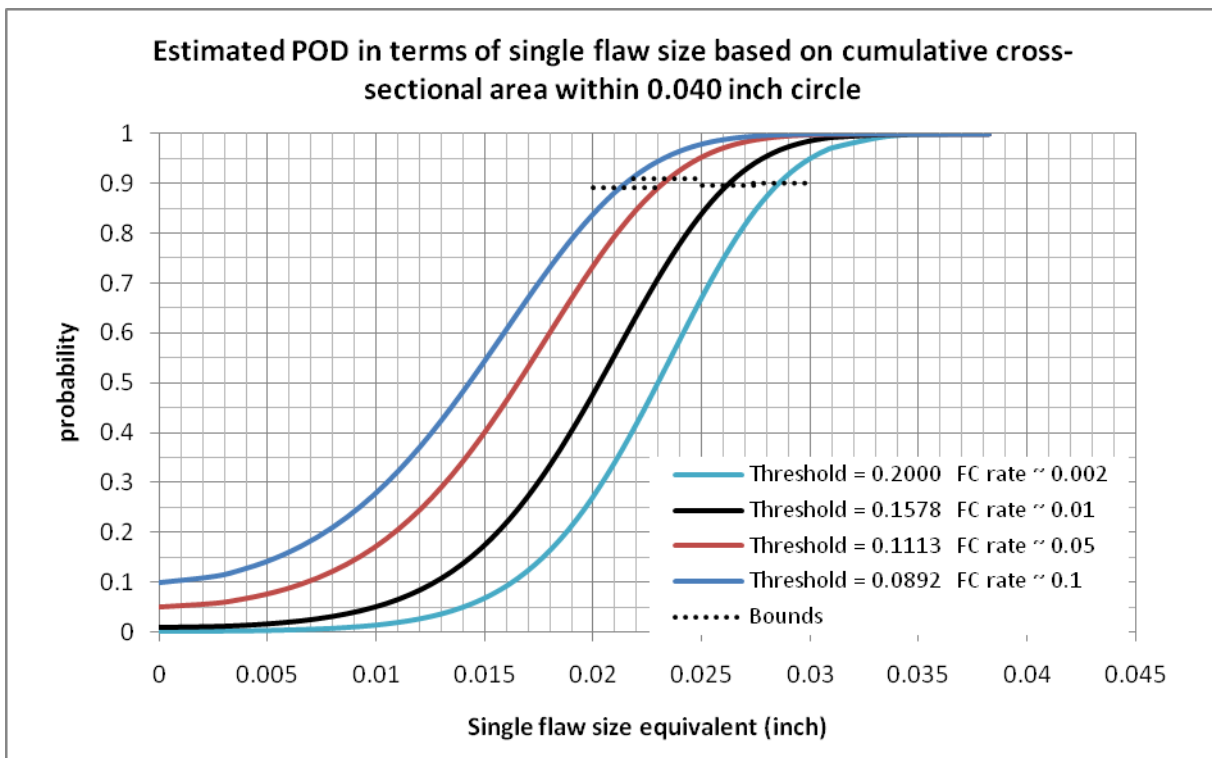
Figure 6.0-1. Estimated POD curves of Figure 5.5-19 with the x-axis transformed to the single surface crack length yielding the cross-sectional area estimates.
