Multistrada 1200 Enduro Rear Shock Absorber

Models: Model Year 2016-2017 Multistrada 1200 Enduro (all country versions)

Recall Bulletin SRV-RCL-17-002

NHTSA Campaign I.D. Number: 17V274
Transport Canada Safety Recall I.D. Number: 2017-223

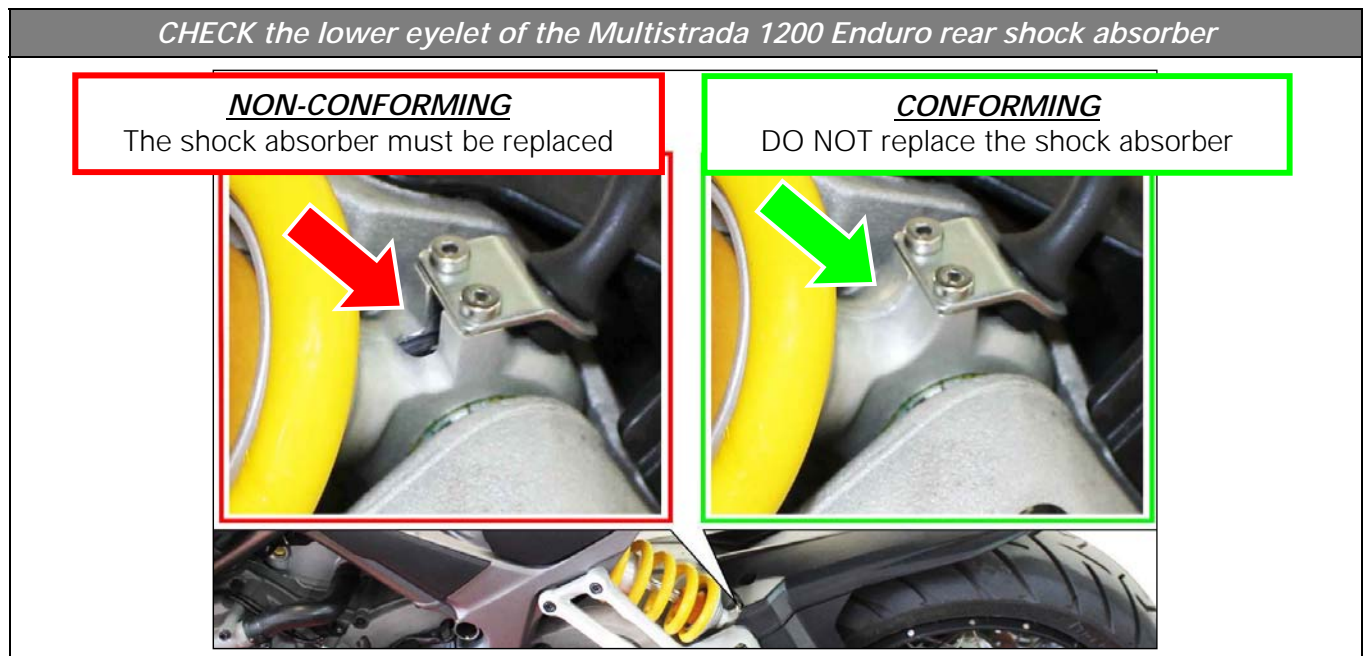
Continuous quality tests on the product in operation has revealed a potential problem with the lower eyelet of the Sachs semi-active rear shock absorber, which attaches the shock absorber to the swing-arm. Intense off-road use of the Multistrada 1200 Enduro could lead to breakage of the lower eyelet. To prevent possible breakage, the lower eyelet of the rear shock absorber was redesigned to make it more robust. The new part number of the rear shock absorber with modified eyelet is 36521464A.

On the motorcycles involved it is therefore necessary to perform a visual inspection of the eyelet structure; and if it is not conforming proceed with the replacement of the shock absorber.

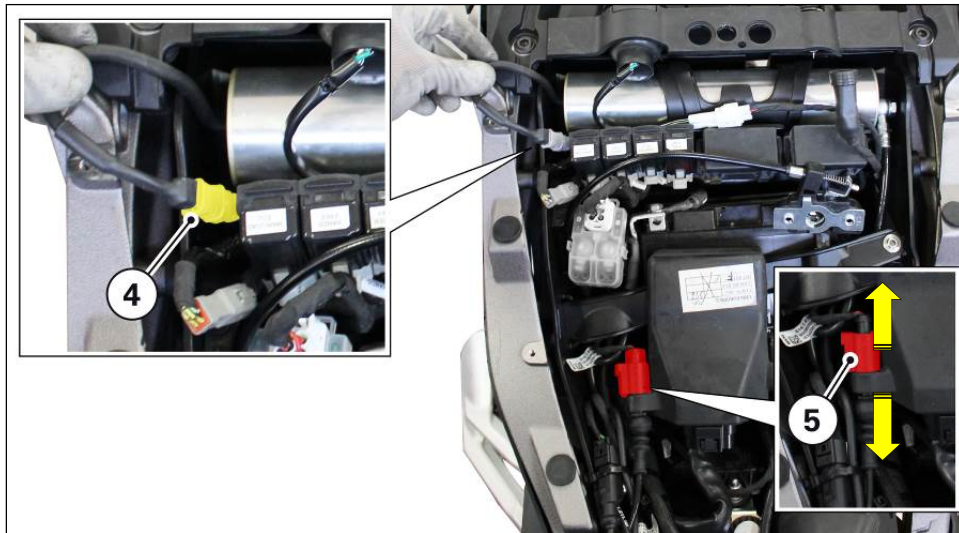
- 5) Disconnect the pre-load adjustment **connector (4)** and rear shock absorber adjustment **connector (5)** sliding it out of its seat on the BBS control unit support.

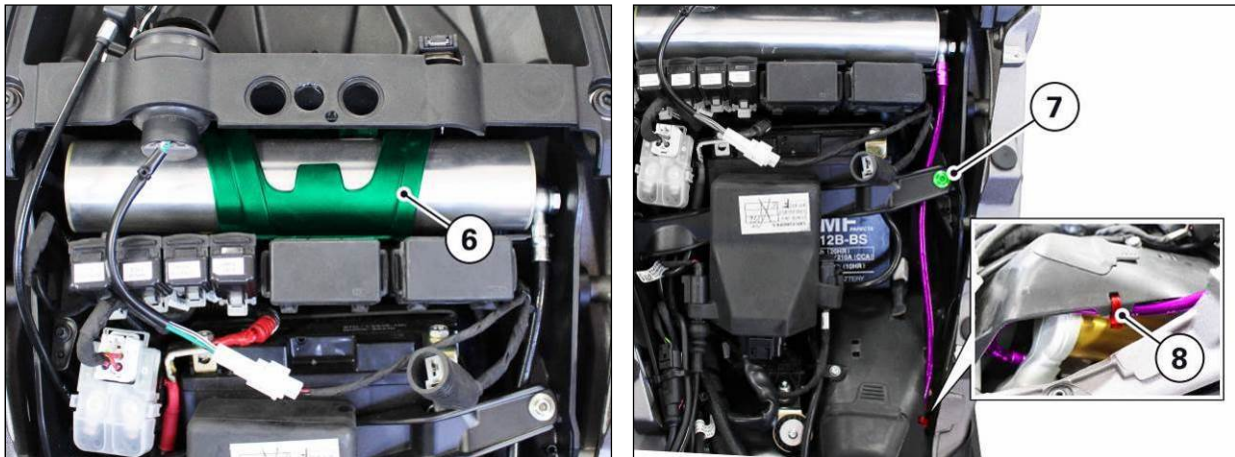
- 6) Remove the pre-load actuator fastening **bracket (6)**.

- 7) Remove the **screw M5x0.8 (7)** fastening the support bracket of the BBS control unit/battery and the **self-locking tie (8)** so as to release the pre-load actuator pipe.

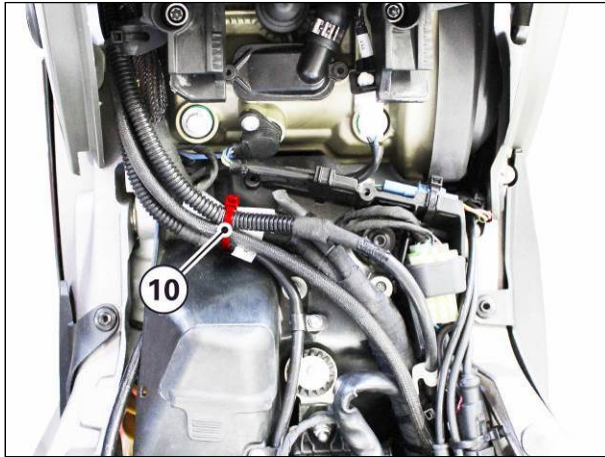
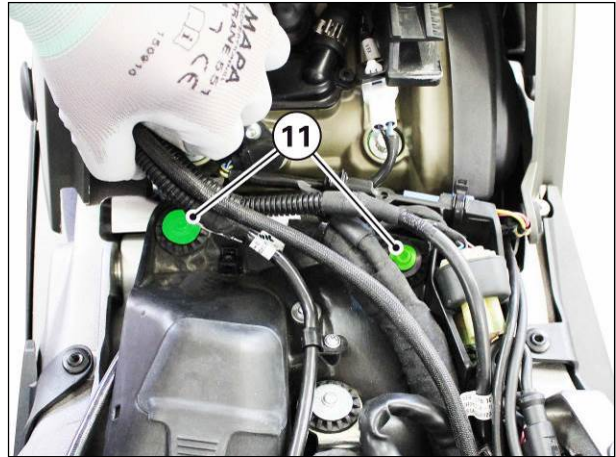
- 9) Remove the **2 screws M6x1 (11)** securing the electric components support to facilitate the subsequent removal of the pre-load actuator.

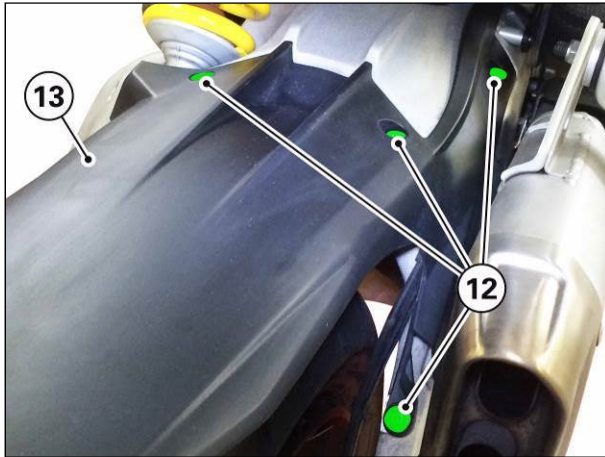
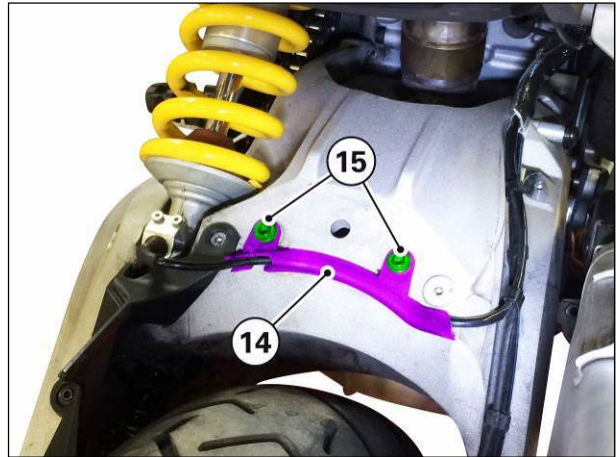
- 10) Remove the **4 screws M5x10.5 (12)** securing the **rear mudguard (13)** to the swing-arm and slide it out.

- 11) Remove the **swing-arm cable guide (14)** by unscrewing the **2 screws M5x10.5 (15)**.

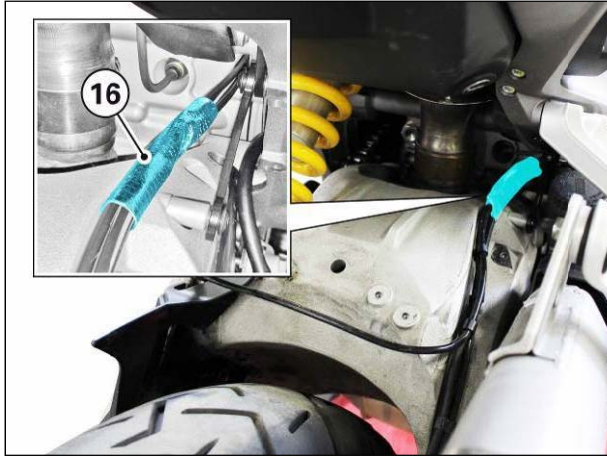
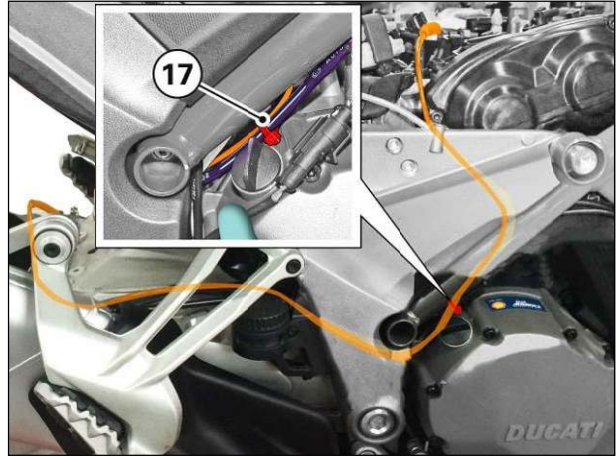
- 13) Remove the **self-locking tie (17)** that joins the rear brake cable/shock absorber adjustment cable.

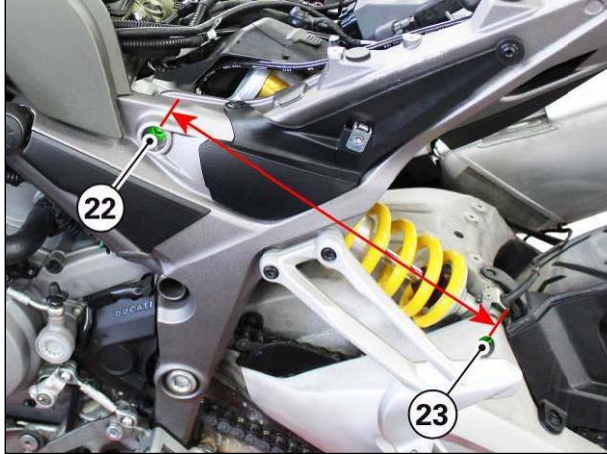
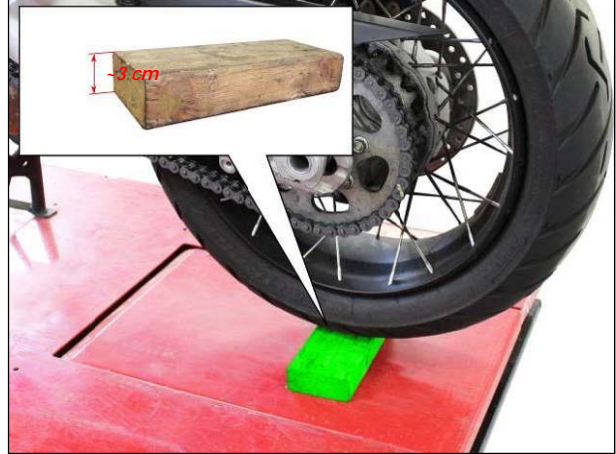
- 15) Remove the **upper screw M10x60 (22)** and the **lower special screw (23)** fastening the rear shock absorber to the frame and swing-arm respectively.

Before removing the shock absorber we suggest positioning a block (height ~3cm) under the rear wheel so as to maintain the distance between centers of the fastening holes and therefore facilitate the reassembly.

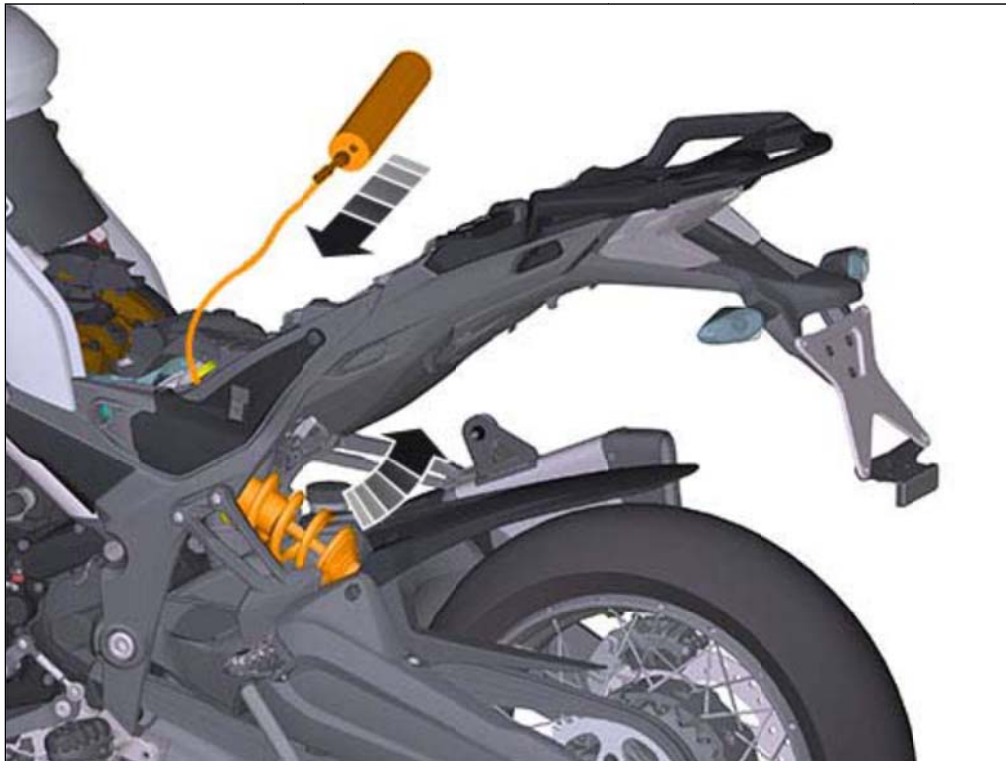
- 16) Lift the electrical components support to allow the pre-load actuator to pass, taking advantage of the space between the frame and the support itself. Remove the shock absorber.

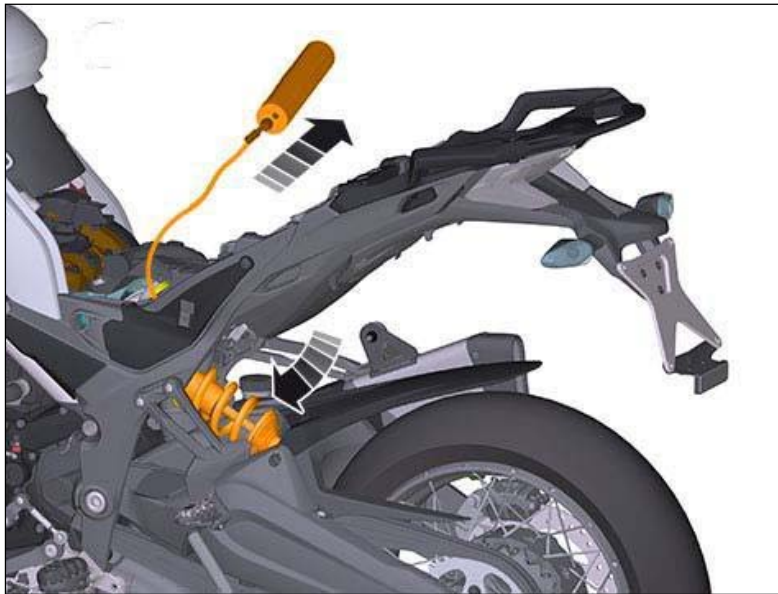
1) Take the **new rear shock absorber part no.36521464A** and insert the pre-load actuator inside the frame taking advantage of the space between the electrical components support and the frame itself. Also position the new shock absorber as shown in the figure.

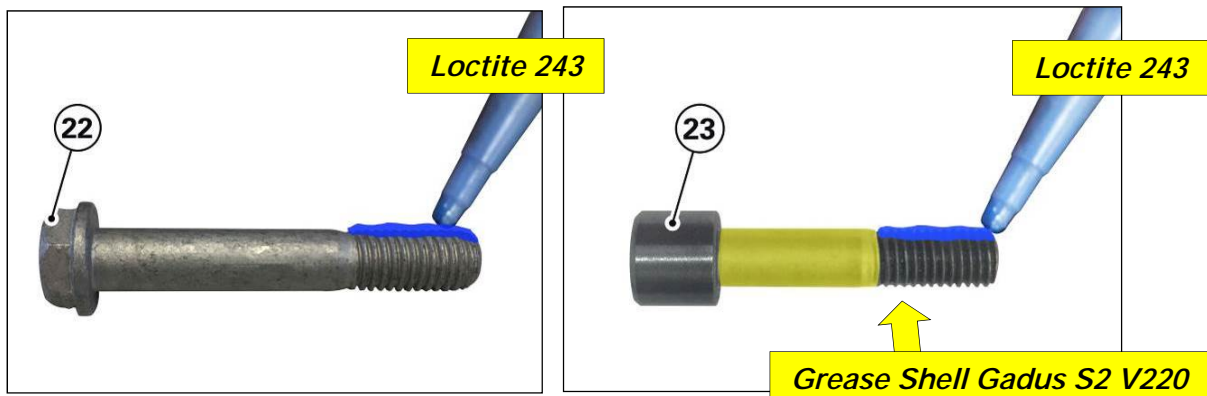
2) Clean the threads of the **screw M10x60 (22)** and of the **special screw (23)** to remove the threadlocker previously applied.

- Apply Loctite 243 to the threading of **upper M10x60 screw (22)**;
- Apply Loctite 243 along the threading and grease SHELL GADUS S2 V220 AD2 on the underhead of the **lower special screw (23)**;

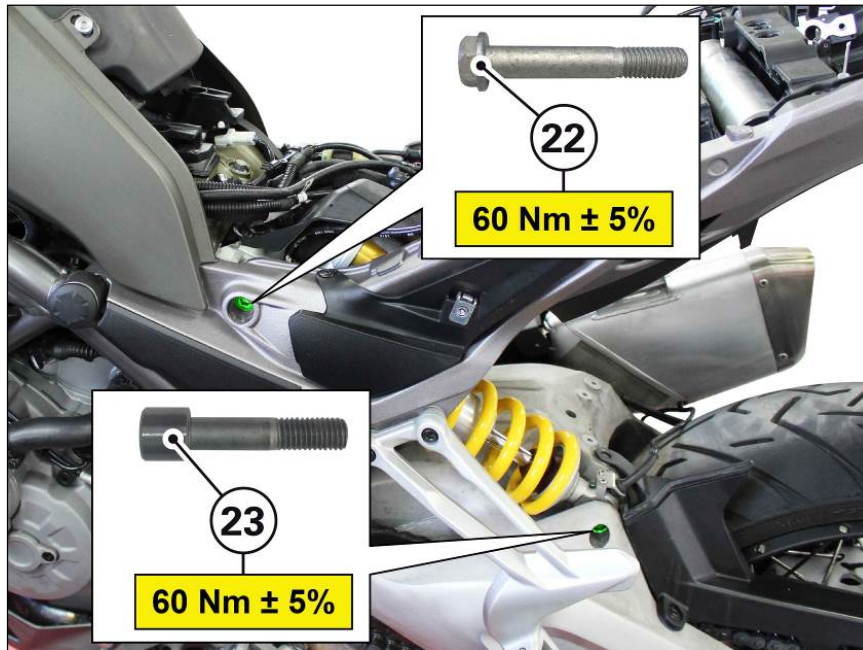
- 3) Tighten **upper M10x60 screw (22)** and **special lower screw (23)** to a torque of **$60 \text{ Nm} \pm 5\%$** .

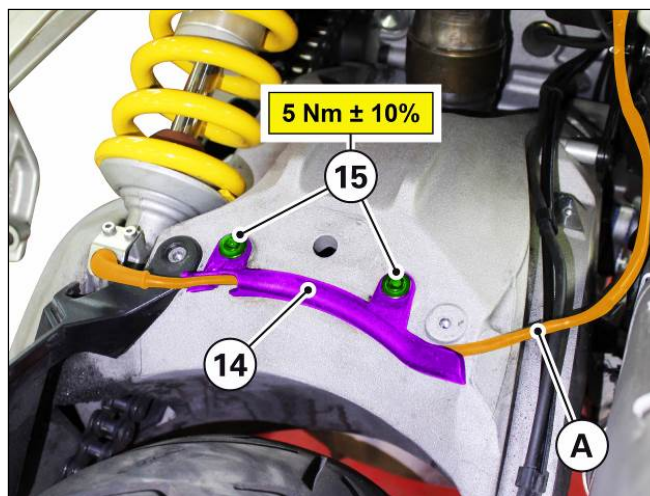
- 4) Remove block positioned under the rear wheel.
- 5) Fit the rear shock absorber adjustment **cable (A)** inside the **cable guide (14)** and position it on the swing-arm oriented as illustrated in the figure.

Tighten the **2 screws M5x10.5 (15)** to a torque of **$5 \text{ Nm} \pm 10\%$** .

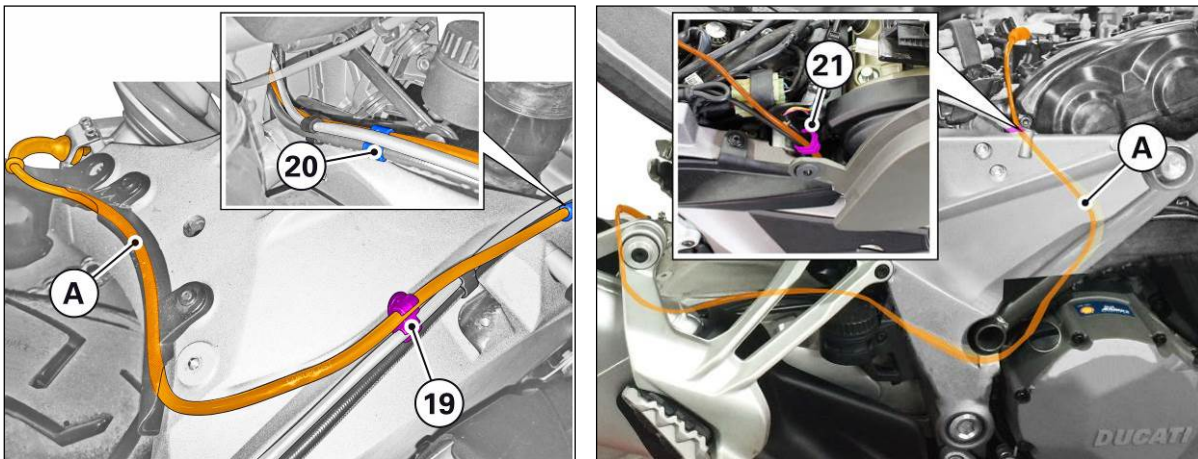
6) Restore the correct positioning of the rear shock absorber adjustment **cable (A)** respecting the position of the **cable guide (19)** (rear speed sensor cable-rear shock absorber adjustment cable) and **(20)** (rear shock absorber adjustment cable-rear brake cable) shown in the figure.

The rear shock absorber adjustment **cable (A)** follows the rear brake oil hose, then passing under the pin fastening engine to the frame plate. Subsequently the cable passes over the exhaust butterfly valve motor cover and continues towards the underseat compartment passing through the **cable guide (21)** as shown in the figure.

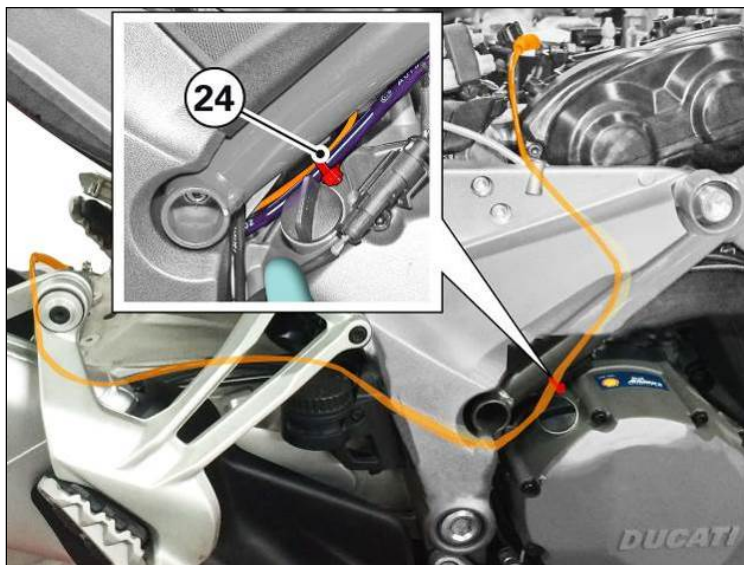
7) Fasten the rear shock absorber adjustment cable (A) and the rear brake hose with a **self-locking tie (24)**.

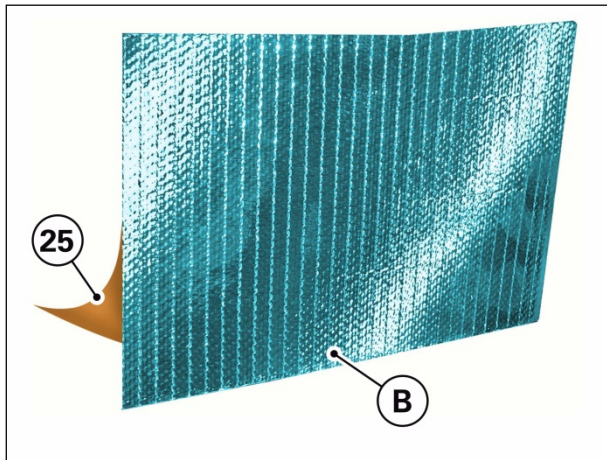
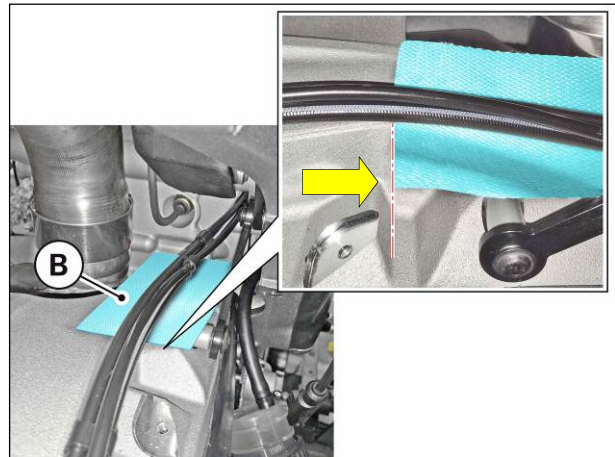
- 8) Install a **new heat reflective shielding (B) part no. 4601E651A** following the procedure below:
- remove the **protective film (25)**;
 - position the heat reflective sheath (B) below the rear brake hose, shock absorber adjustment cable and rear speed sensor cable, aligning it with the rib of the swinging arm as shown in the figure;

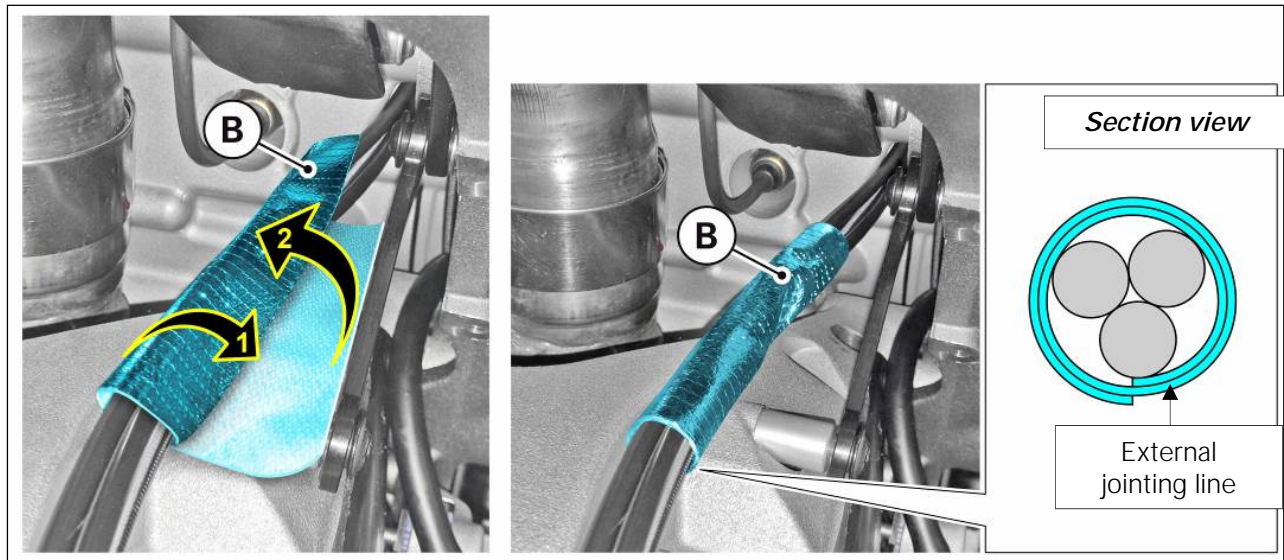
- wrap heat reflective sheath (B) around the rear brake hose, shock absorber adjustment cable and rear speed sensor cable, making sure that the external longitudinal section is positioned at the lower part of the heat reflective material, as shown in the figure.

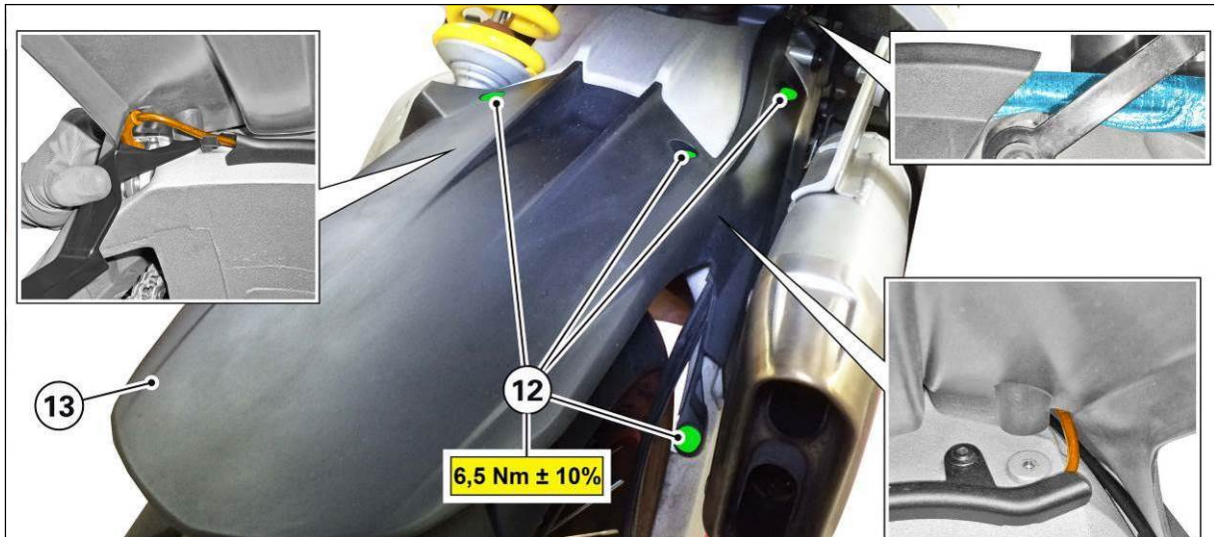
- 9) Reinstall the **rear mudguard (13)** and tighten the **4 fastening screws M5x10.5 (12)** to a torque of **6.5 Nm ± 10%**.

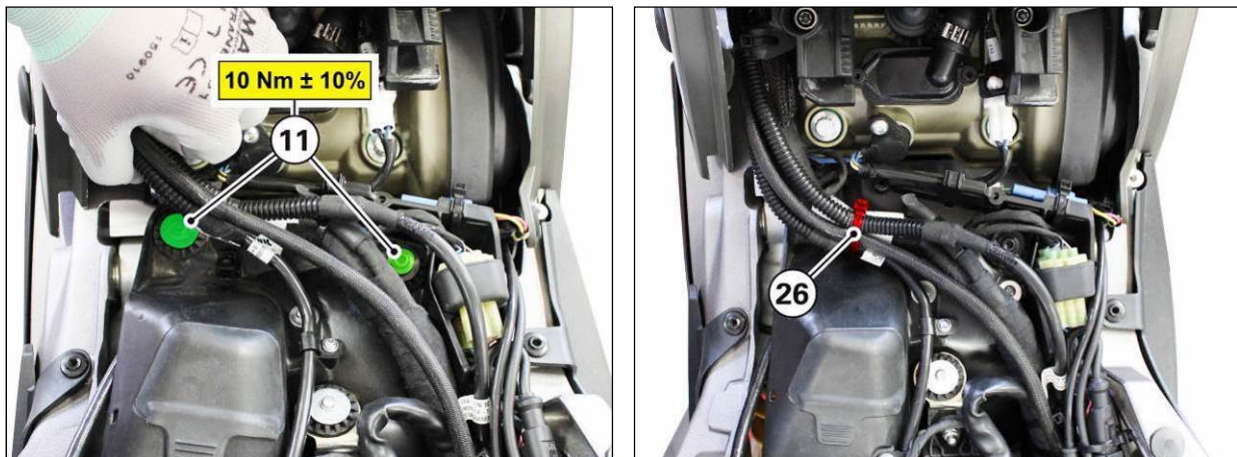
- 10) Fasten the electrical components support by tightening the **2 screws M6x1 (11)** to a torque of **10 Nm ± 10%**.

- 11) Fasten main wiring using a **self-locking tie (26)** as shown in the figure.

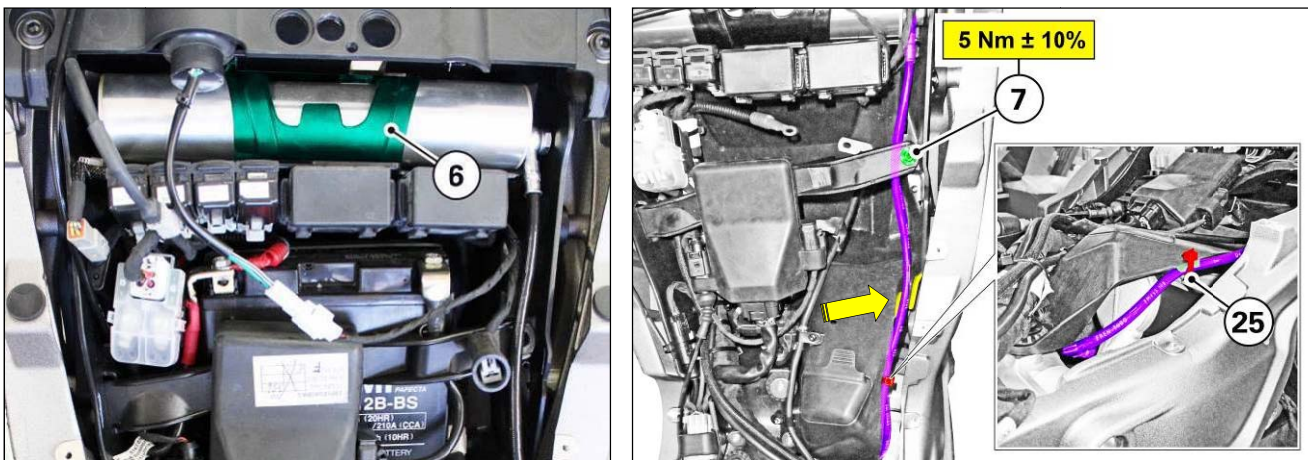
Ensure that the pre-load actuator pipe is placed below the BBS control unit support bracket/battery and that it runs between the tabs of the electrical components compartment support as shown in the figure.

- 14) Fasten the pre-load actuator pipe to the electrical components support using a **self-locking tie (25)** as shown in the figure.

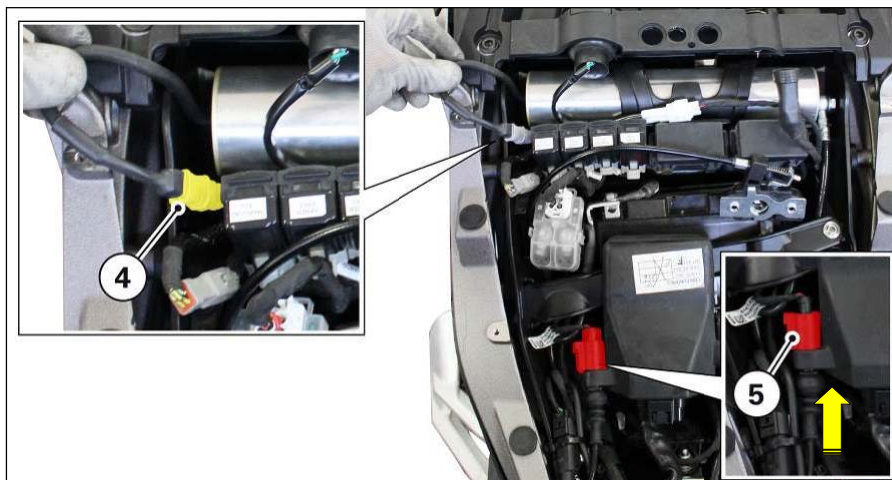
- 15) Connect the pre-load adjustment **connector (4)** and rear shock absorber adjustment **connector (5)**, then insert it into its seat on the BBS control unit support.

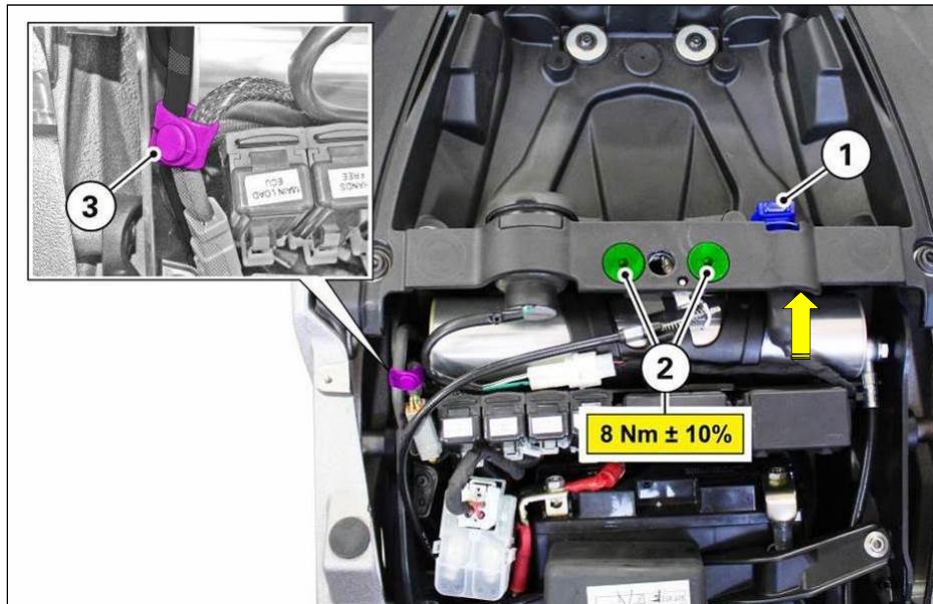
18) Install the **button tie L.39 (3)** connecting tail lights cable and pre-load actuator cable as shown in the figure.

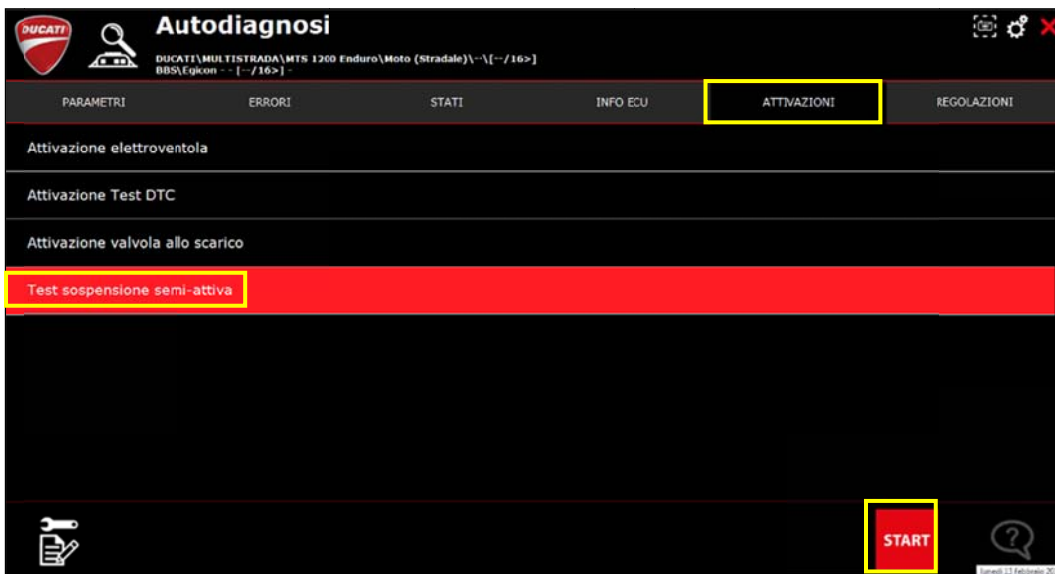
25) Select "*Activations*" and run the "*Semi-active suspension test*" by following the instructions on the screen.
