SSICRE14

*2014 and newer Chevrolet® Silverado & GMC® Sierra Crew-Cab 1500 series with base or premium radio
2015 and newer Chevrolet® Silverado & GMC® Sierra Crew-Cab 2500/3500 with base or premium radio*

Installation

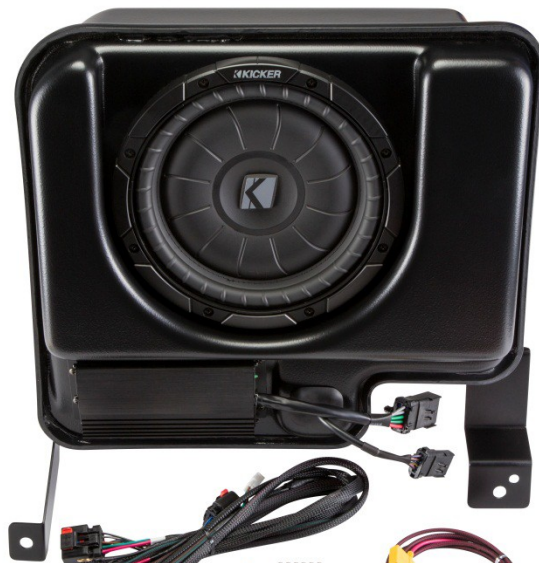
Subwoofer
Assembly

Subwoofer
Body Harness

Fuse
Wire Ties x 6
Wire Taps x 2
Adaptor Harness

Subwoofer
Power
Harness

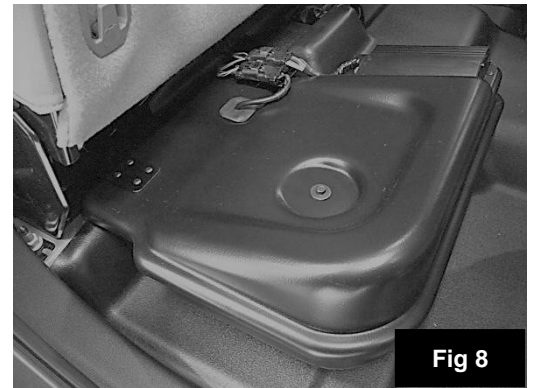
4. Connect the subwoofer wiring to the subwoofer harness and set the enclosure into place by sliding the center bracket through the slit in the carpet and over the seat stud and seatbelt receptacle stud. Fig. 8
5. Reinstall the rear center seatbelt receptacle over the top of the subwoofer bracket and reinstall the factory nut. Torque to 53 Nm (39 ft/lb)
6. Reinstall the rear seat nut. Torque to 109 Nm (80 ft/lb)
7. Install the fuse into the fuse holder.
8. Reinstall all previously removed parts in reverse order
9. Reconnect the negative battery cable(s). Torque to 17 Nm

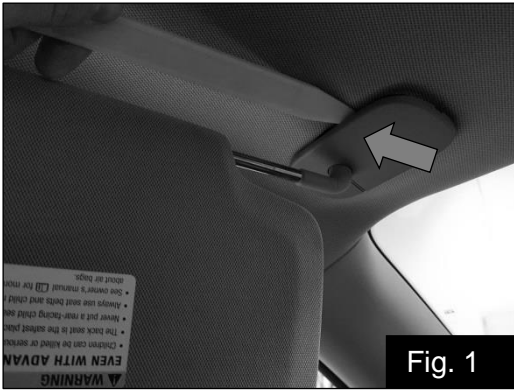
1. Using a panel tool, remove the screw cover from the driver's side visor. Fig. 1
2. Remove the three screws securing the visor, pull visor loose and disconnect wiring. Fig. 2
3. Open the screw covers on the grab handle above the driver's door, remove the two screws and pull loose handle. Fig. 2
