SURE MARINE SERVICE INC.

This oven troubleshooting guide was written specifically for Seaward/Princess/Hillrange stoves *manufactured prior to September 2007*. It is also applicable to many other early models of RV & marine ovens including many Magic Chef, Wedgewood, Kenyon, & early Gas Systems ovens.

INFORMATION ABOUT THE SAFETY VALVE AND PILOT ASSEMBLY

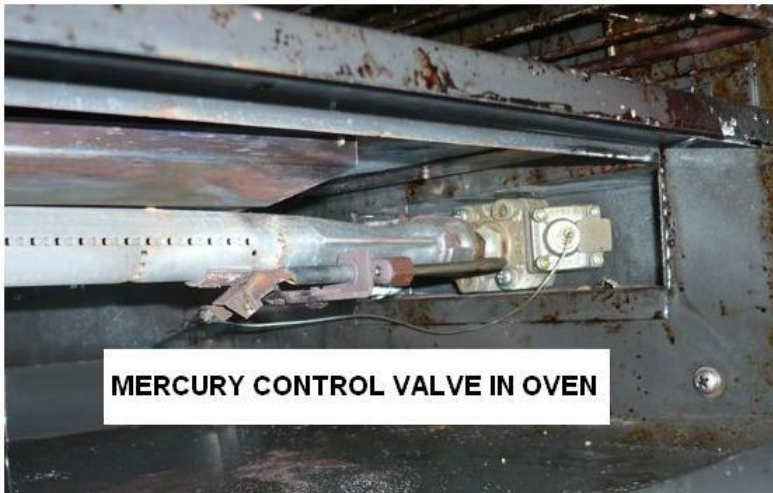
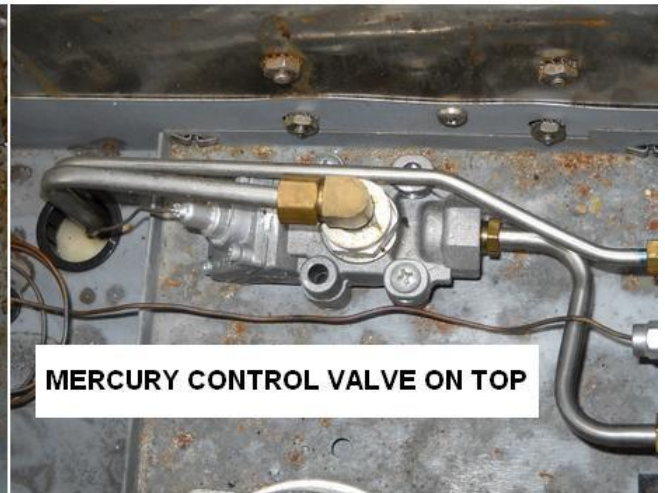
The 'mercury control valve' monitors the pilot flame height using a small probe mounted in the end/tip of the pilot assembly. When it senses a large pilot flame (which happens when the oven thermostat has sensed a need for more heat,) the 'mercury control valve' opens and allows gas to flow to the 'main/large oven burner'.

The 'mercury control valve' itself is normally located on top of the stove directly behind the thermostat, but in early stoves it can be mounted in the oven interior, in the side wall or on the back wall of the oven.

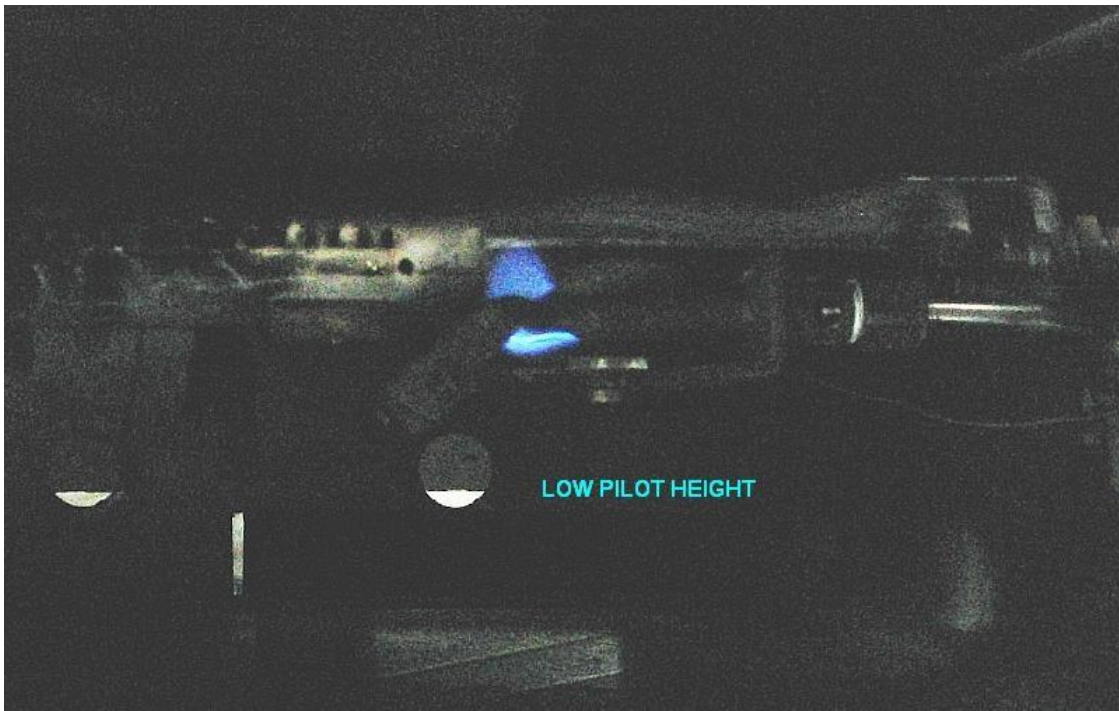
If the pilot does stay lit, but the main burner does not light you need to verify proper operation of the oven thermostat. Verify you have two distinct pilot flame heights 'low pilot height' when the oven is up to temperature (or in pilot only setting,) and 'high pilot height' when the oven is colder than thermostat setting. (example, cold oven with control knob set to 350F).

Try lighting the pilot, and turning the control knob up and down. You should see the two obvious different pilot flame heights.

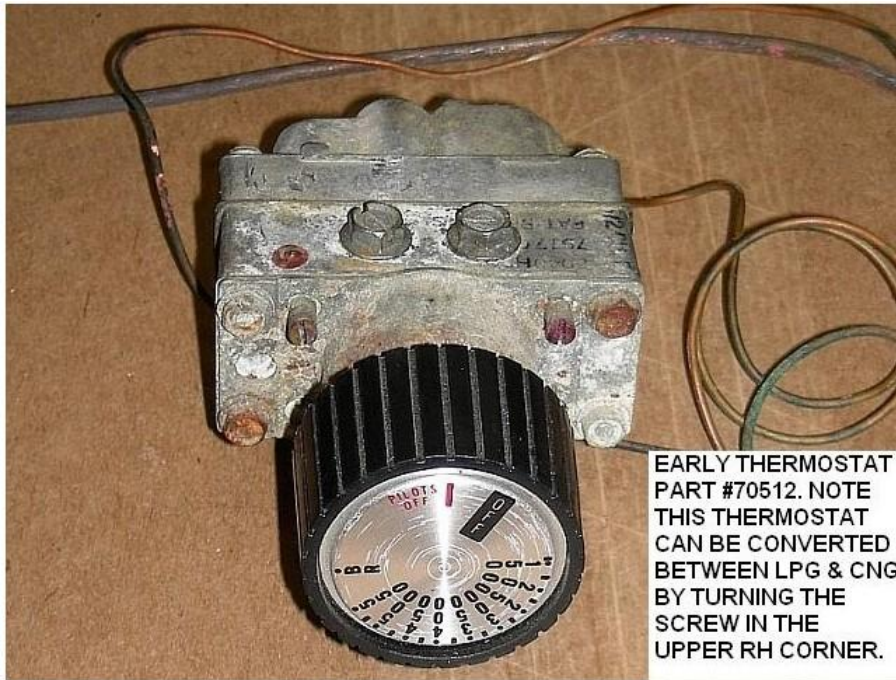
EARLY THERMOSTAT PART #70512. NOTE THIS THERMOSTAT CAN BE CONVERTED BETWEEN LPG & CNG BY TURNING THE SCREW IN THE UPPER RH CORNER.
