## **Survivors amongst the rubble: Traditional timber-laced masonry buildings that survived the great 1999 earthquakes in Turkey and the 2001 earthquake in India, while modern buildings fell**

Randolph Langenbach

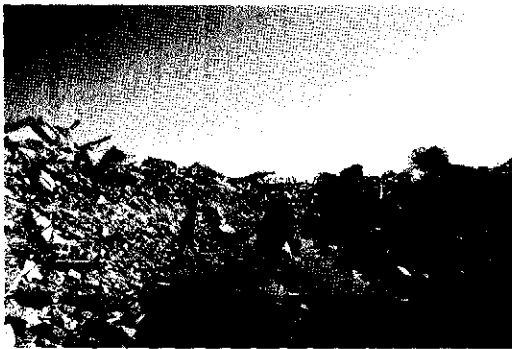
Figure 1  
View of Anjar City Center after the Bhuj Earthquake of January 26, 2001

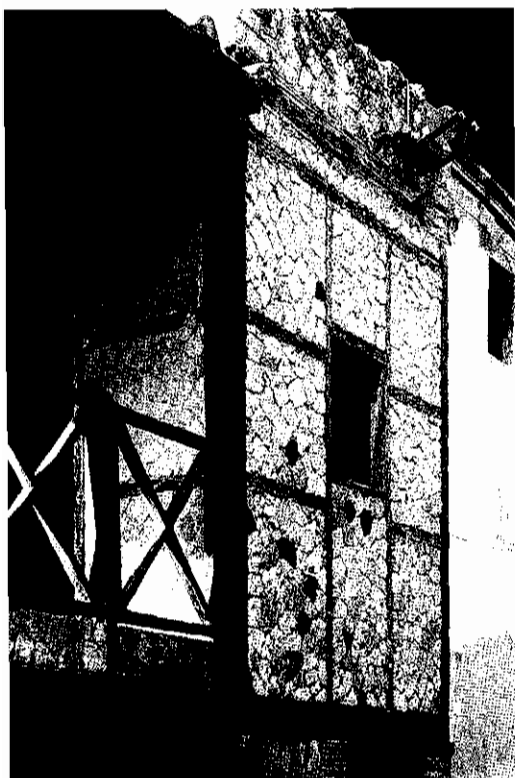
Figure 3  
Pre-79AD Infill-frame construction found and restored at Herculaneum

Because it is rare for the wooden armature of these sorts of buildings to survive as archeological ruins, the chance of finding ancient examples of the infill-frame construction type is low, but the unique burial under volcanic mudflows, and the modern-day archeological uncovering of Herculaneum in Italy has provided the unique opportunity to peer back through 2,000 years and find early examples of this type of construction (Figure 3).<sup>3</sup>

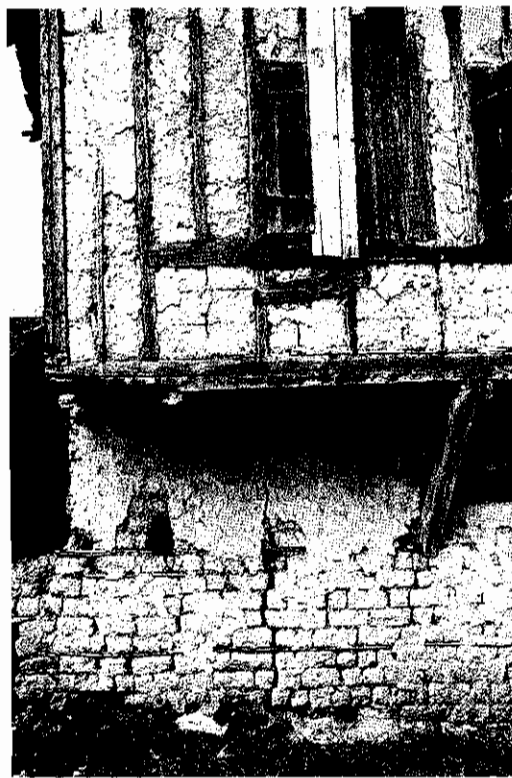
Figure 4  
View of Infill-frame construction in the historic Ottoman town of Safranbolu, Turkey

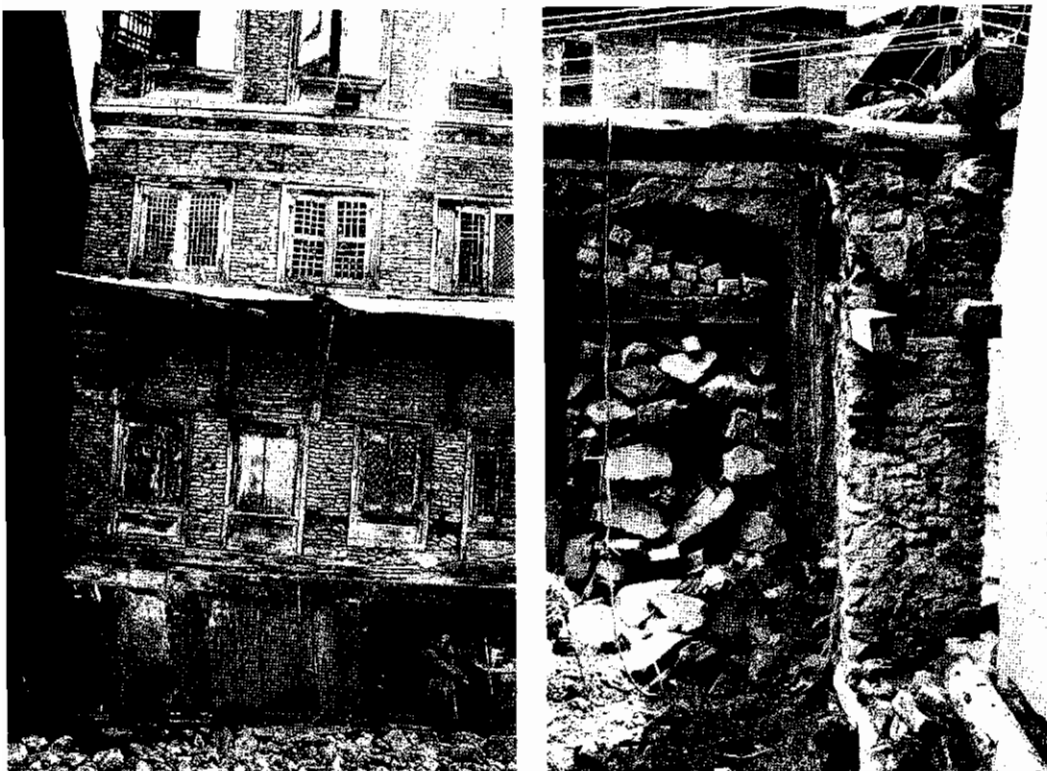
Figures 7 and 8

*Taq* construction in Srinagar, Kashmir and demolished section of wall showing timber lacing in wall section

Some of the most elaborate examples of laced bearing wall construction can be found in Srinagar, Kashmir, where this type of construction, referred to as *Taq*, is the predominant historical vernacular type. Here the type evolved to allow building of structures onto soft waterlogged banks of the alpine lakebed in the Vale of Kashmir, where the heavy masonry structures were subjected to differential settlement. Here the heavy timber beams are laid in only horizontally, with the masonry carrying all of the

vertical loads. The timber bands, which resemble ladders laid into the walls, run both above and below the window frames and at each floor level, where the joists extend through the wall and are secured to the wall by the timbers laid below and above them, which are themselves surmounted by the weight of the overburden of masonry of the floor above or the parapet under the roof.<sup>4</sup>

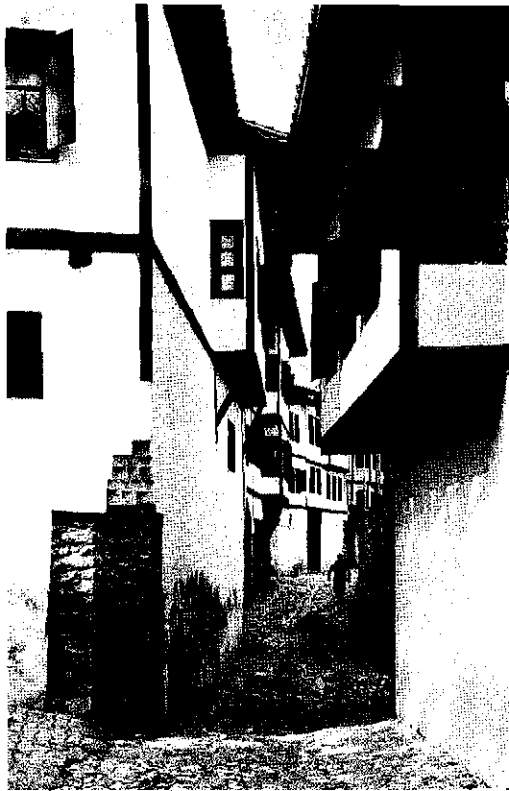
Figure 9  
Traditional Ottoman style Turkish architecture in  
Safranbolu, Turkey

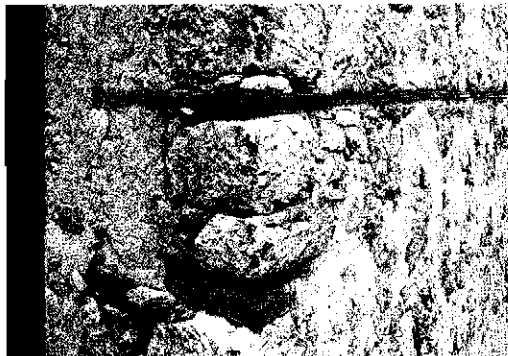
Figure 10  
Laced bearing wall in Safranbolu, Turkey

For those houses where the *hım\_* style rests on the heavy load bearing masonry base, the multi-wythe masonry bearing walls of the first story, are often laced with horizontal timbers, —in Turkish, the timbers are «*hantı* (s) *hatıllar* (pl)»—. In contrast to those used in Kashmir, these are often very thin timber boards laid into the wall at vertical intervals of about 3 feet (1 m). They are placed so that they

overlap at the corners. They thus serve to bind the stone layers together without interrupting the continuity of the masonry construction. In those regions most affected by the 1999 earthquakes, however, the bearing wall type was rare. There, the houses were of *hım\_* construction from the ground up, thus the discussions of earthquake performance of the timber-laced construction as witnessed following the recent earthquakes in Turkey and in India will be focused primarily on this type.

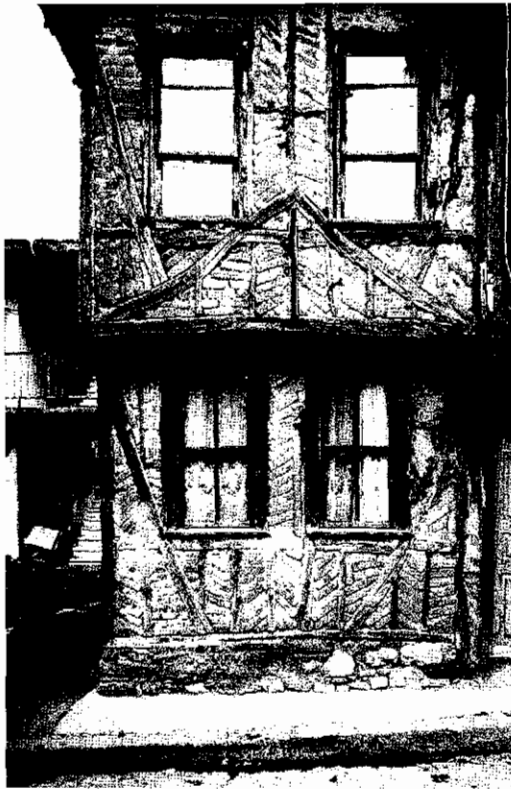
Figure 11  
*Humu* house in Gölcük after earthquake constructed in 1955. There was only slight damage to the interior of this house

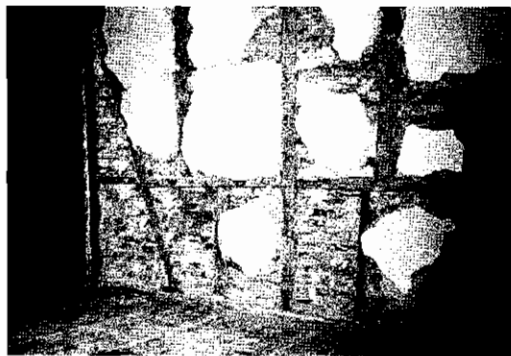
Figure 12  
*Humu* interior wall in Düzce after earthquake

Inspecting the interiors of some of the houses provided a more complete understanding of the behavior of *humi* as a structural system. It was evident that the infill masonry walls responded to the stress of the earthquake by «working» along the joints between the infilling and the timber frame; that is, the straining and sliding of the masonry and timbers dissipated a significant amount of the energy of the earthquake. The only visible manifestation of this internal movement was the presence of cracks in the interior plaster along the walls and at the corners of the rooms, revealing the pattern of the timbers imbedded in the masonry underneath. This level of damage was evident in every house. On the exterior,

unless the house was stuccoed, damage was impossible to see. The bricks themselves were only infrequently displaced sufficiently for a crack to be visible. The movement was primarily along the interface between the timbers and the brick panels rather than forming a crack within the panels themselves.

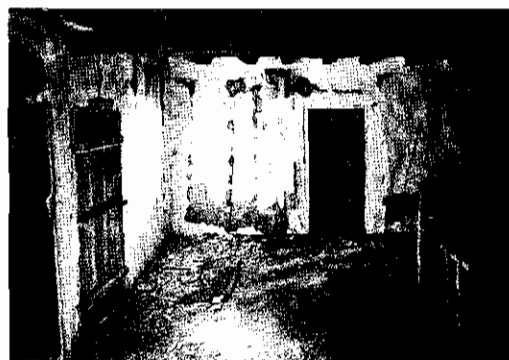
Figure 13  
Interior of *humi* house in Orta after earthquake showing damage to mud and lime plaster over infill walls

In this earthquake, many *humi* houses did suffer widespread cracking and shedding of plaster and stucco, and a few had damage to the infill masonry. This level of damage was hard to explain when compared to that found in the infill-frame houses subjected to the full brunt of the Marmara earthquake, where the shaking was stronger and continued for a longer period. The *humi* houses in Gölcük and Adapazari had about the same level of damage as the Orta houses. This stands in sharp contrast to the performance of the reinforced concrete buildings. While in Orta the reinforced concrete buildings were only lightly damaged, in the Marmara and Düzce earthquake area vast numbers of them suffered heavy damage or collapse.

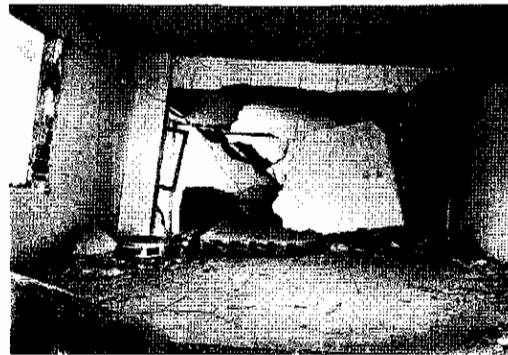
Figure 14  
Collapsed interior infill wall in reinforced concrete building in Gölcük

The infill walls in modern reinforced concrete construction generally have strong mortar binding weak masonry units, and these masonry walls fill each structural bay without intervening studs. In Turkey, the most common infill for the interior partitions and exterior walls is a lightweight hollow clay block that has barely more strength than a dinner plate. In India, commonly it is a low temperature fired brick that performs better than the Turkish material, but none-the-less it can crumble easily.

Rarely is the infill considered in the engineering design process as part of the lateral resisting system, and it is often ignored in calculations. In spite of this, the masonry infill does play a significant role that sometimes can help to save a building that has weakened joints. More often, however, it can contribute to the collapse of a building because its rapid degradation in specific areas can transfer concentrated loads onto localized parts of the frame, which are then overwhelmed. As can be seen in Figure 14, these infill walls can readily collapse completely when an earthquake distorts the building's frame. Sometimes, to avoid damage to the surrounding reinforced concrete frame from the «diagonal strut» effect, where the stiff infill causes a corner column to break, leading to collapse, the infill material is sometimes deliberately separated from the frame.

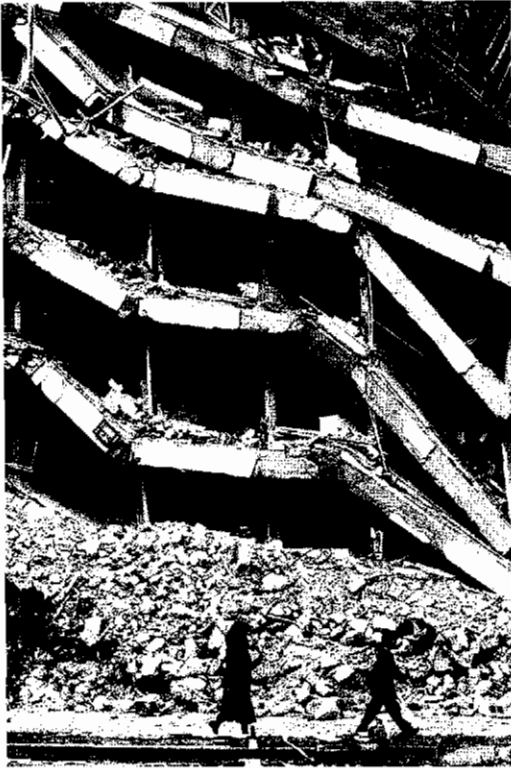
Figure 15  
Collapsed Reinforced concrete building in Gölcük
