by Jarad Warren  
[members.atra.com](http://members.atra.com)

# Don't Guess: Test! Ford's 4F27E, FN4A-EL, FNR5

The 4F27E transmission family has been around for more than ten years, and has become a fairly common sight in today's shops.

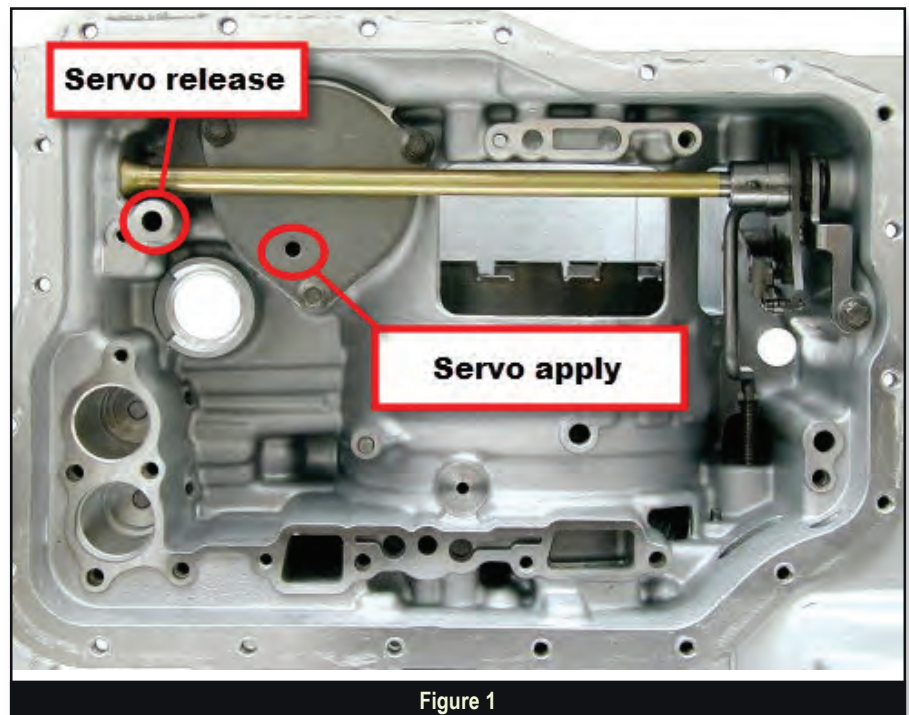
Figure 1

- Remove the valve body.
- Locate the 2-4 band release port (figure 1).
- Apply air to the servo release during teardown.

When the servo pin bore wears, direct clutch apply oil leaks to the sump. This can cause the direct clutches to fail.

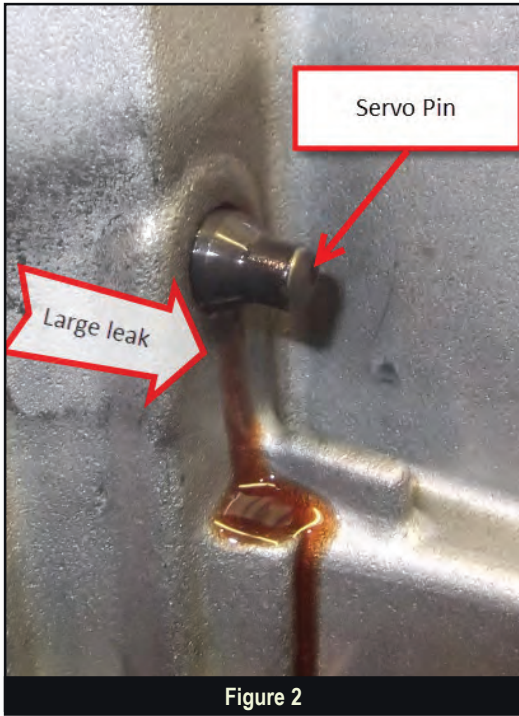
Figure 2

You shouldn't see any signs of a leak between the servo band pin and the inside of the case. The servo shown had a large leak around the pin bore that needed to be addressed (figure 2).

There are aftermarket kits available for servo pin bore wear: Check with your aftermarket suppliers for the repair.

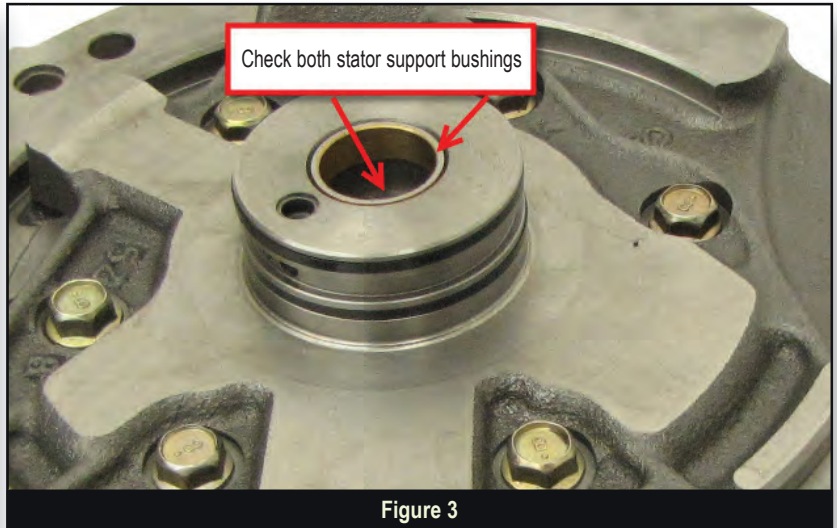
Figure 3

The torque converter clutch circuit has a problem built into it: It uses two bushings in the pump stator support to separate the torque converter clutch release oil and converter apply pressure. Worse yet, the bushings are close

together and wear quickly because they have so little support (figure 3).

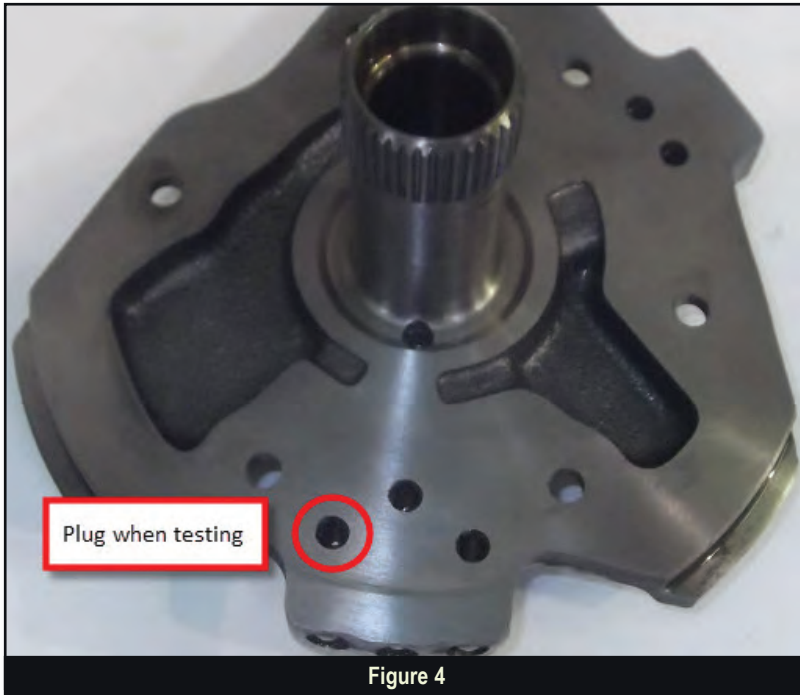
Figure 4

To test the bushings, first you'll need to plug the hole in the stator support (figure 4).

- Slide the stator support onto the input drum.
- Pour ATF into the input shaft.
- Apply low air pressure into the tip of input shaft.

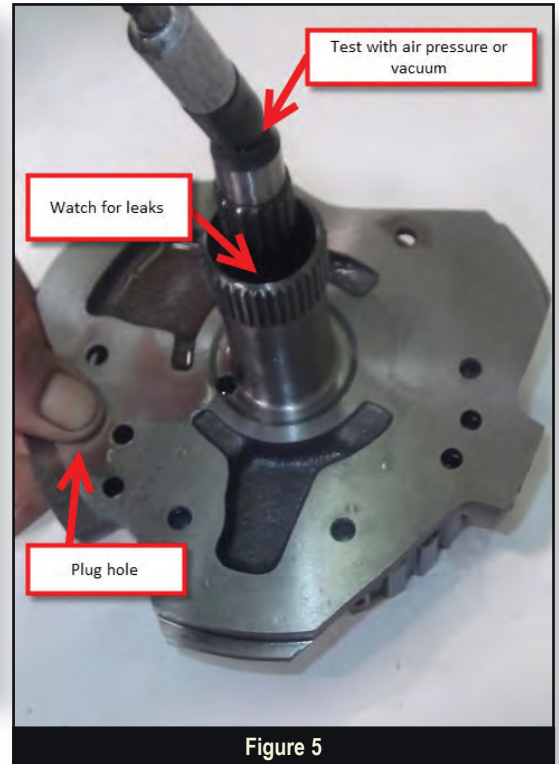
Figure 5

There should be no oil or air leaking around the shaft and bushings (Figure 5).

You can also check the stator support bushings with a vacuum test stand:

- Clean and dry the shaft and the stator support.
- Plug the hole in the stator support.
- Apply a vacuum to the tip of the input shaft.

Testing with vacuum will give you numbers to work with and lets you keep track of pass and fail results.

After you install new bushings in the stator support, repeat the test to confirm your fix.

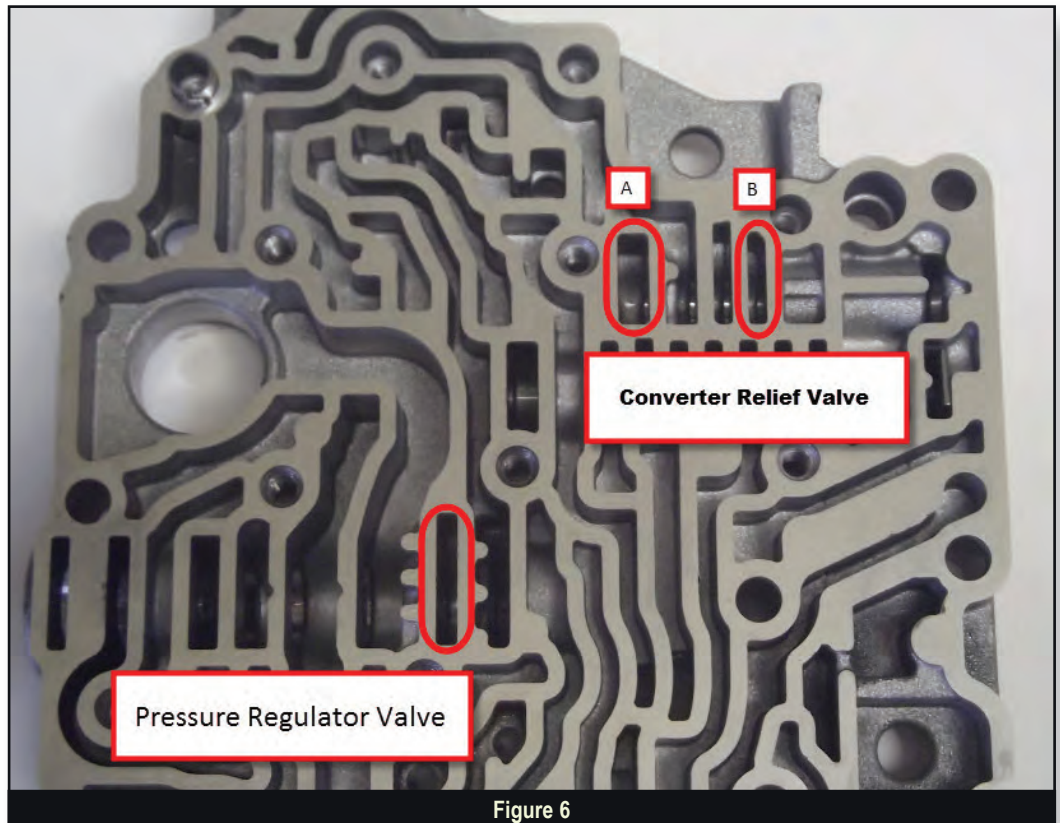
Figure 6

Let's test the pressure regulator valve and converter relief valve in the main section of valve body (figure 6).

The pressure regulator valve is almost always worn on this transmission. Here's an easy, quick test:

- Pour ATF into the test port.
- Cover the test location.
- Apply low air pressure.

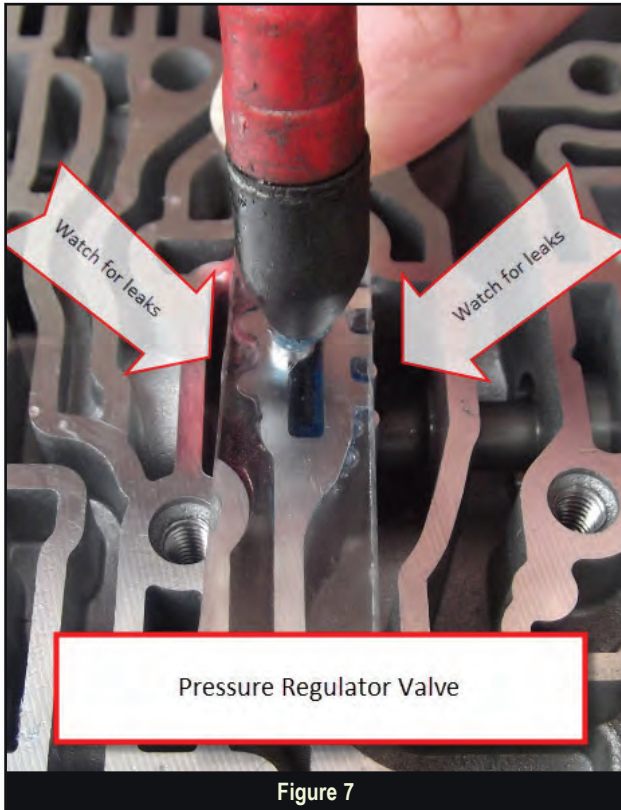
Figure 7

If ATF and air leak into the passages next to the test port (figure 7), the bore needs to be addressed.

If you like to compare test results, you can perform a simple vacuum test on the same test port. This can save you time and money, because it'll show what valves need to be repaired and where you can save money on unneeded repairs.

Wear in the pressure regulator valve may cause unstable line pressure, hard shifts, and problems with converter pressure and lube.

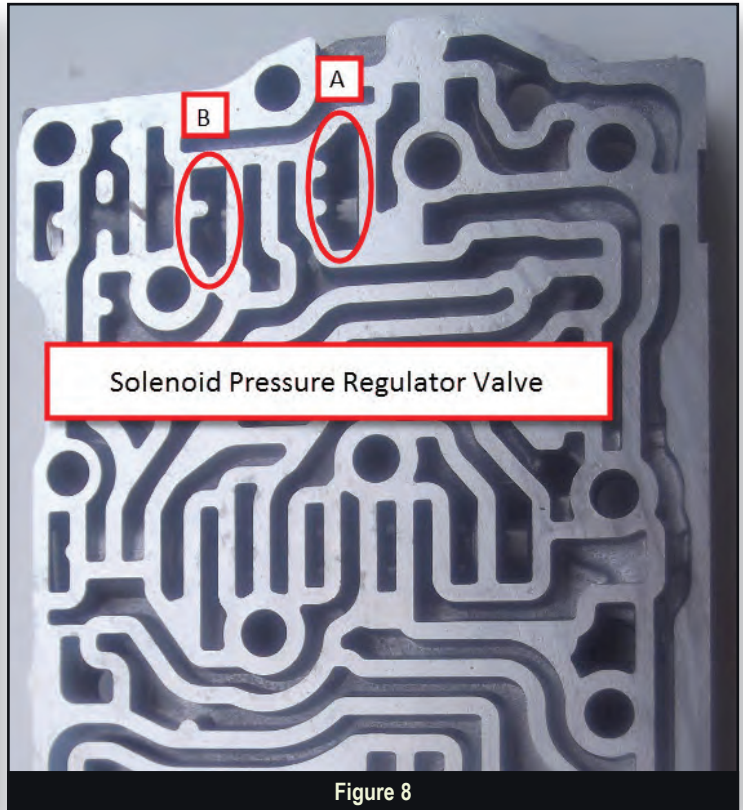
Figure 8

The test locations (figure 8) can be vacuum or wet air tested.

There are two locations to test; at location B you'll need to block the passage on the back of the valve body while testing. The test at location B is

measuring the wear at two valve bore lands at the same time, so test port B will always leak more than A; this is normal.

In this section of the valve body you need to pay attention to the solenoid pressure regulator valve. A worn solenoid pressure regulator valve will cause low line pressure and low clutch pressure. This valve commonly wears out and sticks.

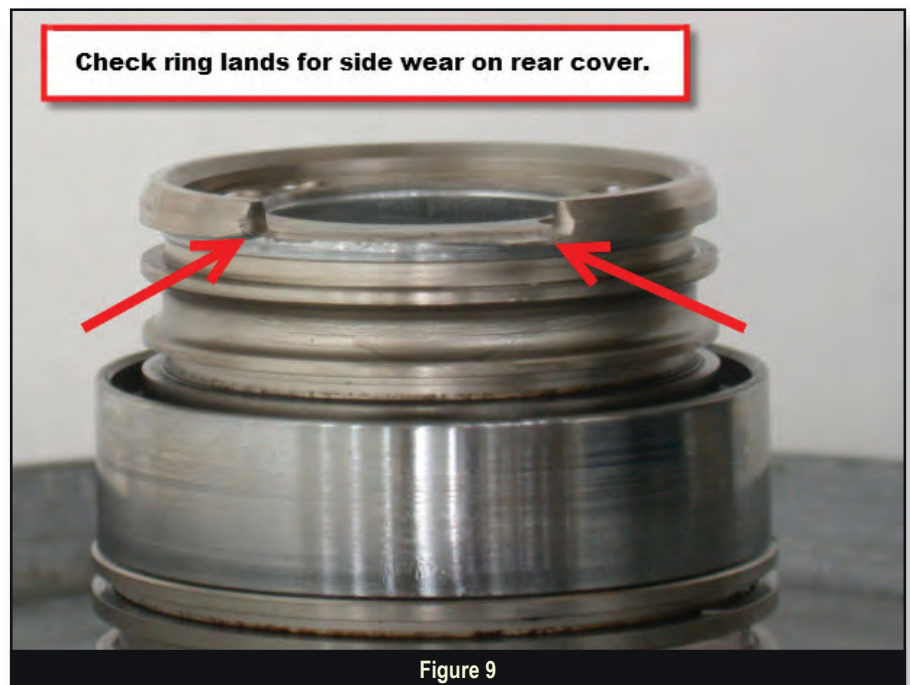
Check the ring lands on the end cover closely, because wear in this area is very common. Figure 9 shows a worn cover at the top ring land. Also inspect the direct drum for ring land wear. This

will cause a 2-3 flare or cause a slip in 3<sup>rd</sup> gear.
