Case Study of Corrosion Rates of an Externally-Heated Sulfur Storage Tank

Brandon Forbes, PE; DJ Cipriano, PE
Controls Southeast Inc.
Charlotte, NC
August 2018

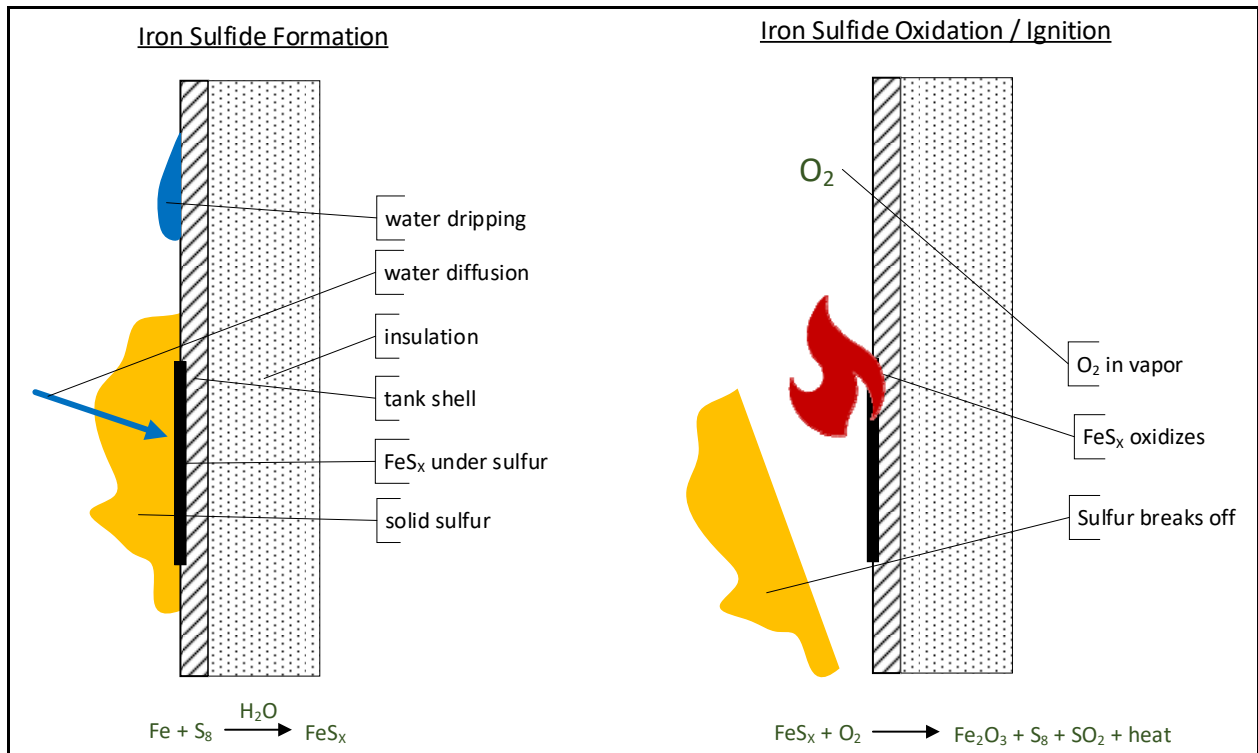
When combined, sulfur, steel, and water react together to form various iron sulfides. These sulfides are pyrophoric – when exposed to oxygen, a rapid exothermic oxidization reaction occurs. With a sufficient mass of accumulated sulfides, the temperature resulting from the oxidation reaction can be high enough to ignite H₂S in the vapor space or ignite the sulfur itself. To avoid this scenario, either the accumulation of sulfides or the oxidation of sulfides must be prevented.

Figure 1: Iron sulfide ignition mechanism

One method of preventing the formation of iron sulfides is to maintain all carbon steel surfaces above 100°C (212°F) to prevent the accumulation of liquid water. The presence of sulfur can frustrate efforts to this end as solid sulfur that builds up on the interior surface insulates the wall and drives down the temperature. Water vapor can penetrate the porous sulfur, condense at the wall, and form iron sulfide. Worse yet, iron sulfide formed in this manner can accumulate in large masses that are only exposed to oxygen when chunks of sulfur fall away from the wall. These large masses of sulfides reach very high temperatures when they suddenly oxidize together.

A better approach is to maintain all carbon steel surfaces above 120°C (247°F) to prevent sulfur from freezing. This prevents the formation of iron sulfides. Even if some small cold spots exist, without large sections of solid sulfur accumulation, it is unlikely that large masses of iron sulfide will form. Small masses of iron sulfide not buried under frozen sulfur are typically not a problem; they tend to oxidize as they form and never reach the critical mass needed to achieve dangerously high temperatures.

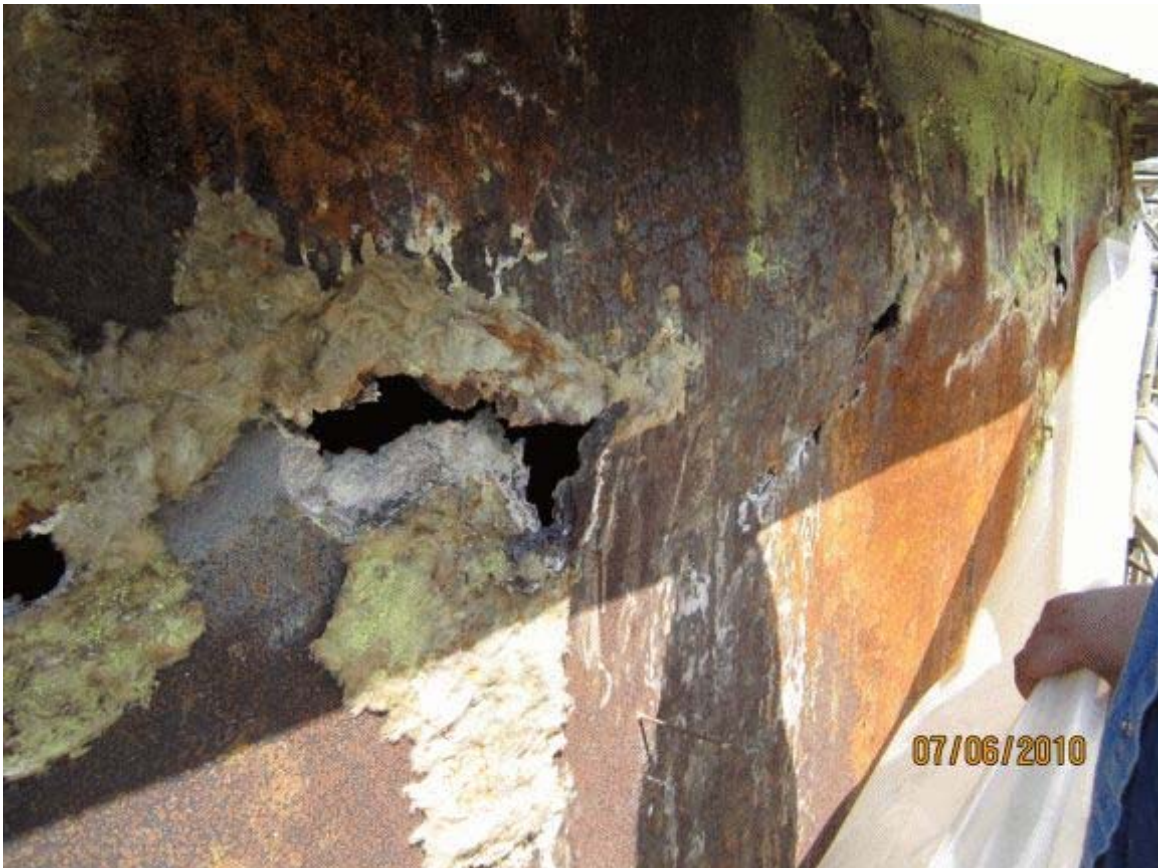
External corrosion can occur due to spilled sulfur. There are several mechanisms by which spilled sulfur can accelerate the corrosion of steel surfaces. Mixing sulfur and water can generate small amounts of sulfuric acid that eat through the steel. Together, sulfur, water and steel can react to decompose the steel and form iron sulfides as described above. Finally, thiobacilli bacteria can also produce sulfuric acid as they digest the sulfur. Sulfur tends to accumulate around the tank vents and on the ground at the base of the tank, these are the areas that tend to be most susceptible to this form of corrosion.

Figure 2: Example sulfur tank shell corrosion

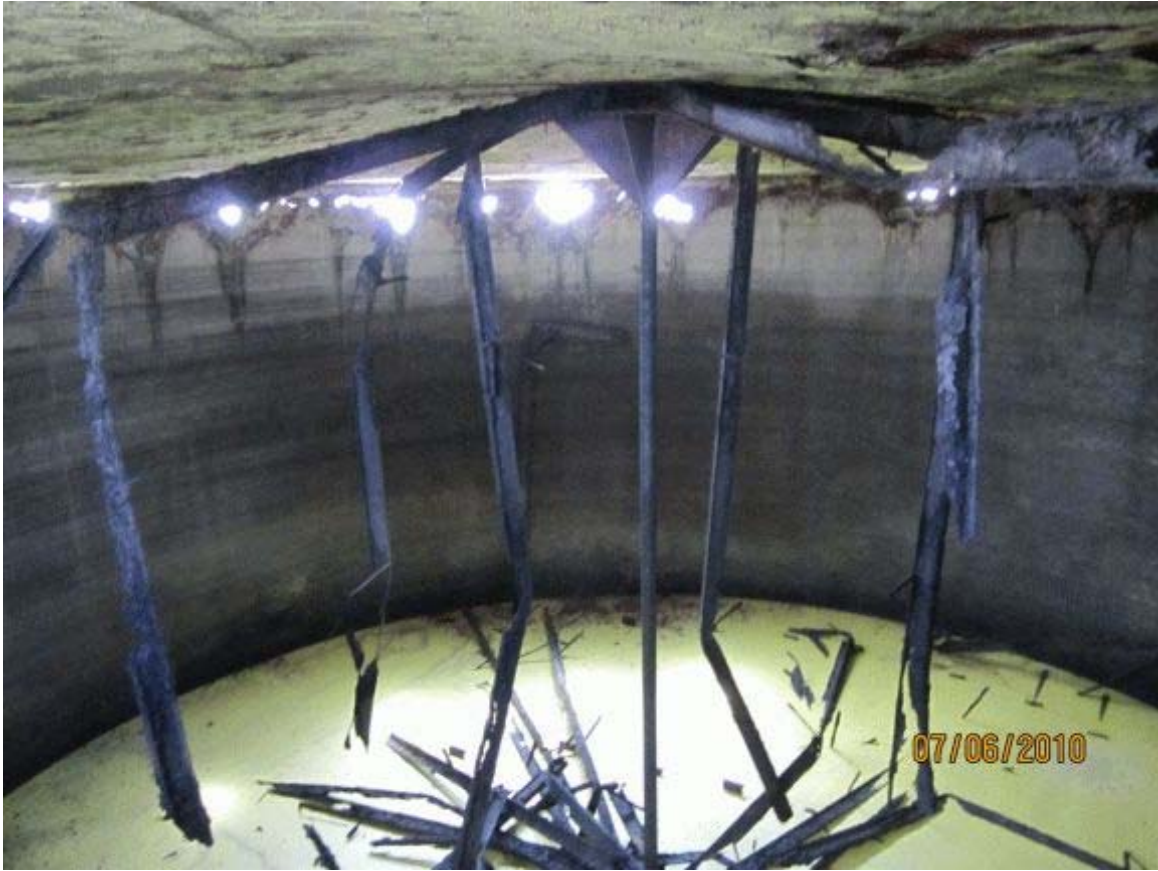
External corrosion can occur due to ambient water exposure. This mechanism is not unique to sulfur storage. Water that penetrates the insulation may sit against the external tank surface for an extended period as evaporation from under the insulation will be slow. Field-erected storage tanks are also subject to water intrusion to the space between the tank bottom and the concrete pad (or ring-wall). Again, evaporation from this area will be slow and significant corrosion can result.

Figure 3: Example sulfur tank structure corrosion

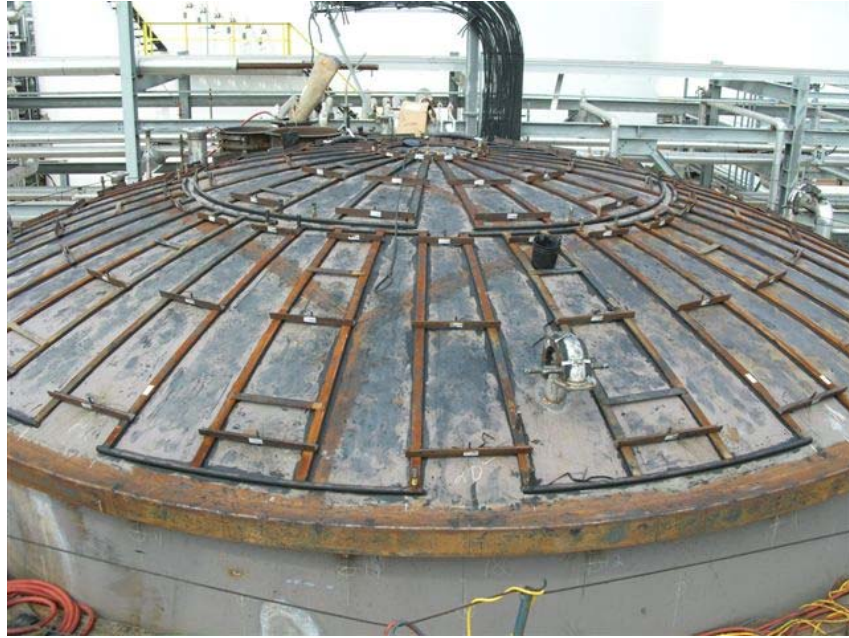
The ControTrace heating system is comprised of multiple heating panels, each comprised of multiple individual heating elements. The heating elements are spaced at a specified distance that maintains the tank wall temperature above the target temperature (typically 125°C) at all locations. Additionally, the panels themselves are shaped to fit closely together and to wrap closely around nozzles and other tank protrusions. In this way, all locations on the tank shell and roof are maintained above the target temperature.

Figure 4: Example ControTrace tank roof heating

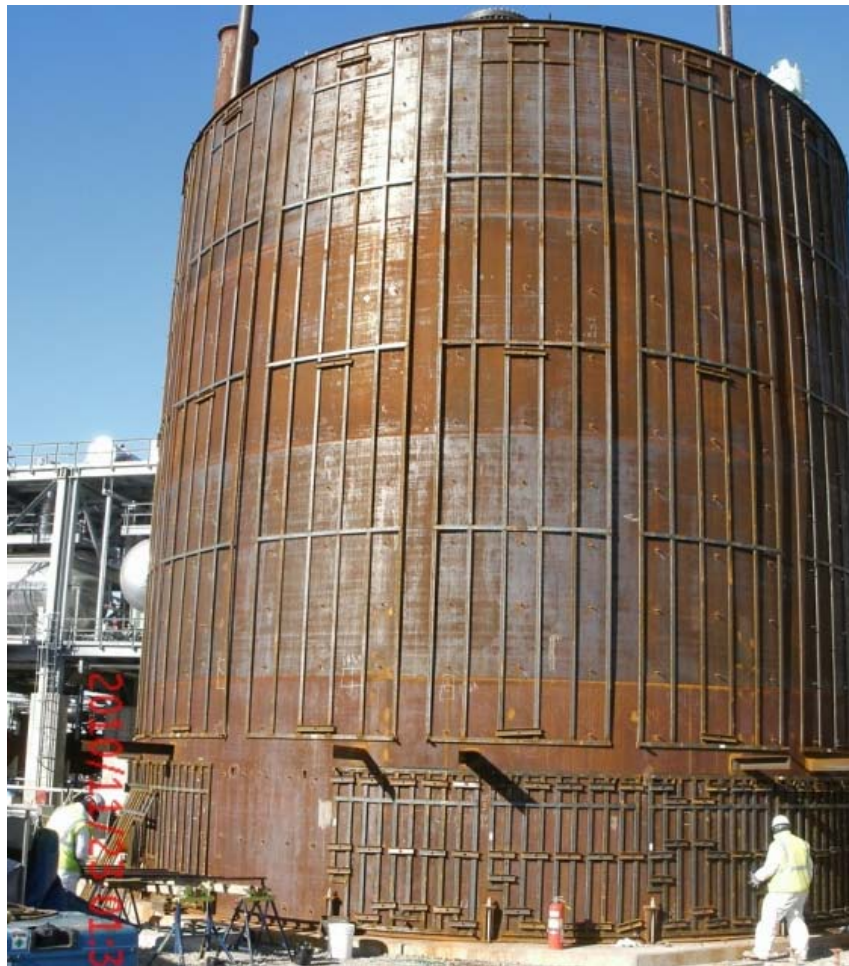
Maintaining the liquid sulfur temperature typically requires additional heat input to offset the heat loss into the ground. The ControTrace heating panels located at the bottom of the tank wall typically utilize additional heating elements in order to provide the additional heat required. This is especially critical when the liquid level is low and the liquid contact area with the heated tank wall is reduced.

Figure 5: Example ControTrace tank shell heating

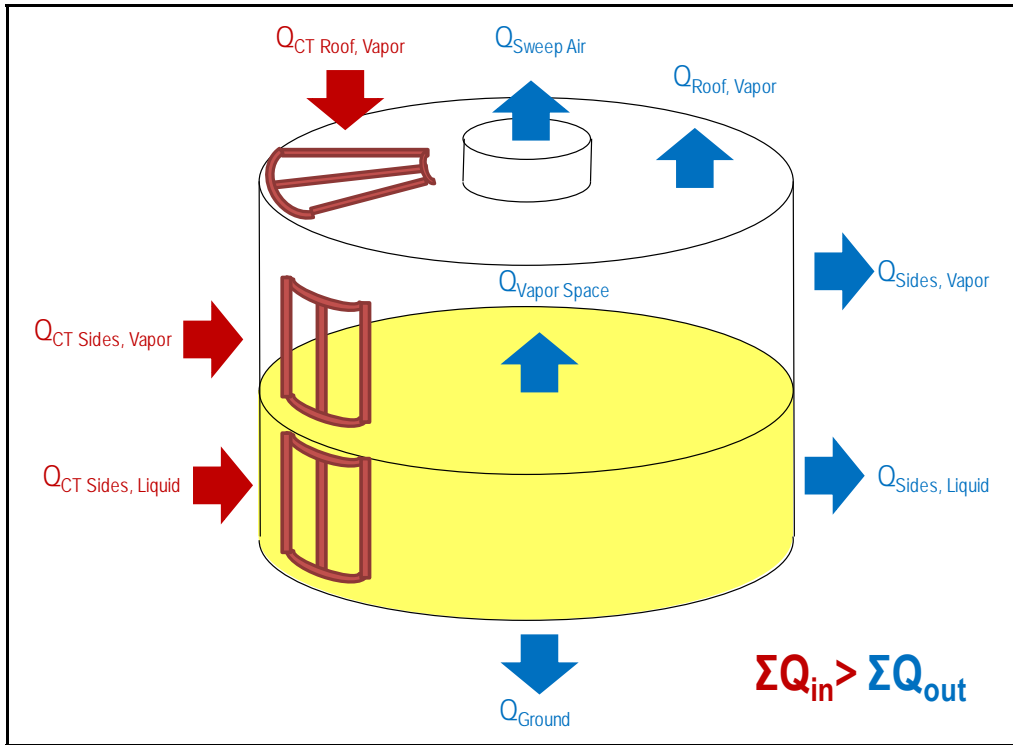
CSI determines the heating system design and predicts the tank temperatures utilizing a proprietary finite-difference model. The model accounts for all relevant heat paths to determine both the liquid and the vapor temperature in the tank. Also, the model calculates the tank shell and roof temperature profile based on a given ControTrace element spacing. In this way, not only is the sulfur temperature maintained, but also a uniform shell and roof surface temperature. CSI's thermal model was developed using CFD modeling to verify uniform sulfur temperature distribution within the vessel. The model has been validated with detailed field temperature measurements including infrared imaging.

Figure 6: CSI Tank model macro-level heat transfer accounting

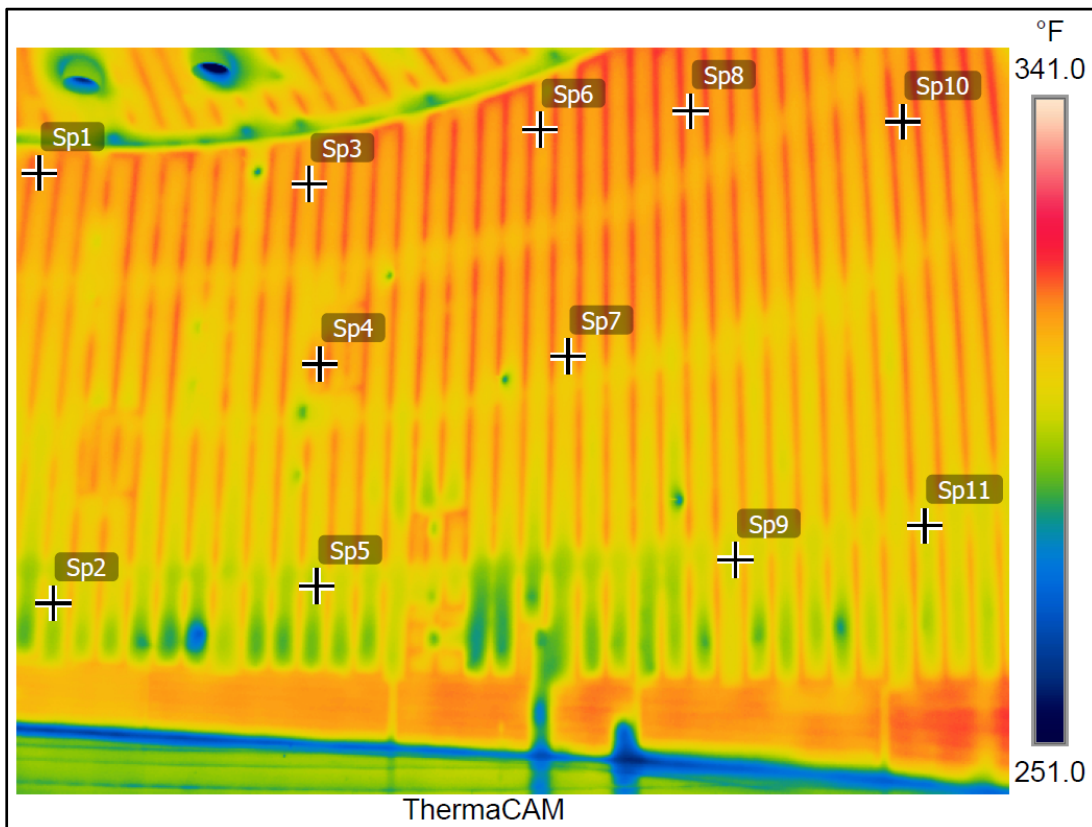
Figure 7: Thermal image of ControTrace-heated sulfur tank interior

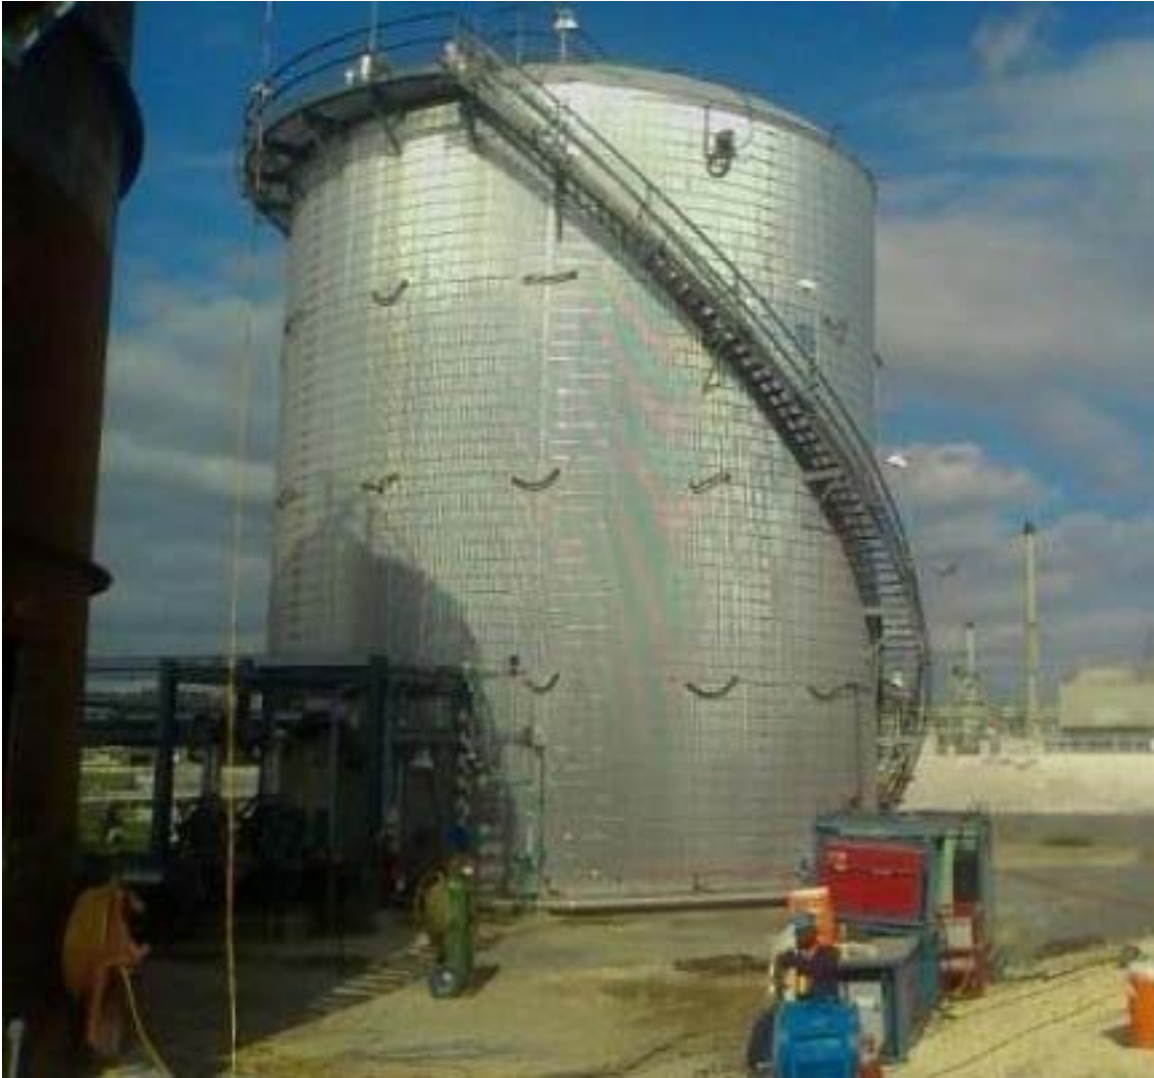
In 2007 the petroleum company commissioned a new sulfur tank at the gulf coast refinery. The tank is 40 ft diameter by 48 ft tall and fabricated from A36 carbon steel. Sulfur in the tank typically contains roughly 100 ppm H₂S. The tank utilizes CSI's ControTrace heating system designed to maintain the sulfur at or above 275°F (135°C) and the tank wall/roof surface at or above 255°F (124°C). The system is comprised of external, bolt-on heating panels applied to both the shell and the roof. ControTrace heating elements were also provided for various nozzles including the roof vents.

The ControTrace panels are attached with a combination of circumferential cables on the shell and studs on the roof. Overall, the installation went smoothly. A few improvements to the installation hardware were identified including: increasing the cable length, decreasing the stud length, providing extra attachment hardware near large nozzles where tank wall distortion is likely, and improving the instructional clarity of the documentation. CSI's current offering considers these and other design improvements.

Figure 8: The tank completed in 2007

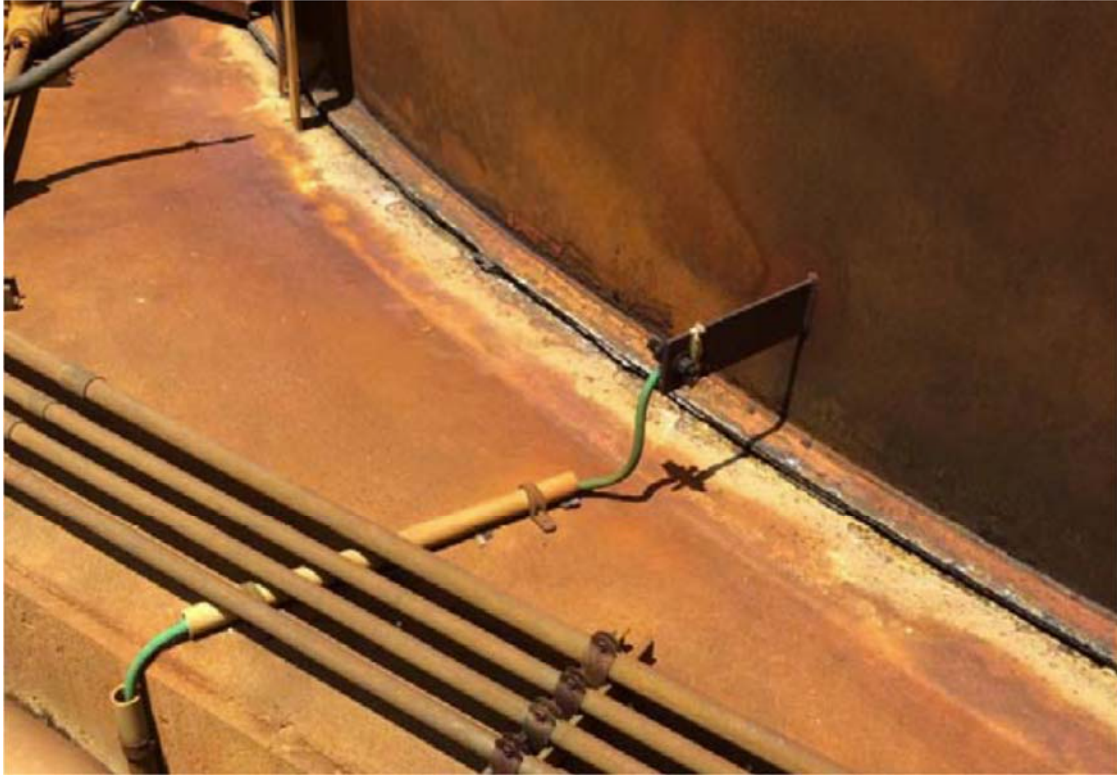
Insulation deterioration was noted at several locations. One quadrant of the roof had particularly poor insulation; regular water intrusion was likely occurring in this area. At the base of the tank, significant corrosion was observed on the under-side of the chime (joint between the shell and the tank bottom). Additionally, sulfur was observed seeping out from under the tank at two locations around the tank perimeter. Some cracking and chipping of the concrete tank foundation was observed, particularly in the area closest to the tank base.

Figure 9: Tank chime overview (bottom corner)

- Slope the concrete foundation away from the tank; this will help prevent water/sulfur from seeping under the floor.
 - Design the tank chime area so that it does not protrude beyond the tank insulation; this will help maintain the temperature of the bottom corner.

- Extend the tank shell insulation all the way down to the foundation; this will help maintain the temperature of the bottom corner. Foamglass or other water-proof insulation should be used where the insulation meets the ground.

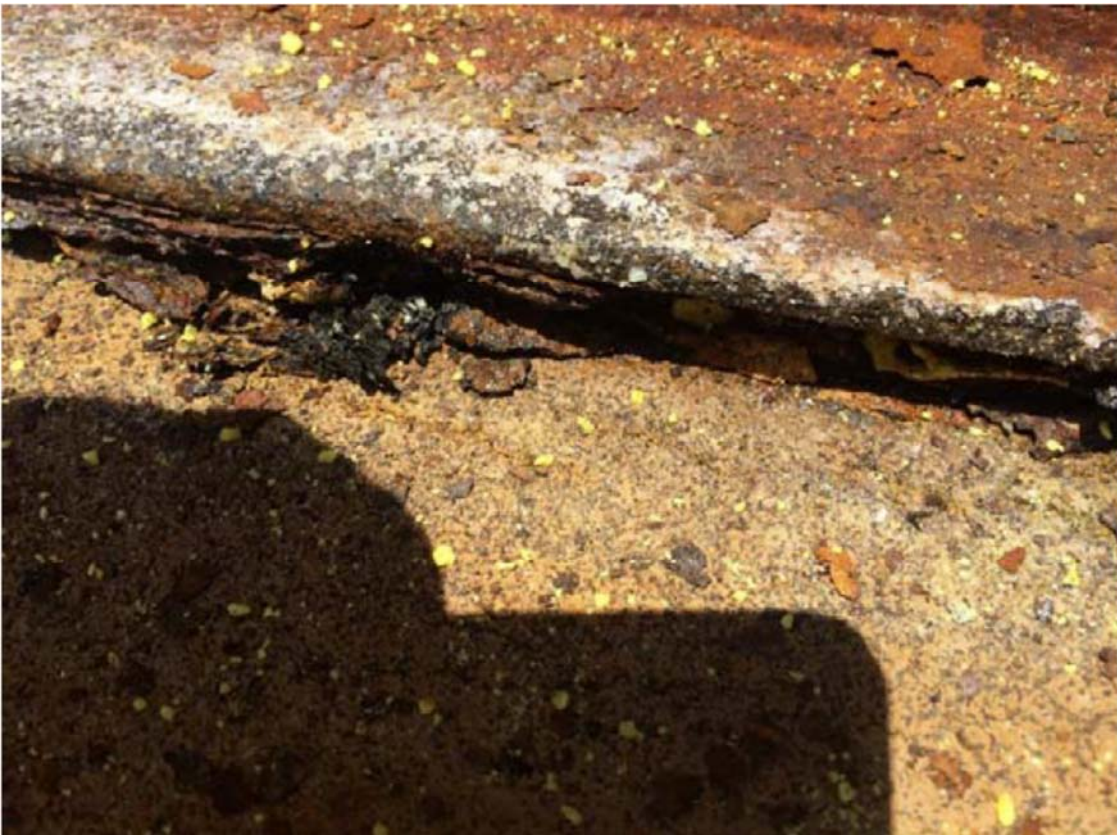
Figure 10: Corrosion and scale under tank chime

As can be deduced from the above observations, the only significant concern revealed by the inspection was the corrosion of the tank floor occurring from the outside-in. The mechanism for this corrosion is thought to be water and sulfur making their way under the tank from the outside. The concrete pad on which the tank sits is a significantly larger diameter than the tank and does not slope away from the tank. Rain water that falls on the pad sits up against the chime and seeps under the tank. The water by itself is likely to cause some corrosion of the tank floor. But if sulfur were to mix with the water, the corrosion rate would be accelerated. The hot tank bottom would likely drive off some portion of the water, leaving a more concentrated water/sulfur mixture. This mixture is likely to form sulfuric acid and/or iron sulfide. In either case, accelerated corrosion would be expected. Sulfur is observed to condense around the tank vents and occasionally spill as a result of maintenance activities. Thus, some quantity of sulfur is typically observed on the concrete pad. There is high confidence that the corrosion mechanism described above is accurate.

To address the tank floor corrosion, the petroleum company replaced the old 3/8" floor with a new 1/2" floor. The new floor is expected to provide a service life of roughly 10 years at which time it is likely to need replaced again. Other minor findings were addressed including replacing the insulation, applying a new internal epoxy coating, and sealing the cracks observed in the concrete pad. It is expected that sloping the pad away from the tank and changing the design of the bottom corner of the tank would significantly reduce the rate of floor corrosion. But it was decided that the cost of such changes could not be justified on an existing tank.

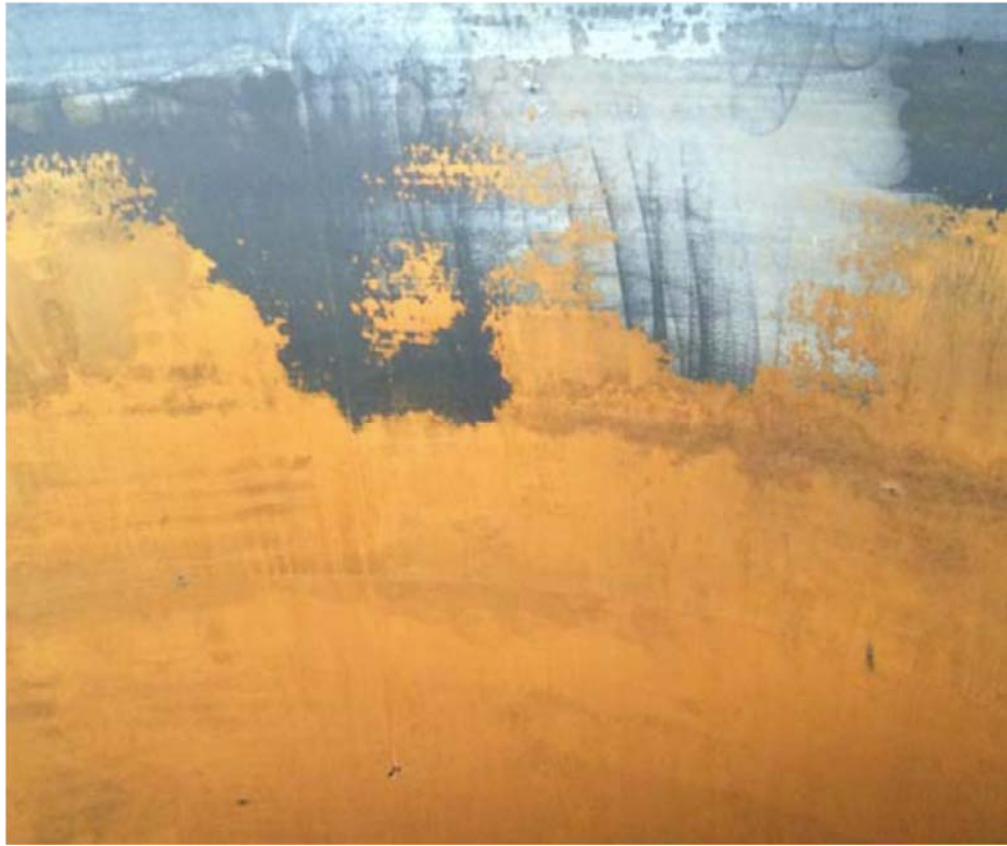
Ultrasonic wall thickness measurements were taken at 24 different location on the tank roof and 4 location on each vent nozzle. A light coating of rust was noted on both the internal and external surfaces, but there was no scale/pitting and UT measurements showed that no wall thinning had occurred. The vents were all clear with no significant sulfur build-up.

Figure 11: Typical interior shell/roof surface with light coating of rust

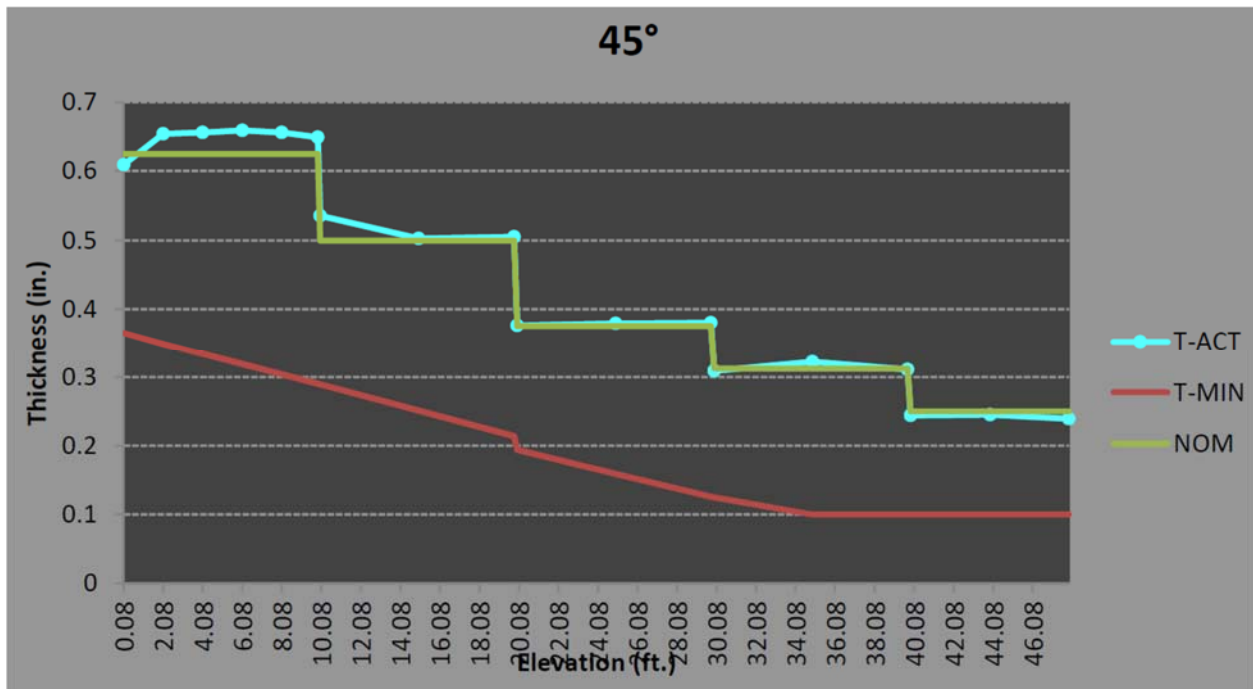
Ultrasonic wall thickness measurements were taken at 156 different location on the tank shell. Again, a light coating of rust was observed on both the internal and external surfaces. Wall thinning of the shell was observed only on the bottom 1 inch near the chime. Wall thinning in this region was calculated to be occurring at a rate of 0.0034 in/yr. At this rate, the tank wall thickness is projected to drop below the design thickness in the year 2082.

Figure 12: Tank shell measured thickness compared to nominal and minimum thickness; note single point of wall thinning at 0.08 ft elevation

The corrosion on the bottom 1 inch of the shell is likely the result of three factors:

1. The diameter of the tank bottom is roughly 12 inches larger than the tank shell. Thus the floor plates extend out beyond the tank shell and insulation forming a thermal 'fin' that draws heat away from the bottom corner of the tank.
2. Water intrusion under the tank creates a significant heat load that also draws heat away from the bottom corner of the tank.
3. The tank insulation does not extend all the way down to the floor of the tank. A small section of the tank shell is left exposed further lowering the shell temperature at the bottom corner of the tank.

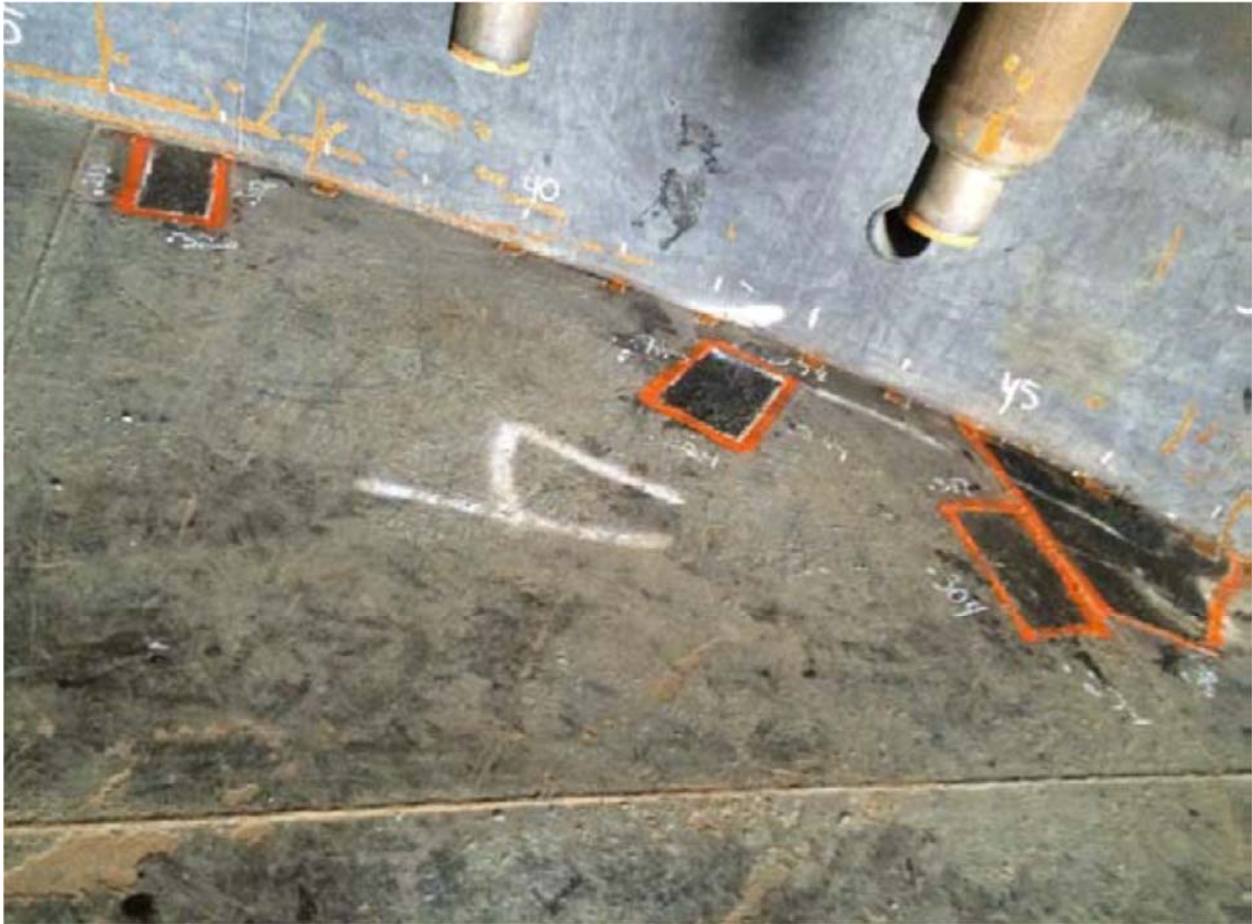
Ultrasonic wall thickness measurements were taken at 209 different locations on the tank floor. Measurements at 32 of those locations showed that the floor thickness was at or below the design thickness. All 32 of these locations were within 1 inch of the chime. A single through-hole was found - also at the tank perimeter. The corrosion of the tank bottom occurred primarily on the bottom-side of the plates (from the ground-up); the top surface of the plates was observed to be relatively corrosion-free.

Figure 13: Typical tank floor surface with bottom-up corrosion near perimeter; boxes mark UT measurement locations

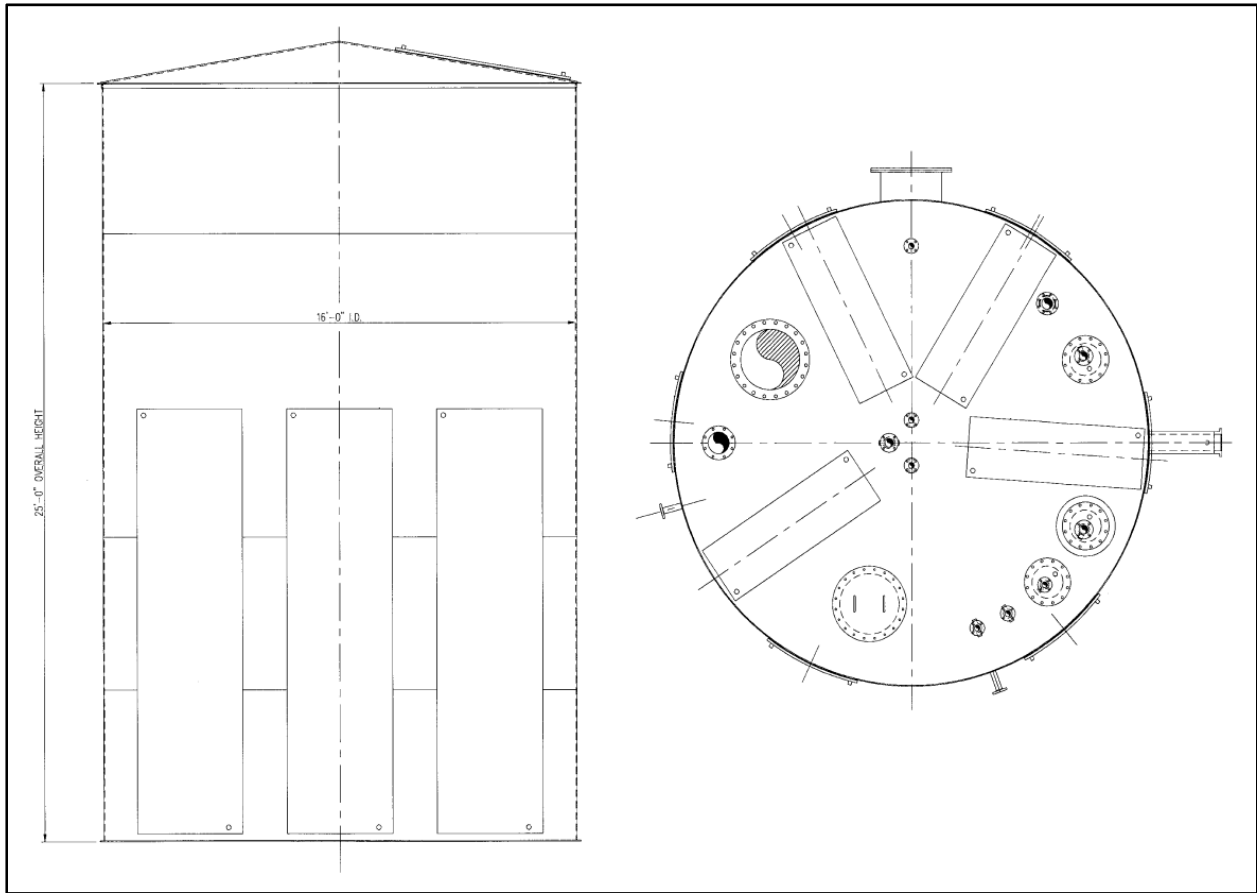
Panel coils are constructed from two plates that are stitched together to form a panel. Steam is applied to the space between the plates, and the assembly is attached to the exterior surface of the tank. Panel coils are practically limited to a rectangular profile; thus, they must be placed on the tank with considerable space between them to accommodate the tank roof geometry and to avoid nozzles. These gaps between the panels are large enough that the resulting tank surface temperature is non-uniform.

Figure 14: The second sulfur tank panel coil arrangement

- The complete tank roof was replaced; roof corrosion was most prominent around the nozzles.
- Two patches were required on the shell due to wall thinning.
- Two patches were required on the floor due to wall thinning.
- An annular ring was installed on the floor to address wall thinning at the perimeter.
