TECHNICAL INSTRUCTIONS

Safety (Non Compliance) Recall 21TA02

NHTSA Recall No. 21V-554

**PASSENGER SEATBELT AUTOMATIC LOCKING RETRATOR FUNCTION –
MAY NOT ACTIVATE**

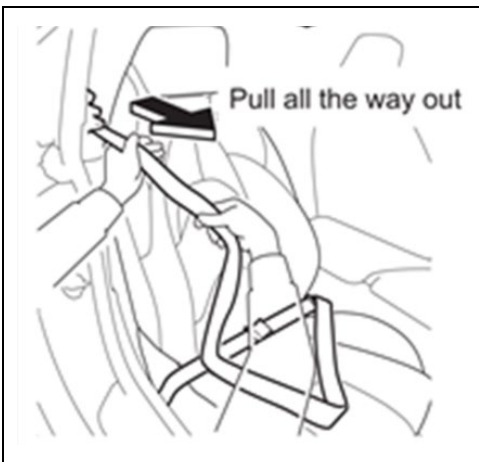
- b. Fully extend RH outer seat belt assembly to enable ALR function.

Remove Seatbelt webbing slowly. If seatbelt webbing is pulled to quickly, ELR may activate and the inspection process will need to be restarted.

NOTE: Once the RH outer seat belt has been fully extended, it will not be possible to pull the belt out any further.

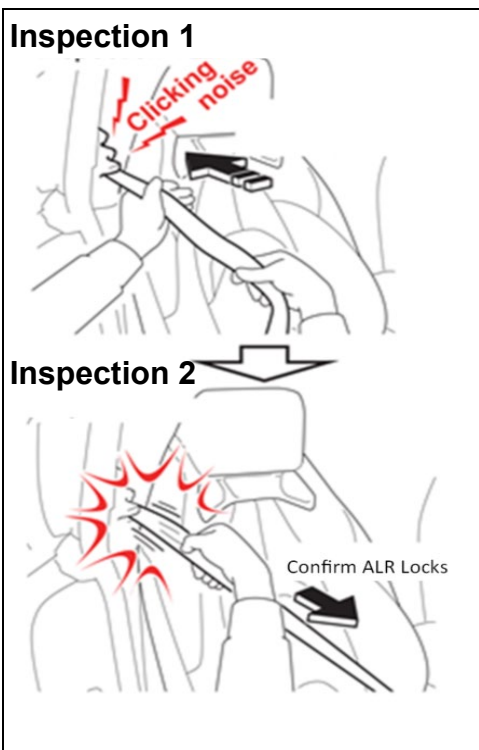
- c. With the seatbelt buckled, slowly allow RH outer seat belt webbing to fully retract.

NOTE: If ALR has been correctly enabled, an audible clicking noise will be heard as the seat belt is being retracted.

- d. Confirm ALR locks by slowly pulling seatbelt out.

Do NOT pull seatbelt webbing quickly, ELR function will activate.

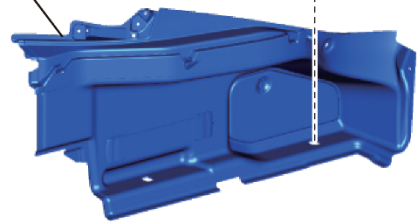
DO NOT REMOVE THE FOLLOWING COMPONENTS

w/ Courtesy Light:

ROPE HOOK
 x2
 x2

DECK TRIM SIDE BOARD AND DECK SIDE TRIM COVER RH

DECK TRIM REAR COVER

for 10 Speakers:

REAR No.2 SPEAKER ASSEMBLY

for 12 Speakers:

REAR No.3 SPEAKER ASSEMBLY

No.1 LUGGAGE COMPARTMENT LIGHT ASSEMBLY

TRIANGLE REFLECTOR SET

The following steps of the TIS repair manual process need to be skipped. The parts are illustrated in VI. COMPONENTS.

- **NO. 1 LUGGAGE COMPARTMENT LIGHT ASSEMBLY (w/ Front Center Speaker)**
- **TRIANGLE REFLECTOR SET (w/ Front Center Speaker)**
- **DECK TRIM REAR COVER (w/ Front Center Speaker)**
- **ROPE HOOK (w/ Front Center Speaker)**
- **DECK TRIM SIDE BOARD AND DECK SIDE TRIM COVER RH (w/ Front Center Speaker)**
- **REAR NO. 3 SPEAKER ASSEMBLY (w/ Front Center Speaker)**
- **REAR NO. 2 SPEAKER ASSEMBLY (w/ Front Center Speaker)**

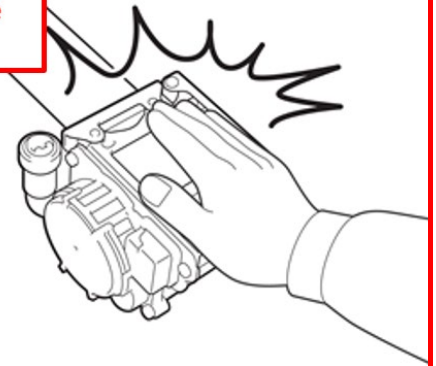
- **DO NOT touch the area around the retractor, even when a front seat outer belt assembly or rear seat outer belt assembly is temporarily removed during service.** If the pretensioner unexpectedly deploys and the front seat outer belt assembly or rear seat outer belt assembly is retracted during an operation, it could cause a serious accident.
- **When storing a pretensioner, DO NOT place objects on top of it or place it in a pile.**

Do NOT touch the area around the retractor.
