TECHNICAL SERVICE BULLETIN

Technical Service Bulletin: 225-V21025

The thermistor installed in the vehicle is not in an optimal location. The thermistor will need relocated, and software upgrade to the FireFly electronic control system is also required.

PART NUMBER: 09 000 562 REV C

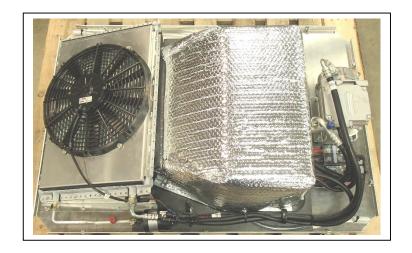
Parts List	
52 001 180 Install Instr, RV RT Freeze-up T-stat, Pressure Switch	
(1) 01 000 351-Thermostat, Non-Adj (31-39)	
(1) 15 000 162 - Switch, PS 350 w/WP Conn	
(2) 02 000 052 - Wiretie,14 x 3/16	
(2) 02 000 107 - Screw,10x1/2 PH Phil Blk	
(2) 08 000 112 - Tape, Foil 2" x 150' roll	
(1) Replacement Electrical Panel
