## **Terahertz Imaging and Backscatter Radiography Probability of Detection Study for Space Shuttle Foam Inspections**

**Warren Ussery**  
Lockheed Martin Space Systems Company  
504-257-1934

**James Walker**  
NASA MSFC  
256-961-1784

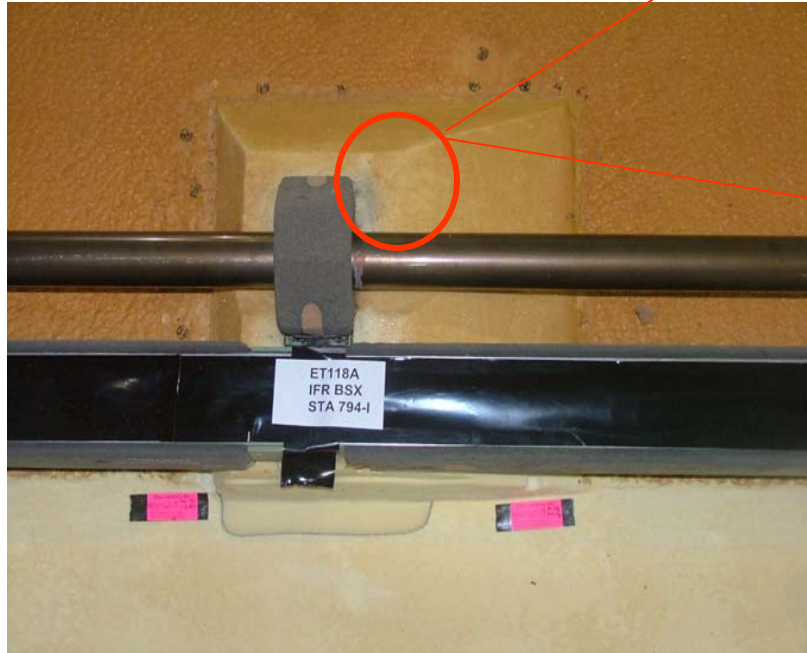
- **Example 1**
  - THZ image has distinct response from void
  - BSX image has marginal response from void

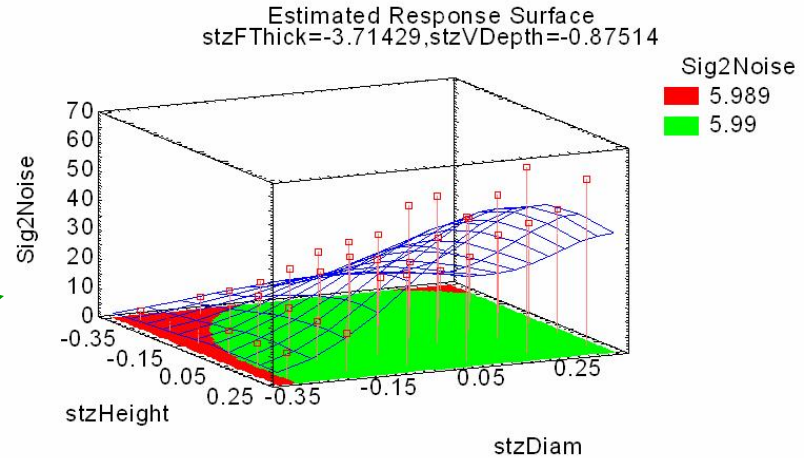
Single variable versus multi-variable POD response

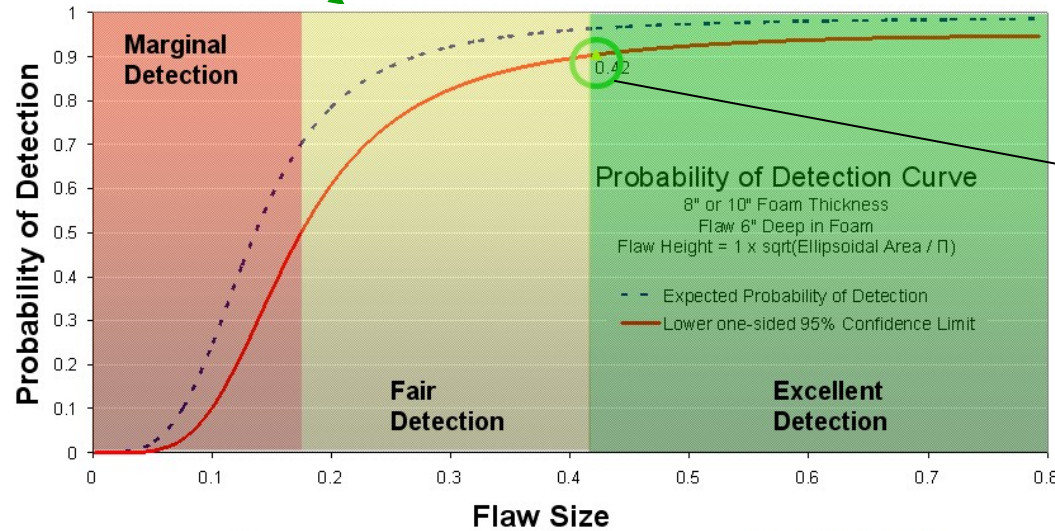
90/95 Value: Intersection of 95% confidence curve with 90% probability of detection

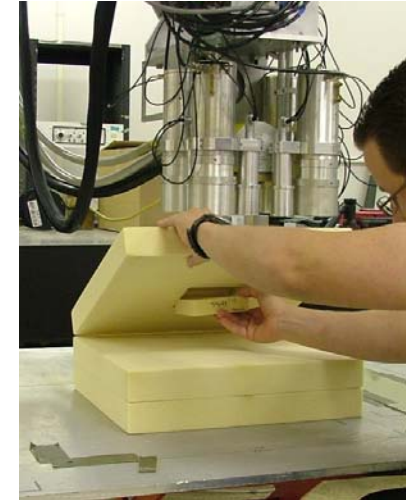
POD test article

- **POD Approach for BSX/THZ of Ice Frost Ramps (IFRs)**
  - Test article consisted of flat blocks with inserted semi-natural defects
  - This design allowed POD calculation for different defect depths and foam thicknesses
  - Sample population of 400 composed of 100 defects and 300 blanks
  - A POD sample consisted of a BSX and THZ inspection of one coupon
  - Three interpreters analyzed the 400 samples for a total of 1200 discrete results

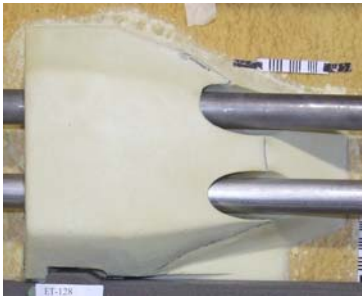
ET Ice Frost Ramp

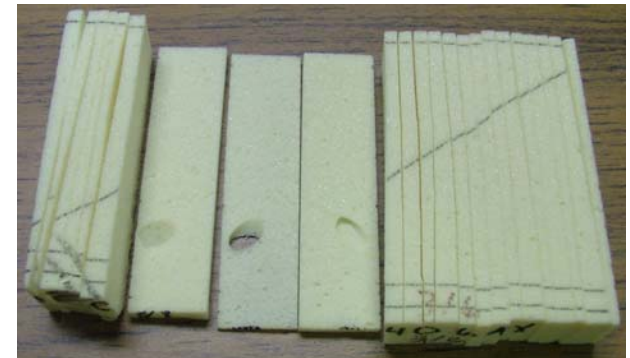
Coupon with defects after final dissection

- Test matrix and experimental design:
  - Ken Johnson (MSFC Statistics and Trending group)
  - Ward Rummel (Independent Contractor)
- Randomized inspection order
- Interpreters were blind to sample contents
- Three Level II certified radiographers evaluated data
- All 400 samples were dissected to confirm defect sizes or false positives

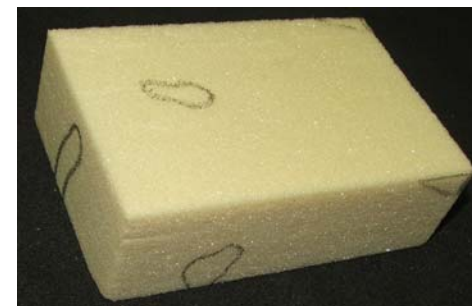
Coupon with defects marked after x-ray inspection

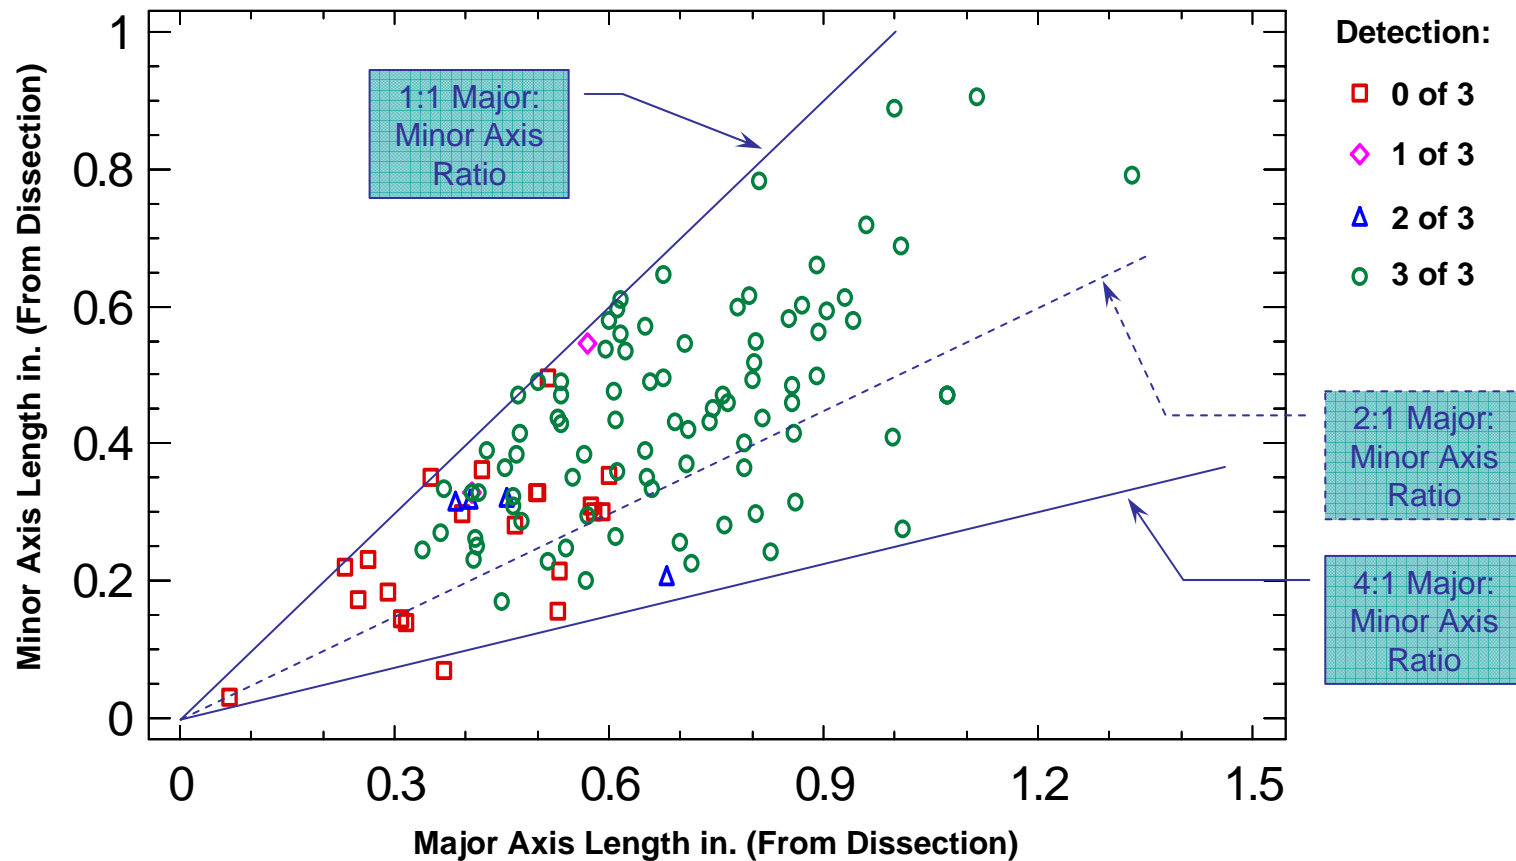
Plot of Major v Minor Axis Lengths

- More elongated flaws require larger major axis dimension for detection
- Thinner flaws (smaller height or thru-thickness) require larger major axis dimension for detection
- Deeper flaws (under larger amounts of foam) require larger major axis dimension for detection
