THE DESIGNED LANDSCAPE AT HENRY TATE MEWS, STREATHAM

Landscape management guidelines

Henry Tate Mews, Streatham
(previously known as Park Hill / St Michael's Convent)

Landscape Management Guidelines 2012

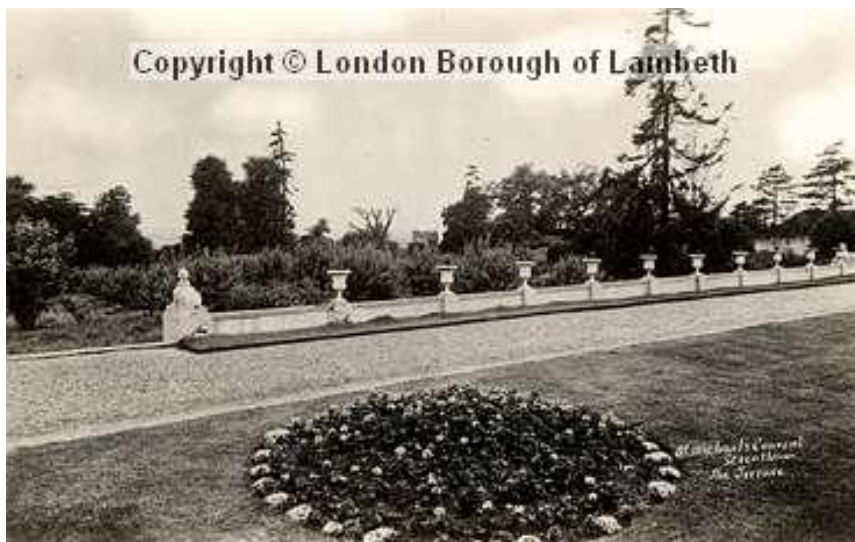
Figure 2 The terrace in 1939. (Copyright London Borough of Lambeth, postcard held in Landmark collection, #1155.)

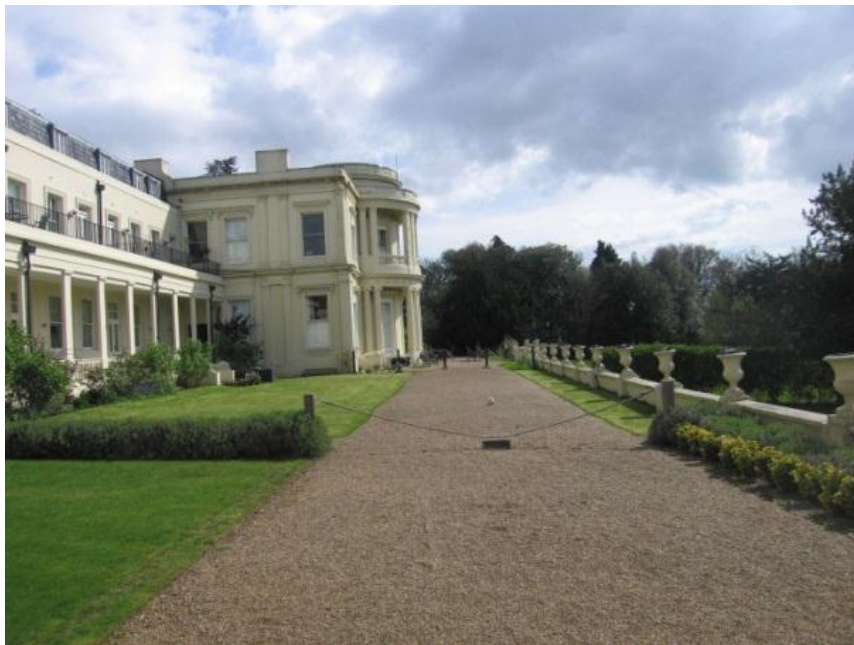
Stretches of terrace have varying ownership and access arrangements but this situation is minimised visually and so the impressive length of the terrace can still be viewed as a visual whole.

Figure 3 There are different ownership and access arrangements for various stretches of the terrace but this distinction is successfully and importantly kept to a near-minimum, visually.

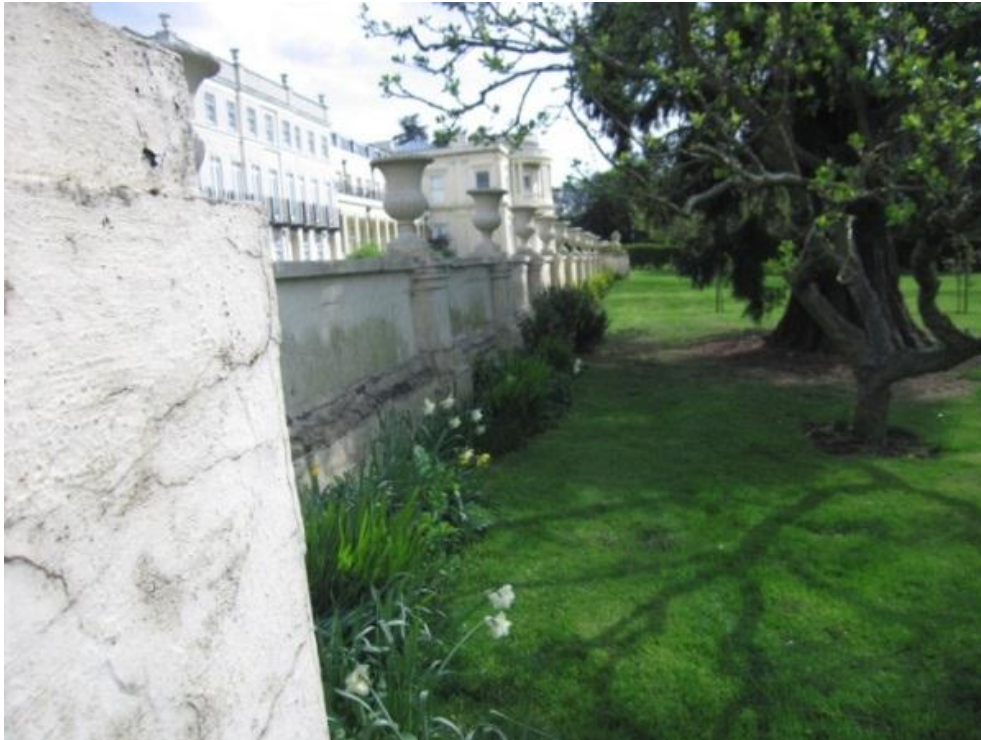
6.1.3.2. Structural condition

Figure 4 The terrace walls, showing the need for repair.

The terrace structure itself is in need of urgent expert repair – residents have this in hand and English Heritage (EH) have suggested that an application be made to EH for a grant towards funding this work.

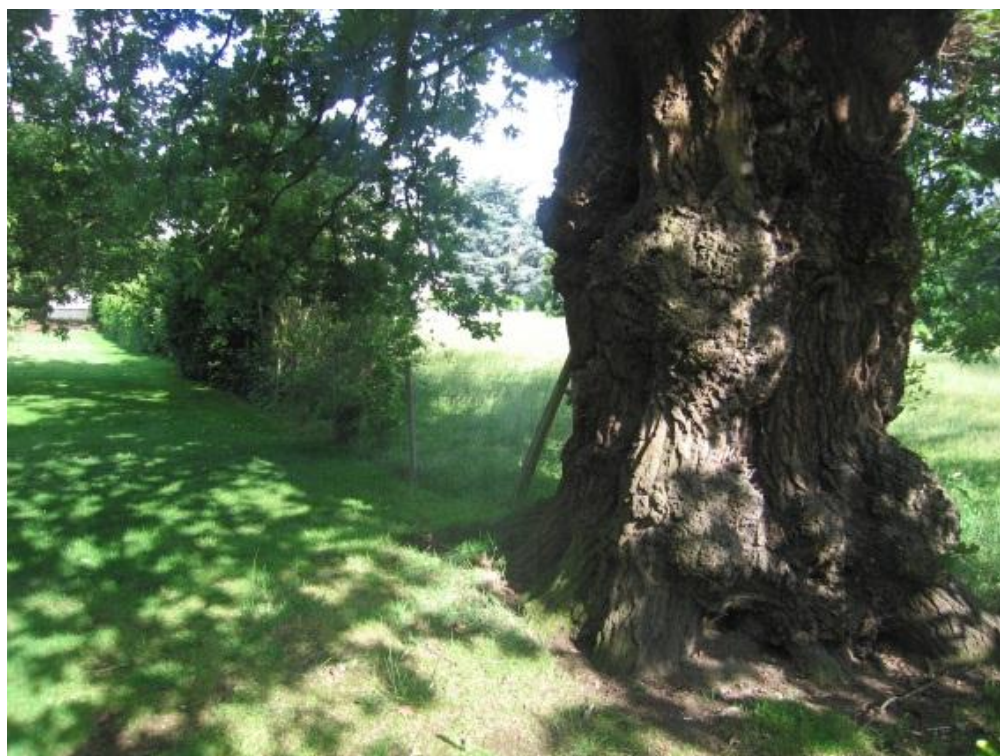
Figure 5 The lawn clearly receives two different management regimes – to the left of this picture is closely cropped lawn, and to the right is a longer meadow.

Residents may wish to aim for a relatively close-cut “fine smooth turf” that was described as being the view in 1849.¹³

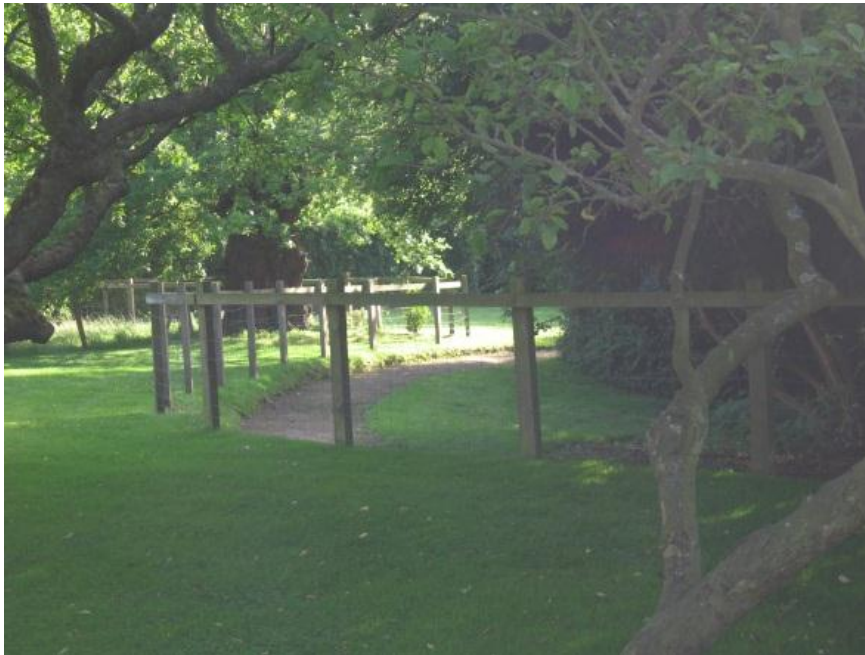
Figure 6 A fence demarcates different areas of the garden, creating a visual obstacle and being at odds with the gardens' 'gentleman's residence' character.

A desirable long term aim would be to make residents more fully aware of the sensitivity of the landscape and to foster an understanding so that the fence is no longer needed and could be removed.

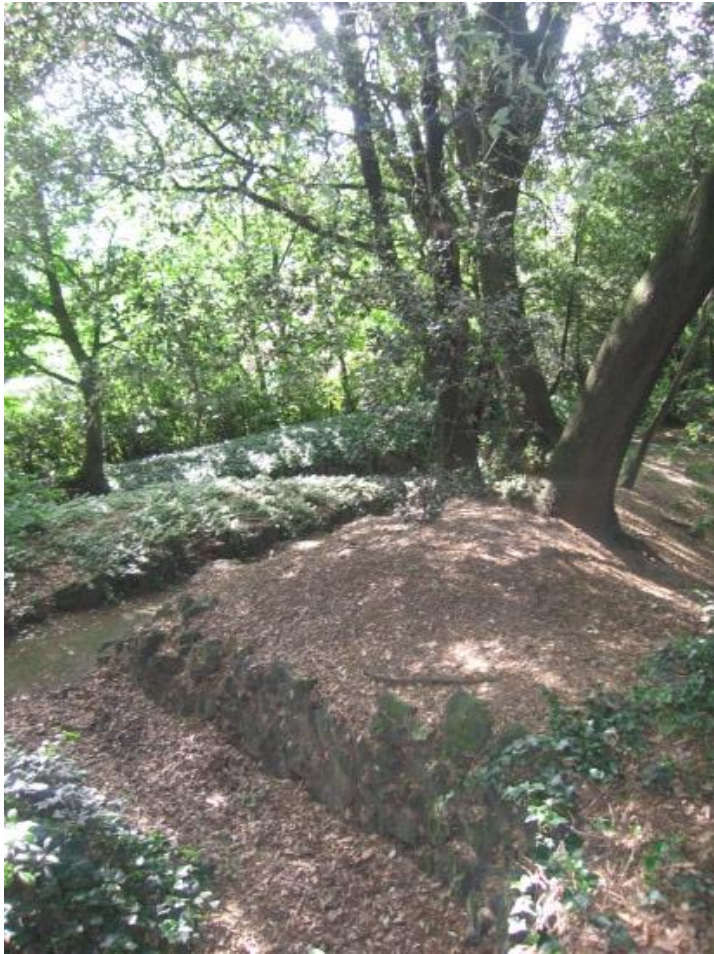
Figure 8 Circuit walk detour leading to a viewing mount for enjoying the scene of the lake with mansion beyond.

The lakeside viewing mount survives in good condition, with the paths having been well-retained. There are some difficulties however with fallen debris and unmanaged tree growth obscuring both the mount and its important view.

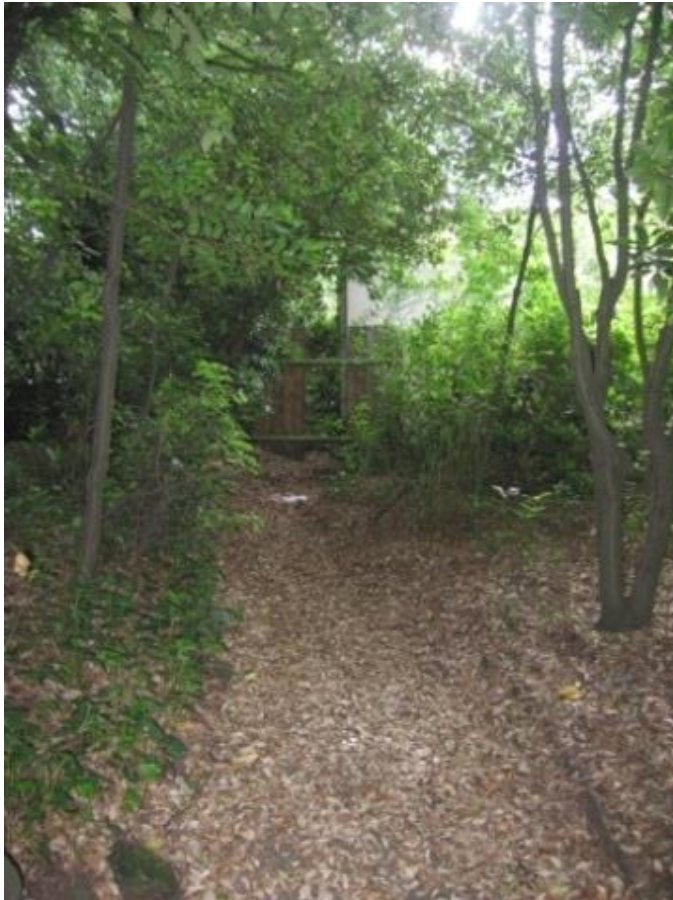
Figure 9 Recent boarding prevents access to the circuit walk at the southern entrance.

The owner of the southern garden should be encouraged to reopen this route.

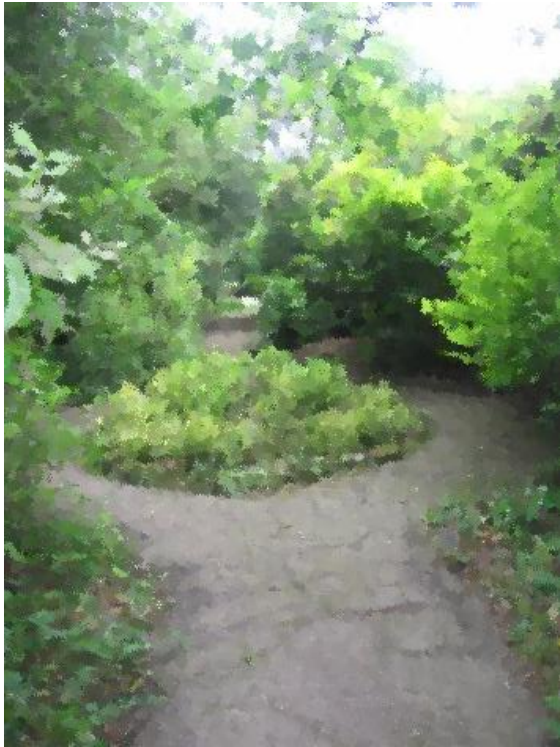
Figure 10 A circuit walk flowerbed requiring attention.

It is notable that not only does the circuit walk ‘take in’ high profile features such as the lake, terrace and ravine, but also includes more understated incidents such as circular flowerbeds along the path (including in the separately-managed south-western portion). These should be maintained, conserved, and planted attractively.

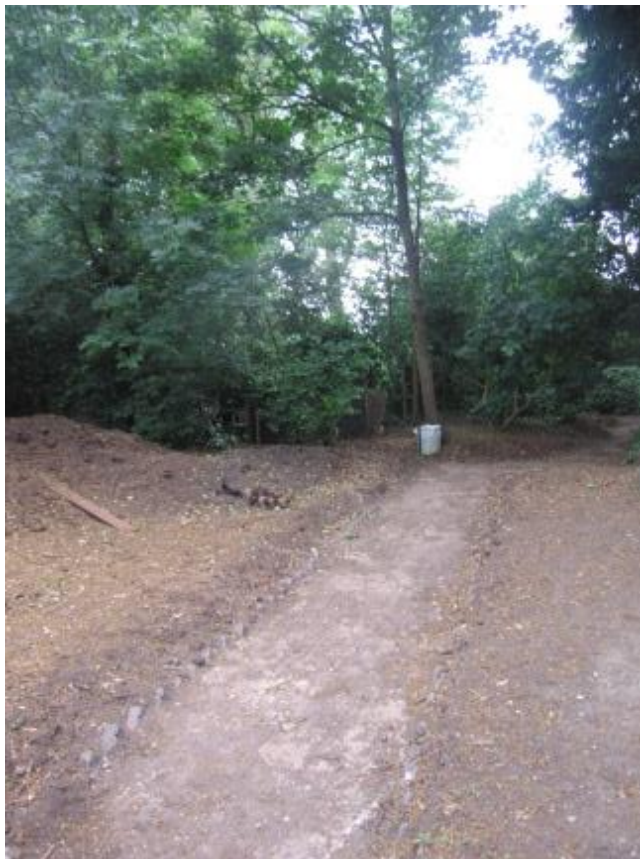
Beyond the lake in the south western corner of the gardens is an interesting area of dense woodland and shrubbery. Historically, this would have been a naturalistic but carefully-designed woodland walk. The presence of edged paths demonstrates that this area is not simply a wild corner but was carefully designed with a level of ornamentation.

Figure 11 Attractively-edged historic paths.

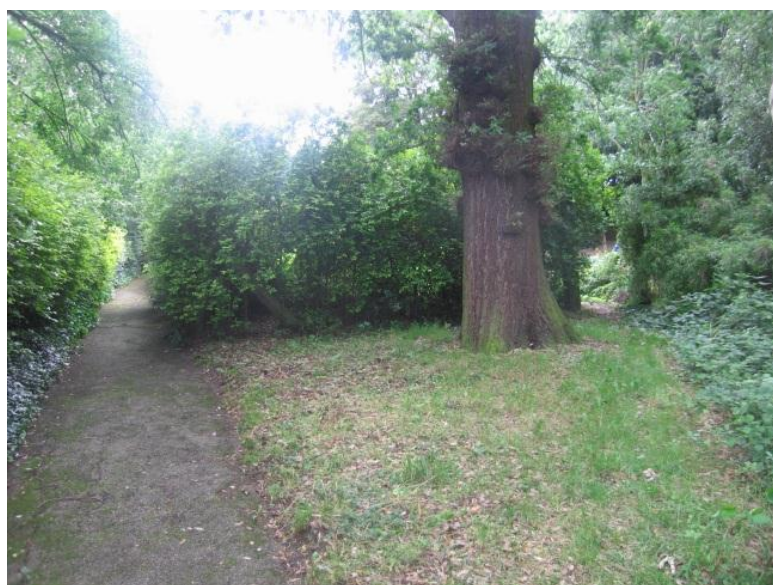
A solid hedge screens the compost and vegetable patch area but this blocks potentially attractive views and intrudes upon the flow of the designed walk in this area.

Figure 12 A hedge block the view through the south-western woodland garden, visually obstructing the attractive scene.

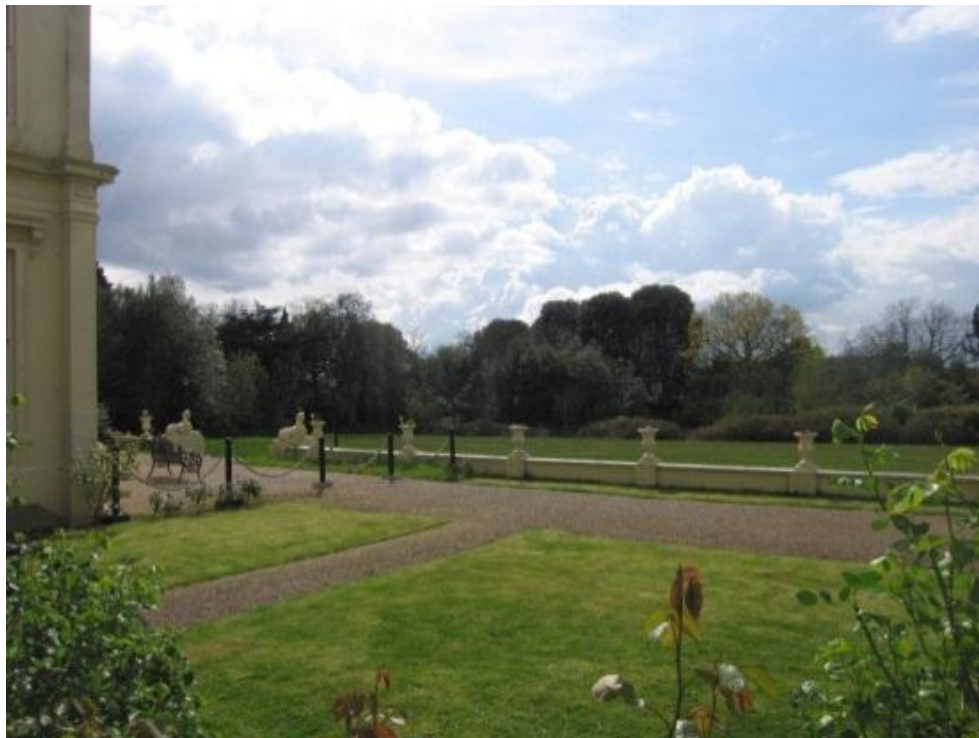
The important view of the lake from the mansion is still intact, with no modern development visible in the setting behind.

Figure 13 The important lake view from the house and terrace is still largely intact and as intended in the 19th century – a rare survival given the site’s modern urban location.

However, the quality of the planting behind the lake has deteriorated: excessive growth and other clutter partly obscure the views across the water.

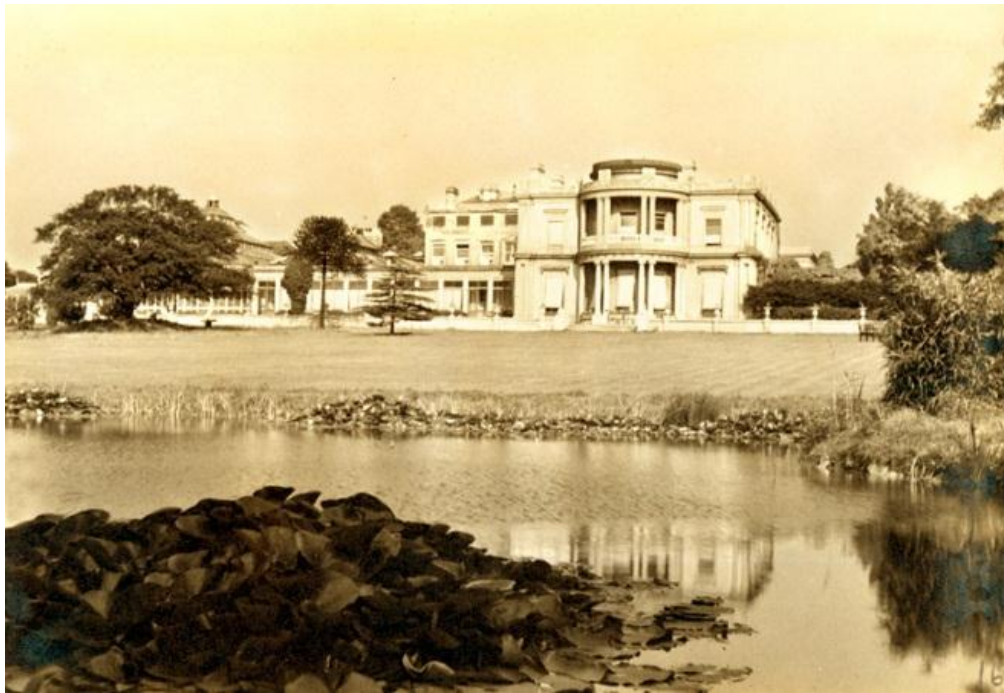
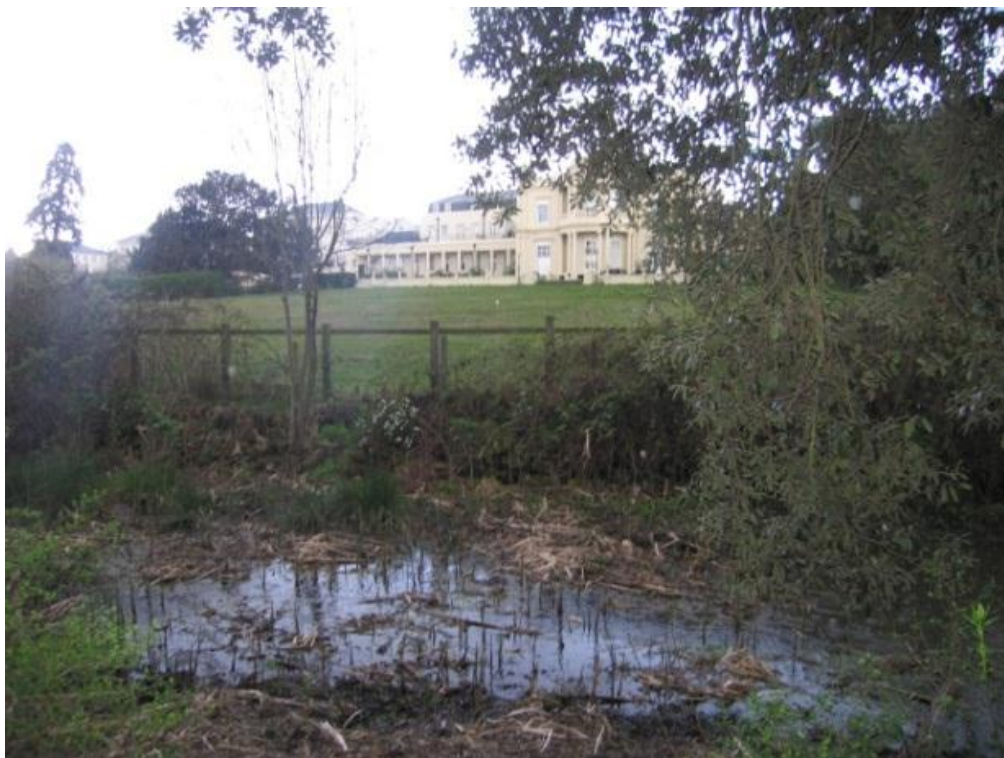
Figure 14 Lake in early 20th century (above), and in 2012 (below).
 (Archive picture taken from <http://www.ideal-homes.org.uk/lambeth/lambeth-assets/galleries/streatham/st-michaels-convent>)

The silted lake requires specialist advice on clearance work.

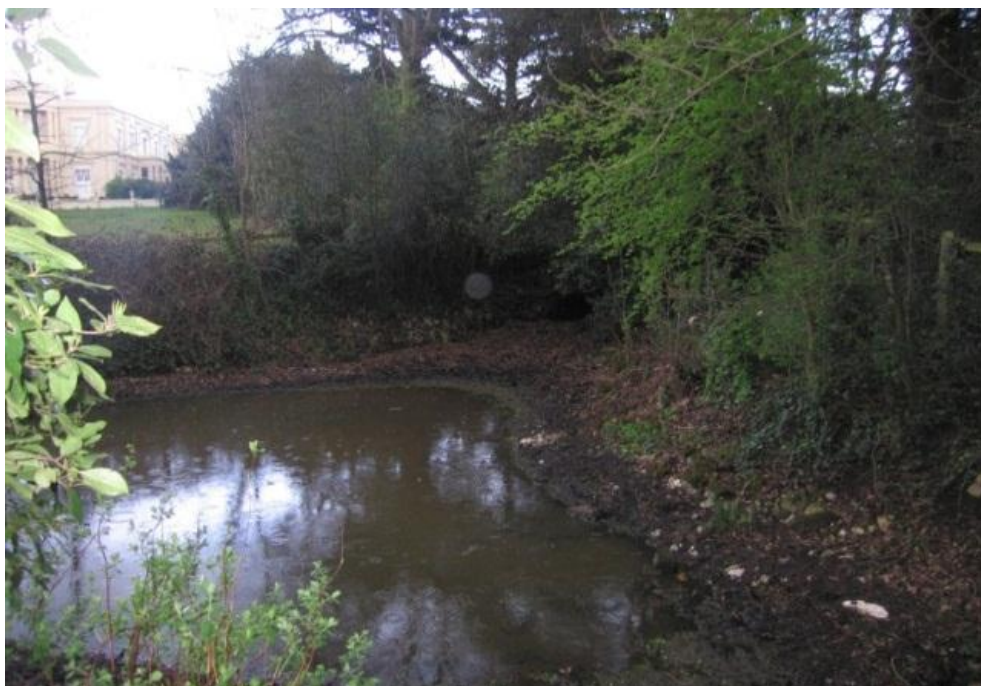
Figure 15 The boathouse when clear, and obscured in 2012.

The boathouse could be cleared with relative ease and would once more be an attractive and entertaining feature on a walk around the gardens.

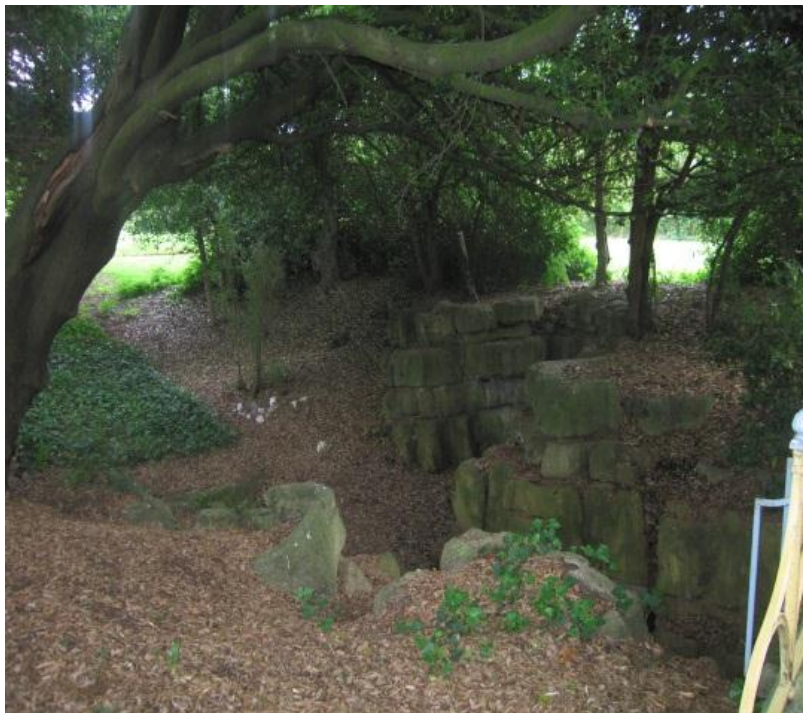
Figure 16 Debris of earth and leaf fall has in some places obscured the original Pulhamite formations and would benefit from being cleared.

Even in the 19th century the heavy tree canopy caused difficulties²³ and now the whole area would benefit from the thinning of tree canopies so as to reduce leaf fall and improve light below.

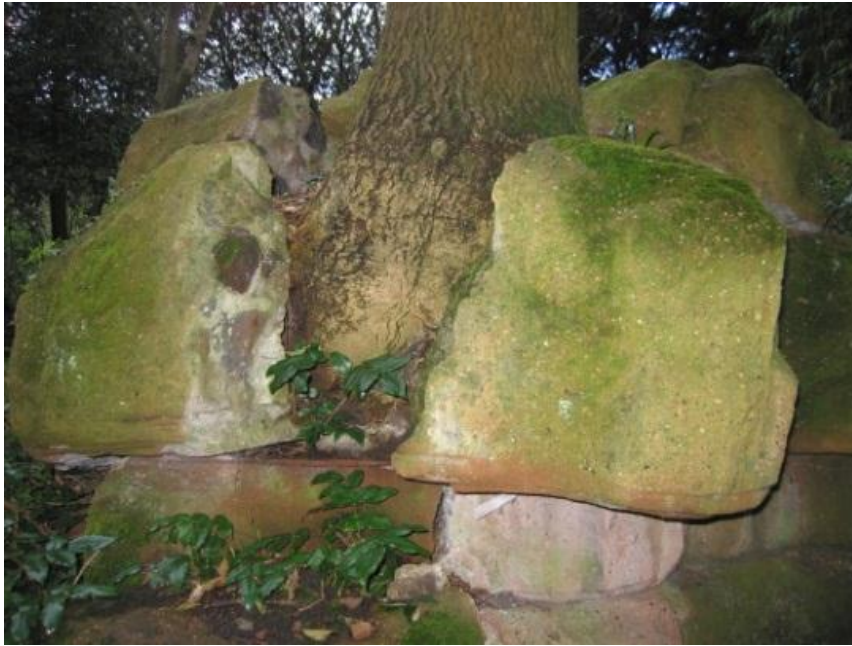
Figure 17 Tree roots damage the Pulhamite in places.

Additionally, some tree roots are causing damage to the Pulham structures and should be removed in accordance with the Tree Survey. This needs to be done with care so as to minimise ensuing damage to the Pulhamite, which may subsequently need to be repaired.

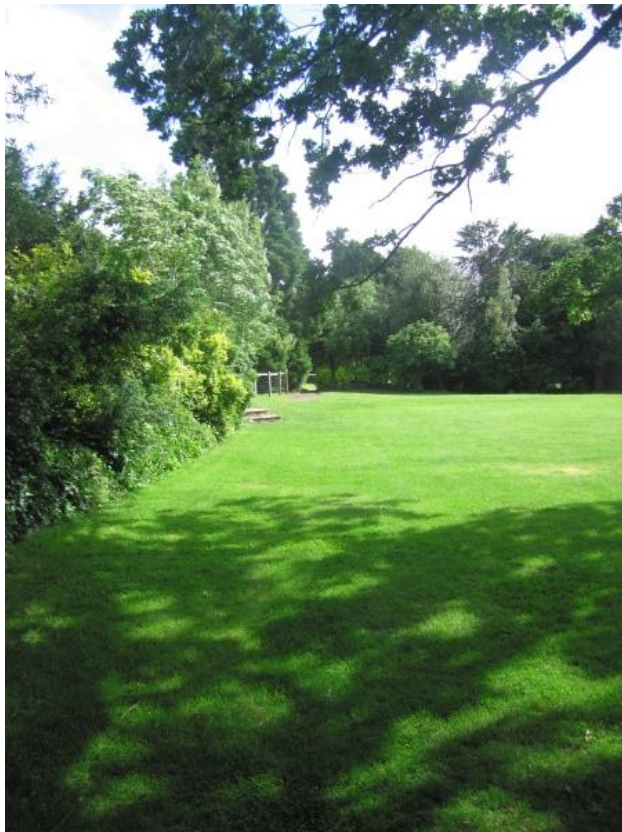
Figure 18 Lower lawn, historically used as a bowling green.

This area is intact and in good condition, although no longer in use as a bowling green. The summerhouse has been lost but the folly survives and is in good condition following recent restoration.

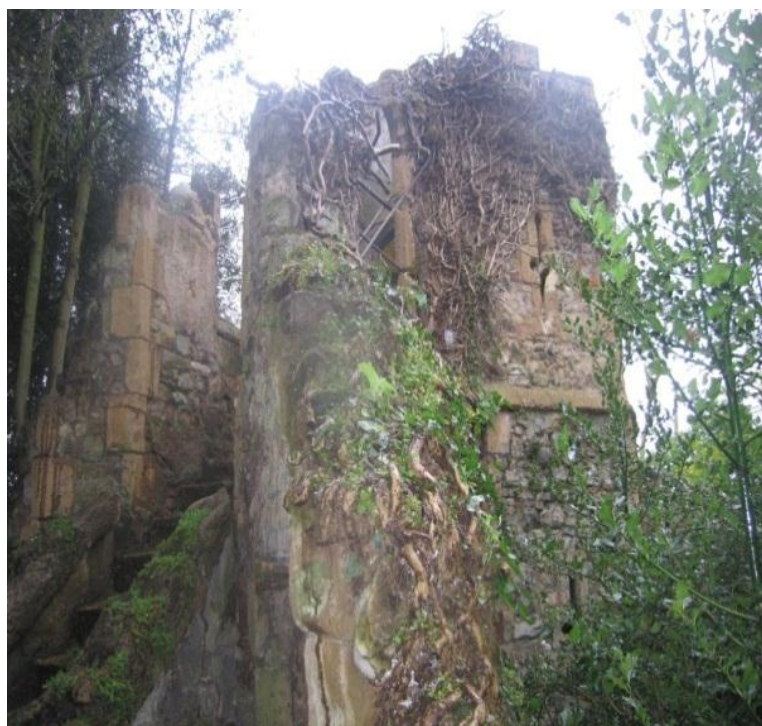
The folly has been restored by residents in recent years and is in good condition although will require ongoing maintenance, for which provision should be made to prevent a lapse into the decay–restoration–decay cycle.

Figure 19 The folly in 2012.

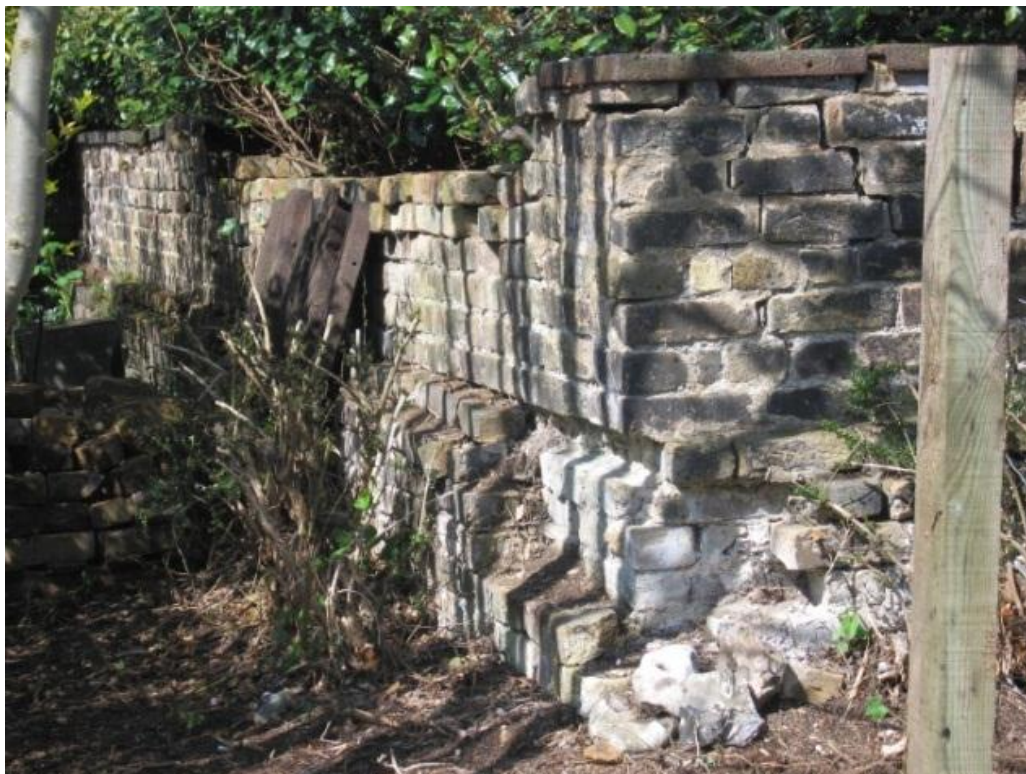
The wall bordering the east side of the lawn (adjacent to the kitchen garden) is in need of repair.

Figure 20 The wall is in need of serious and careful repair.

In addition, EH encourage the Management to apply to EH for a grant towards the cost of these works.

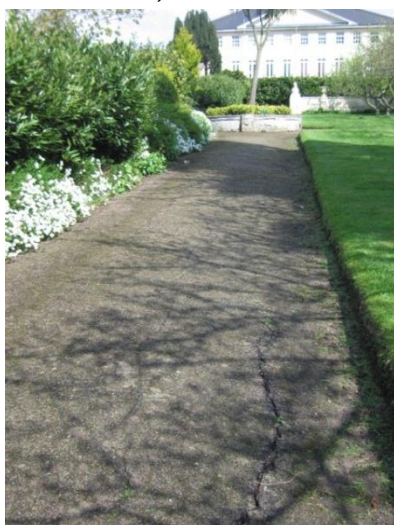
The line of the historic path has been maintained but is now surfaced in tarmac, which is in most places cracked and uneven. It will need to be replaced in the near future, and EH would be glad to advise on a more appropriate material.

Figure 21 An appropriate replacement will be needed for cracked tarmac.

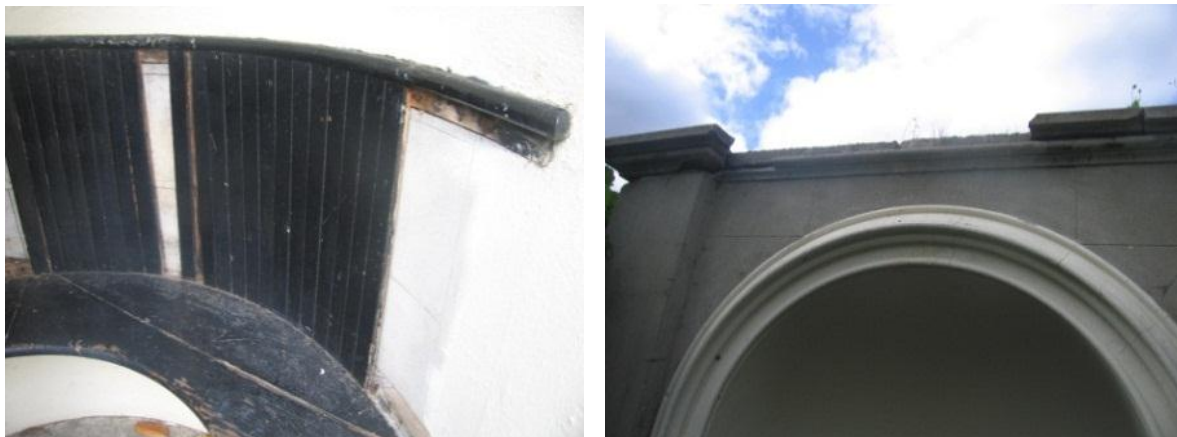
The alcove is in need of some repair to the stonework and also repairs to the seat itself are already underway. Parts of the stonework have fallen away and lie nearby the alcove: these should be retrieved and kept securely whilst awaiting repair.

Figure 22 The stonework and seat of the alcove are in need of repair.

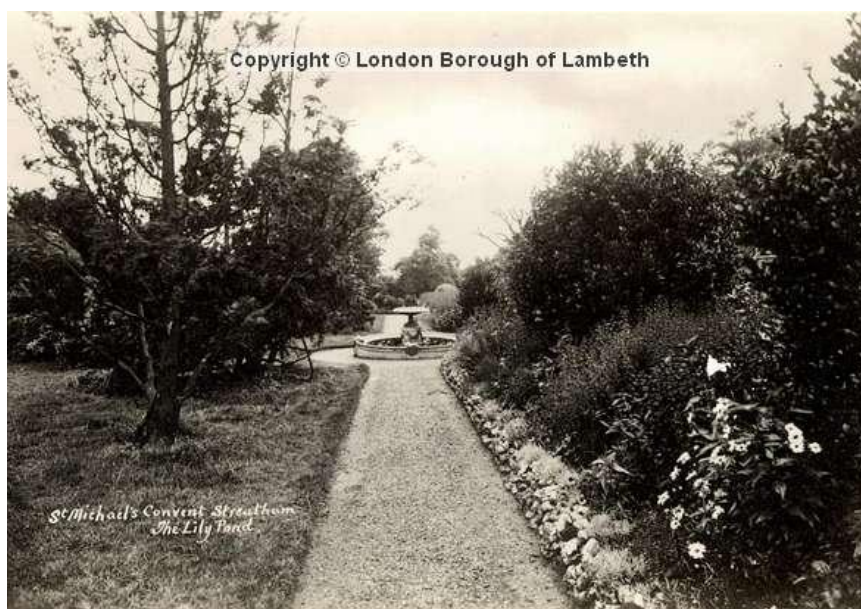
Figure 23 Historically, the round flowerbed in front of the alcove was a water feature.²⁸ (Archive photograph from Landmark –landmark.lambeth.gov.uk, Postcard Albums collection, #1156, copyright London Borough of Lambeth)

The walls of this feature require some repair and residents may wish to take this opportunity to reinstate its historic use as a water feature.

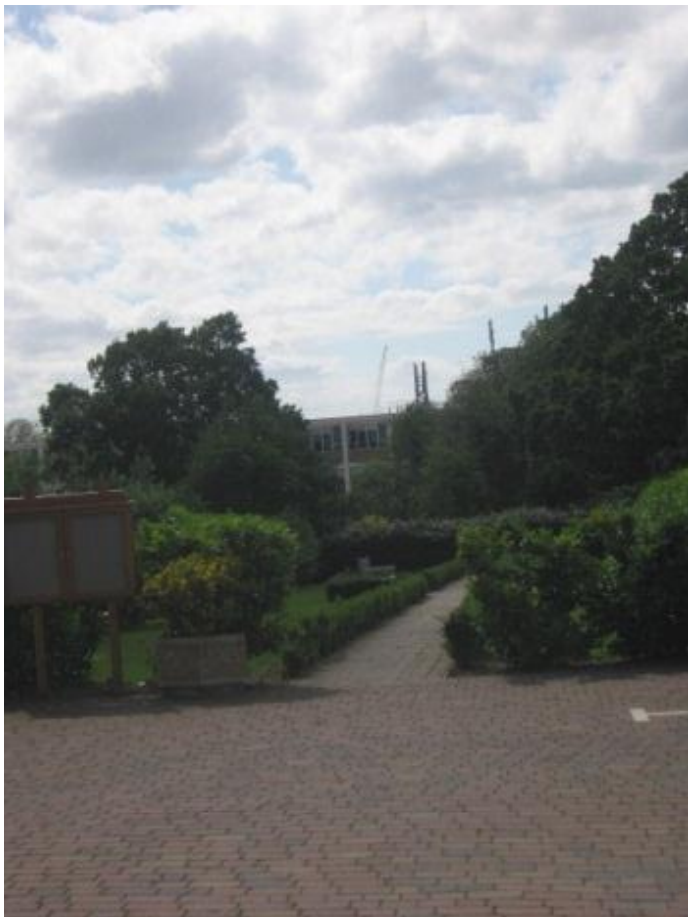
The kitchen gardens were almost entirely built over with housing in the 1990s but a small parcel survives immediately behind the alcove border. This is now labelled as the Herb Garden and is mainly laid to lawn with a path down the middle along the historic line.

A portion of wall still survives, in good repair, as the back wall of some of the modern housing.

Figure 24 Surviving part of the kitchen garden

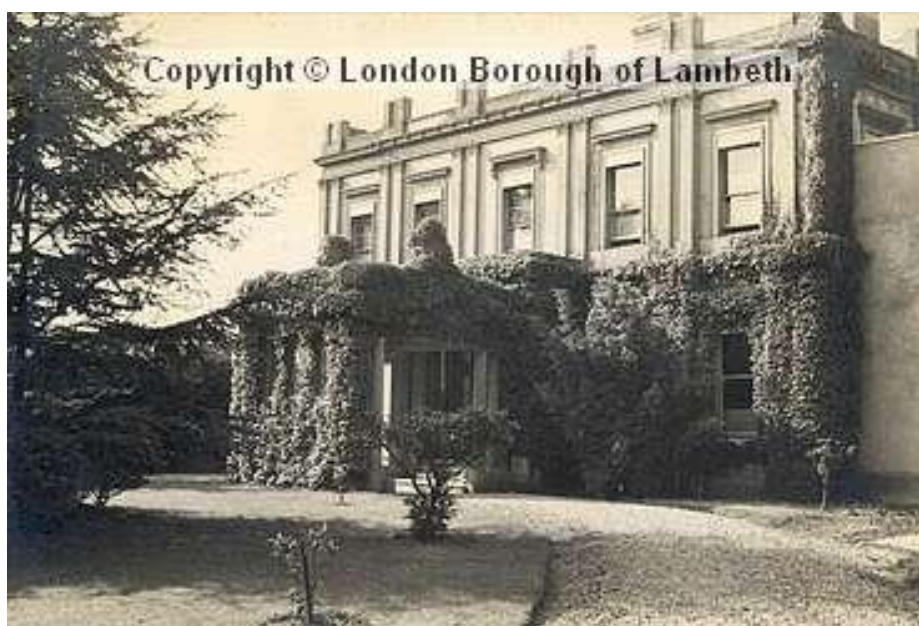
Gardens to the immediate south front of the house provided visitors with their first impression of the property and were designed to be simple, smart and impressive to maximise the view of the house. The driveway curved round to a turning circle with grassed centre and a splendid feature tree in the middle.

Figure 25 South front of the house in 1939.

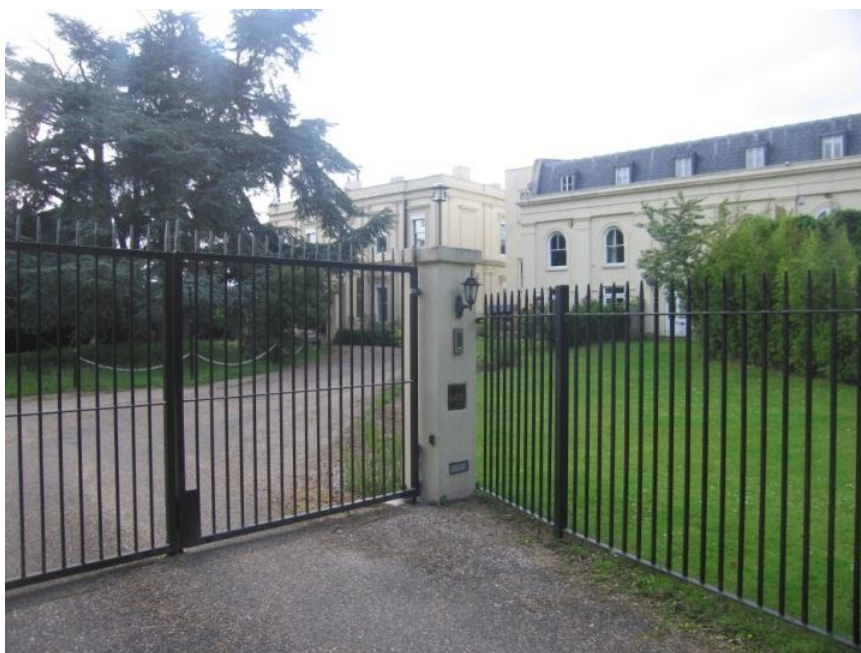
It is regrettable that the division of the landscape is so visually obvious, and that it is so clear that the grounds are managed as many small portions rather than as a single important heritage asset. Multiple ownership need not necessarily prevent a single management regime and a cohesive approach would significantly improve the value of this heritage asset. Therefore, the residents of these dwellings should be encouraged to adopt a ‘working together’ approach.

Figure 26 The south front in 2012.

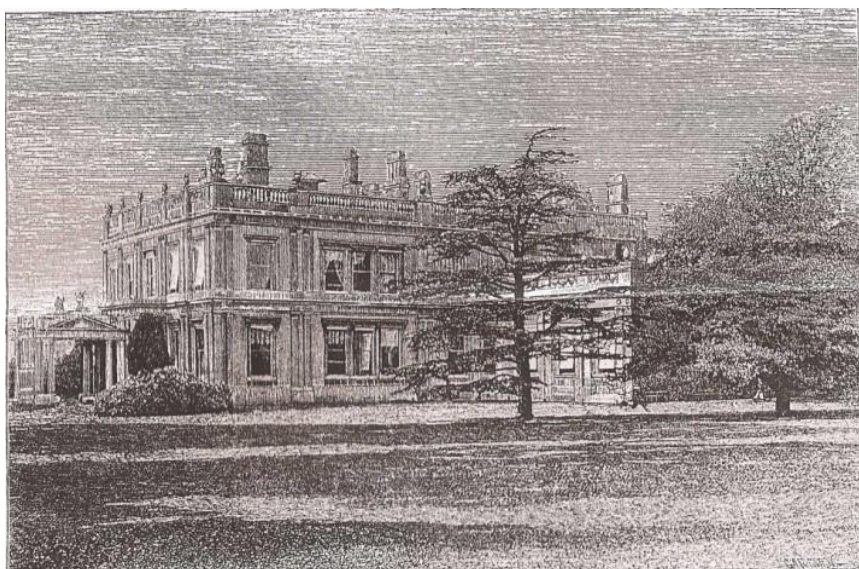
Figure 27 The south and east front of the house in 1886. *The Garden* 29, (1886). p569

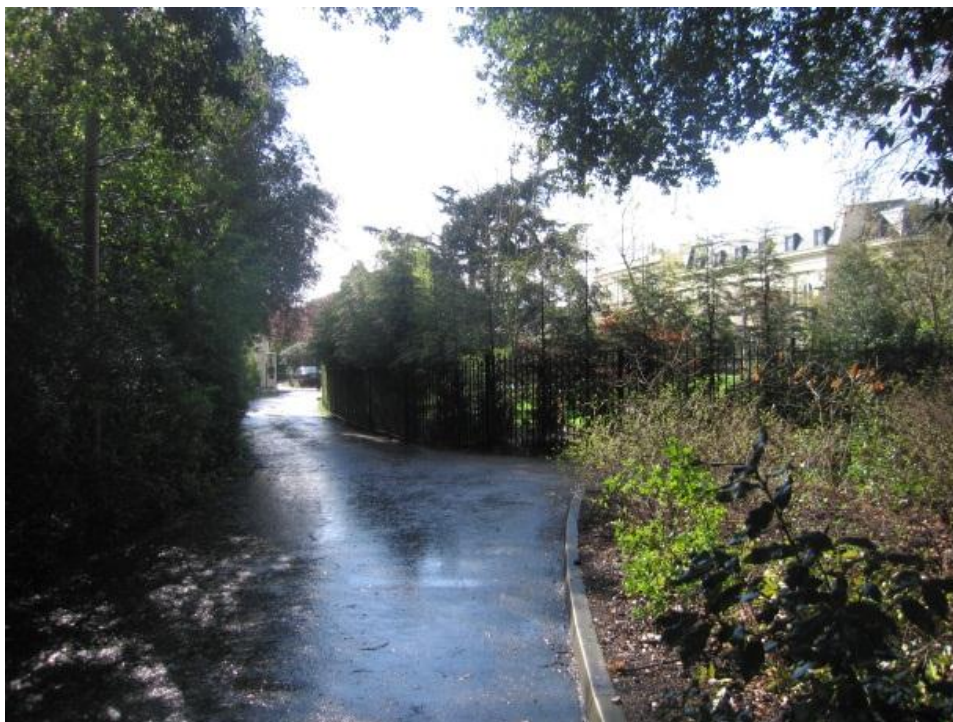
Today the left fork of the drive way ends in a gate marking a part of the gardens in separate ownership. It is bounded by modern railings and dense hedging.

Figure 28 The left approach is now bounded with hedging, fencing and a gate, which serves to regrettably sever it from the rest of the historic landscape.

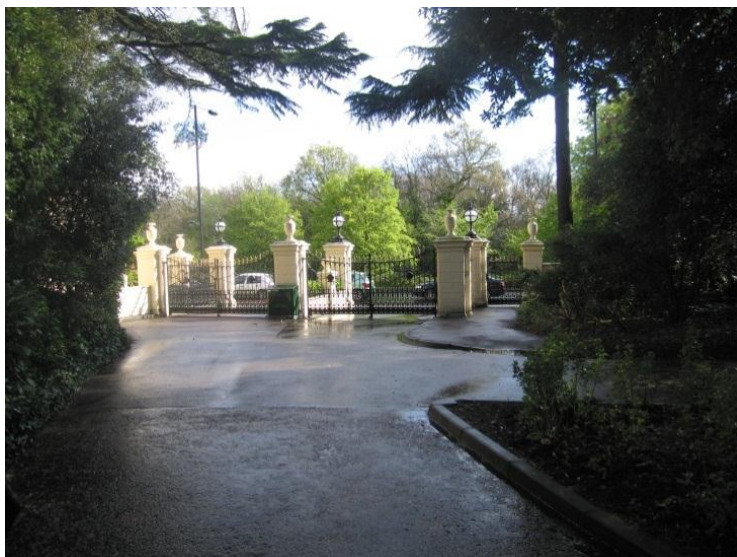
The drives are surfaced in tarmac that is in good condition. This is perfectly serviceable but a bound gravel would be more in keeping with the historic surfacing and should be considered as and when the tarmac needs replacing.

Figure 29 Drive with serviceable but inappropriately modern and municipal tarmac and concrete edging

The drive is edged in concrete edging which again is perfectly serviceable but a discreet iron or wooden edge would be historically more appropriate and should be considered as a replacement in due course.

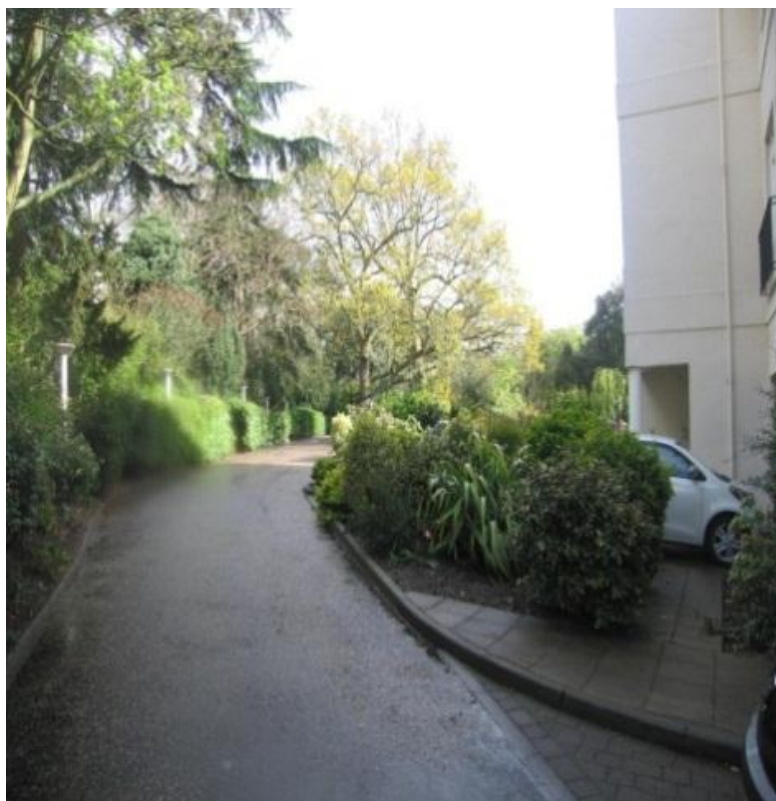
There are some surviving mature ornamental trees from this design to be seen along the entrance drive and these should be maintained and protected and, where appropriate, replaced with the same species.

Figure 30 Mature trees from the historic designed landscape survive along the drive.

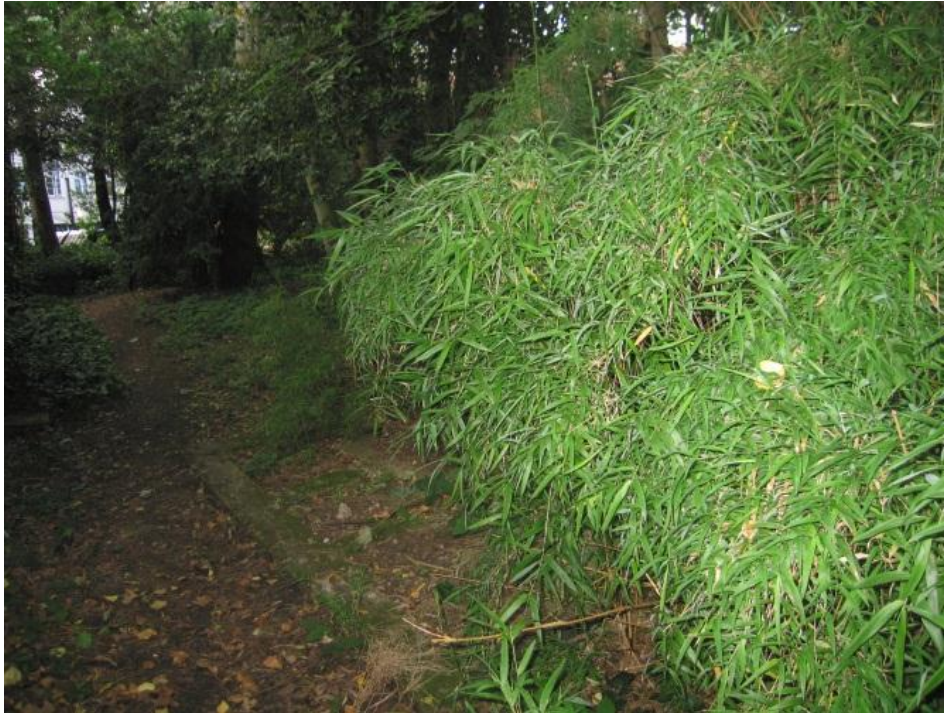
Furthermore, within the grounds of Benhurst Court there are other elements of the Park Hill designed landscape still existing, particularly trees and paths immediately adjacent to the fence. Clearly these are in entirely separate ownership from that of the Henry Tate Mews portion of the historic designed landscape, but the Henry Tate Management Ltd may wish to make residents of Benhurst Court aware of these remnants and encourage their conservation.

Figure 31 There are some parts of Park Hill's historic gardens still surviving within the grounds of Benhurst Court.

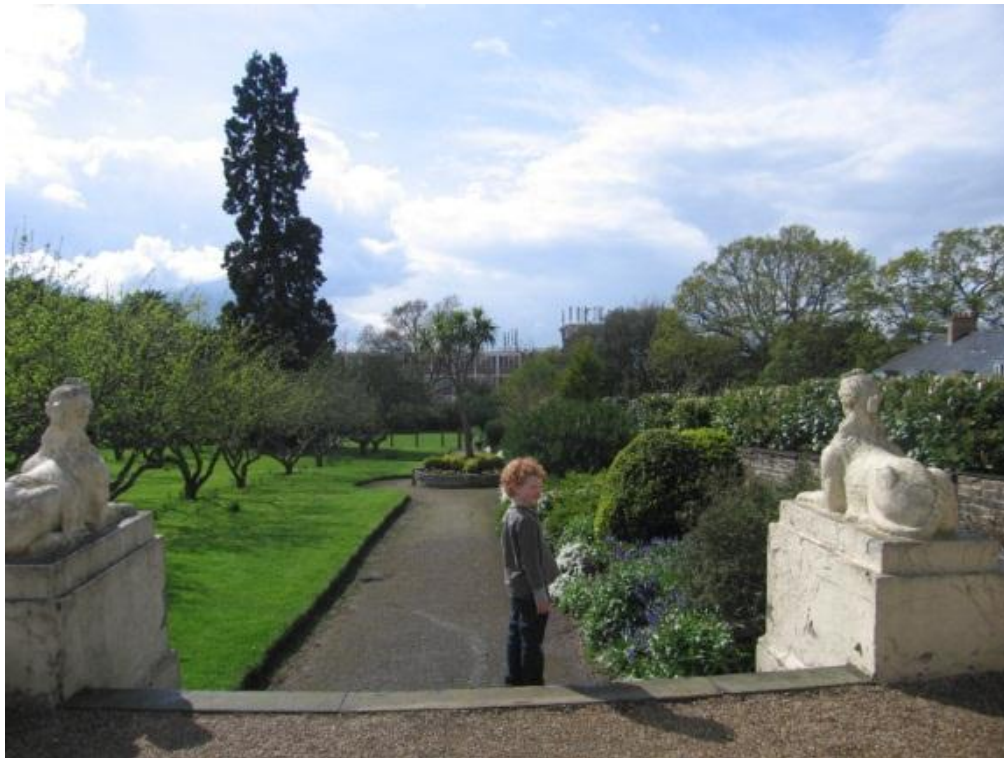
Figure 32 The view to the west is largely intact but the school buildings are intrusive and could be screened with mixed tree planting.

be given to careful tree planting on the boundary to screen this view. Trees could be taken from the palette described as being in the 1886 lake backdrop – lombardy poplar, black poplar, birches, copper beech, and the smaller laburnums, hemlock spruces, and arbutus.

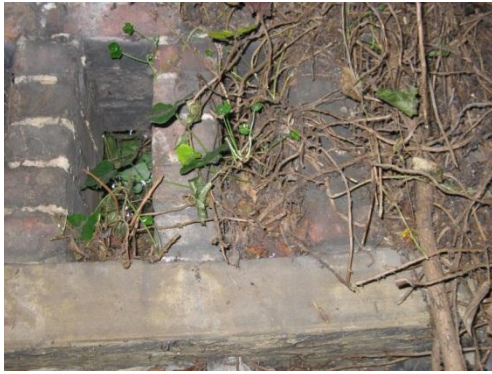
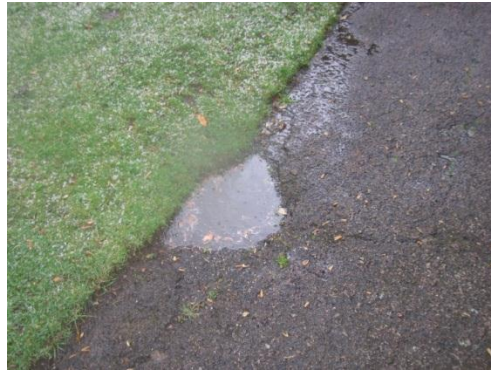
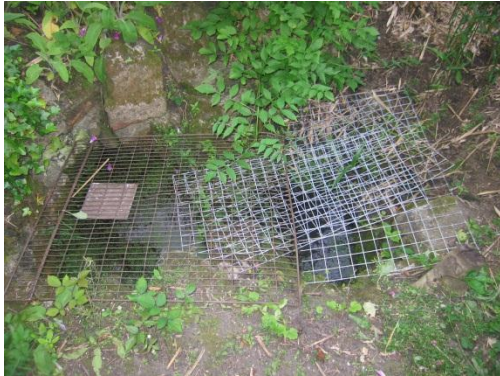
Poor drainage is a problem within the west garden and needs to be addressed as the site floods quickly in wet weather. (It is likely that the poor drainage results from a combination of the old drainage structures needing repair and the complex historic water supply network having been disrupted during 20th century building works.)

Figure 33 The water management and drainage system at Henry Tate Mews is complex and sensitive.

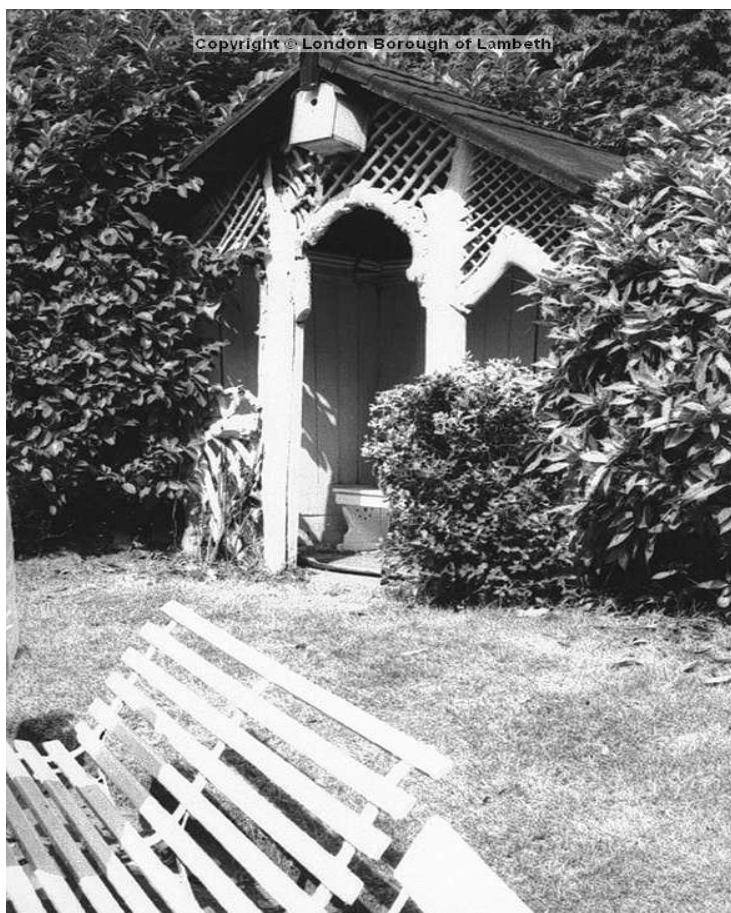
Figure 34 This photograph was taken from landmark.lambeth.gov.uk, where it is said to be 'Ornate summer house in the grounds of Park Hill'. Streatham Antiquarian Society collection, #3140, copyright London Borough of Lambeth.

Local archives and other historic records show that there were a number of garden buildings at the site, now lost. It is likely that the footprints or foundations of these still exist and that the materials are scattered or re-used around the gardens. With a view to building up evidence and an accurate record of these, residents may wish to be vigilant for these when working in the gardens, even though actual recreation and reinstatement is unlikely to be a realistic option.

Further research into the history of the garden and these buildings is recommended and it might be useful for residents to contact the local authority archive service – Lambeth Landmarks, <http://landmark.lambeth.gov.uk/default.asp> - to discuss the following archive pictures, their source, and to discuss the basis on which their captions were written.
