THE DESIGNED LANDSCAPE AT HENRY TATE MEWS, STREATHAM

Landscape management guidelines

Henry Tate Mews, Streatham
(previously known as Park Hill / St Michael's Convent)

Landscape Management Guidelines 2012

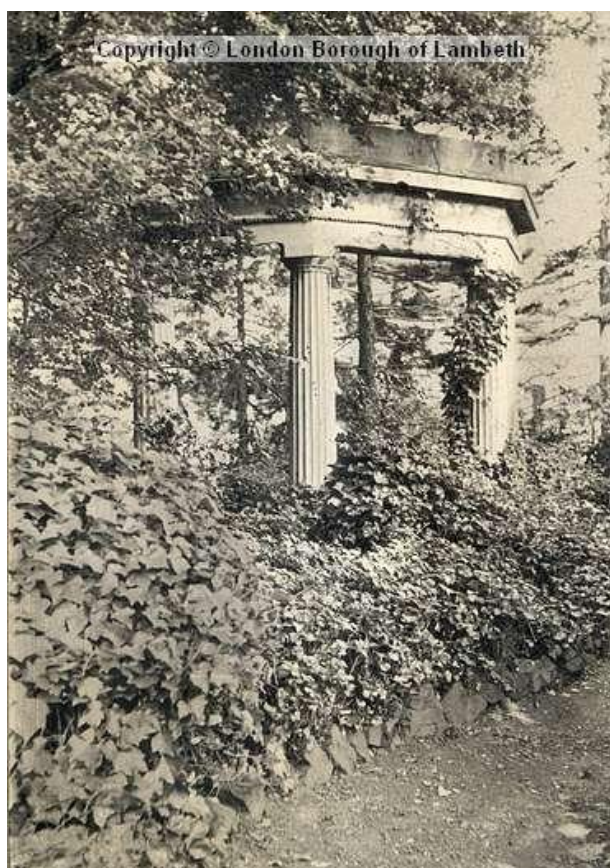
Figure 36 This photograph was taken from landmark.lambeth.gov.uk, where it is said to be ‘The remains of the entrance lodge built in 1835’. Streatham Antiquarian Society collection, #3146, copyright London Borough of Lambeth.

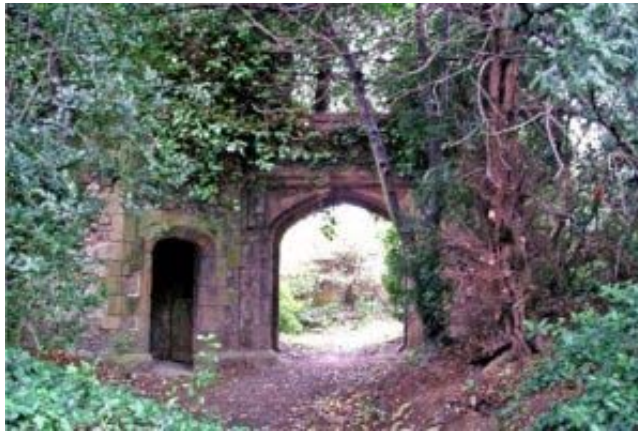
Fig 1 - The ruined tower and gateway at Park Hill, Streatham

The ‘ruined tower’ is in a separate corner of the grounds, and, as can be seen from Fig 1, is now covered by overgrowth and not easy to photograph, but the walls of the tower have traditional mediaeval ‘cross slit’ windows, and it is possible to enter the single rooms on both floors. Unfortunately, most of the panoramic views from the upper floor are now obscured by nearby buildings, but it is intriguing to imagine what a vantage point this must have been all those years ago.

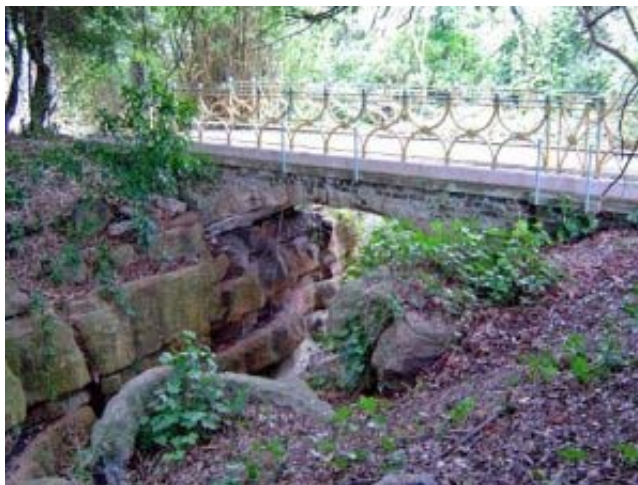
Fig 2 - The bridge over the 'rocky ravine' at Park Hill. (Photo by Desireé McDougall)

It is a short walk from here to the arched bridge over the ‘rocky ravine,’ which can be seen here in Fig 2. There are planting pockets along the top of the bank, and in the cliffs themselves, and there are also the remains of some – but not much – ashlar surfacing to the brick facing of the bridge itself. The railings are a faithful replacement copy of the original balustrading, which is thought to have been designed especially for William Leaf by John Bounaroti Papworth.

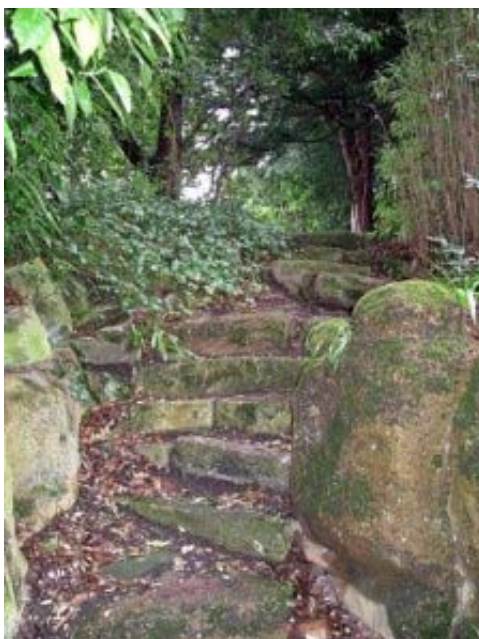
Fig 3 - Rustic stone steps leading down into the 'rocky ravine' at Park Hill

From here, one descends into the ravine itself, which is not as difficult as it may look at first sight. It is possible to enter via a gentle slope at the far end from the bridge, or down a flight of rustic stone steps, shown in Fig 3. Looking along the walkway is very reminiscent of many other Pulham scenes – a pathway winding away into the distance between random outbreaks of huge rocks – some with massive overhangs. As Sally Festing commented in her article, they had a slightly pinkish hue, and Fig 4 shows a typical glimpse along the 'ravine.'

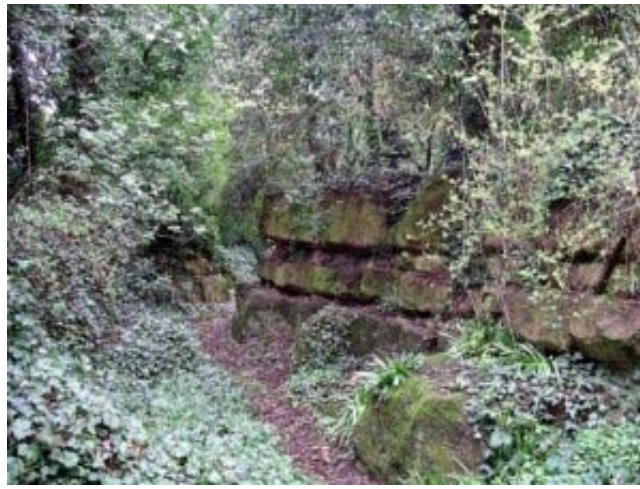
Fig 4 - Part of the bank of the rocky ravine

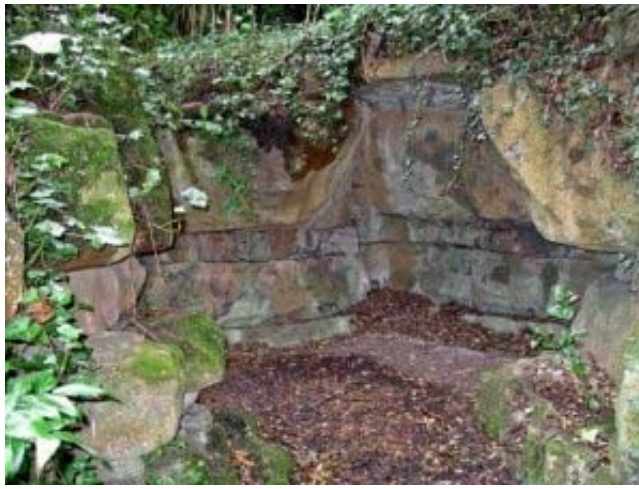
Fig 5 - One of the grottoes that the Nuns of St Michael's Convent adorned with religious statues, and used as shrines

A short way further along is the section of the walkway that Cheryl Markovsky says the Nuns referred to as ‘The Caves.’ It is a collection of grottoes that they converted into religious shrines by adorning them with statues, and it is easy to imagine how peaceful, and how suitable for their meditations it would have been for them here. The statues have naturally all been removed by now, but one of the empty grottoes is pictured here in Fig 5.

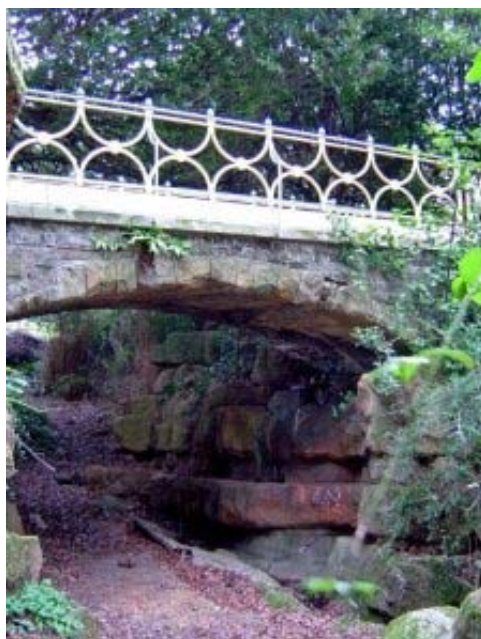
Fig 7 - The rocky bank and remains of the stream that used to flow beneath the bridge at Park Hill, Streatham (Photo by Desireé McDougall)

Finally, back at the bridge itself, one can clearly see the rockwork beneath, and extending away up the slope beyond. The remains of the channel along which ran the stream that was fed from the lake can also be seen clearly in Fig 7. From here, one can return to the grand terrace along the front of the mansion, but almost all of the vases and sphinx-like models that now top the boundary wall are copies or the originals that were stolen a few years ago. It is impossible to claim positively that the originals were by Pulham, but it must be a strong probability.
