THE EXPLORERS CLUB FLAG 132 REPORT

The *Warwick* Project, Bermuda

11 June – 17 July, 2011

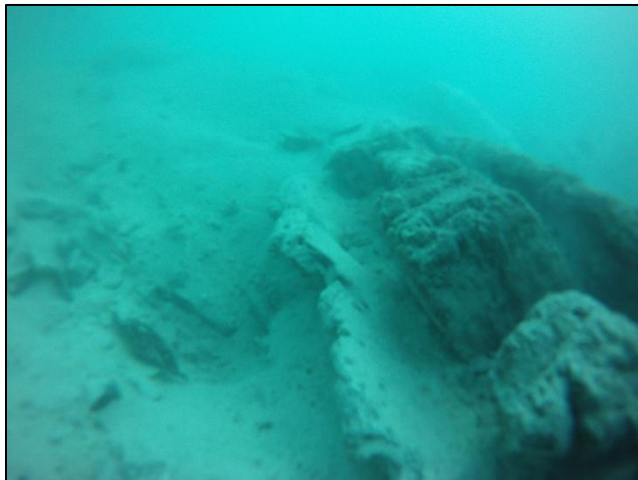
Ceiling planks and hull timbers of the Warwick uncovered for the first time in nearly 400 years

Under the ballast pile and remaining overburden lies the well-preserved starboard section of the vessel from the turn of the bilge to the gun wale.

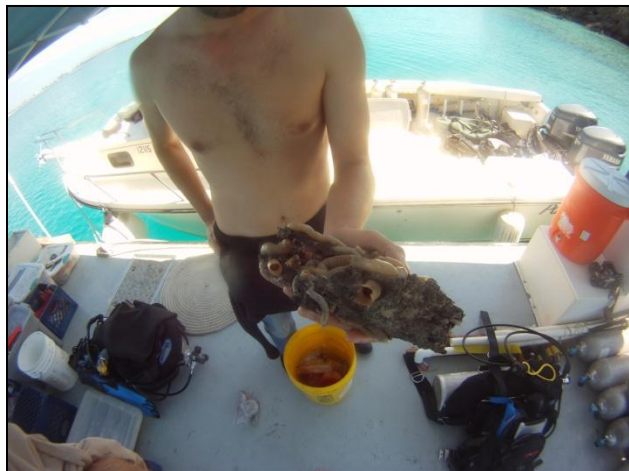
A section of hull heavily damaged by *Teredo navalis* commonly known as shipworm.

Damage to the Warwick timbers caused by burrowing Teredo worms can be seen in the photo above. The tube-like objects running through the wood artifact are calcareous build ups created by the worms as they burrow.

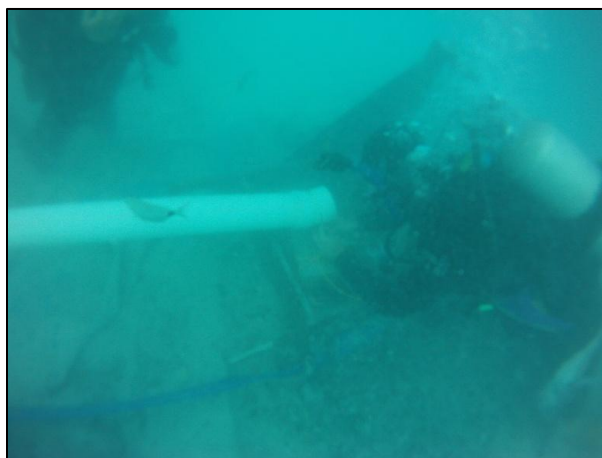
Dredgers removing overburden. Exhaust from the dredgers is directed onto screens to make sure no artifact is missed

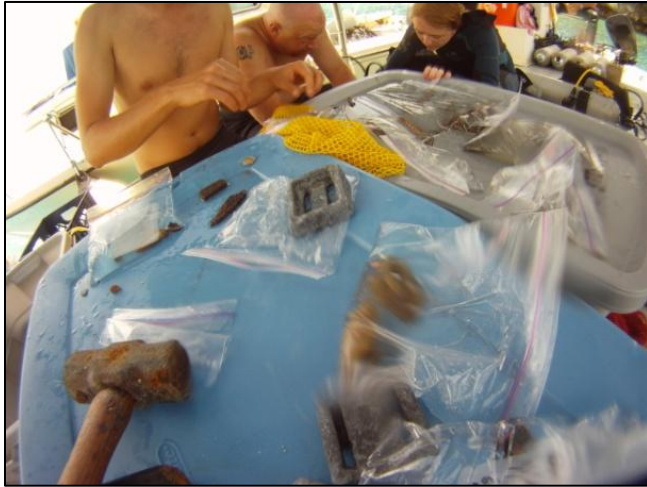
midship section. In the late morning we switched to the dredgers. The afternoon dives were spent on the screens sifting through debris which has been carefully excavated from the hull. In addition to clay pottery shards, we found more animal bones. We also found a number of wooden strips of saplings which might have been "withies" used to instead of iron or copper bands around the staves making up a barrel.

Archaeologists sorting artifacts for conservation

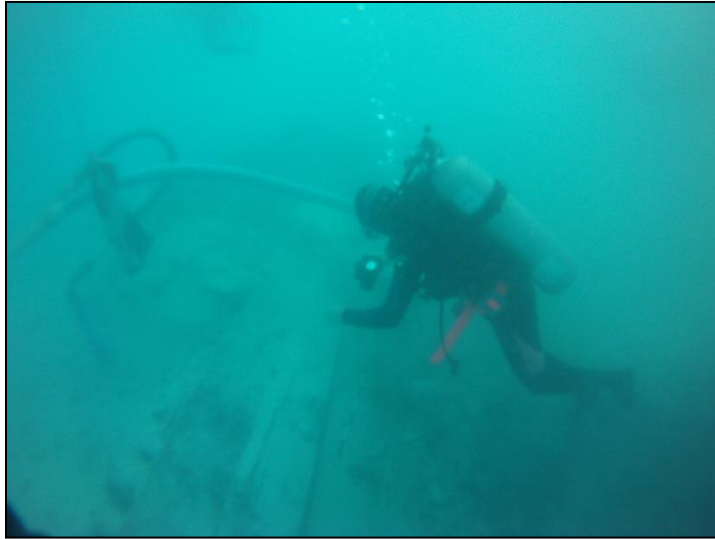
A diver recording Warwick's ceiling planks

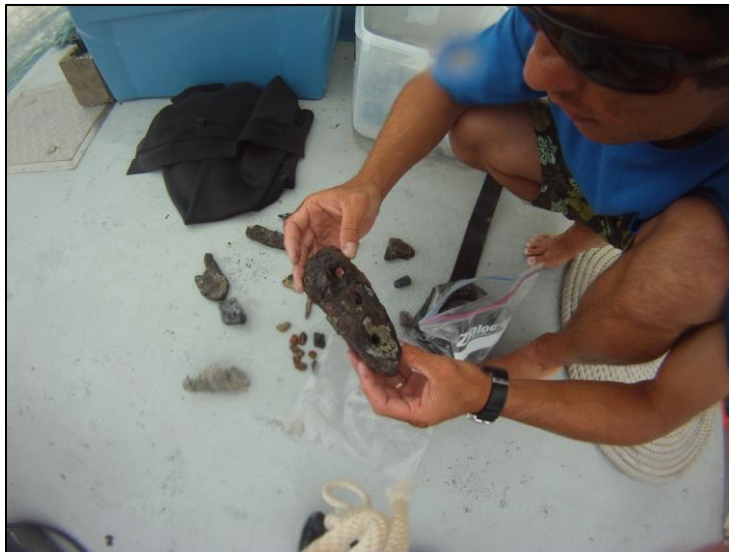
Rodrigo examines a wooden artifact with multiple nail holes

On the surface, items are quickly analyzed and then placed back into tubs filled with water to minimize exposure to air. By the end of the day we had most of the exposed ballast pile removed from the site.

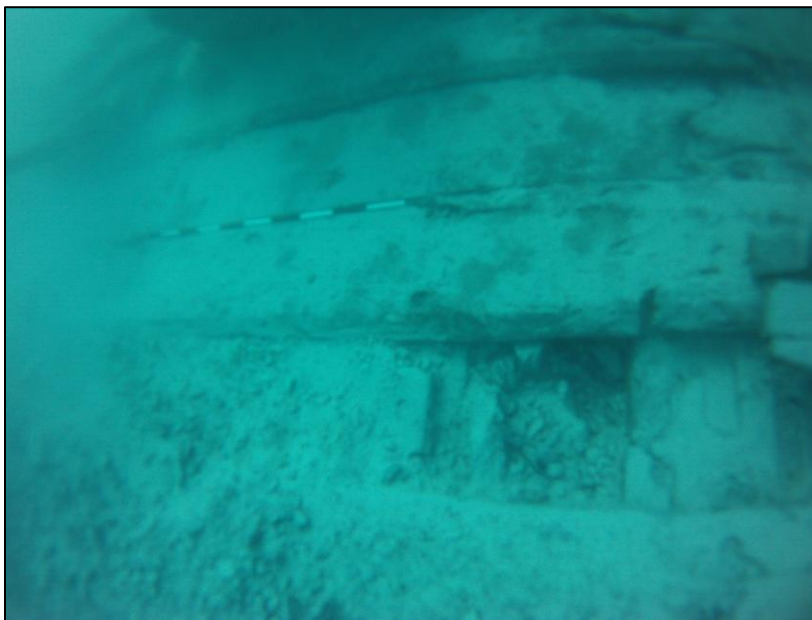
Ceiling timbers of Warwick. One timber is missing showing the seabed underneath the wreck

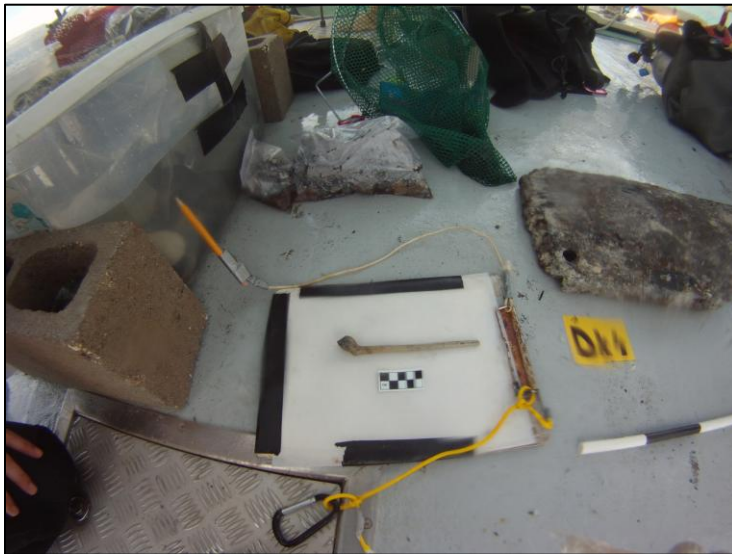
While dredging, Rodrigo uncovered a nearly complete clay pipe (left).

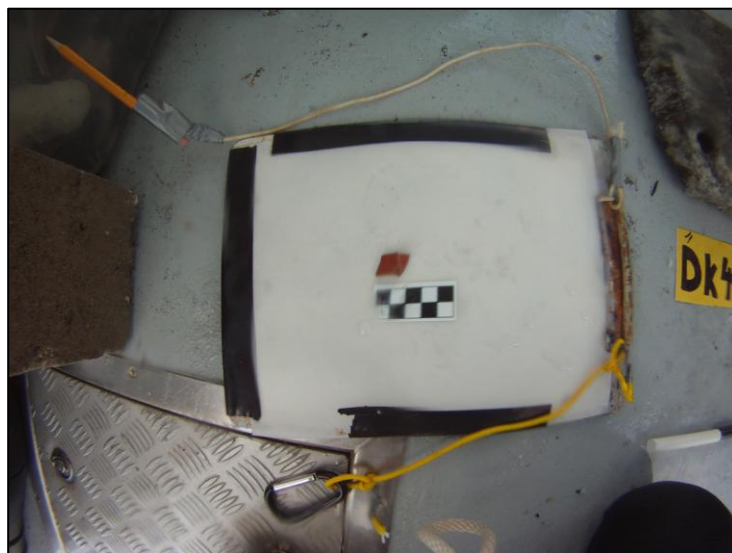
A good example of Roman era pottery known as *Terra Sigillata* "small figures" was also recovered. This artifact may have ended up in Bermuda as part of *Warwick's* ballast- which was likely to have been dredged rock from English rivers which are full of Roman era pottery.

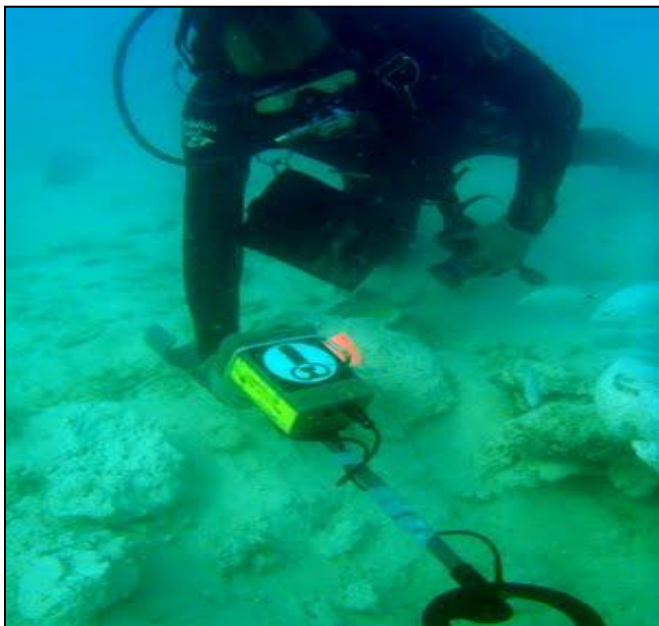
We also continued exploring east of Warwick's stern with the metal detector. Large concretion of bolts, wood and other metal objects were identified. In order to preserve the objects, they will be recorded *in situ*, and then raised stored in water containers and taken to the lab for x-ray to see what is inside. We also recovered some lead shot and a powder charge, sometimes referred to as an "Apostle".

James Davidson (Above) is using a metal detector to locate musket balls

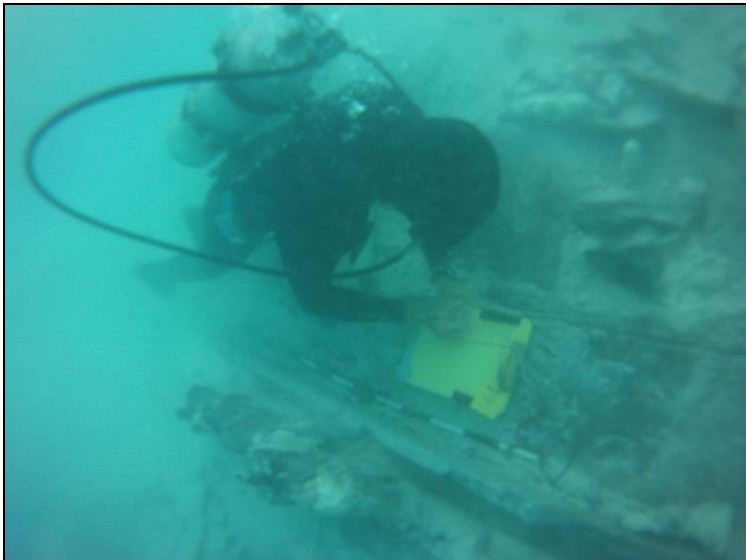
There are numerous loose deck planks on the wreck, lying randomly across the beams and top timbers. Although not necessarily in their original position, these planks can be great sources of information. Each artifact is raised and then traced on clear plastic acetate, recording important features such as fasteners, tool marks and grain pattern. These minute details provide significant information on how the ship was designed and built.

Doug Inglis recording timbers on the bottom

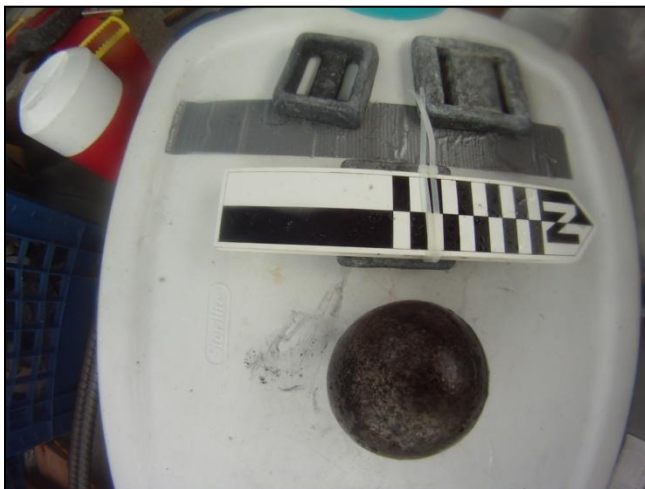
This morning James and Maureen recovered a concreted mass containing with at least two cannon balls. One of which was easily removed from its concreted encasing revealing a beautifully preserved iron canon ball as well as bar shot.

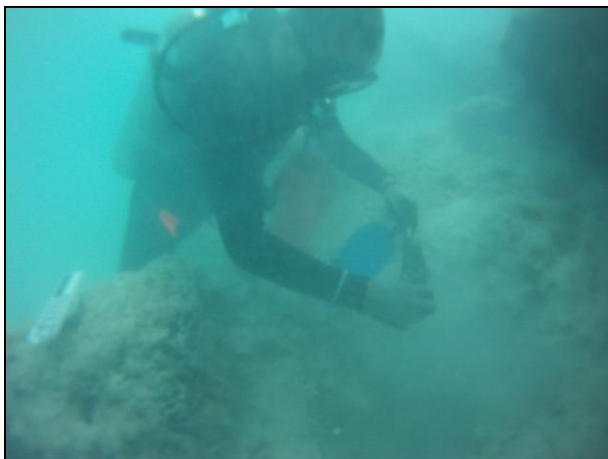
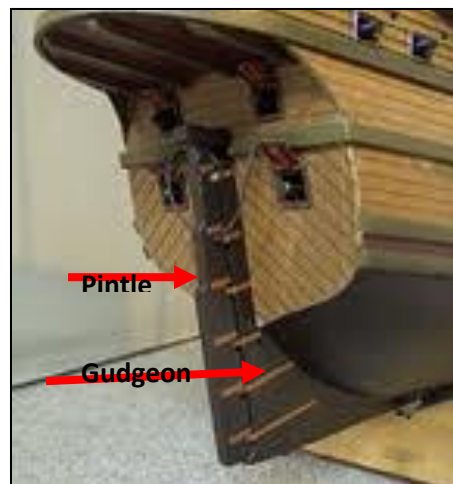
Above left James Davidson carefully hand fanning to expose a “gudgeon”. Above right, image of a rudder held in place with use of pintles & gudgeons (Wikipedia).

Another significant artifact brought to the surface today was a “gudgeon”, which is essentially a metal bracket used to attach the rudder to the ship.

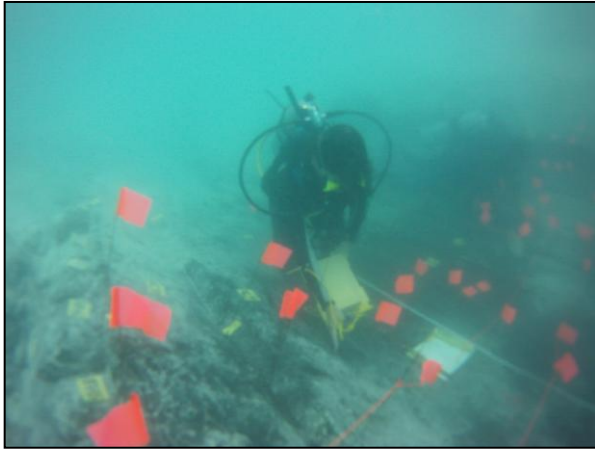
Dr Batchvarov in a field of "Kroum Sticks"

Meanwhile, 6 meters below, Dr. Kroum Batchvarov and his assistant complete final hull measurements on the Warwick. This system was designed by Dr. Batchvarov and first used on the *Vasa* in Sweden. This innovative non invasive technique uses sticks placed between planks to obtain accurate measurements of framing timbers which are located below the floors.

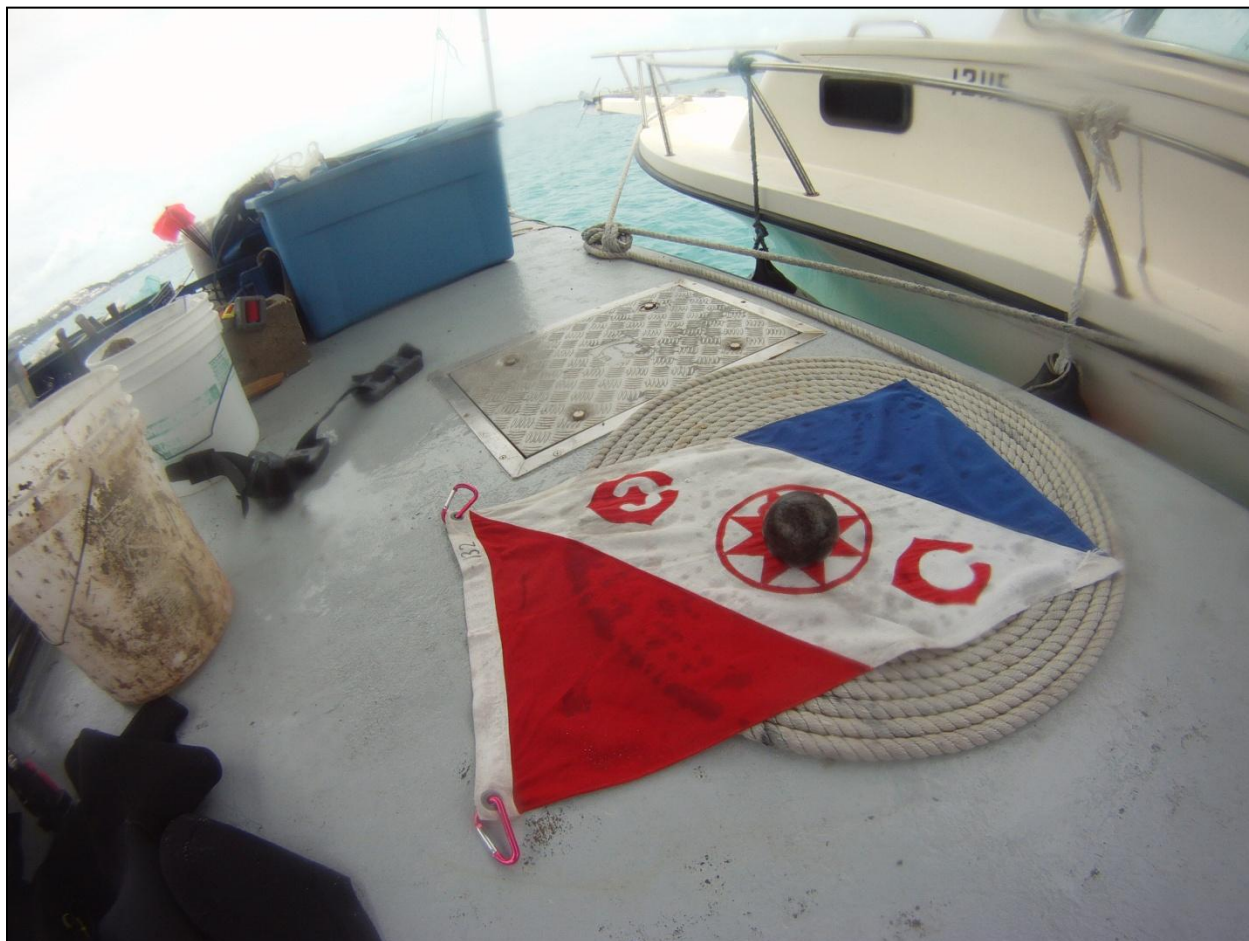
Canon ball recovered from the Warwick with Flag 132
