The Ozarka RC-200

First version of partially assembled home broadcast receiver to be completed and then sold door-to-door by enterprising men as described in a sales program called the *Ozarka Plan*.

It's 2017 restoration from a 'barn fresh' wreck to what you see now.

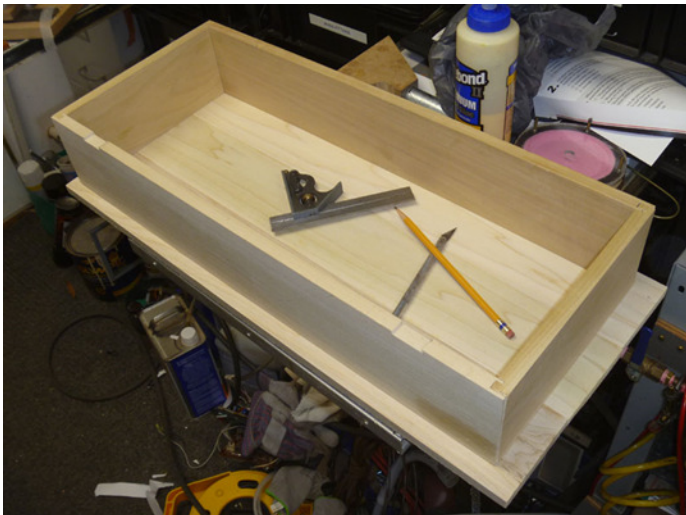
advertisement , I could determine how best to construct a replica battery box. There are inconsistencies between the photo shown in Popular Mechanics and the set shown in the 2010 ARC article. I can presume that the April 1924 photo and line drawing shown in the assembly instructions is of a prototype receiver. Notice that the front of the battery box is flush with the front of the radio cabinet. I suspect that by the time of production in quantity they had realized that this made it difficult to lift the front of the radio to gain access to the battery compartment. By insetting the front of the box as shown in the ARC photo, that problem was eliminated. Don Patterson's factory finished radio cabinet also shows this same type of inset. The cabinet uses 'locking rabbet' joints. The kerf cut-to-depth is only 3/32" wide. My radial arm saw makes a 1/8" + wide cut so I had to resort to making the cuts with a miter box. It was not fun at all to get these cuts made correctly with the miserable excuse for a "precision miter box" that Stanley sells at the home centers these days.

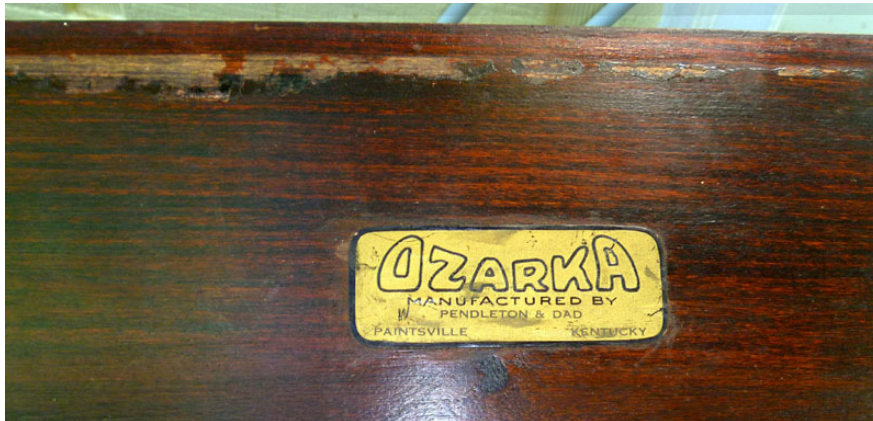
While the 'barn fresh' exterior of my cabinet was virtually devoid of any clues as to how the cabinet should have been finished, the inside of the top lid was still in good shape except along areas that rested on the frame of the cabinet. Although I do not know the wood species, it appears to have a red mahogany stain and top coats of a polymerizing varnish. I made my replica battery box from poplar. Trying to match the color of this new work to the old cabinet was time consuming and not entirely successful.

To repair the completely lost patches of varnish along the inside-front edge of the top lid I did the following. There is a product called Constantine Pad-

Lac that is no longer available. You apply with cheese cloth several times a day until it has filled-in the missing areas. Of course anything

like this will build-out onto the surface of the adjacent varnished areas. The first inclination is to wet sand the excess, but I found it much easier to use a very sharp cabinetmakers card scraper to plane off the excess lacquer. Works like a charm. The final finish is done with #0000 steel wool followed by waxing.

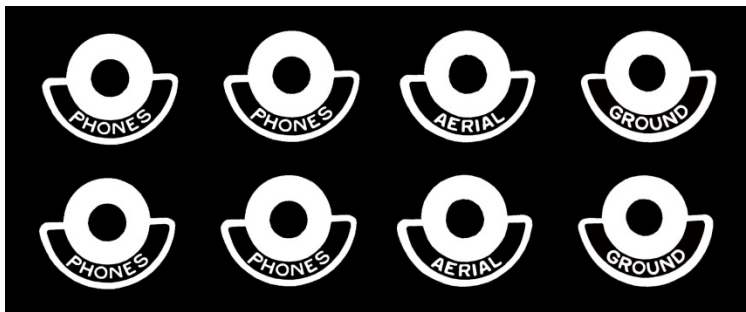
There are four tags that identify Aerial, Ground & 2 x Phones. These front panel tags were heavily corroded and could not be made presentable. I scanned the tags and use Photoshop to

produce new graphics. My local trophy shop has a laser engraver that zapped the graphic onto a small aluminum plate for the grand cost of \$5. I used a punch, nibbler tool and jeweler files to cut the tags to size. The detector/tube module inside the radio has the same style of tags for battery connections but fortunately they are in pretty good shape so were retained.

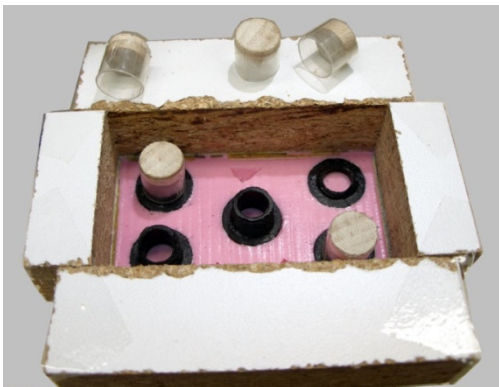
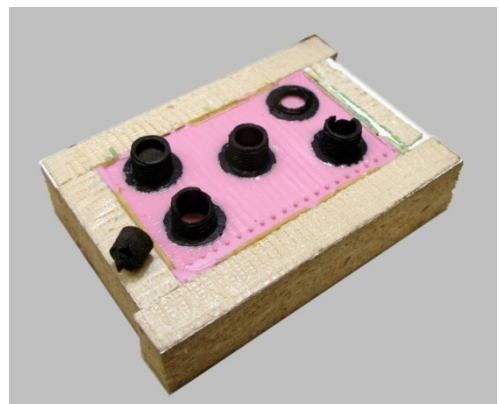
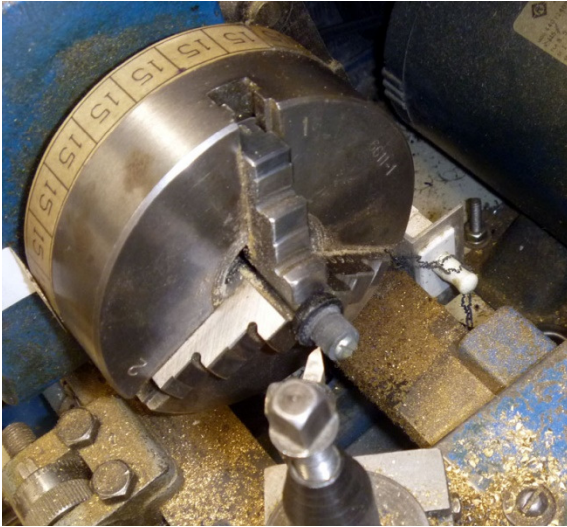
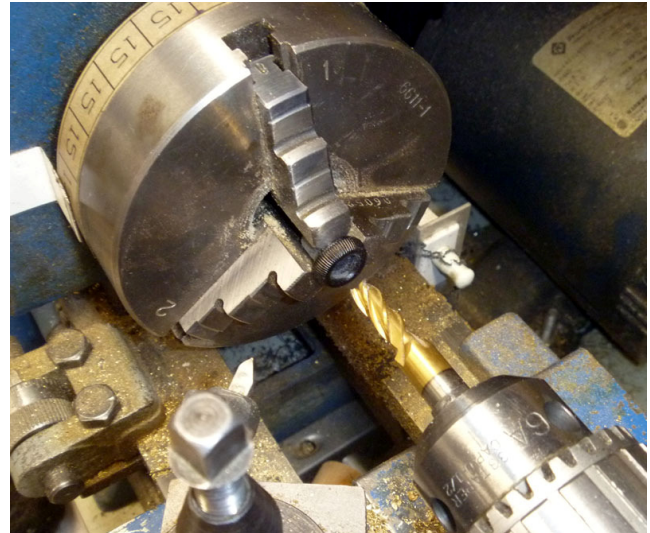
There are molded Bakelite bushings in the bottom and back of the radio cabinet for battery connections.

Two were

missing and four were damaged. I wanted to make a silicone rubber mold and cast new urethane resin replicas. Because of the damage to the original parts, it took some time to figure out how to prepare them to serve as

masters for making the rubber mold. There was only one cylindrical surface of the original part that could serve as a reference; this is the inside diameter of the bushing. This also provides an axis reference. Foam plugs were inserted in the bushings far enough down to provide a perpendicular surface. The outer damaged cylindrical surfaces of the bushings were covered with very thin polyester sleeves reinforced from the inside with small wood dowel plugs. This made it possible to cast the silicone rubber mold. The mold produces a cast urethane part that now has surfaces that can be machined on a lathe to true dimensions.

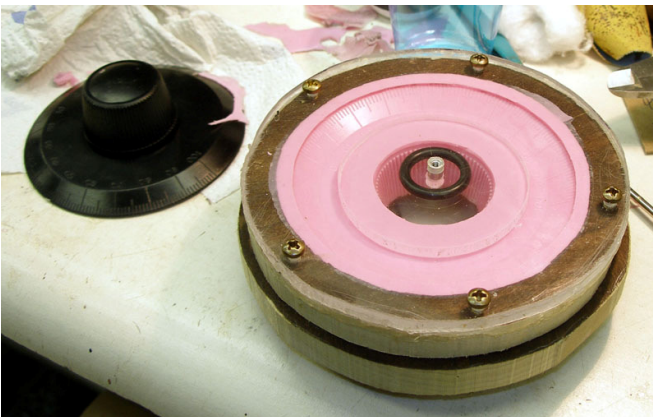
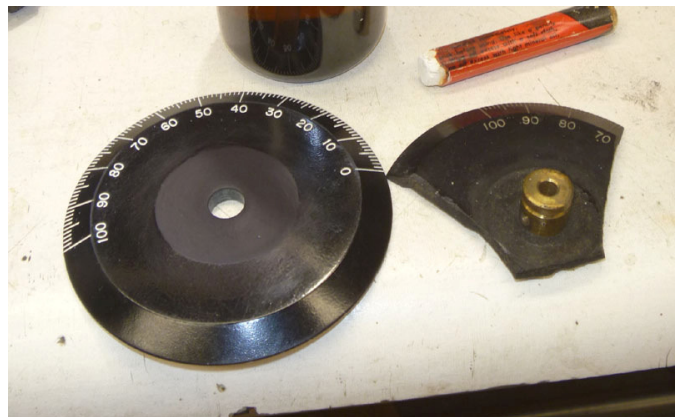
The #3 large dial survived only with about 30% of the dial skirt remaining. I looked for years for a replacement dial with no luck. I finally figured out

how I could make two silicone rubber molds from which I could cast new parts for the replica dial. The dial has a brass center insert that joins the skirt to the knob; this is a knurled part that was molded in place. My replica brass insert could not be molded in place and maintain the required precision in alignment. I figured out how to stake the part securely into the skirt. The cast knob press fits nicely into the brass insert. The original special knob, with center hole for the Vernier knob, was with the radio and could be extracted from the brass bushing to make a silicone rubber mold. Since the skirt was to be cast from urethane resin, I did not want the luster of this part to contrast with the original part. What you see on the restored radio for the #3 knob is a total replica. (As it turned out, the replica parts match very closely to the original.)

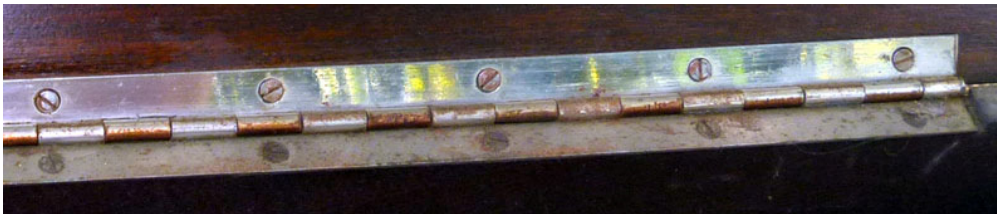
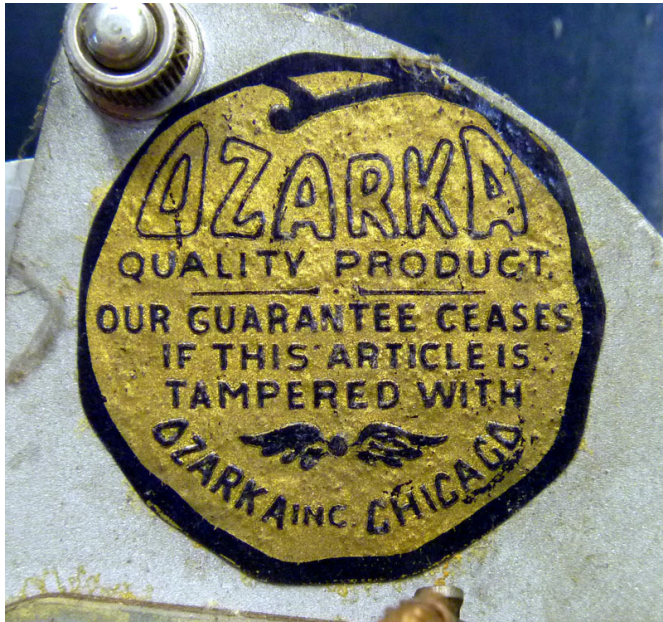
The nickel plated contacts on the front panel required ultrasonic cleaning to remove heavy corrosion so that they could be polished and re-plated with nickel.

needed plating. The piano hinge, also nickel plated, was rusty but it is too large a part for me to plate. I spent 2-3 hours carefully scraping the rust crystals off the surface. I discovered long ago that frequently rust crystals will grow up through fissures in the nickel plate and spread out for a considerable distance over the surface of good nickel plate. These crystals can be broken free of the nickel plate surface using a toothpick or wood craft stick lubricated with a little waterless hand cleaner like Go-Jo or Goop. The net result is that the remaining nickel plate will appear much better than you ever expected. The hand cleaner is removed with solvent and then the surface is sprayed with a clear acrylic lacquer. There were areas of the hinge where the plating was completely gone due to rusting. There I simply

Also the flat head wood screws for the piano hinge of the cabinet top lid

sanded, applied a very fine Dremel wire brush and then polished with white rouge to yield a bright steel surface. The contrast in color is noticeable but I

have found no way to touch-up such an area with metallic paint that results in any lesser contrast to adjacent real plate.

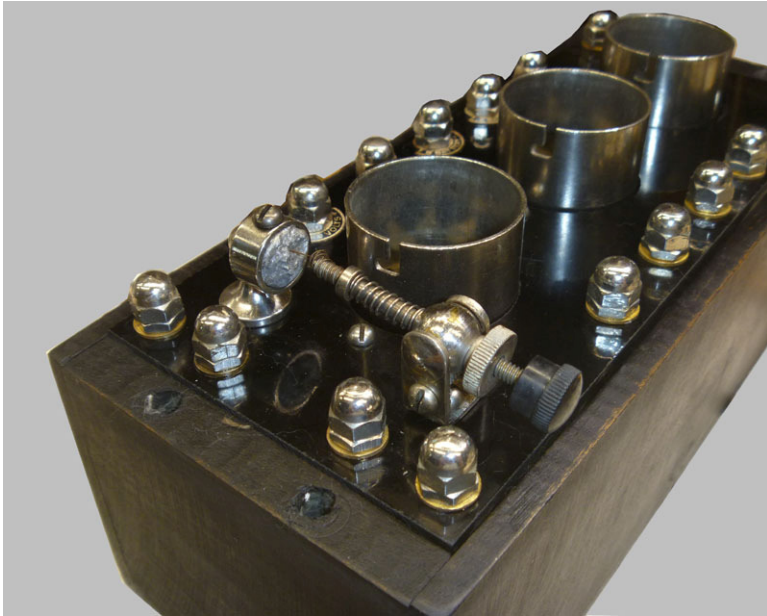
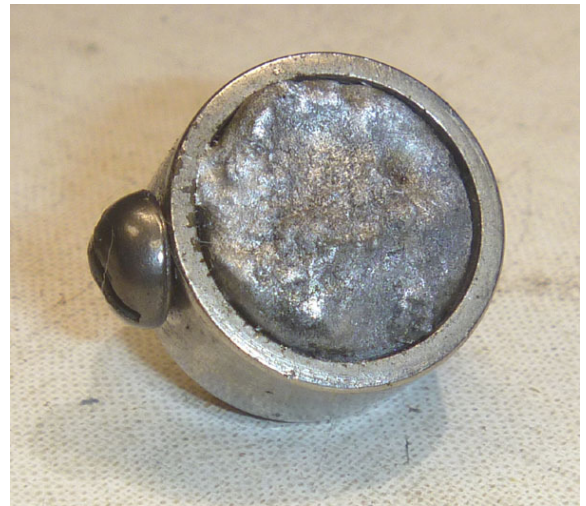
The composition of the crystal detector is a mystery to me. It almost seems to maybe be a solidified paste of low temperature alloy like Woods Metal and finely ground galena. The 4 page instructions I have barely mention this detector at all; only saying that the cats whisker should rest lightly anywhere on the surface of the material.

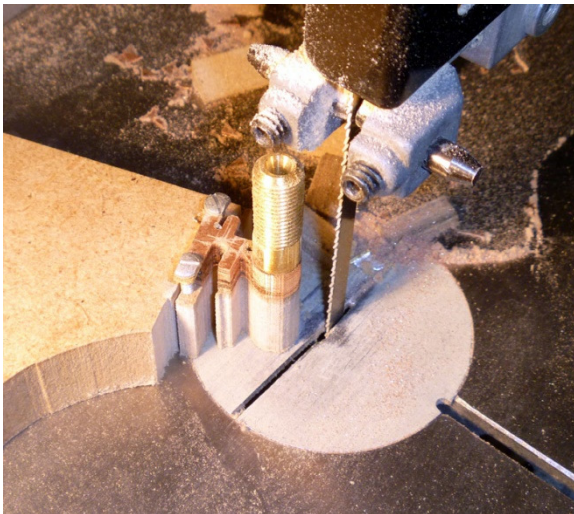
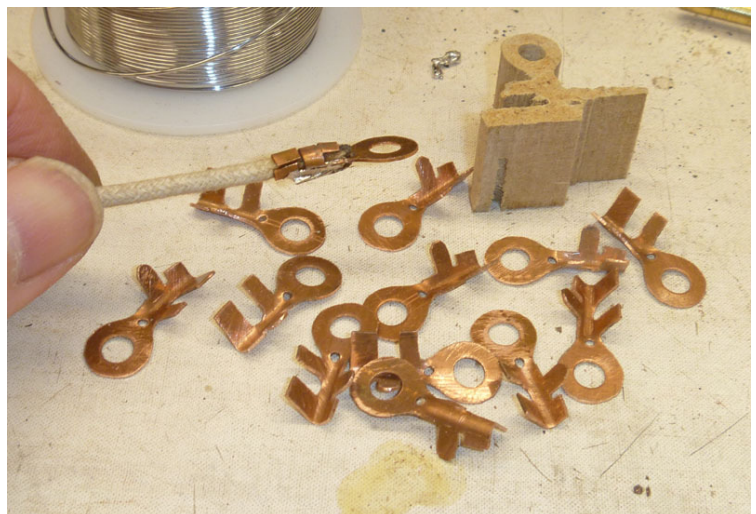
The instructions tell you to attach copper ring terminals to each wire to be connected to the back side of the tube module. I noted that there are no special instructions on how to crimp these terminals and I cannot recall seeing any catalogs or magazines of the day that show crimping tools. So the crimping task was likely to have been done with some degree of difficulty with a pair of common slip-joint pliers although radio catalogs of the day did offer small long-nose pliers. After crimping you were instructed to solder the wire to the back of the crimp.

I did not have any copper ring terminals like those used in this radio so I made my own. I have used this technique several times before. A lot of work but satisfying in my quest to preserve as much history as possible.

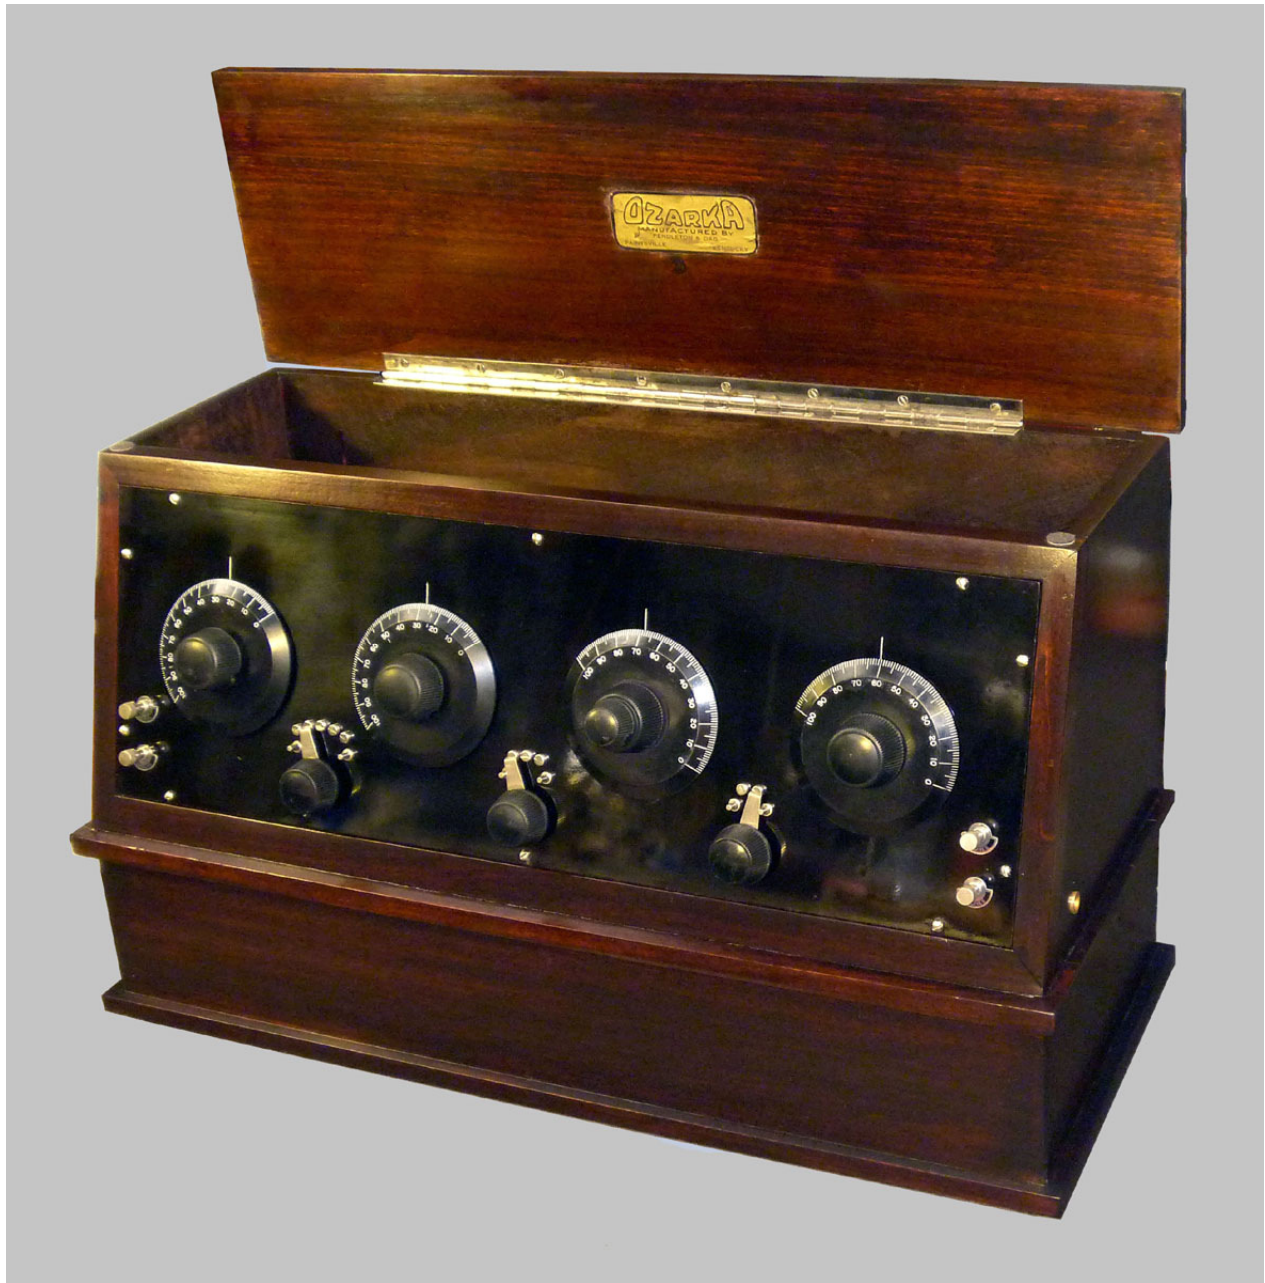
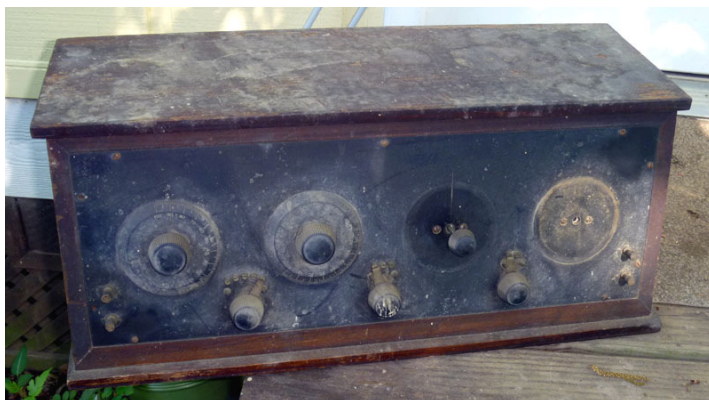
As found condition.

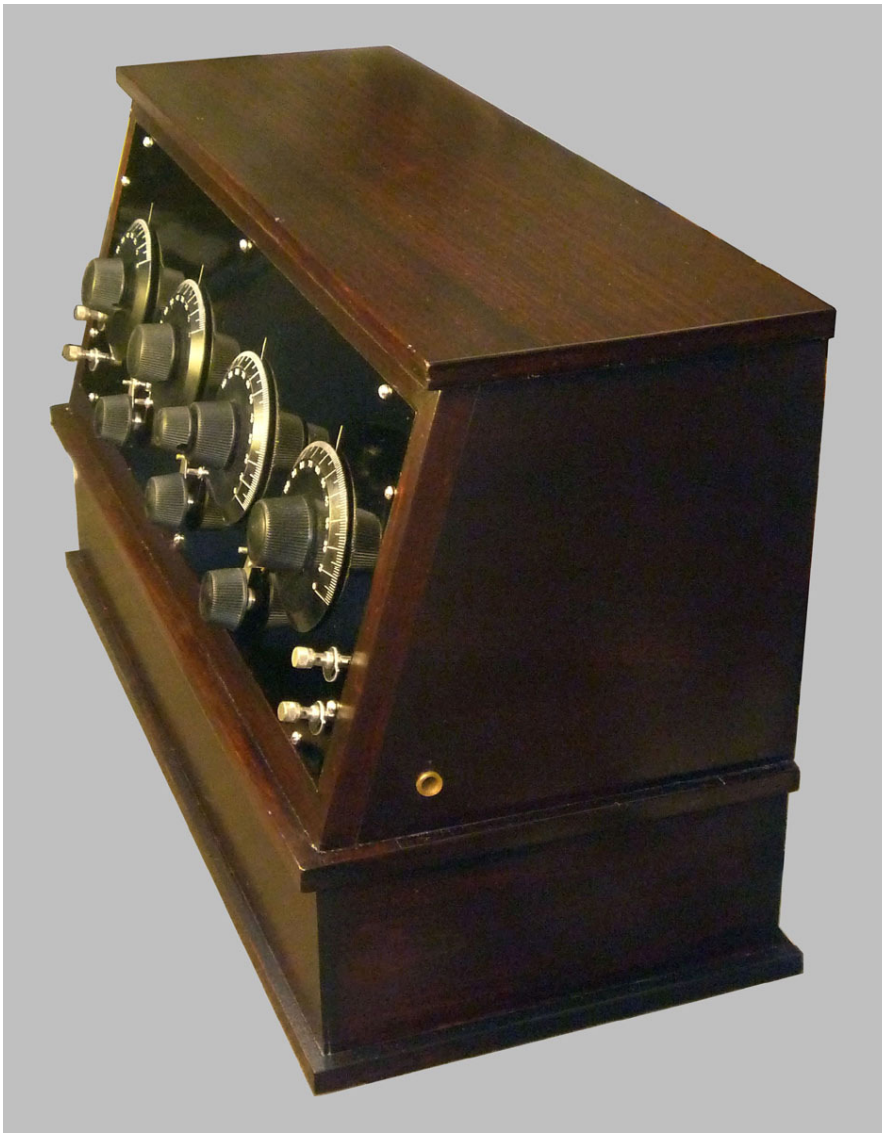
Note loudspeaker jack on side of cabinet. There is no mention of this feature in the literature. I presume it was a modification made by the assembler.

The battery box, #3 knob from the left and i.d. tags for Aerial, Ground & Phones are my reproductions.

Tap switch contacts and piano hinge screws were nickel plated.

Even though the piano hinge is nickel plated, the surviving battery box hinges are Stanley brass plated steel. The two bushings are supposed to be for wires going to a 6 Volt storage battery if you did not use dry cells for the tube filaments.

These bushings are urethane resin reproductions I made.

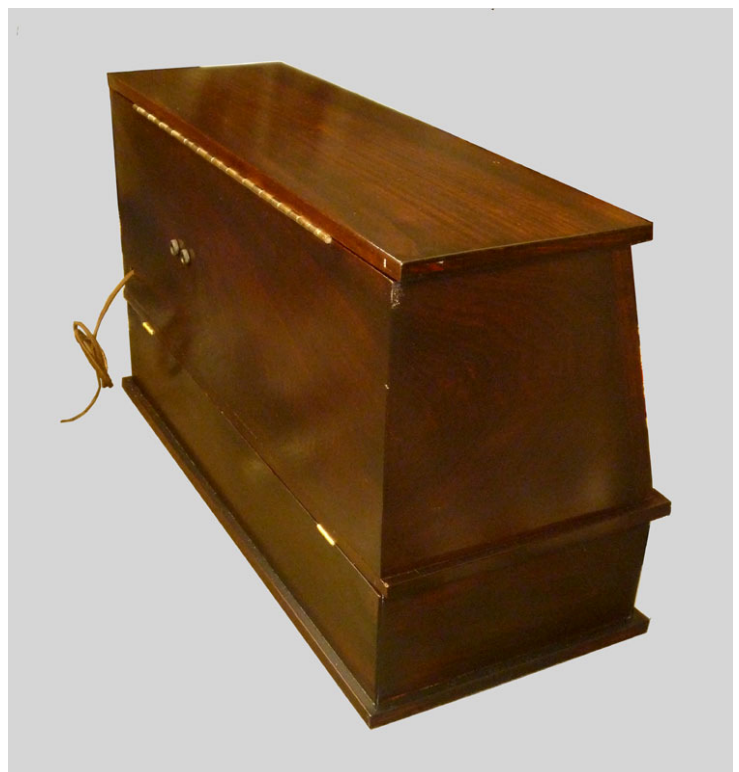
The radio was shipped with all components mounted. The assembler had to remove the panel in order to gain access for wiring. The assembler cut the 'old gold' colored wire to specified lengths and crimped and soldered the wires to copper ring terminals at each end.

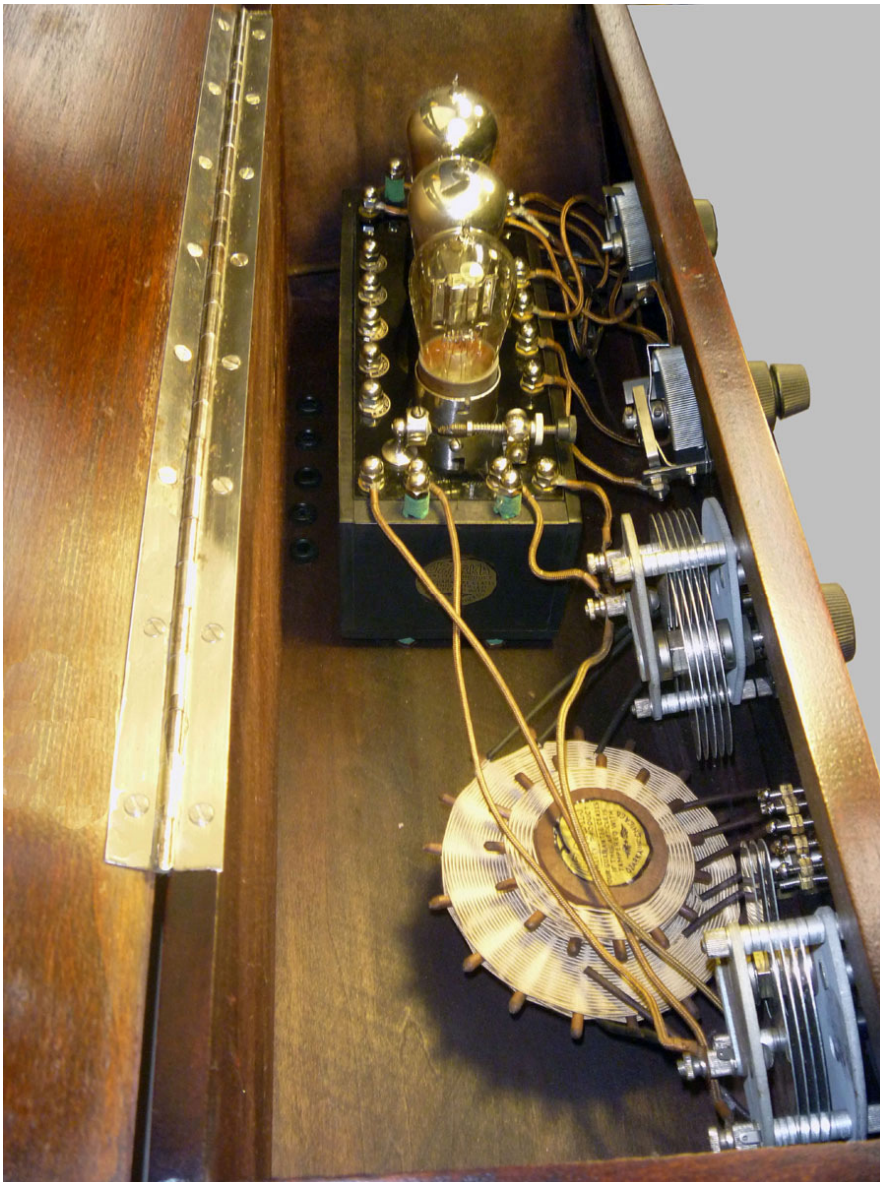
Colored wires for power connections were attached to the back of the tube/detector module and pass through Bakelite bushings down into the battery box.

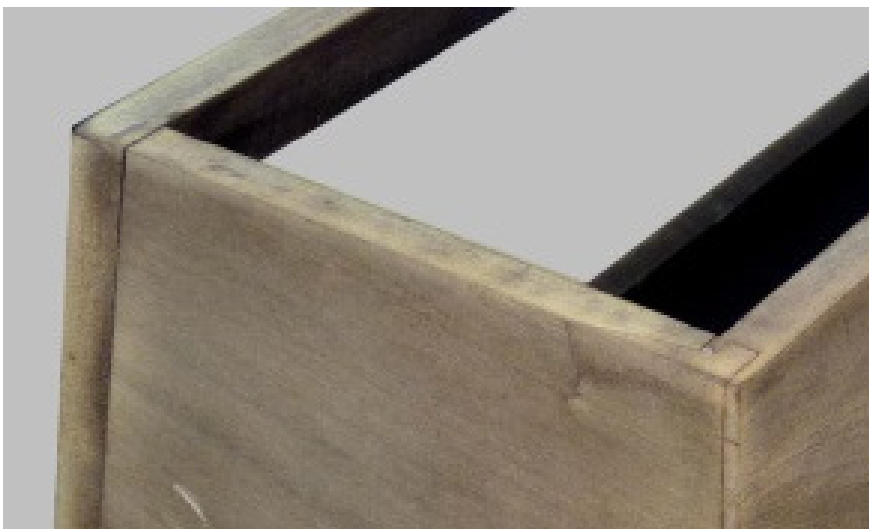
Stripped cabinet showing locking rabbet joints used on back of cabinet and on construction of the battery box.

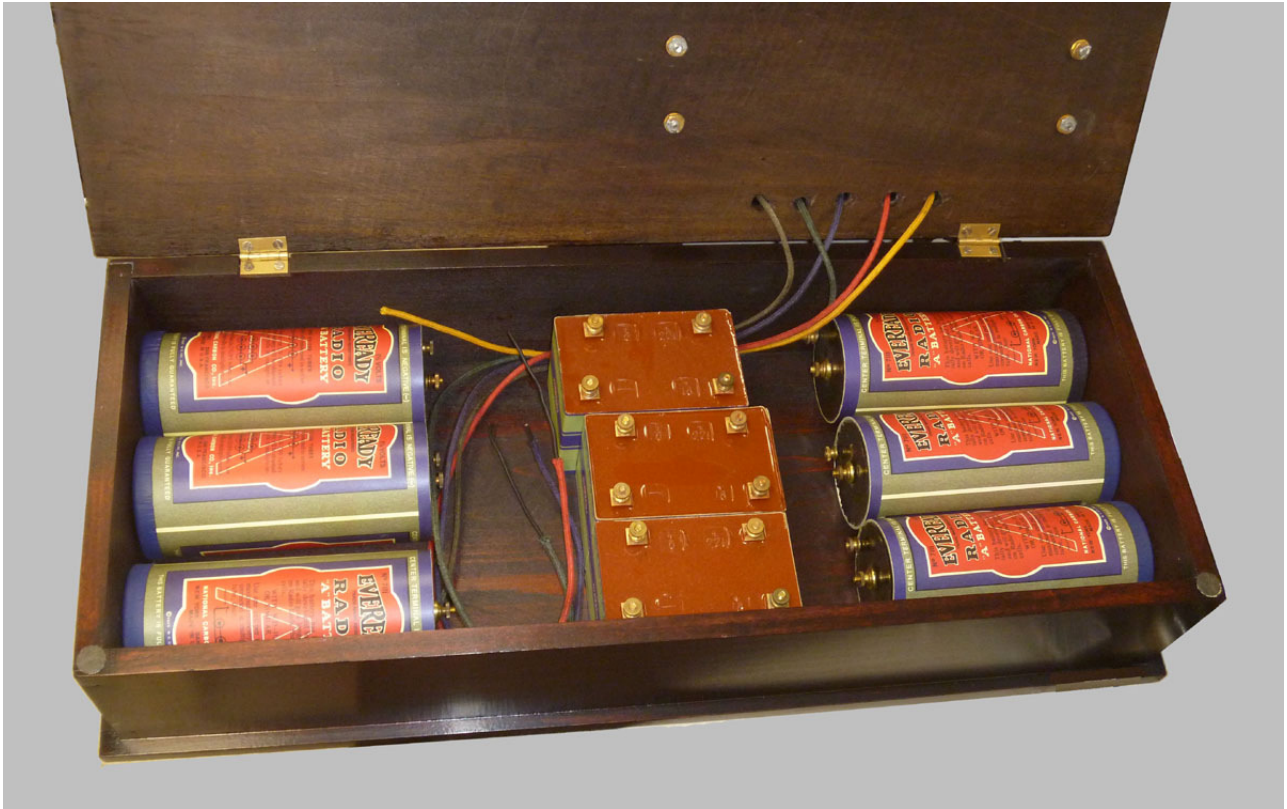
Note: You had options of what kind of tubes you could use. If you were using dry cell UV-199 tubes, this would have been a good arrangement for the first generation of this set where the tube module indicates a B+ of 60 Volts. (Three 22 ½ Volt 'B' batteries connected in series for the Plate circuits and two – three cell strings of 1 ½ Volt 'A' batteries connected in parallel to provide 4 ½ Volts to the tube filament circuits.)

If you were using UV-200A and UV-201A tubes powered by an external storage battery, this compartment would have had either two 45 Volt 'B' batteries or four 22 ½ Volt batteries. I found it interesting to note that with the specification of 90 Volts 'B', there was no mention of a 'C' bias battery. It seems that 'C' bias to reduce unnecessary 'B' battery current drain did not come into general usage till the latter half of 1924. (First adverts for this set were from around February 1924.)
