# THE PECULIARITIES OF HISTORIC SLATE ROOFS WITH EXAMPLES OF WRONGFUL CONDEMNATIONS

BY JOSEPH JENKINS

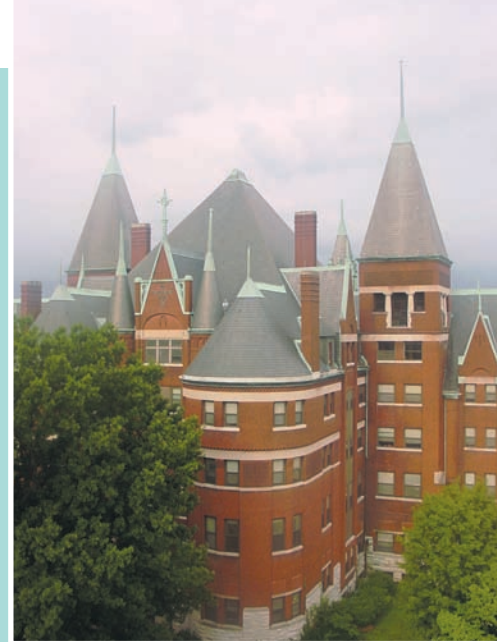
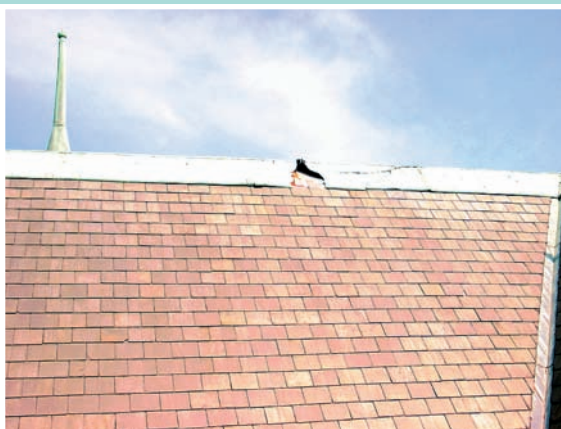
An inspection by the author revealed that the slates were a Buckingham or Peach

Bottom variety of exceptional quality. There was essentially no wear visible on the slates after 120 years. The very steep slopes and the semi-dry conditions of the area had helped preserve the copper, most of which was original. The wind and hail damage on the roof was quite limited and all of it was repairable for less than 3% of the replacement cost. The slates themselves could be expected to last another century, although the copper flashings would have to be replaced eventually. The main leak was in a copper valley and was unrelated to the storm damage. Although this beautiful slate could last at least another century, contractors were earnestly attempting to permanently destroy it.

*The photo at right is only the entranceway to Castle Park, which has large wings emanating in three directions. The slate, at 120 years of age, is in excellent condition. Roofing contractors, however, would love to tear it off. Left: Minimal wind damage does not justify replacing the entire roof when the slate is still in good shape. (Photos by Joseph Jenkins.)*

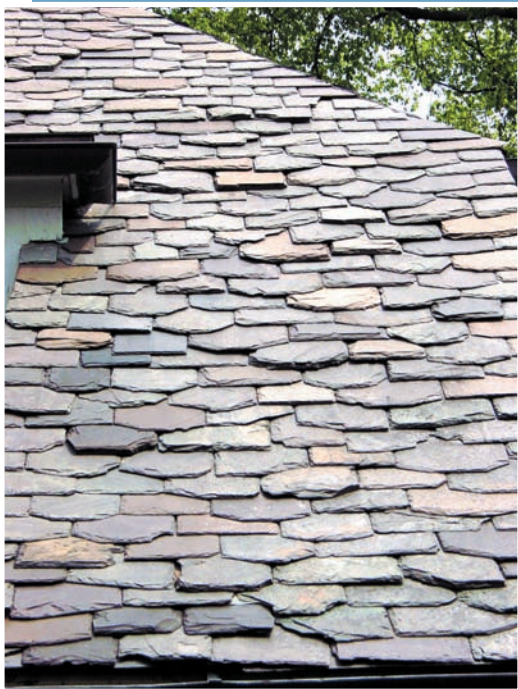
*Chicago area home with beautiful 75-year-old “ragged butt” slate roof condemned by three roofing contractors. (Photo by Joseph Jenkins.)*

A residence in an upscale Chicago neighborhood suffered hail damage to its unique “ragged butt” style 75-year-old slate roof. Three firms looked at the roof and all three condemned it before the owner contacted the author for an impartial inspection. Hail damage to the mixed Vermont and Buckingham slate was certainly evident, but it was limited and all readily repairable by any contractor with a minimum of slate roof restoration experience. The inspection revealed about 150 slates needing to be replaced – a couple days’ work for experienced professionals.

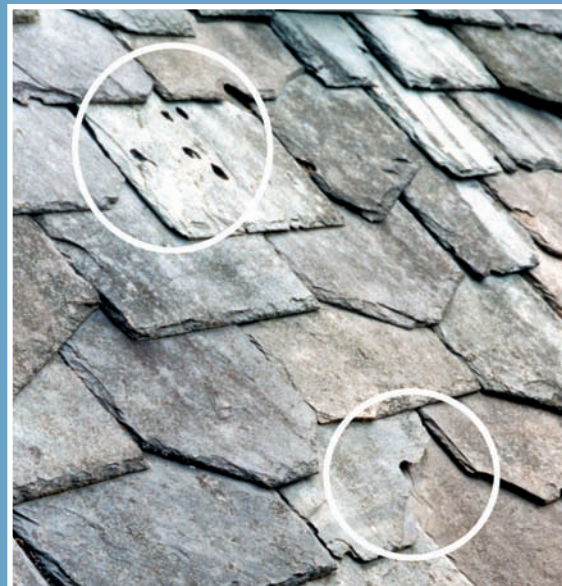
*Hail damage of this nature, as seen on Chicago area “ragged butt” slate roof, is repairable by simply removing the damaged slates and replacing them. Most of the slates are undamaged. (Photo by Joseph Jenkins.)*

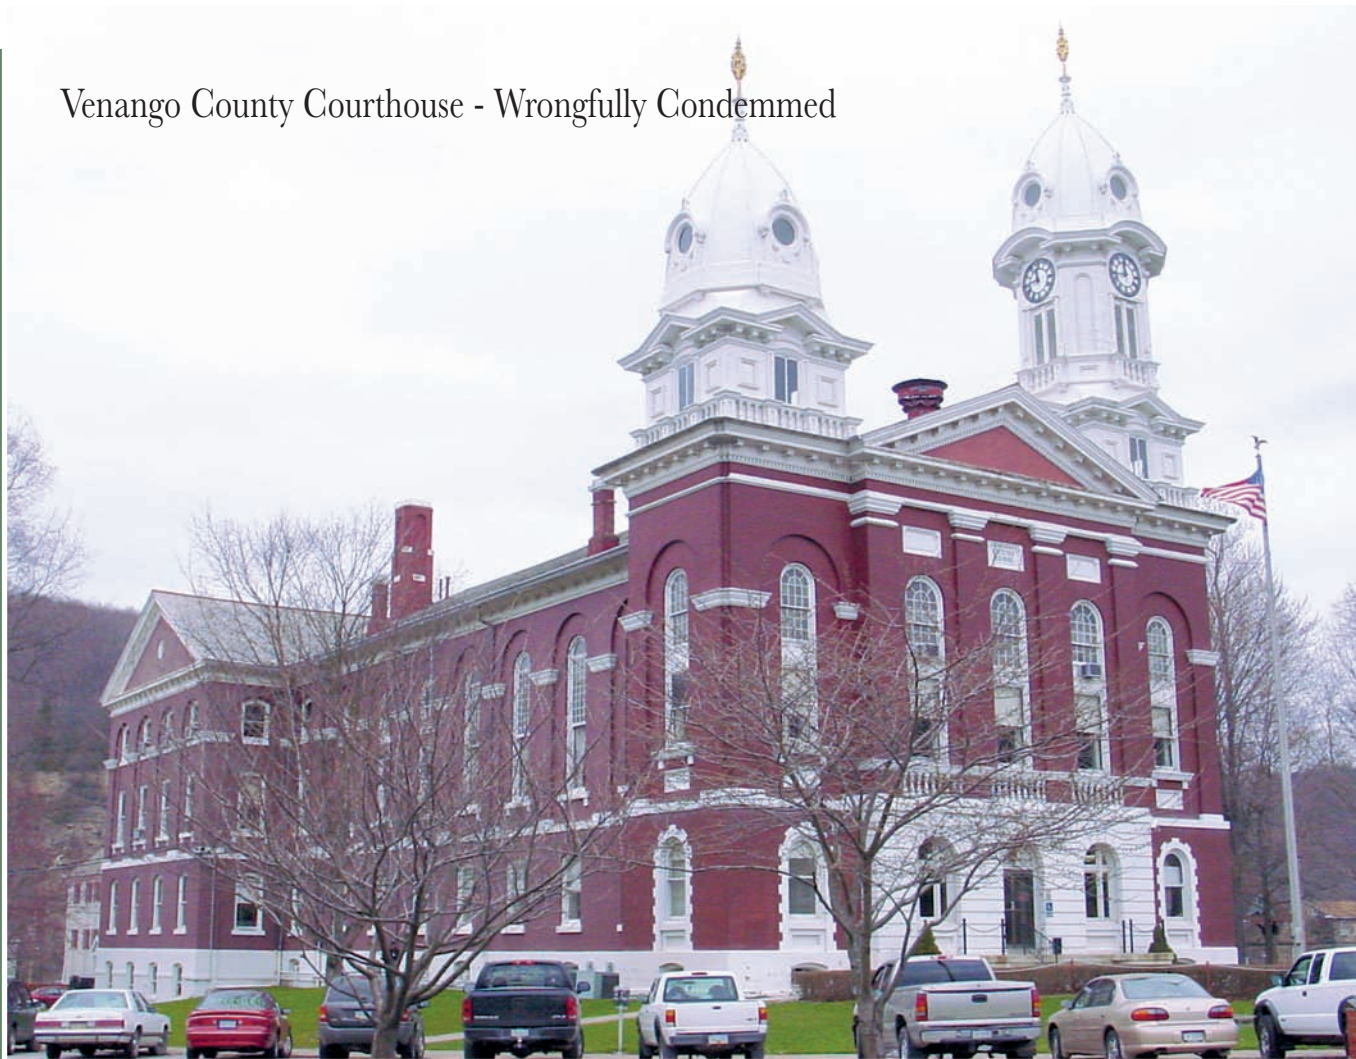
*This courthouse roof was unnecessarily condemned and scheduled for replacement. The Vermont “sea green” slate roof is only 72 years old – about halfway through its life. Comprehensive restoration work on this roof will only cost 10% of the cost for total replacement because the slates and fasteners are still in good condition. Most of the flashings, however, need to be replaced. (Photo by Joseph Jenkins.)*

In 2004, the author was called to consult on the replacement of a Pennsylvania courthouse roof. The 130-square Vermont “sea green” slate roof was approximately 72 years old. A county engineer insisted that the roof was beyond repair and was “absolutely certain” it had to be completely replaced. The author’s inspection revealed that most of the problems with the roof were related to bad repairs in the past, all reversible. The slate itself was still good and could be expected to last at least another 50 years if not 75 or more. Replacement costs of \$358,451 were reduced to restoration costs of \$35,000, which included replacement of virtually all flashings with stainless steel – a savings to the cash-strapped county of over \$300,000.

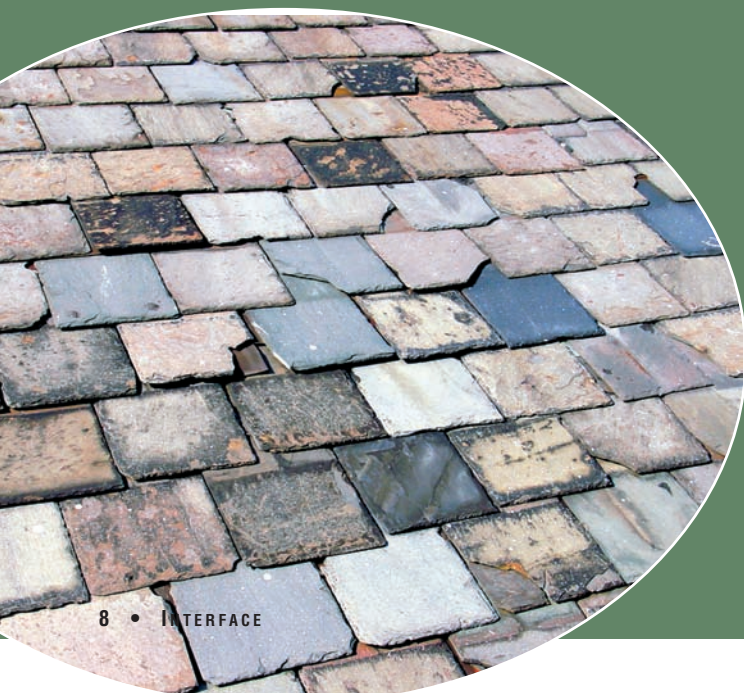
*Most of the problems associated with the Venango County Courthouse roof were caused by bad repair work over the years, an example of which is shown at left. The wrong type and color of slates were used to repair this roof, indicating the repair contractor didn’t understand proper restoration techniques. These will all need to be removed and replaced with slates that match the original roof. The author counted approximately 700 slates like this on the courthouse roof. (Photo by Joseph Jenkins.)*

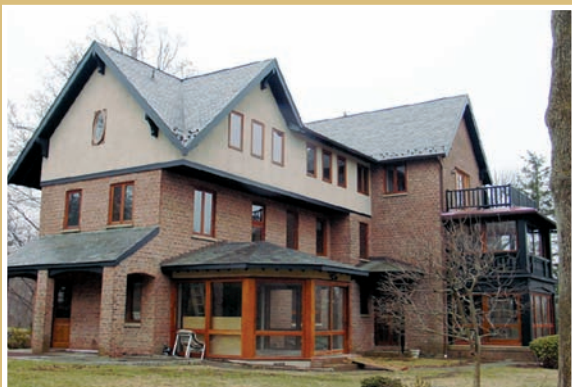
*Ten-year-old slate roof on a private residence condemned by roofing contractors. The nominal snow guard damage, however, was covered by homeowner's insurance; the roof did not need to be replaced at all. (Photo by Joseph Jenkins.)*

The author's inspection revealed that the snow guards had let loose due to severe weather that winter, combined with an inadequate number of snow guards for the size and slope of the roof. Each snow guard was hooked onto a slating nail, causing a slate to be pulled out with the snow guard. The damages amounted to a maximum of \$10,000 and all of it was covered by homeowner's insurance. Otherwise, the roof was fine. So much for "experts."

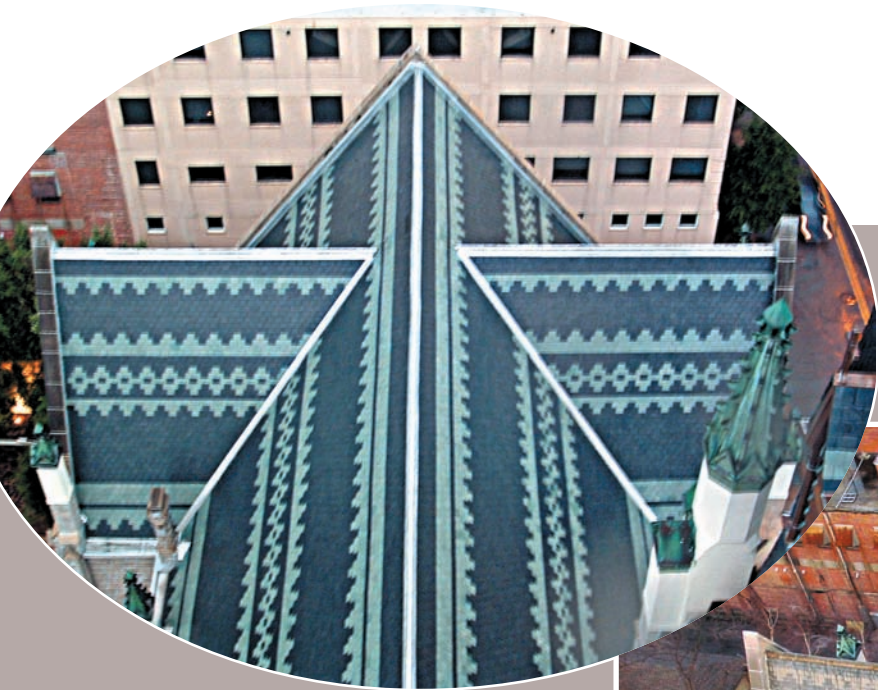
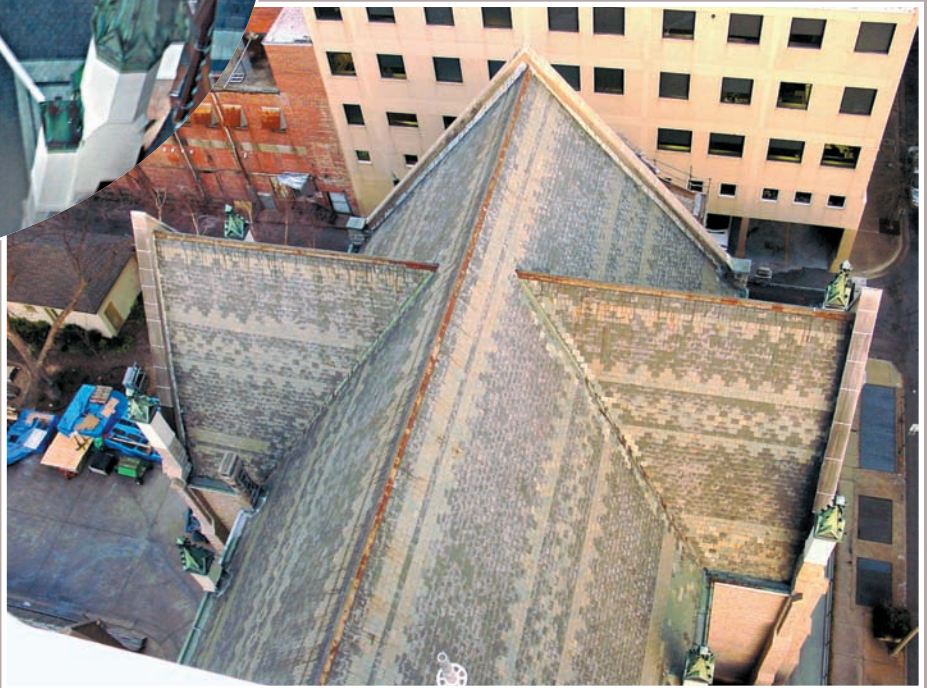
The Cathedral of St. Andrew in Little Rock, Arkansas, had worn out its black Pennsylvania slate after 120 years (below). The cathedral's new roof, left, installed by Midland Engineering in 2003, is likely to last 150 years. Vermont unfading green slate mixed with Welsh black slate and terne-coated stainless steel flashings should outperform the original roof. (Photo below by Joseph Jenkins; left photo by Lyle Bandurski.)

A slate roof will wear out, of course, and at the end of its life, nothing can save it. This was the case with the Cathedral of St. Andrew in Arkansas. The cathedral roof was made up of Pennsylvania black slates and Vermont unfading green slates mixed in an ornate pattern. At 120 years of age, the PA black slate had simply worn out – become soft, flaky, and falling apart – especially on the southern exposure and on the main body of the church. The Vermont unfading green slates showed almost no wear at all, despite their age of 120 years.

The original roof was inspected by the author to determine its condition and to draw up specifications for replacement. The new slate roof was subsequently installed by Midland Engineering of South Bend, Indiana, to match the original roof. This time, however, Vermont unfading green slates were mixed with Welsh black slates from Cwt-y-Bugail. All of the copper flashings were replaced with terne-coated stainless steel (some 4-lb. sheet lead was also used). The new slate roof is expected to last at least 150 years.
