## **THIS IS AN EARLY EDITION OF TH400 DISASSEMBLY PROCEDURES**

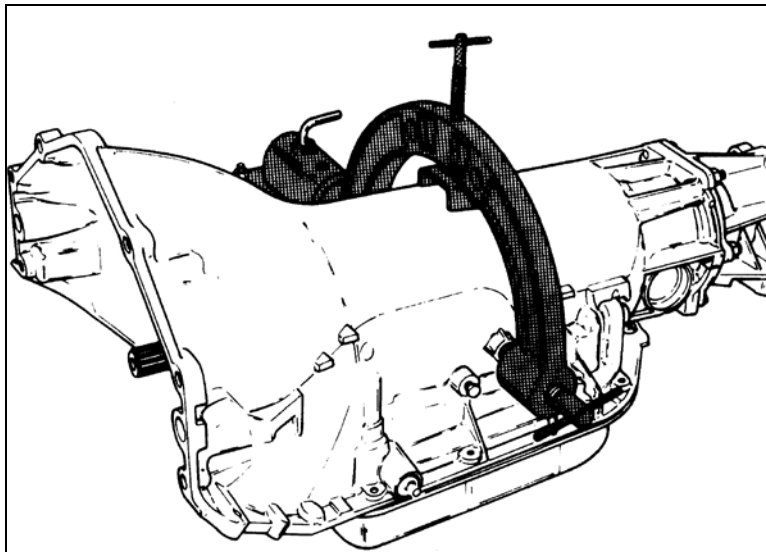
**FIGURE 2-1**

The transmission may be mounted in a specialized holding fixture during the disassembly process. See Figure 2-1. In most cases, it is easier to disassemble the transmission on the bench top. The use of the holding fixture is best reserved for final assembly or when performing services that do not require a complete teardown of the transmission. When using the holding fixture, do not over-tighten the holding screws.

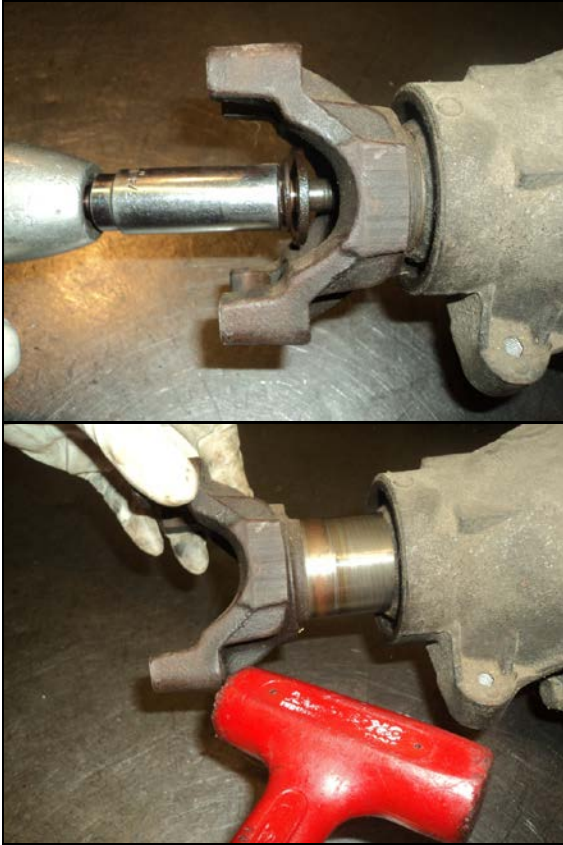
**FIGURE 2-2**

Vehicles equipt with a two piece drive shaft assembly utilize a bolt on yoke. If present, remove the bolt that fastens the yoke to the output shaft and remove the yoke. If the yoke is stubborn, use a rubber mallet or ball peen hammer to aid in its removal. See Figures 2-2 and 2-3. Note that some heavy duty truck models are fitted with a parking brake assembly. If present, remove it at this time.

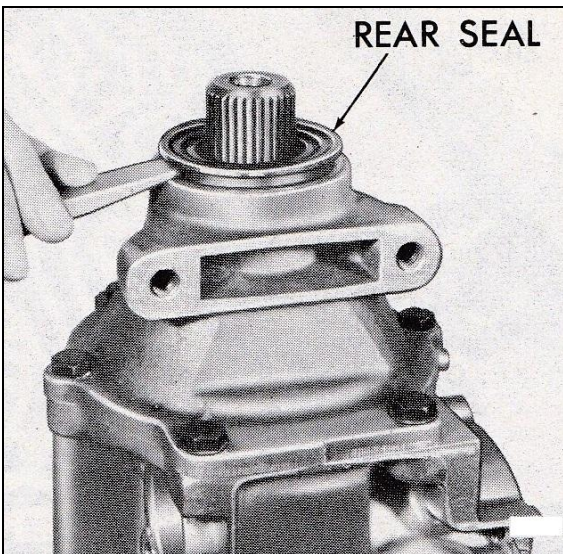
**FIGURE 2-4**

Remove the rear seal (26) from the extension housing (27). See Figure 2-4. Avoid damaging or gouging the seal bore in the housing. Seal removal is easier while the extension housing is still bolted to the transmission case. If the transmission mount is still attached to the extension housing, remove it at this time. Remove the six extension housing to case bolts (23). See Figure 2-5.

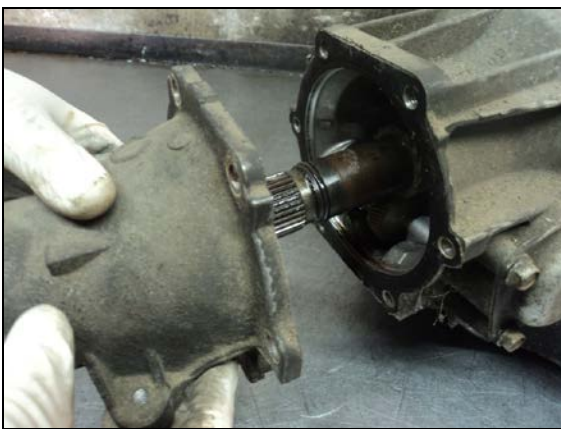
**FIGURE 2-6**

Remove the extension housing from the transmission case. See Figure 2-6. There are several different types of extension housings in use. Four wheel drive models use a specialized extension housing to attach the transfer case to the rear of the transmission. Remove and discard the extension housing to case gasket (34). See Figure 2-7. 1964 thru 1966 models use an o-ring seal instead of a gasket at this location. If present, remove and discard.

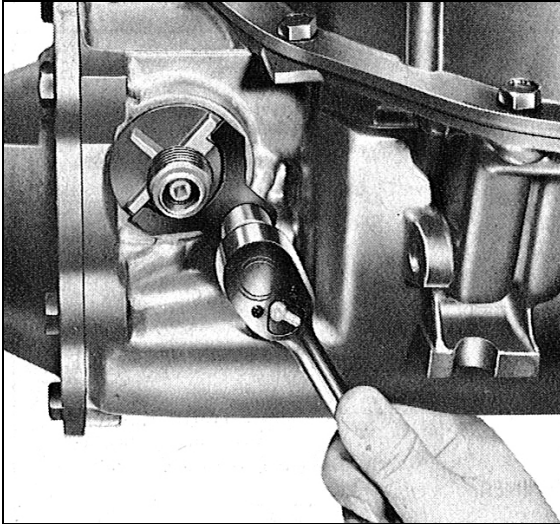
FIGURE 2-8

Remove the speedometer housing retainer bolt (83) and the speedometer housing retainer from the transmission case. See Figure 2-8. Remove the speedometer driven gear assembly from the transmission case. See Figure 2-9. Note that some models may be fitted with a speed sensor assembly (81) instead of the speedometer driven gear assembly. If present, remove the sensor by pulling it straight out of the case. DO NOT twist the sensor when removing it as it may become damaged from contact with the speed sensor rotor. Four wheel drive vehicles are not equipped with a speedometer or speed sensor assembly at this location.

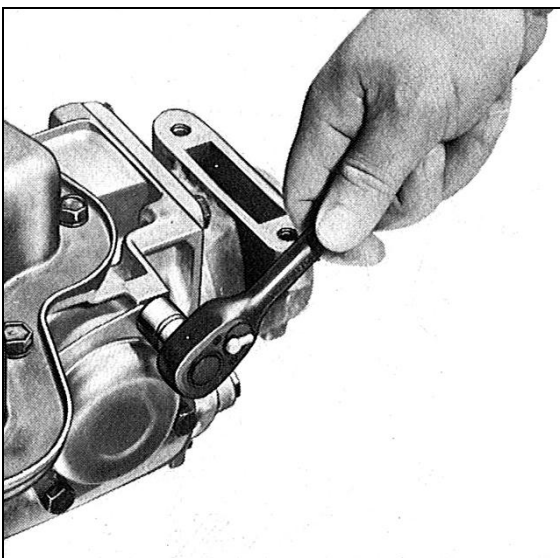
FIGURE 2-10

Remove the four governor cover to case bolts (19). See Figure 2-10. Remove the governor cover (20) and discard the governor cover to case gasket (21). Remove the governor assembly (22) from the case. See Figure 2-11. Note that modified transmissions may not use a governor assembly.

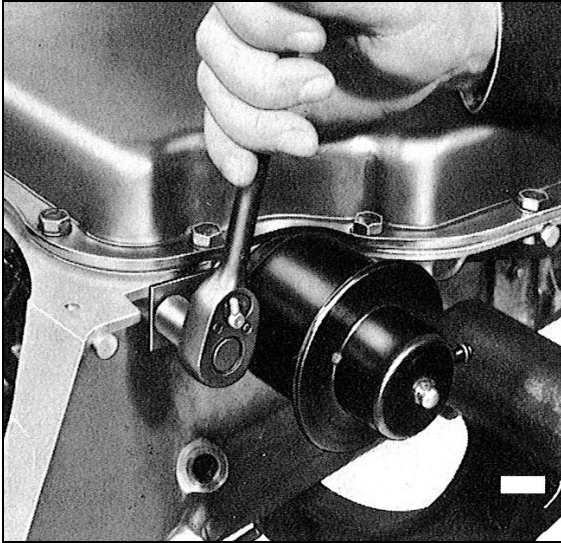
FIGURE 2-12

Remove the modulator retainer bolt (11) and modulator retainer (12) from the transmission case. See Figure 2-12. Remove the vacuum modulator assembly (13) from the transmission case. See Figure 2-13. Note that modified transmissions may not use a modulator assembly. Use a magnet to remove the vacuum modulator valve (15) from the case bore. Remove and discard the o-ring. (14). See Figure 2-14. Note that Jeep models use different modulator components. Refer to Figure 2-15 for disassembly.

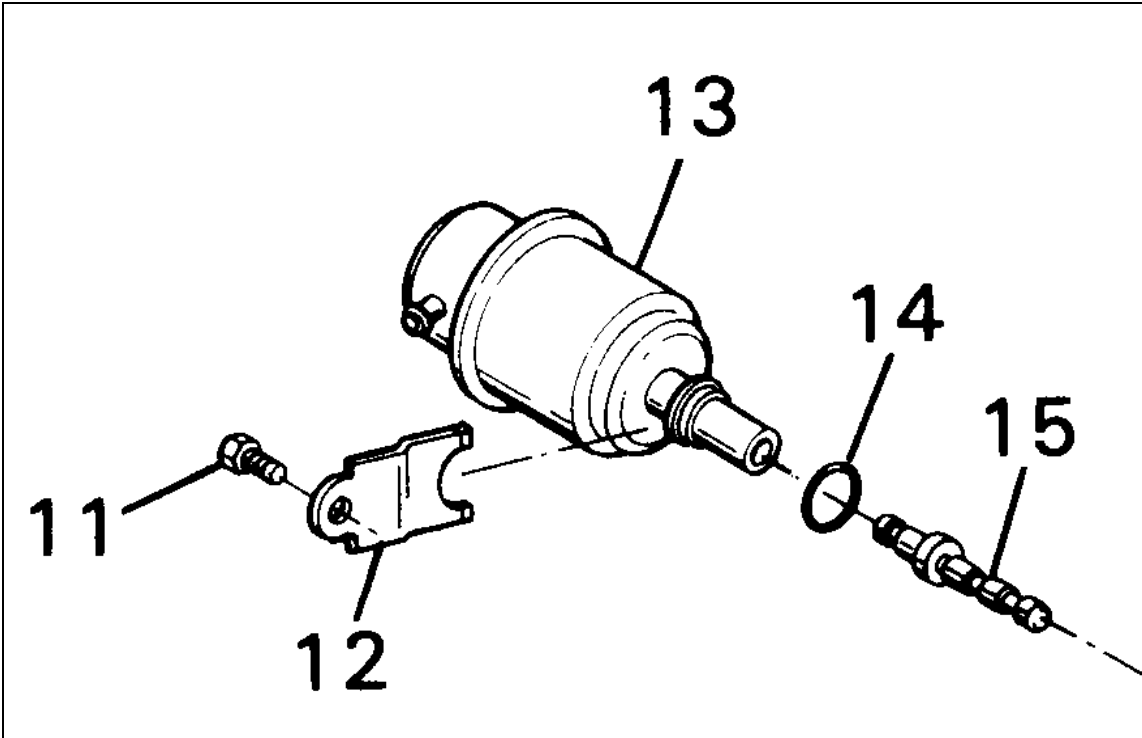
FIGURE 2-14 VACUUM MODULATOR AND RELATED COMPONENTS GM

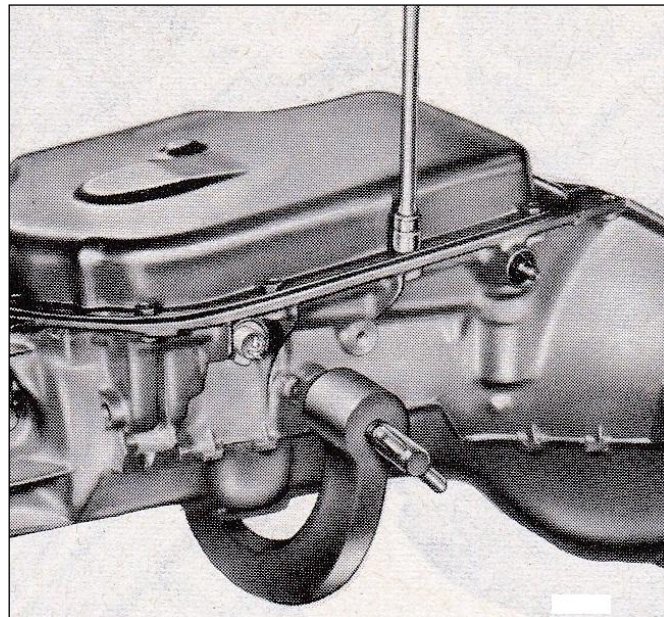
**FIGURE 2-16**

**Remove 13 bolts (37) that retain the oil pan (38) to the case. Note the heel print at the rear of the pan, designating a 1964 to 1967 model TH400. See Figure 2-16.**

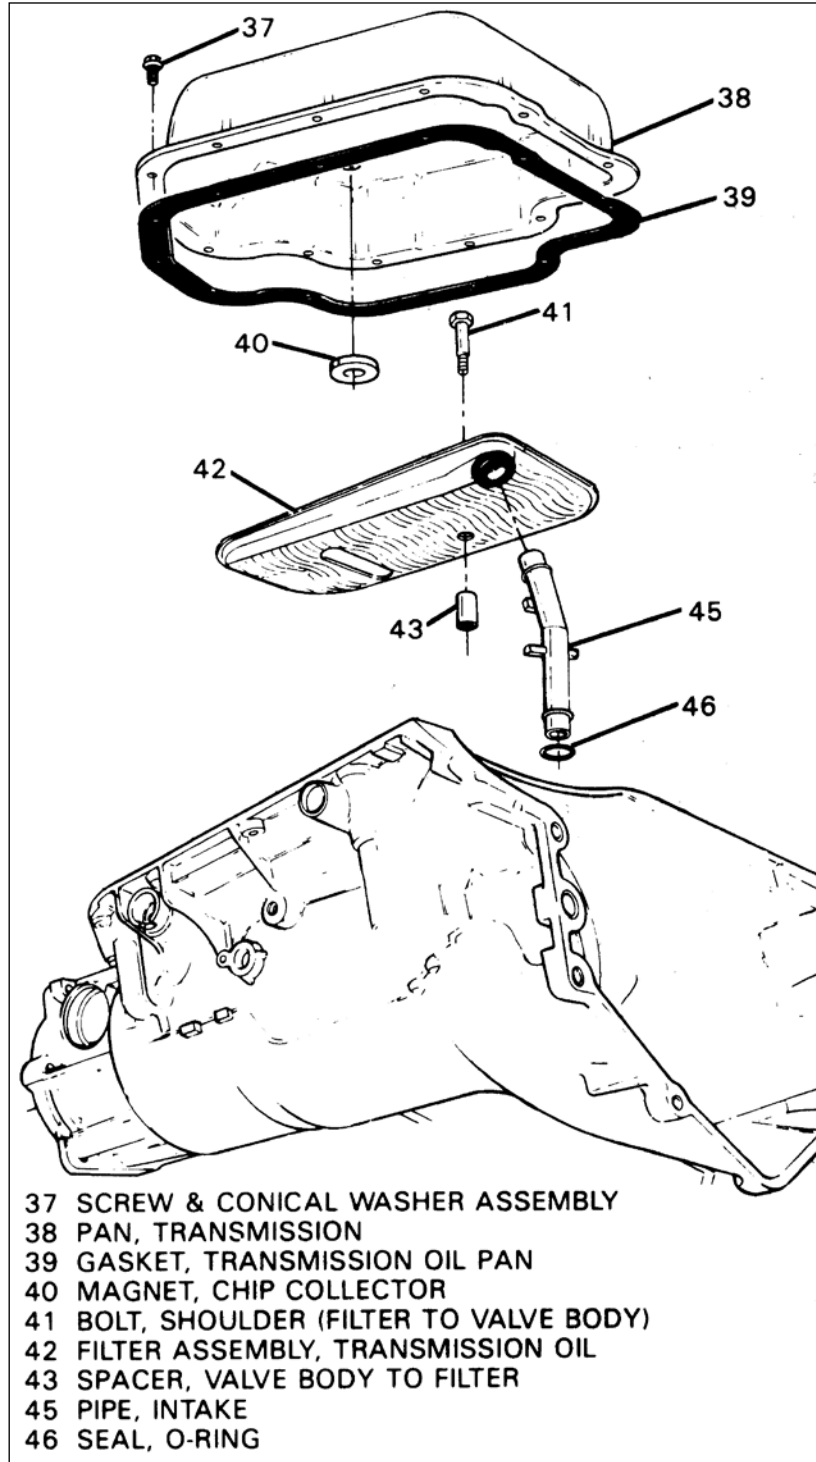
FIGURE 2-17

Remove the oil pan and remove and discard the oil pan gasket (39). On 1968 and later models remove the filter to valve body shoulder bolt (41). If the transmission is equipped with a deep pan, be sure to collect the valve body to filter spacer (43). See Figure 2-17.

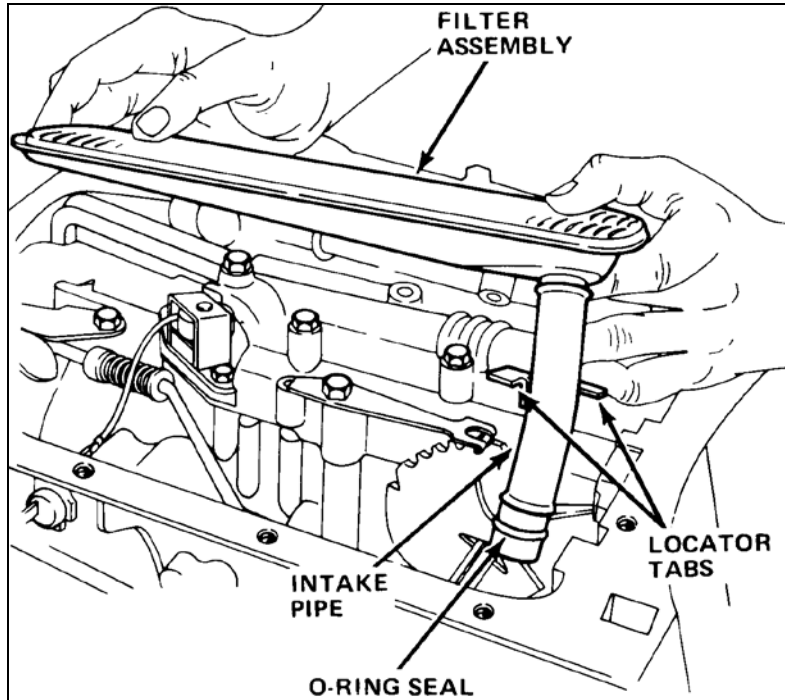
FIGURE 2-18

Remove and discard the filter (42), and remove the intake pipe (45). Remove and discard the o-ring seal (46) from the case end of the intake pipe. See Figure 2-18. If the o-ring is not present on the pipe, you will find it in the pipe bore in the case. 1964 to 1967 models use a one piece filter assembly as shown in Figure 2-19.

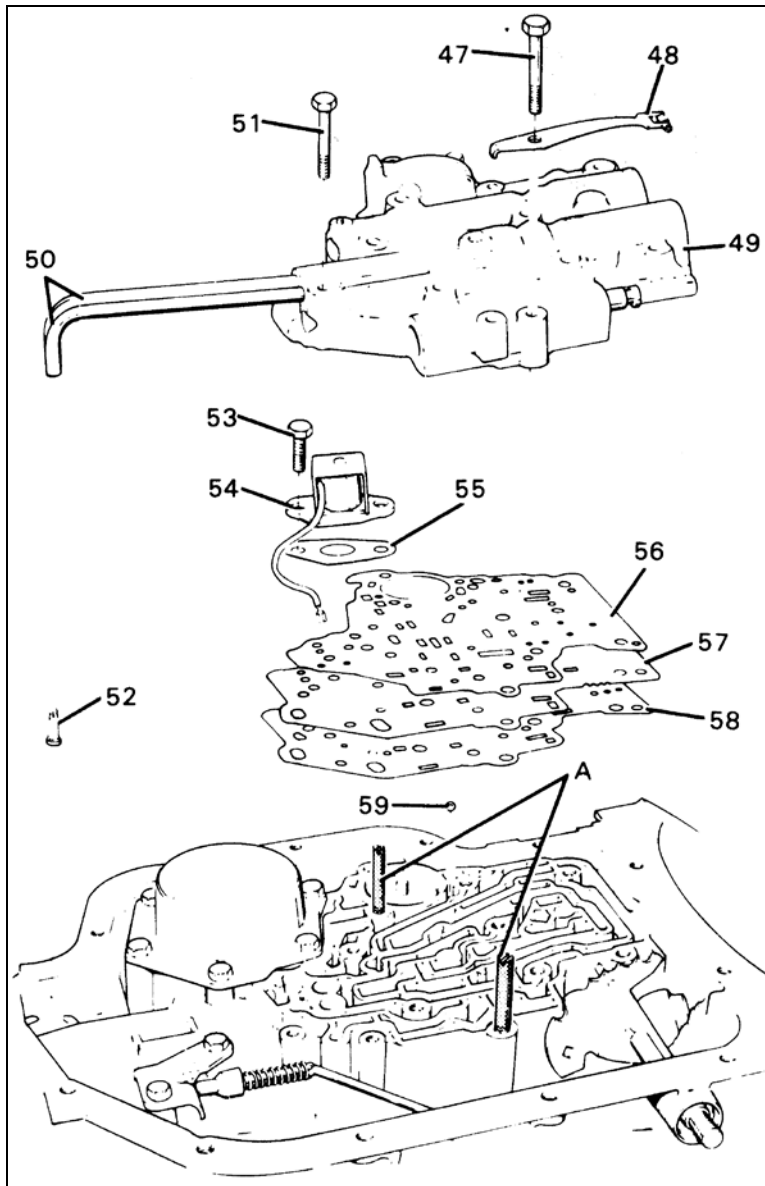
FIGURE 2-20

Use Figure 2-20 as a guide to remove the valve body assembly (49) and related components.

- 47 BOLT, HEX HD 5/16-18 X 1.875 (V.B. TO CASE)
- 48 MANUAL DETENT ROLLER & SPRING ASSEMBLY
- 49 CONTROL VALVE ASSEMBLY
- 50 PIPE, GOVERNOR
- 51 BOLT
- 52 SCREEN ASSEMBLY, GOVERNOR
- 53 SCREW, HEX HD & WASHER
- 54 SOLENOID ASSEMBLY
- 55 GASKET, SOLENOID
- 56 GASKET, VALVE BODY TO SPACER PLATE
- 57 PLATE, VALVE BODY SPACER
- 58 GASKET, SPACER PLATE TO CASE
- 59 BALL, (.25" DIA.) (6)

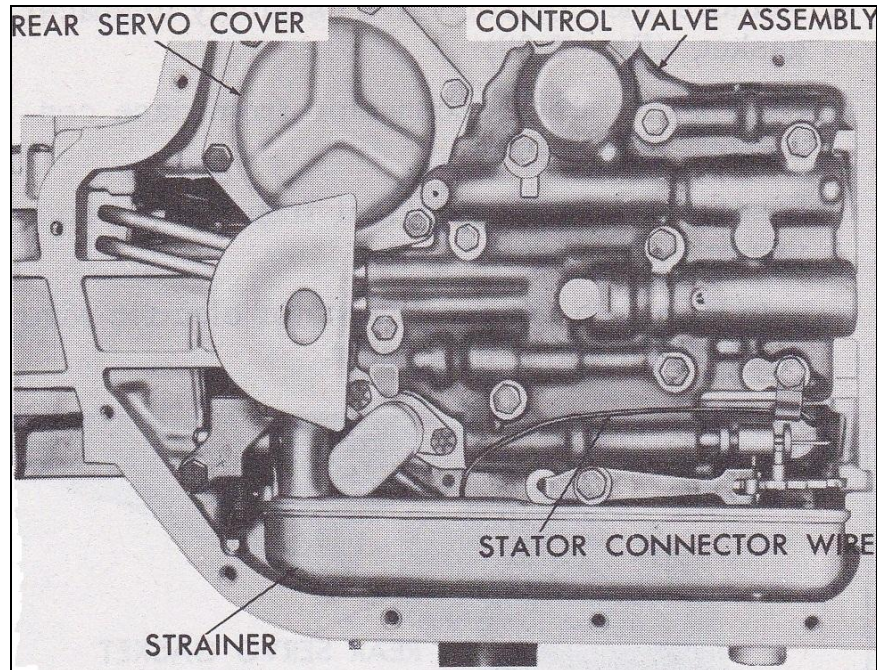
FIGURE 2-21

With variable pitch models, note the presence of the stator solenoid connecting wire attached to the valve body. Use caution to avoid damaging the wire. See Figure 2-21.

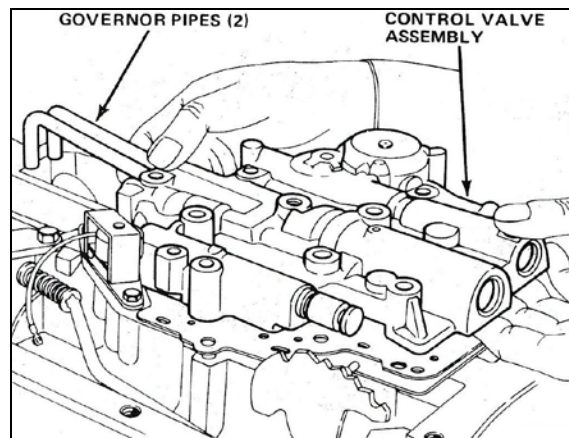
FIGURE 2-23

Remove the manual detent roller and spring assembly (48). See Figure 2-22. Using a 1/2" socket, remove eight or ten (model dependant) large valve body retaining bolts (47). Using a 7/16" socket, remove three small valve body retaining bolts (51). Lift the valve body assembly (49) and governor pipes (50) off of the valve body mounting flange of the transmission case. See Figure 2-23. Note that modified transmissions may not include governor pipes (50).

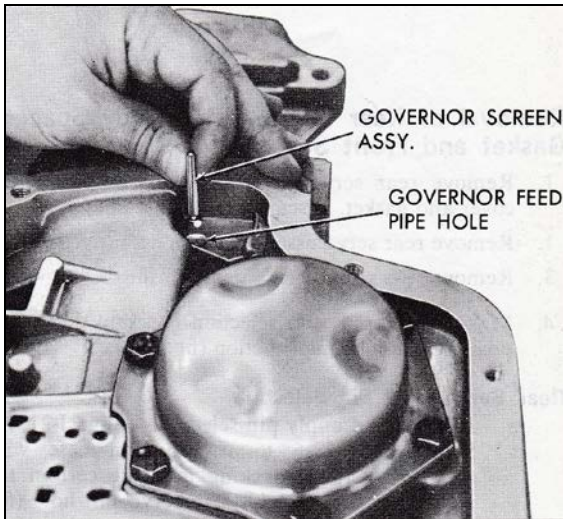
FIGURE 2-24

If present, remove the governor screen (52) from the case. See Figure 2-24. If not stuck to the plate, remove the valve body to spacer plate gasket (56) from the valve body spacer plate (57). See Figure 2-25. Most competition TH400 transmissions utilize custom valve body to spacer plate and spacer plate to case gaskets available only from the manufacturer. When servicing such transmissions, exercise caution not to damage gaskets if intentions are to on reinstall them.

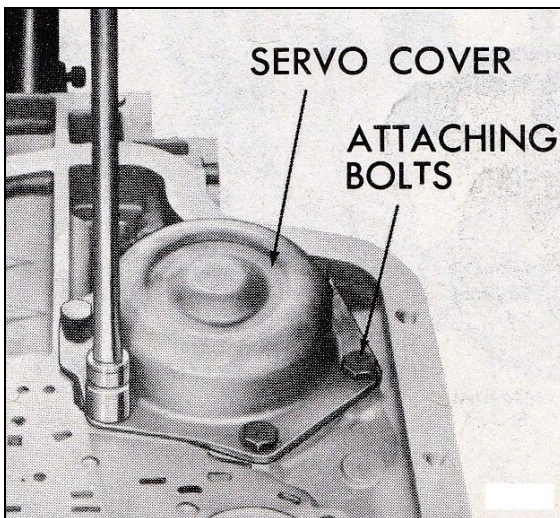
FIGURE 2-26

Remove the six rear servo retaining bolts (65) that retain the rear servo cover (66) to the transmission case. See Figure 2-26. Remove the rear servo cover and rear servo cover gasket (67) from the case as shown in Figure 2-27. Note that the cover will be under spring pressure from the rear accumulator spring (78). Discard the gasket.

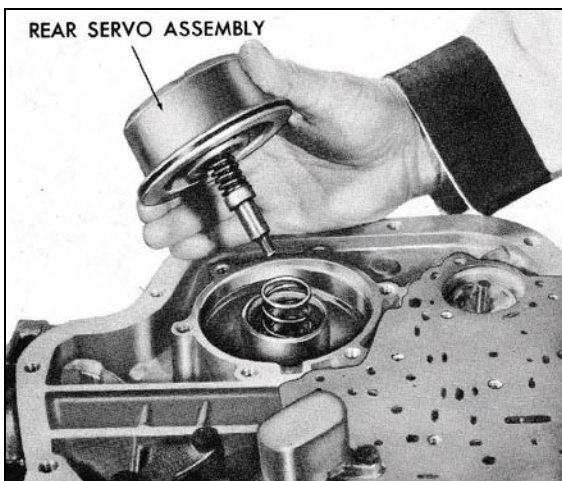
FIGURE 2-28

Remove the rear servo assembly from its bore in the transmission case. See Figure 2-28. If the servo is stuck in the bore, gently tap the piston with a rubber mallet to release it. Note that the rear servo assembly installed in 1964 model year transmissions differs from the one pictured here. Remove the rear accumulator spring from the case as shown in Figure 2-29.

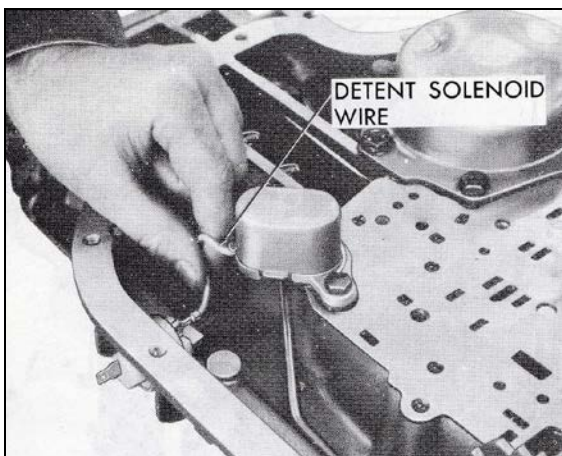
FIGURE 2-30

Unplug the detent solenoid (54) terminal end from the electrical connector (35). See Figure 2-30. With variable pitch models, disconnect the stator connector from the case connector sleeve. See Figure 2-31.

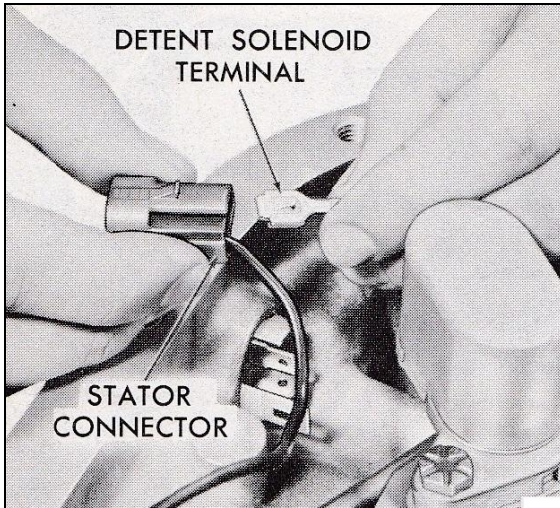
FIGURE 2-32

With variable pitch models, disconnect the detent solenoid wire from the stator connector. See Figure 2-32. Remove the two bolts (53) that retain the solenoid to the case, and remove the solenoid. See Figure 2-33.

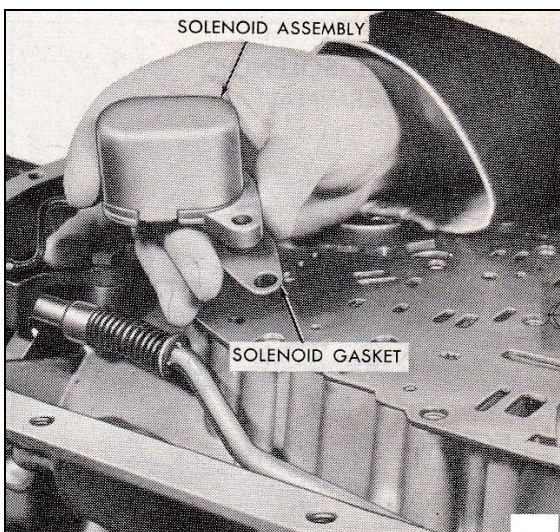
FIGURE 2-34

Note that there are two different detent solenoids used in the TH400. The late model is shown in Figure 2-33. The early model is shown in Figure 2-34. Note the use of the solenoid gasket with the early model. With early models, remove and discard the gasket. Note that modified transmissions may not include a detent solenoid. Remove the valve body spacer plate (57) and spacer plate to case gasket (58) from the case as shown in Figure 2-35.

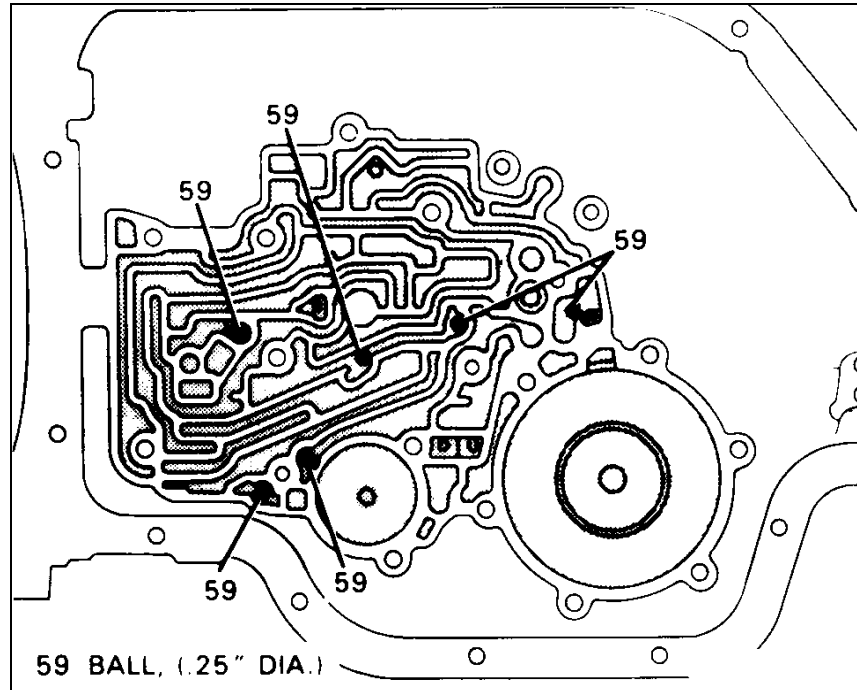
FIGURE 2-36

Use a magnet to remove the .250" checkballs from their positions in the transmission case. 1965 to 1987 models will have six checkballs. See Figure 2-36. 1988 and up models will have seven checkballs. See Figure 2-37. If the transmission has been previously serviced, some or all of the checkballs may have been omitted.

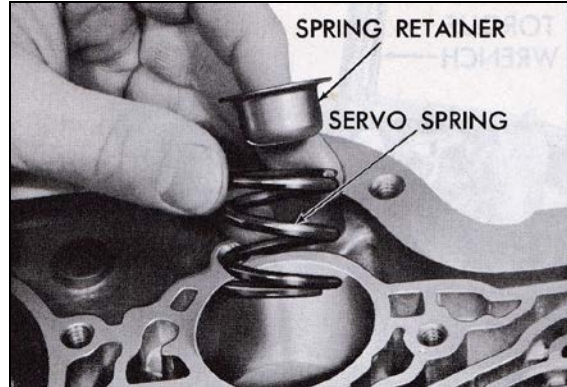
GM FIGURE 2-39

Remove the front servo piston, washer, and servo pin from the front servo bore, followed by the spring retainer and spring. See Figures 2-38 and 2-39. Two different front servo assemblies are used in the TH400. This is covered in detail in the appropriate section of this manual. Note that modified transmissions may not include a front servo assembly.

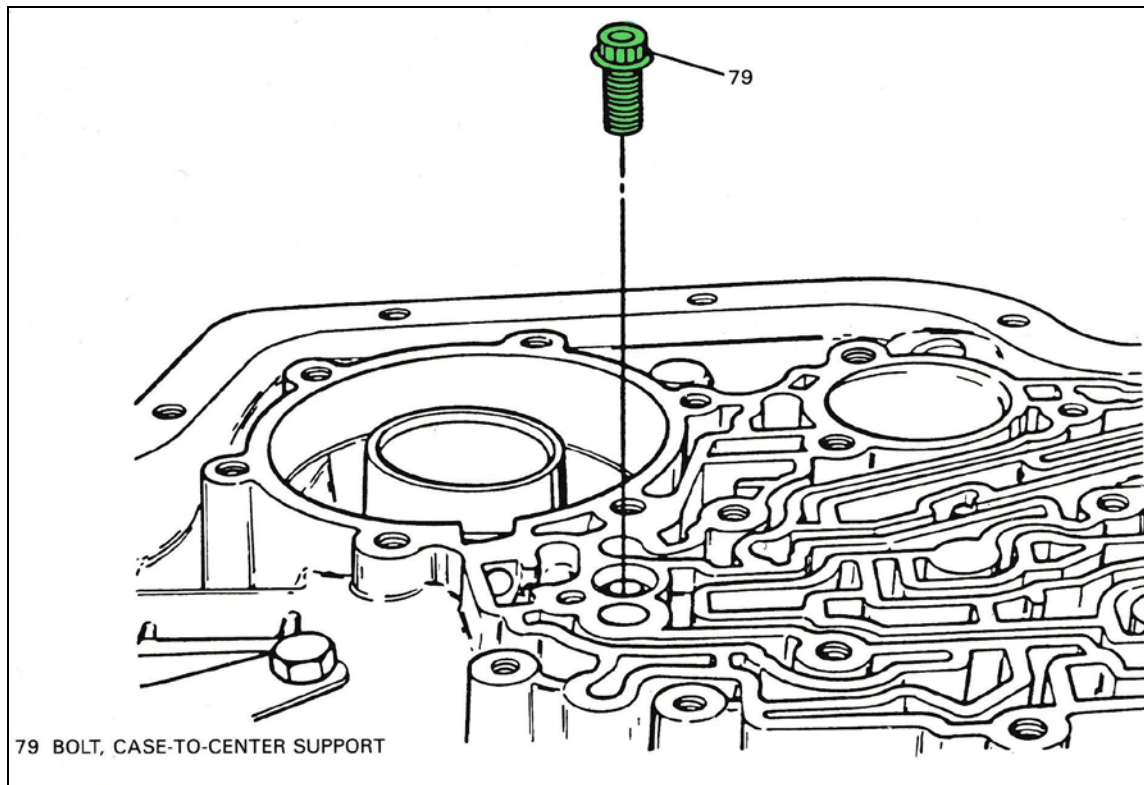
FIGURE 2-40

The center support is retained to the transmission case with the case to center support bolt (79). See Figure 2-40.

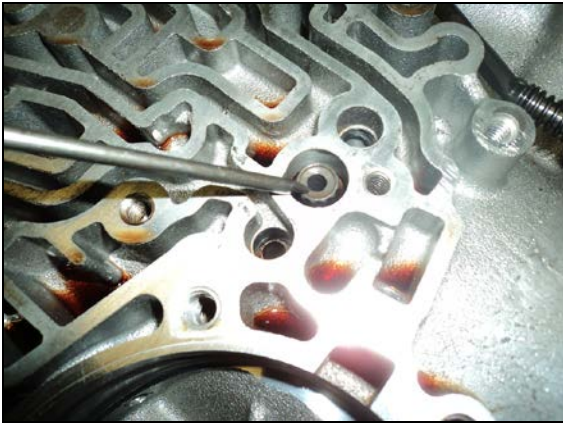
FIGURE 2-41

A close up of the bolt location is shown in Figure 2-41. 1964 and 1965 models use an Allen bolt at this location. See Figure 2-42.

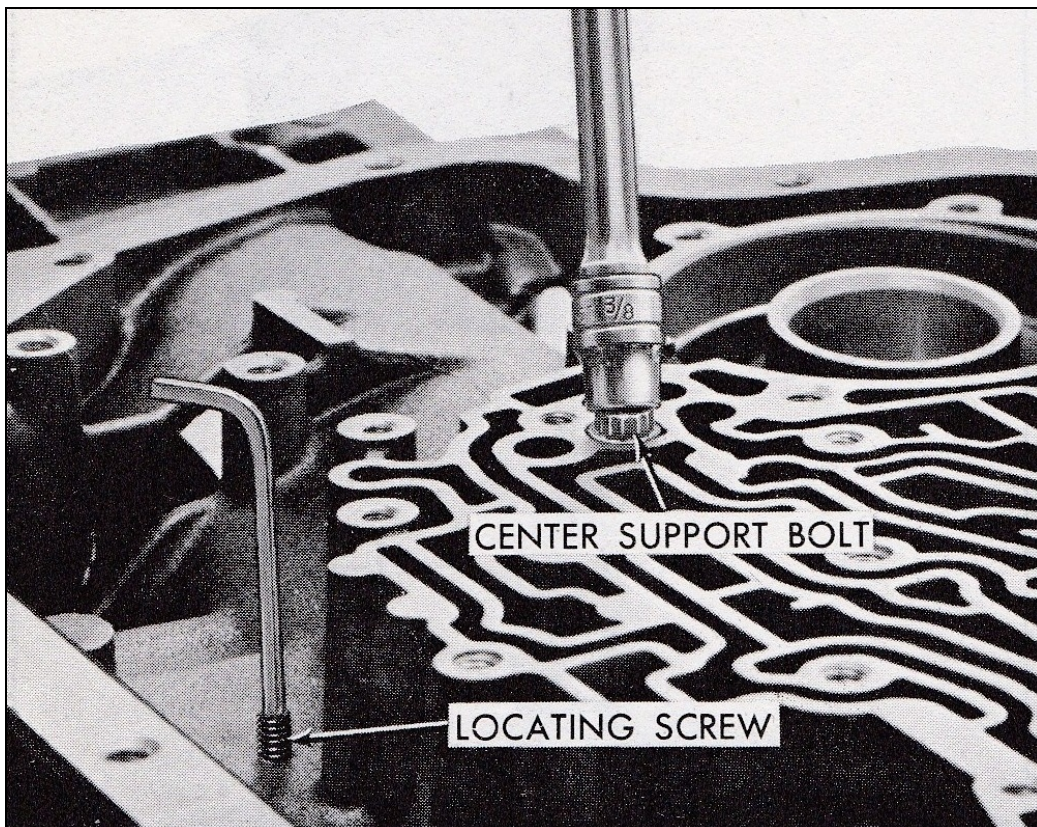
FIGURE 2-43

1966 and later models use a thin wall 3/8" 12 point socket. Remove the case to center support bolt with a hand tool as shown in Figure 2-43. Do not use an air gun as it may result in damage to the threads in the cast iron center support. Note that 1964 to 1968 models use a center support locating screw at the location shown in the figure. If the locating screw is present, it should not be contacting the center support. Back it off two turns to be certain.

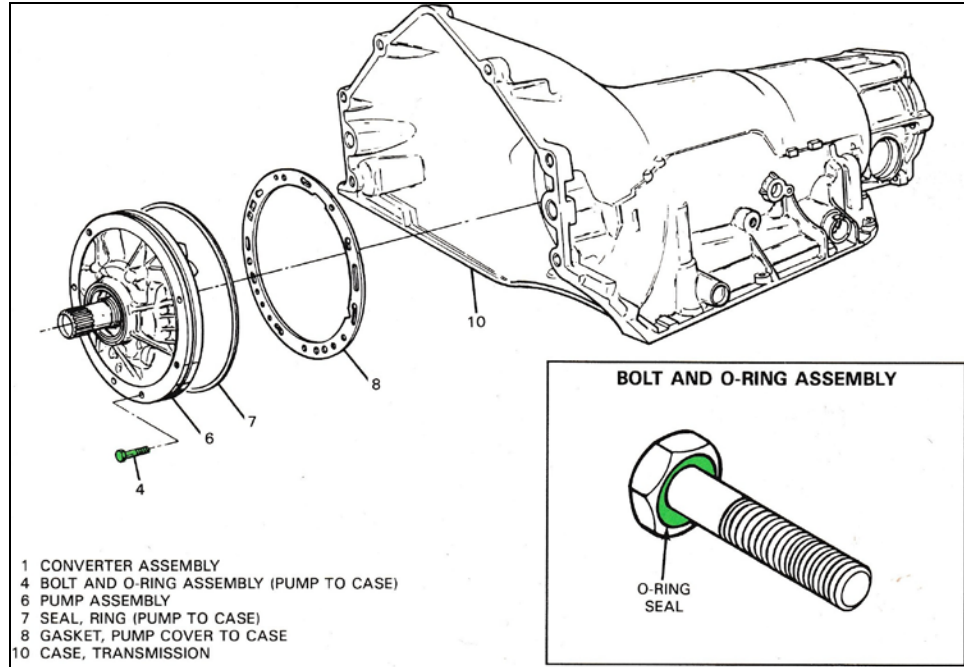
FIGURE 2-44

Use Figure 2-44 as a guide to remove the oil pump (49) and related components.

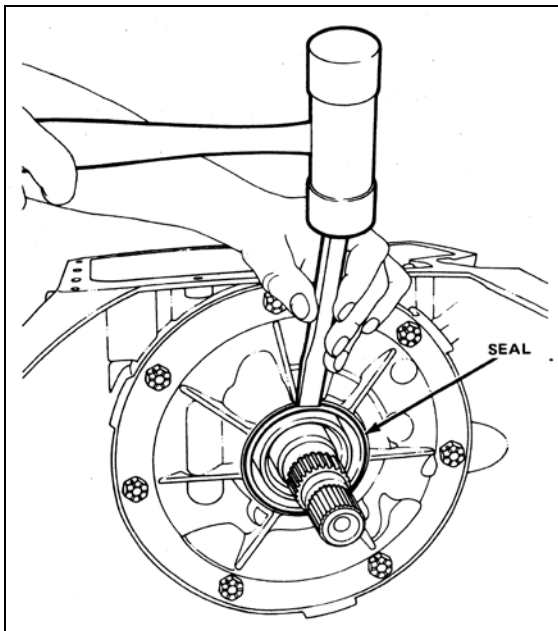
FIGURE 2-45

Remove the front seal (2) from the pump body (201). See Figure 2-45. Avoid damaging or gouging the seal bore in the pump body. Seal removal is easier while the oil pump is still bolted to the transmission case. Remove the six or eight (model dependant) pump to case bolts (4). See Figure 2-46.

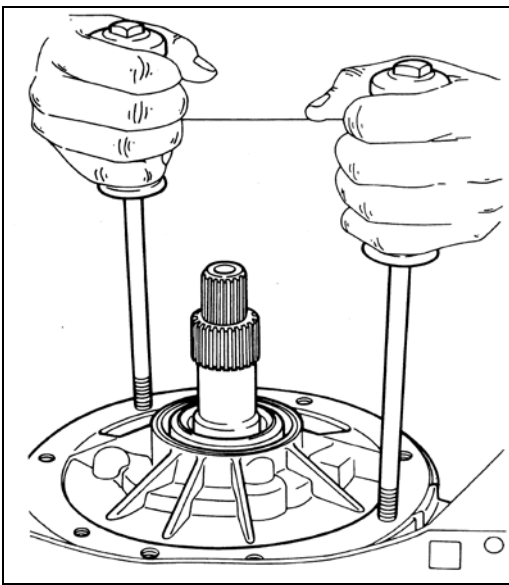
FIGURE 2-47 AMC/JEEP

Use a pair of slide hammers to remove the pump from the transmission case. Thread the two 3/8-16 slide hammer bolts into the holes in the pump body at the 5 and 10 o'clock positions. If the body is not threaded, use the slide hammers to "tap" threads. Bump outward evenly with the slide hammers to remove the pump. See Figure 2-47. When using one slide hammer, you can pull up on the stator shaft while bumping the slide hammer to remove the pump. If hammers are not available, install two 3/16-18 bolts at the locations shown. Grasp the bolt heads with locking pliers and remove the pump. The pump can also be removed by inserting a stout screwdriver into the case at the location shown in Figure 2-48 and gently prying it out. With variable pitch models, use caution as you guide the stator connector wire out of the case with the oil pump. See Figure 2-49. Remove and discard the pump to case o-ring (7) and pump to case gasket (8). See Figure 2-50.

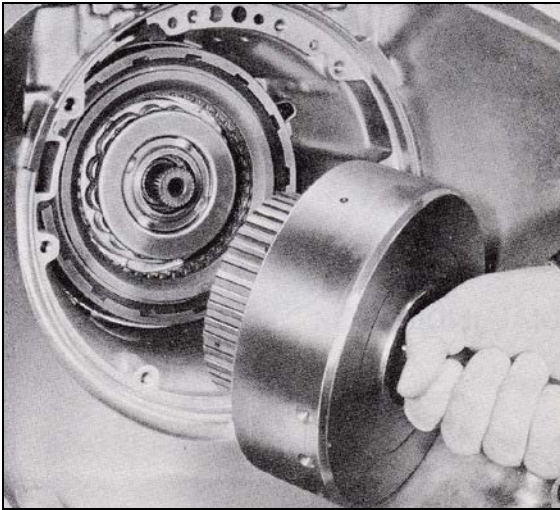
FIGURE 2-51

Remove the forward clutch assembly from the case. See Figure 2-51. Remove the direct clutch assembly from the case. See Figure 2-52. If it did not come out with the forward clutch housing, you will find the thrust washer (617) at the front of the direct clutch housing. Note that modified transmissions may use a thrust bearing at this location.

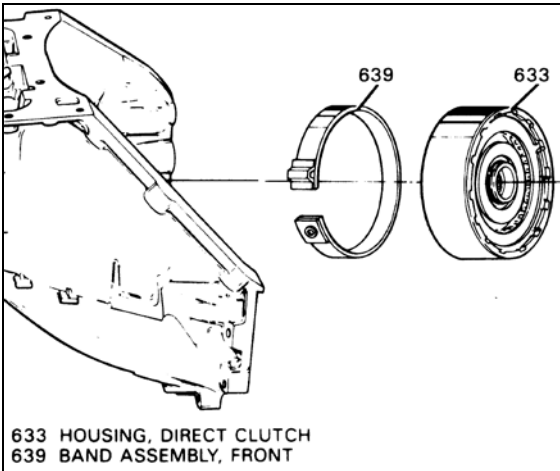
FIGURE 2-53

Remove the front band (639) from the case. See Figures 2-53 and 2-54. Note that modified transmissions may not use an intermediate band at this location.

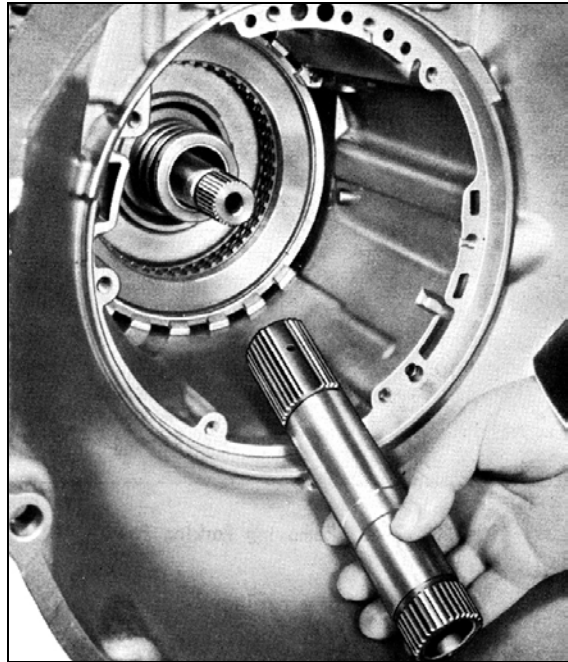
FIGURE 2-56

Snap rings are used to retain the intermediate clutch pack components and center support to the case. See Figure 2-55. Remove the sun gear shaft (664) from the center support. See Figure 2-56.

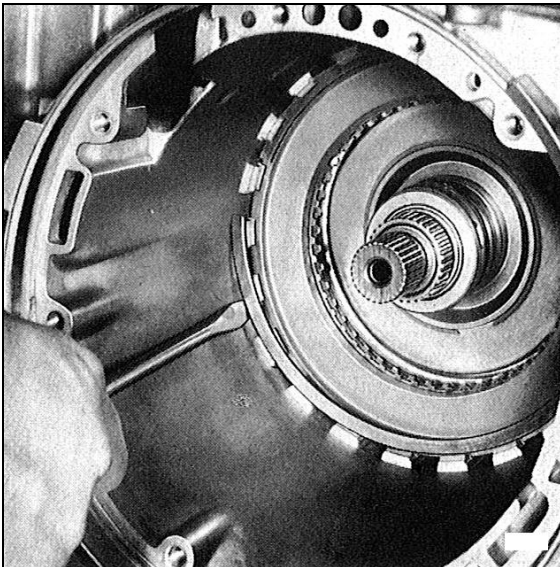
FIGURE 3-57

Remove the intermediate clutch snap ring (640) that retains the intermediate clutch backing plate (641) to the case. See Figure 3-55. Remove the intermediate clutch backing plate (641) and the remaining components of the intermediate clutch pack (642,643,644) from the transmission case. See Figure 3-57 and 3-58.

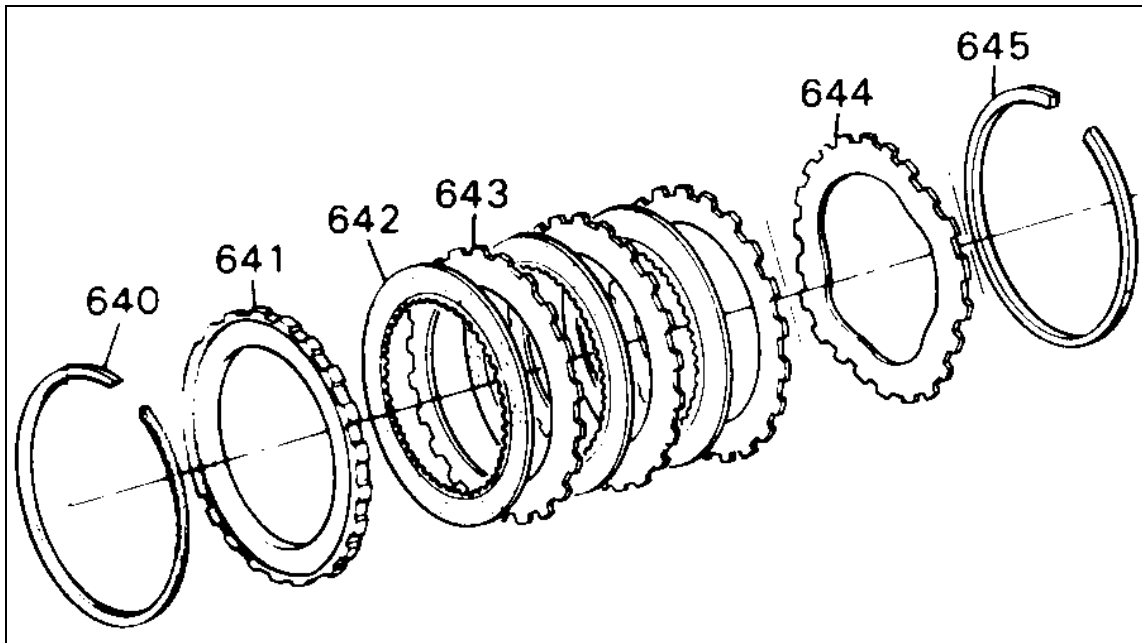
FIGURE 3-59

Remove the beveled snap ring (645) that retains the center support to the case. See Figure 3-58. Grasp and lift up on the center support (654) to remove it from the transmission case. See cut away view in Figure 3-59.

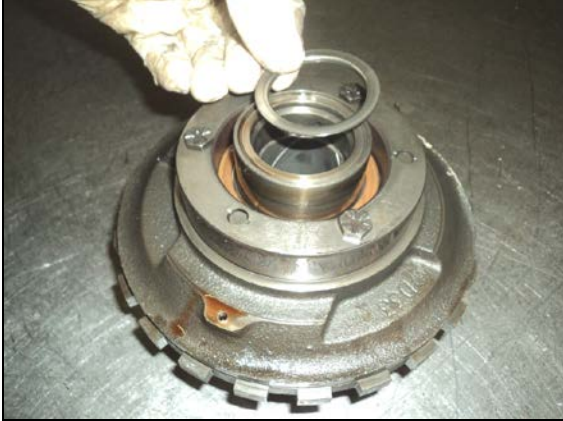
**FIGURE 3-60**

Turn the center support upside down and remove the thrust bearing to center support race (660), from its location at the rear of the center support. See Figure 3-60. Remove the thrust washer (656) from its recess at the rear of the center support. See Figure 3-61. If either item did not come out with the support, they will be found sitting on top of the geartrain.

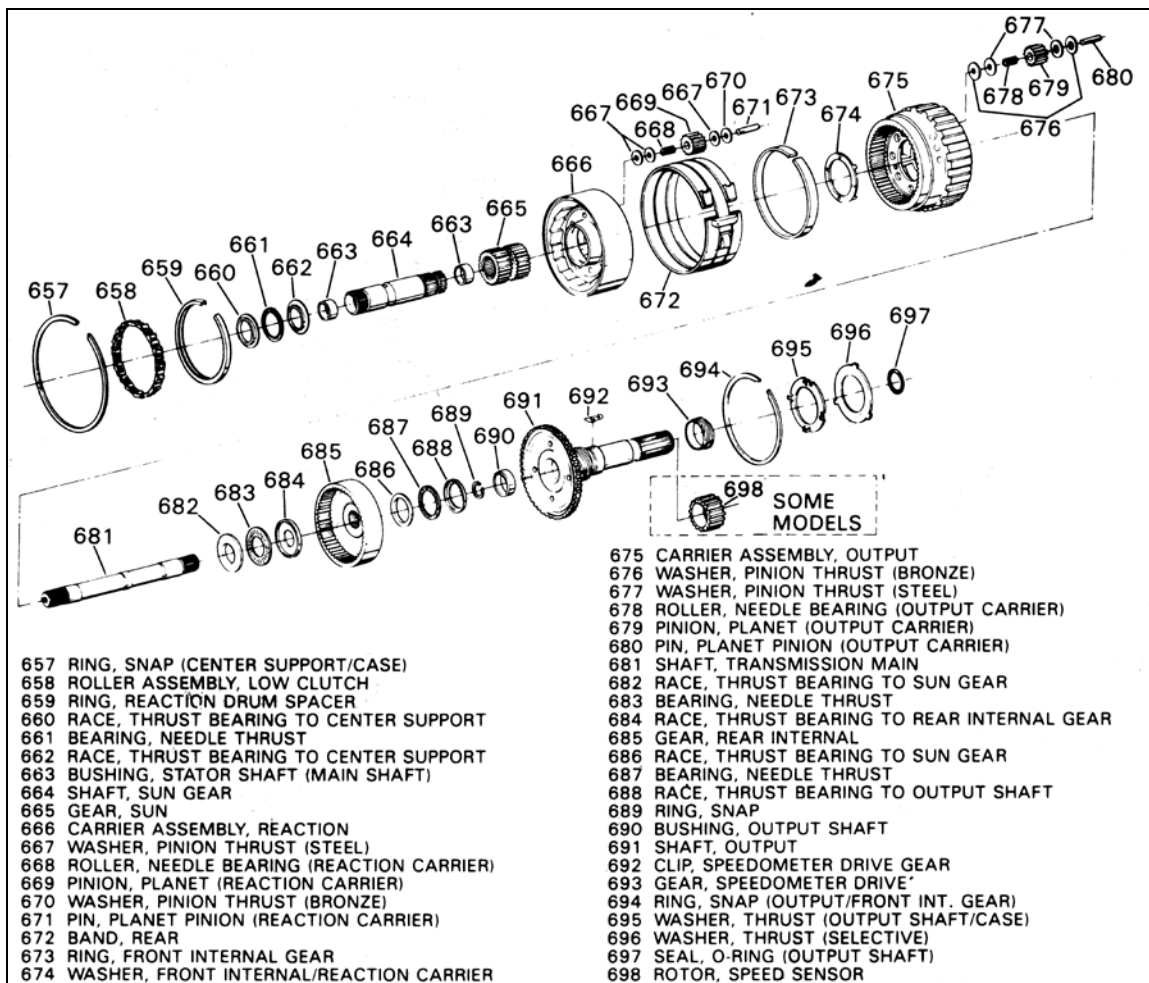
FIGURE 3-62

Use Figure 3-62 as a guide to remove the remaining geartrain components from the transmission case.

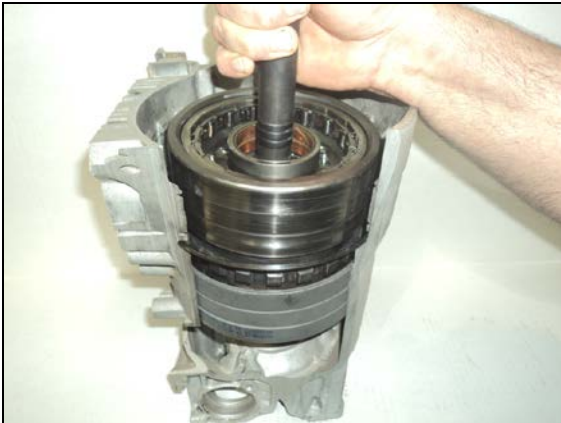
FIGURE 3-63

Grasp and lift up on the main shaft to remove the remaining geartrain components from the transmission case. See cut away view in Figure 3-63. Stand the assembly upright on the workbench. Reach into the inside diameter of the reaction carrier with a hooked scribe or pencil magnet and remove the remaining components of the three piece thrust bearing assembly (660,661,662) from the front face of the sun gear (665) and set aside. See Figure 3-64.

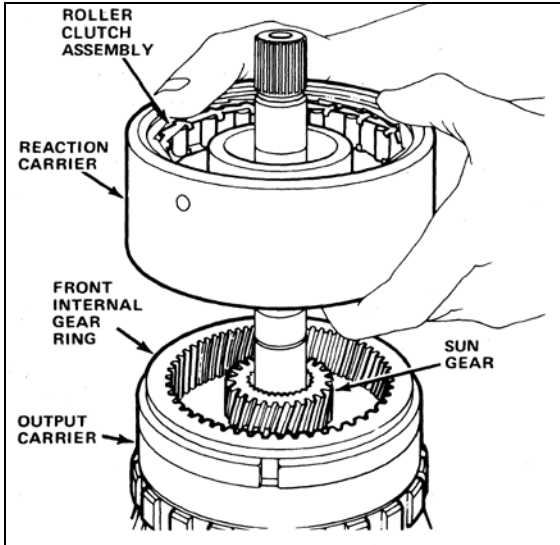
FIGURE 3-65

Lift the reaction carrier assembly (666) off the output carrier (675). See Figure 3-65. Remove the front internal gear silencer ring (673) from the output carrier (675). See Figure 3-66.

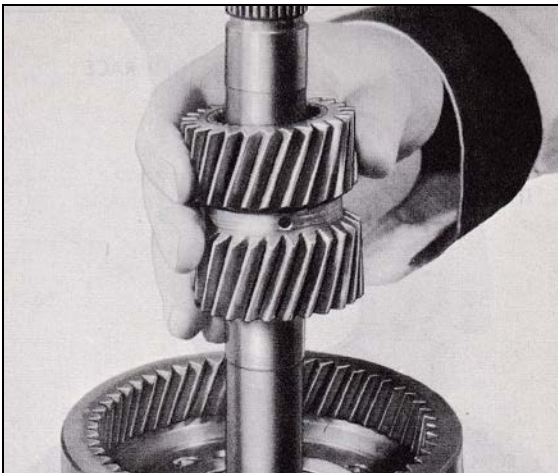
FIGURE 3-67

Remove the sun gear (665) from the output carrier. See Figure 3-67. Remove the thrust washer (674) from the front face of the output carrier (675). See Figure 3-68. Note that it may be metal or plastic. Note that modified transmissions may use a thrust bearing at this location.

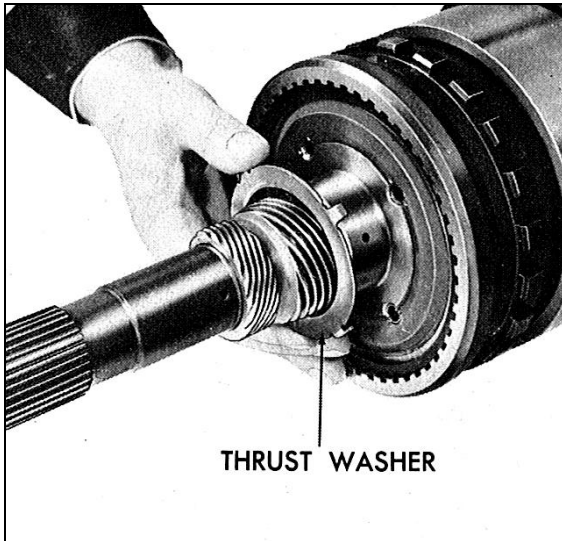
FIGURE 3-69

Remove the thrust washer (695) from the rear face of the output shaft (693). See Figure 3-69. Note that modified transmissions may use a thrust bearing at this location. Place the assembly with the mainshaft pointing down thru a hole in the

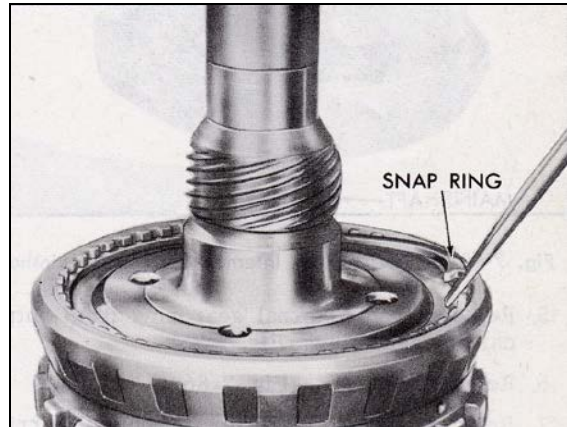
GM FIGURE 3-70

workbench. Remove the snap ring (694) that retains the output shaft (691) to the output carrier (675). See Figure 3-70.

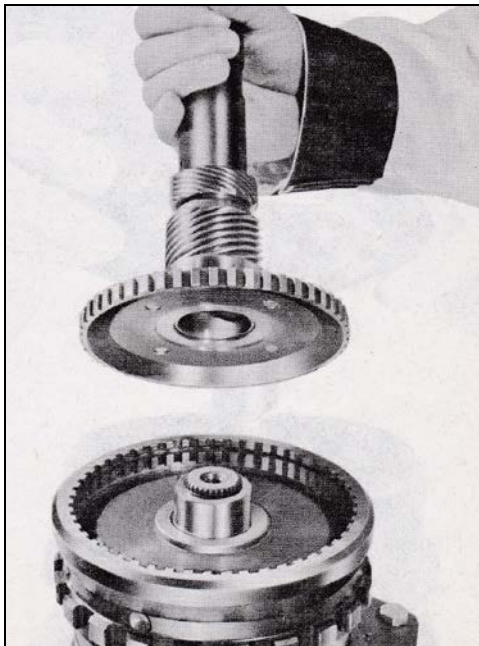
FIGURE 3-71

Remove the output shaft from the carrier. See Figure 3-71. Remove the three piece thrust bearing assembly (686,687,688) from the rear face of the rear internal gear (685). See Figure 3-72. Some of the assembly may remain with the output shaft.

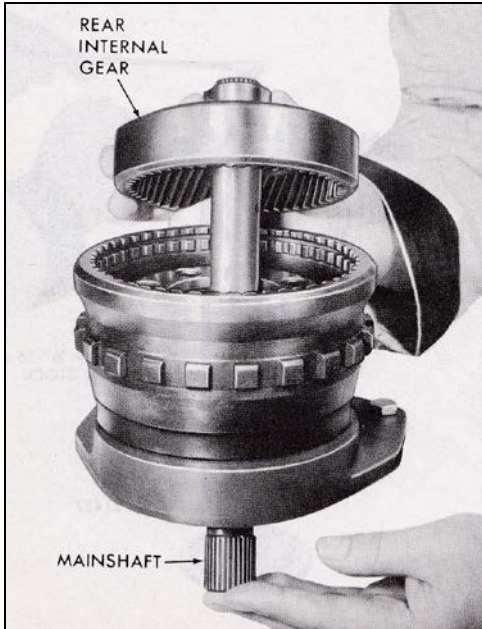
**FIGURE 3-73**

Remove assembled rear internal gear (685) and main shaft (681) from the output carrier (675). See Figure 3-73. Remove the three piece thrust bearing assembly (682,683,684) from the front face of the rear internal gear. See Figure. 3-74

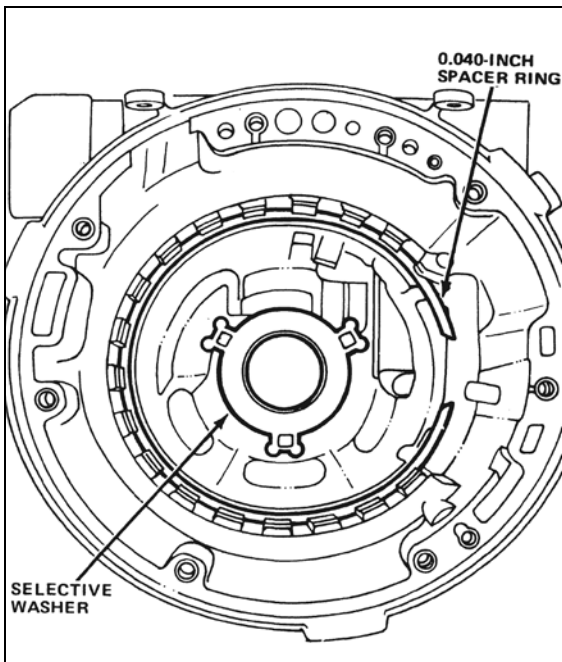
**FIGURE 3-75**

If present, remove the center support to case .040" spacer ring (657) from the transmission case. Figure 3-75 and Figure 3-76.

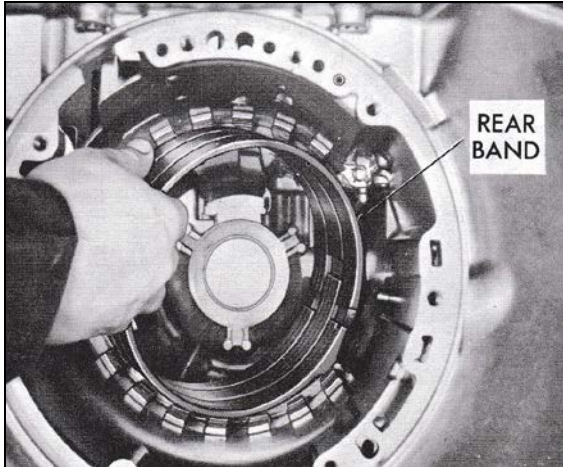
FIGURE 3-77

Disengage the rear band (672) from the anchor pins and remove it from the transmission case. See Figure 3-77. Remove the selective thrust washer (696) from the transmission case. See Figures 3-78 and 3-79. Note that modified transmissions may use a thrust bearing and shims at this location.
