## **THIS IS AN EARLY EDITION OF TH400 DISASSEMBLY PROCEDURES**

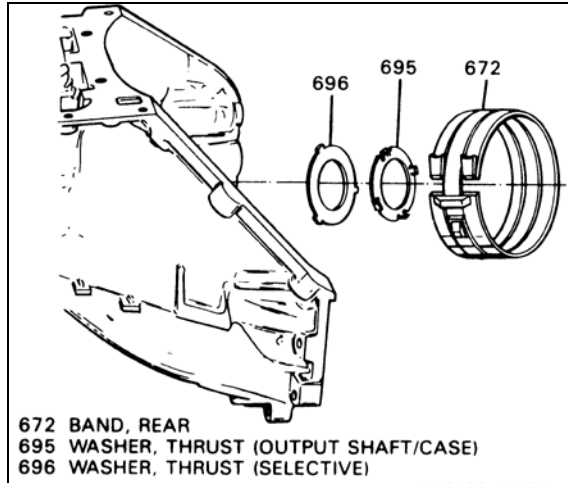
Disengage the rear band (672) from the anchor pins and remove it from the transmission case. See Figure 3-77. Remove the selective thrust washer (696) from the transmission case. See Figures 3-78 and 3-79. Note that modified transmissions may use a thrust bearing and shims at this location.

672 BAND, REAR  
695 WASHER, THRUST (OUTPUT SHAFT/CASE)  
696 WASHER, THRUST (SELECTIVE)
