TIVAR® 88 High Performance Lining Solutions Engineering Case Book

**Applications, Case Studies, & Technical Resources
to assist your design process**

TIVAR® 88 HIGH PERFORMANCE LINING SOLUTIONS

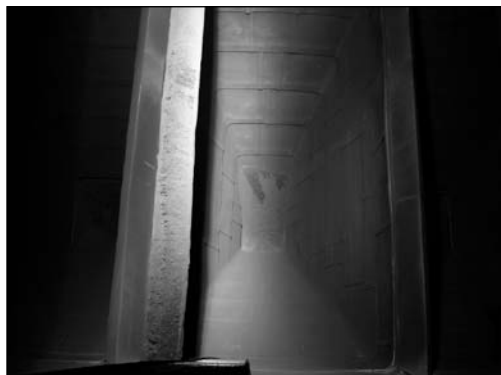
Figure 1: Unit #2 Coal Bunker Lansing Board of Water and Light Lansing

In 2003 the Eckert Station installed TIVAR® 88 w/ BurnGuard liners in (1) 3 outlet coal bunker supporting Unit #2. The TIVAR® 88 w/BurnGuard liners were installed directly over the existing gunitite surfaces on the sloping walls of the bunker. Since the installation of the TIVAR® 88 w/BurnGuard liners in 2003, the plant has not experienced any fires in the Unit # 2 bunker. The cost of the TIVAR® 88 liner installation was 50% less than the Unit #5 approach. An additional benefit from the lining was a reduction in the frequency of bunker filling. In the fall of 2005 the Eckert Station installed TIVAR® 88 w/BurnGuard liners in the Unit #4 coal bunker.

An inspection was performed on the Unit 2 bunker liners in March, 2006. The TIVAR® 88 w/BurnGuard liners had no measurable wear and were providing continuous flow with no bunker fires and no maintenance.

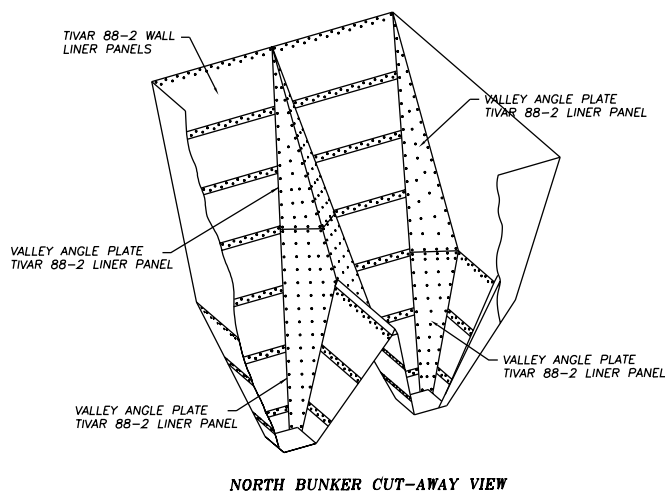
Figure 1: TIVAR® 88-2 liners were used on the valley angle clean-out as well as the sloping walls in the bunker.

A corrective action plan was implemented to alleviate the coal flow problems. An internationally known flow consultant was hired to do a flow analysis on the bunkers and to develop a solution for eliminating the bunker fires. The recommendation was to convert the bunkers from funnel flow to mass flow. Achieving mass flow would require adding valley angle clean-out plates and covering all of the sloping wall surfaces with TIVAR® 88-2 (Fig. 1).

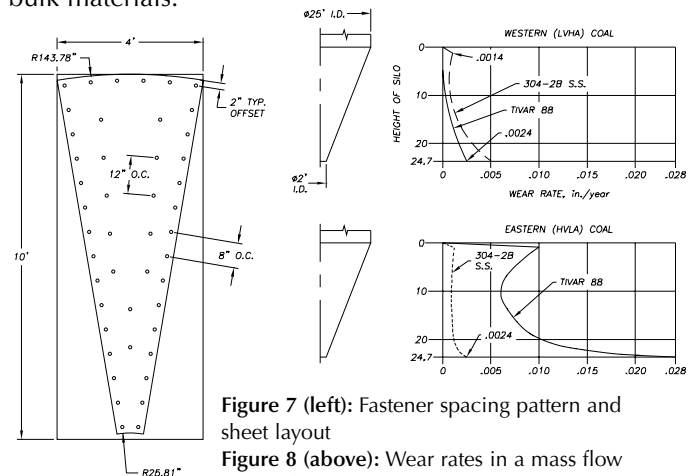
Figure 7 (left): Fastener spacing pattern and sheet layout

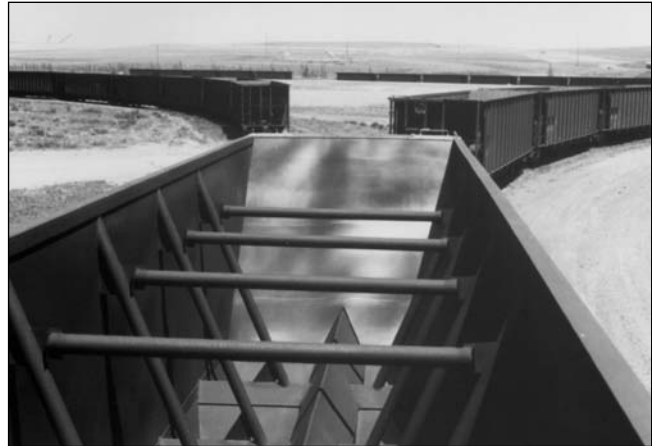
Basin Electric railcars with TIVAR® 88-2 liners installed.

Tested in year-round weather conditions, the 100-ton capacity cars showed less than 1/16-ton carryback – an insignificant amount as deemed by the utility. Turnaround times at the railyard receiving bunkers have been cut by as much as 50% and loads are effectively discharged without the frequent use of car shakers, thawing sheds or other techniques that fatigue railcar structures.

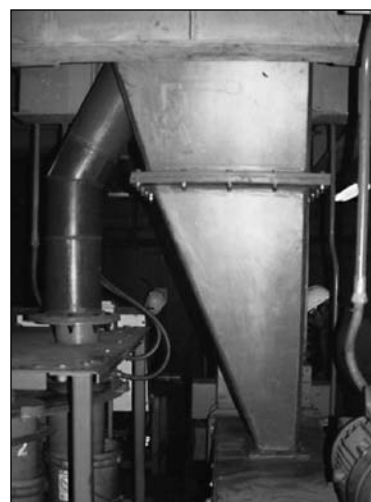
After
Sample collector manufactured completely with TIVAR® 88-2 eliminates build-up and quality control problems.

The sample collector portion of the ship loading process no longer experiences material build-up or contamination. The quality control department is now in a position to trust the values they are recording through the sample collector. This small, simple modification was relatively inexpensive compared to the costs associated with flow and contamination problems.

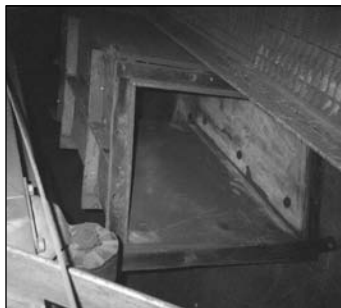
Original rectangular shape transfer chute.

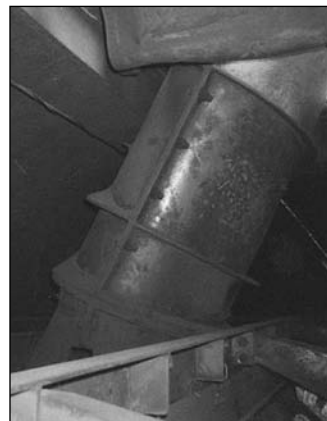
New round steel loading chute is lined with TIVAR® 88.

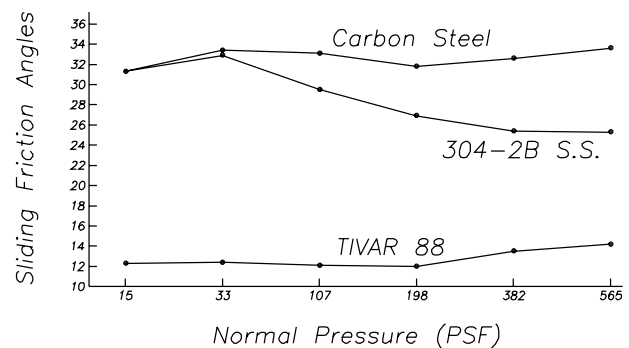
Figure 1: The sub-bituminous coal for this test came from the Powder River Basin in Wyoming. Data is presented for information purposes only and is not intended to be used for design criteria.
