APTA BTS-BC-RP-006-17

Transit Bus Air Disc Brake Operation and Wheels-On Inspection

Abstract: This document establishes a recommended practice for wheels-on transit bus front/rear axle pneumatic disc brake inspection. Individual operating agencies should modify these guidelines to accommodate their specific equipment and mode of operation.

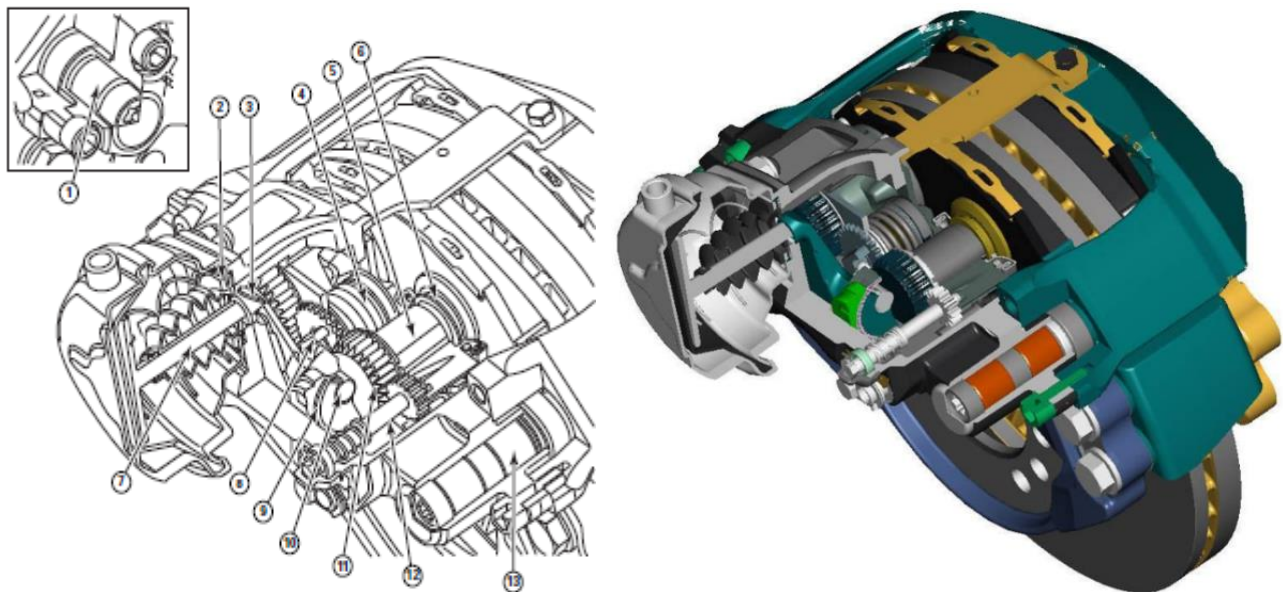
FIGURE 3

Meritor EX225 Caliper Gear-Driven Adjustment Mechanism (Not Serviceable)

- 1 Short slide pin oval bushing
- 2 Housing seal
- 3 Operating shaft
- 4 Return spring
- 5 Piston
- 6 Piston head
- 7 Chamber piston
- 8 Adjuster shaft
- 9 Half bearing
- 10 Roller
- 11 Tappet
- 12 Adjuster stem
- 13 Long side pin bushing

The adjuster mechanism is not serviceable on either design and should not be disassembled. **Figure 3** and **Figure 4** show the difference between the Meritor EX225 (gear-driven) and the Knorr-Bremse (timing chain) caliper adjusting mechanism.

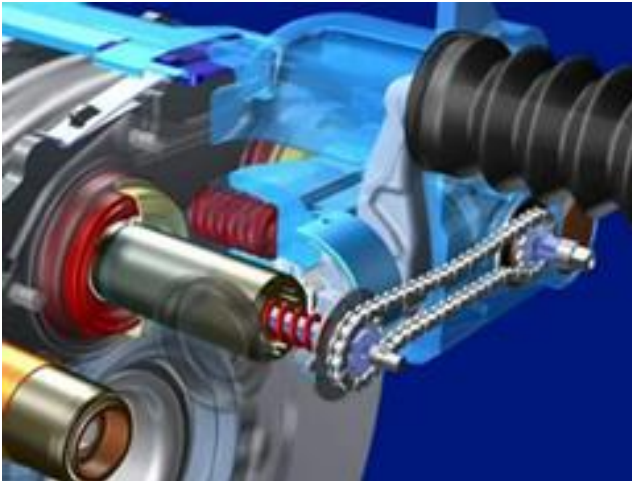
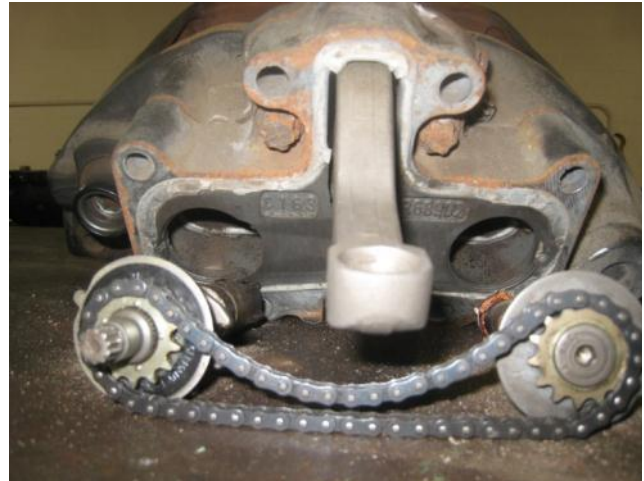
FIGURE 4

Knorr-Bremse Timing Chain Mechanism (Not Serviceable)

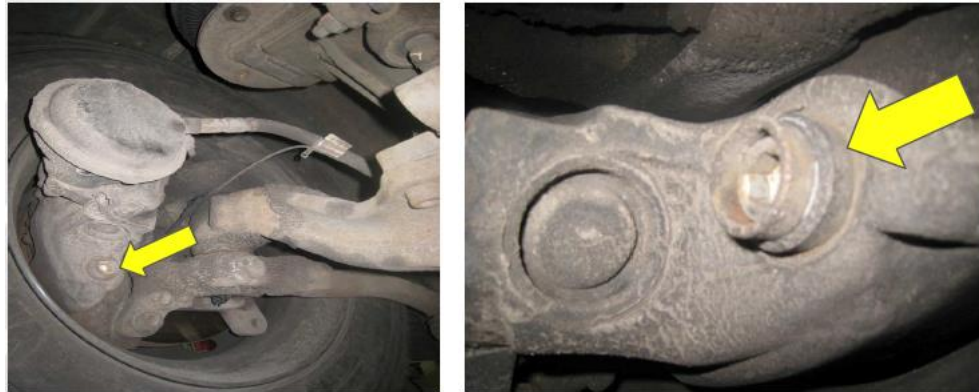
FIGURE 9

Dirt, road salts and debris can obstruct the view of the guide pin or wear indicator (**Figure 9**). Care should be exercised to ensure that the solid rubber bushing is not mistaken for the stainless steel guide pin.

Condition of the Wear Indicator After Use in Revenue Service

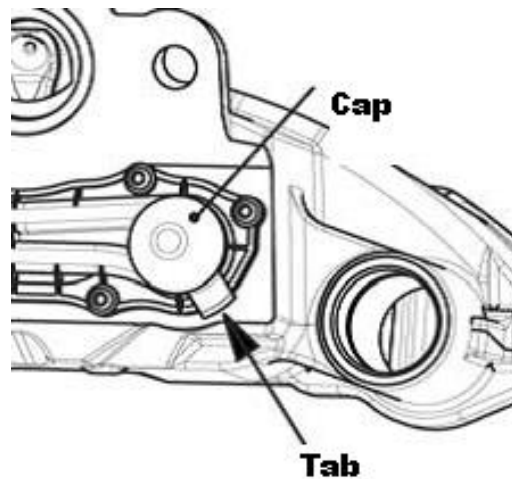
FIGURE 12
Adjuster Protective Cap and Tab

- Inspect caliper for heavy rust and damage, which may indicate a non-working or overheated brake.
- Inspect condition of adjuster protective cap (**Figure 12**).

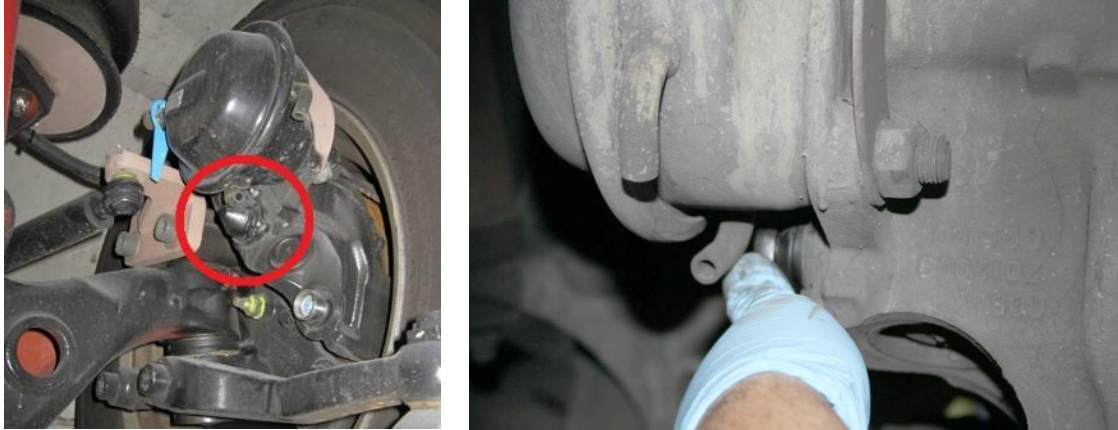
FIGURE 13
Brake Adjuster Inspection Locations

The brake adjuster is located on the inboard side of the caliper. It will be above the wear indicator, behind the brake chamber (see [Figure 13](#)).

To inspect the adjuster operation, remove the adjuster cap using the tab and install the shear adapter. Do not attempt to turn the splines without the adapter. Use a 10 mm box end wrench or ratchet/socket to turn the shear adapter counterclockwise (one half-turn). Make a few moderate brake applications (at about 30 psi). Wrench/socket should turn clockwise in small increments. Listen for the clicks as the mechanism increases running clearance.

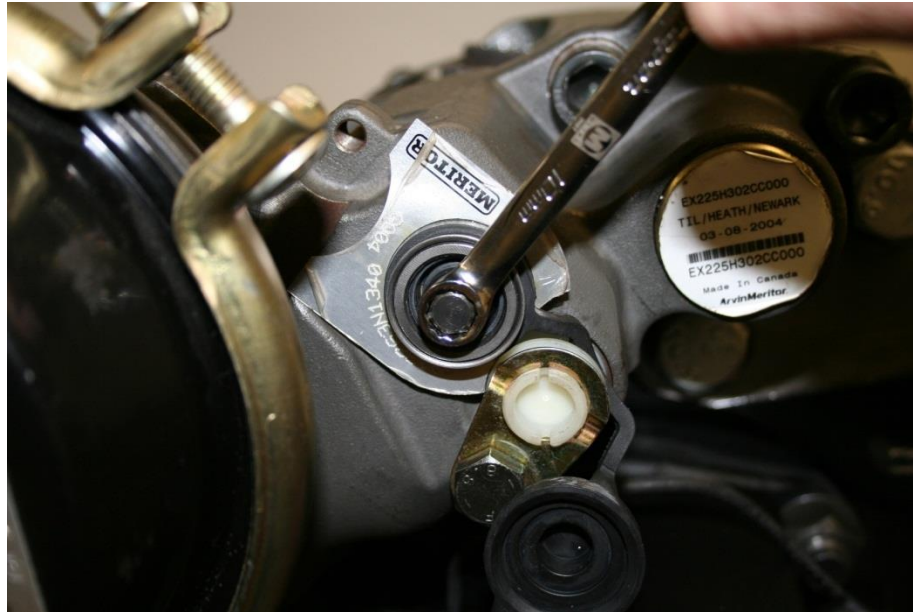
FIGURE 15
Meritor Brake Adjuster Setting

Using a 10 mm wrench, rotate the adjuster stem counterclockwise until you feel the adjuster stem stop (**Figure 15**). De-adjustment requires more force than adjustment. Do not exceed 30 ft-lbs (41 Nm) in either direction.

If the manual adjuster does not rotate in either direction, then replace the caliper assembly.

Make sure the wrench is positioned so that it can move clockwise without obstruction. Apply brakes with about 30 psi air pressure five to 10 times. The wrench should turn a small amount clockwise with each brake application, with the amount of movement diminishing with subsequent brake applications. If the wrench does not turn, turns only on first application, or turns forward and backward with every application, then the adjuster has failed and the caliper must be replaced.

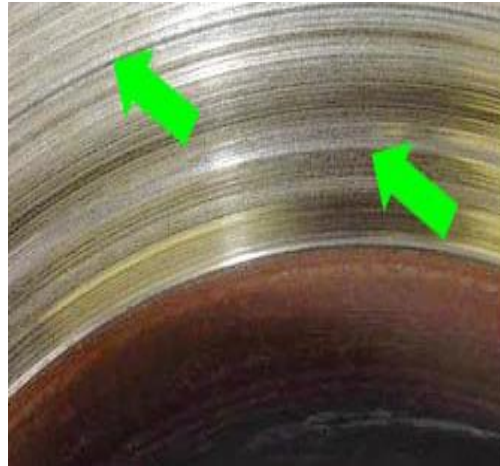
FIGURE 19
Brake Rotor Grooves

Brake rotor with grooves

- Inspect the swept area of the rotor for defects and damage. Only the inner side of the rotor can be visually inspected fully with wheels on (although some areas of the outer side of the rotor may be visible through the wheel hand-holes), so extra care should be exercised to check as much of the rotor as possible.
- Brake rotors should be checked for contamination from the following:
 - lubricant residue due to leaking axle seals
 - road debris and contaminants
 - surface rust indicating inoperative brake
- Check surface of rotors for large cracks, grooves, scoring or hot spots. See **Figure 17**, **Figure 18**, **Figure 19** and **Figure 20**.

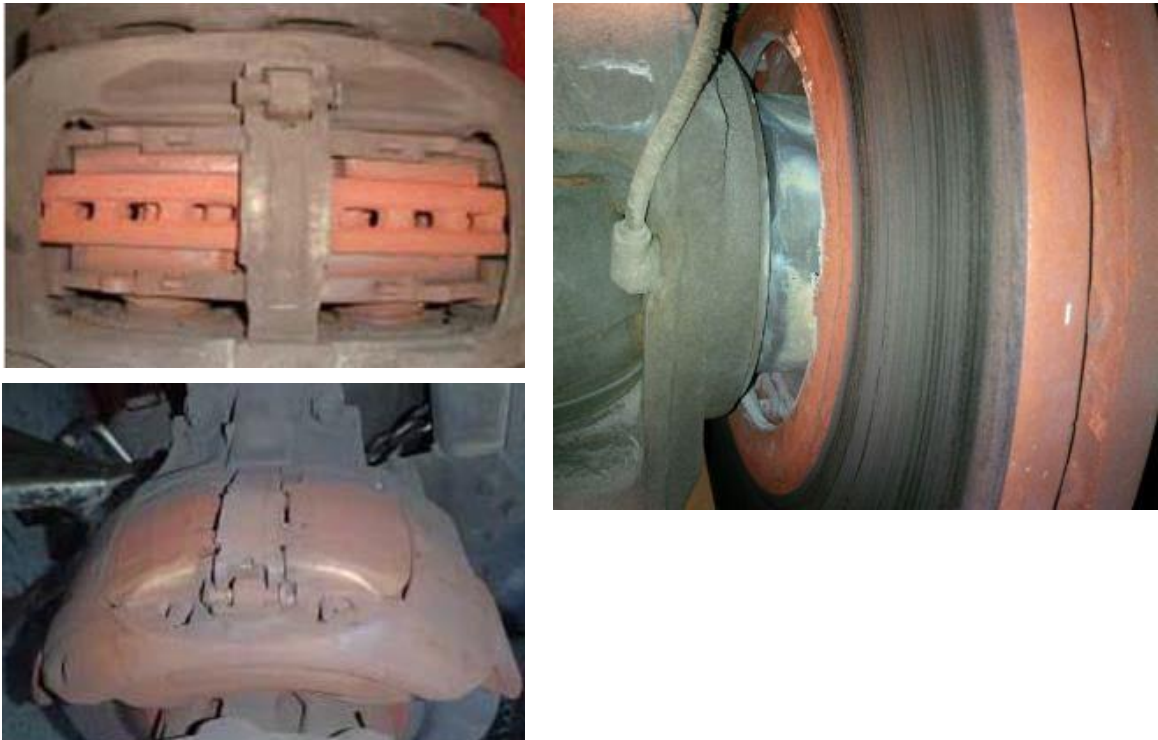
FIGURE 20
Brake Overheating

Bright-red coloration indicating brake overheating condition

Blue bands or marks on the rotor surface indicate that the rotor was very hot. Also, bright-red coloration of rotor edges and nearby caliper castings indicate that overheating conditions have occurred (see **Figure 20**). Determine the root cause of the overheating condition. Identify and repair the cause of the overheating condition, and then replace the rotors and pads.

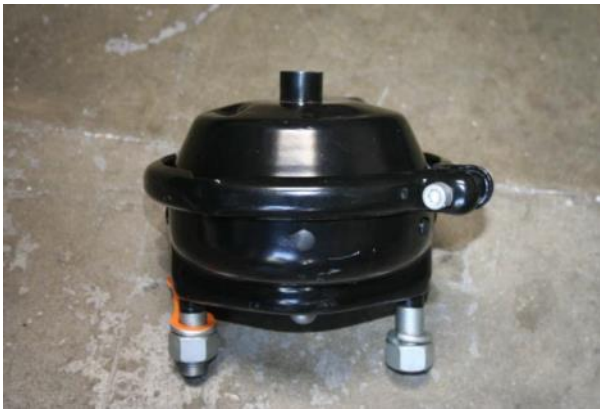
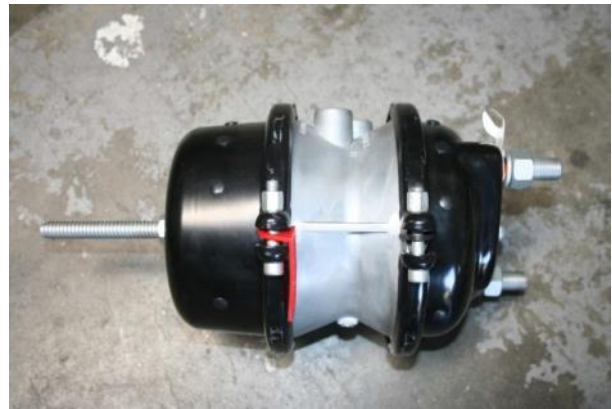
FIGURE 21
Brake Chambers

With the brake system at governor full cut-out pressure, release the parking brake (when applicable) and then apply the service brakes and listen for any air leaks. Any leaks mean the vehicle should be taken out of service until repairs are made. Chambers (**Figure 21**) must:

- be the same size on the same axle;
- contain cage tool and sealing plug (if applicable; some chambers have integrated caging bolts);
- display no evidence of contact with wheel, body, suspension or frame;
- have chamber mounting hardware and clamp band hardware (if present) in place and tight; and
- be free of dents and corrosion.

Front service brake chamber

Rear spring brake chamber
