# **TRUSS GUSSET PLATES**

Wahid Albert, PE NYSDOT Office of Structures October 2008

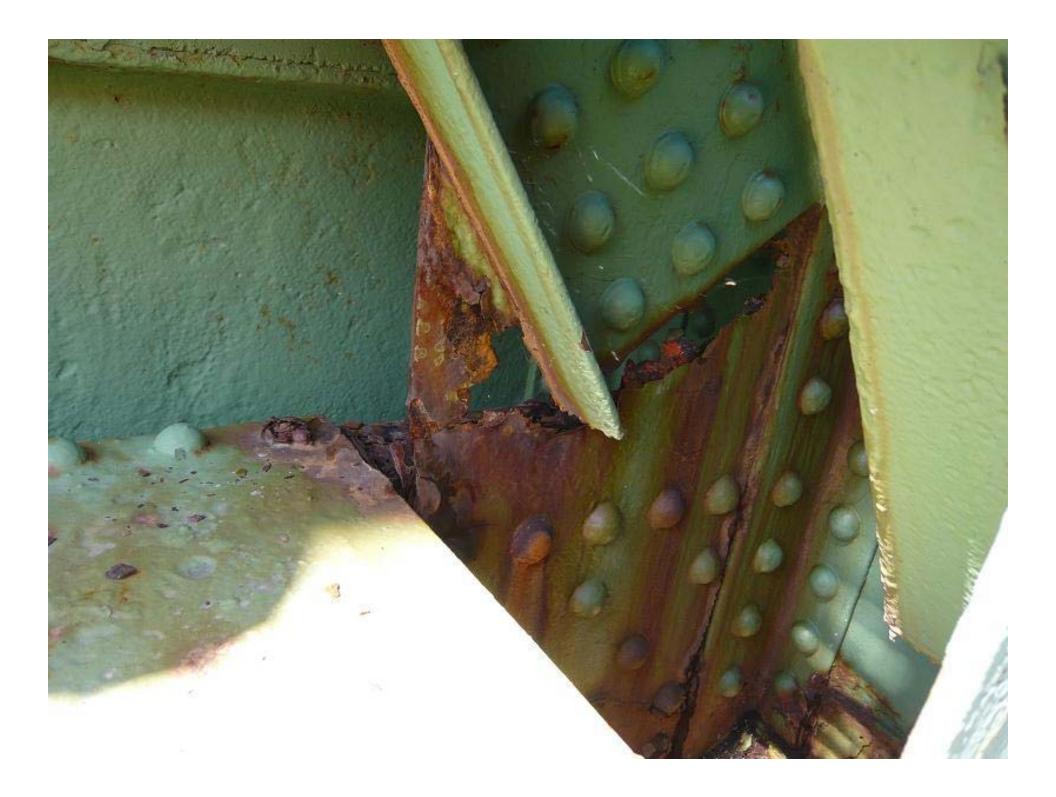
#### ROUTE 23 OVER SCHOHARIE CREEK

#### **REPAIR EXAMPLE**
