# Wood and Timber Condition Assessment Manual Second Edition

General Technical Report  
FPL-GTR-234

# **Wood and Timber Condition Assessment Manual**

## **Second Edition**

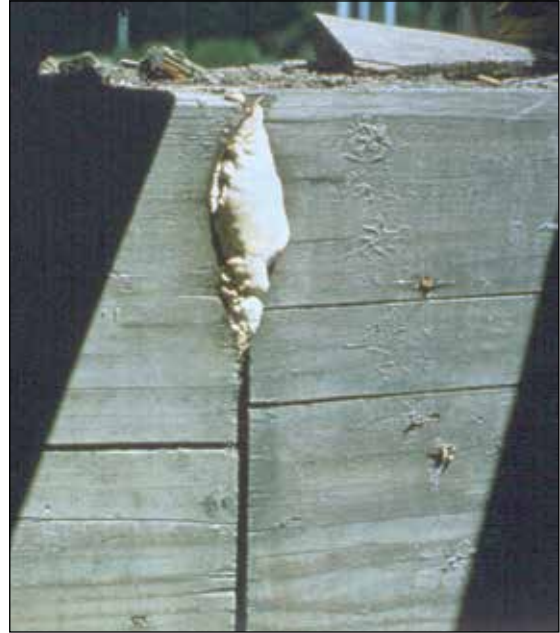
Figure 1.1—Fruiting body between two beams.

Figures 1.1 and 1.2 show fruiting bodies that were observed during inspection of Washington State University’s football stadium. Figure 1.2 shows the extent of deterioration inside the beam. Note that in Figure 1.1, the fruiting body is located where two timber beams (placed end-to-end) rest on a column. Exposed end grain allows for moisture accumulation and subsequent absorption by the timbers. Figure 1.3 illustrates the potential extent of deterioration in both beams.

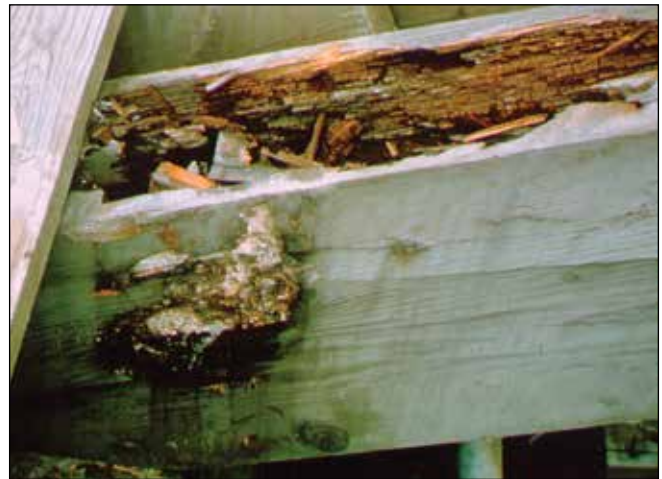
Figure 1.2—Fruiting bodies can indicate extensive damage inside the beam.

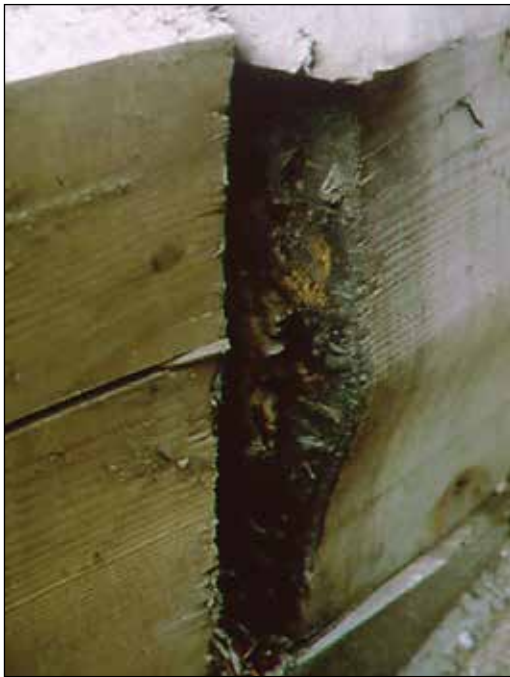
Figure 1.4—The timber beam's outer shell buckled as a result of interior deterioration.

Figure 1.4 shows a timber beam that failed in bearing (compression perpendicular to grain). Such collapse indicates that the inner portion of the timber is severely deteriorated. Figure 1.5 illustrates that when the inner portion of the timber is severely deteriorated, the outer shell can collapse when the timber is stressed in bearing.

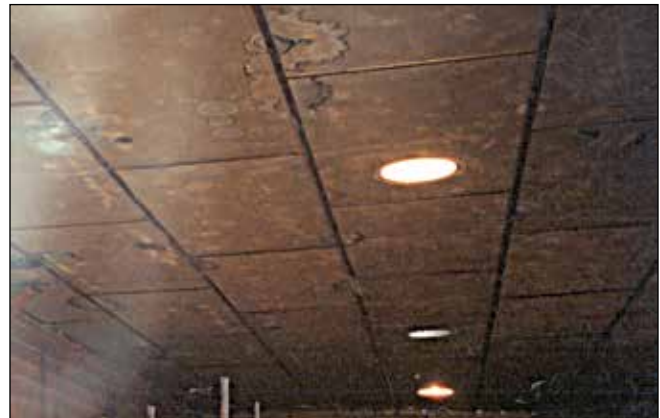
Figure 1.6—The ceiling panels were stained and discolored.

Inspection of the Red Cliff Recreation Hall near Bayfield, Wisconsin, revealed severe staining and discoloration of the fiberboard product used in the ceiling (Figs. 1.6 and 1.7). Discoloration and mold indicated that the structure had been exposed to moisture and the wood could possibly be deteriorated. Removal of several ceiling panels revealed that the fiberglass insulation above them was saturated with water (Fig. 1.8). This moisture provided an ideal environment for the growth of mold and decay fungi. As a consequence of

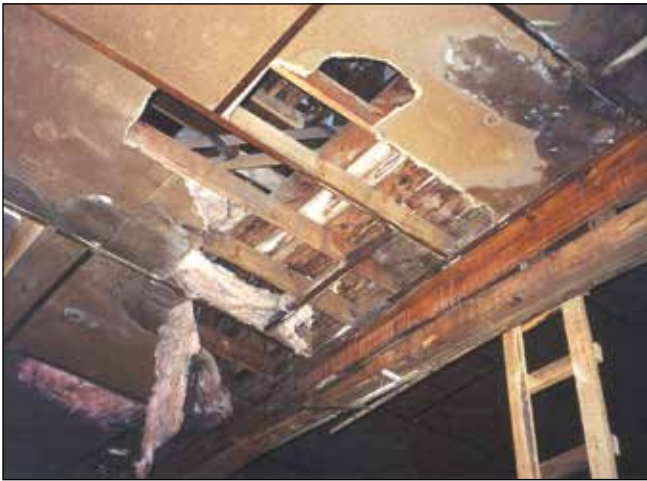
**Figure 1.8**—Removing the ceiling panels revealed that the fiberglass insulation was saturated with water.

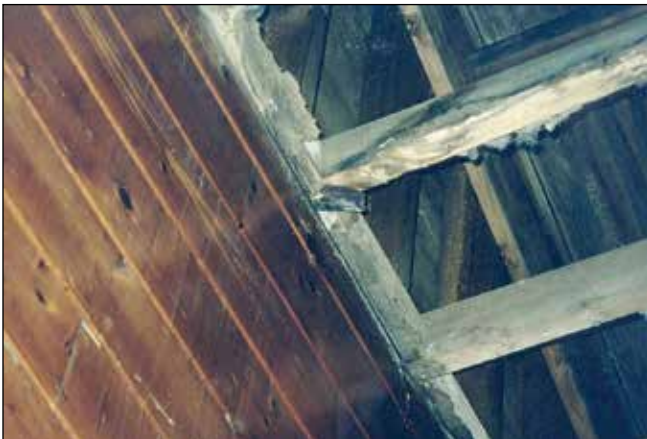
**Figure 1.9**—As a consequence of the moisture exposure, wood members in the roof and walls also contained areas of deterioration.

this moisture exposure, wood members in the roof and walls also contained areas of deterioration (Fig. 1.9).

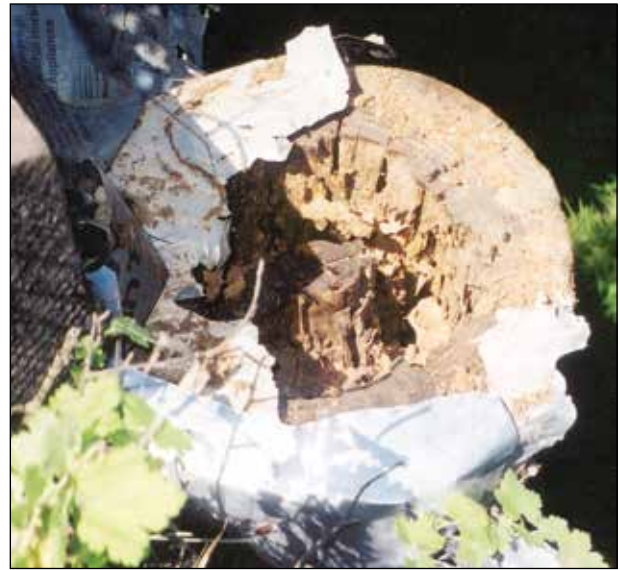
**Figure 1.10**—Damage to a bridge piling.

Figure 1.10 is a piling from a bridge. Initially deteriorated by decay, carpenter ants were attracted to the softened wood and continued to destroy the piling. Once the flashing was removed, the severe deterioration could be readily observed.

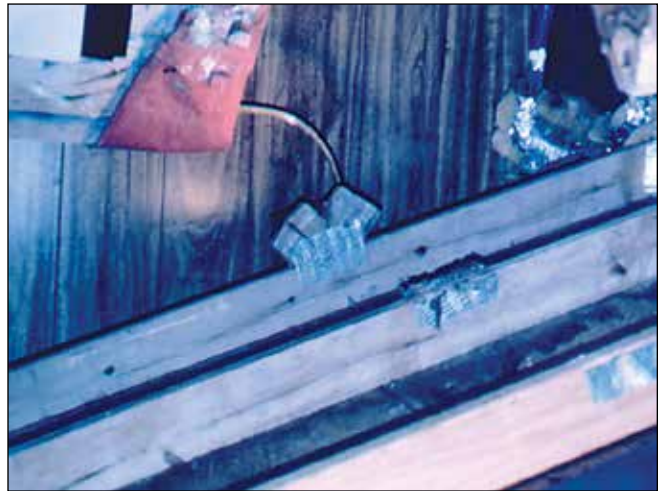
**Figure 1.11**—Metal plate connectors were cut and bent so that the webs could be removed. This should never be done.

Frequently, it is observed that entire structural members have been removed. Figures 1.11 and 1.12 show an in-service wood truss that had its webs removed by the homeowner with the intent of creating living space in the attic.

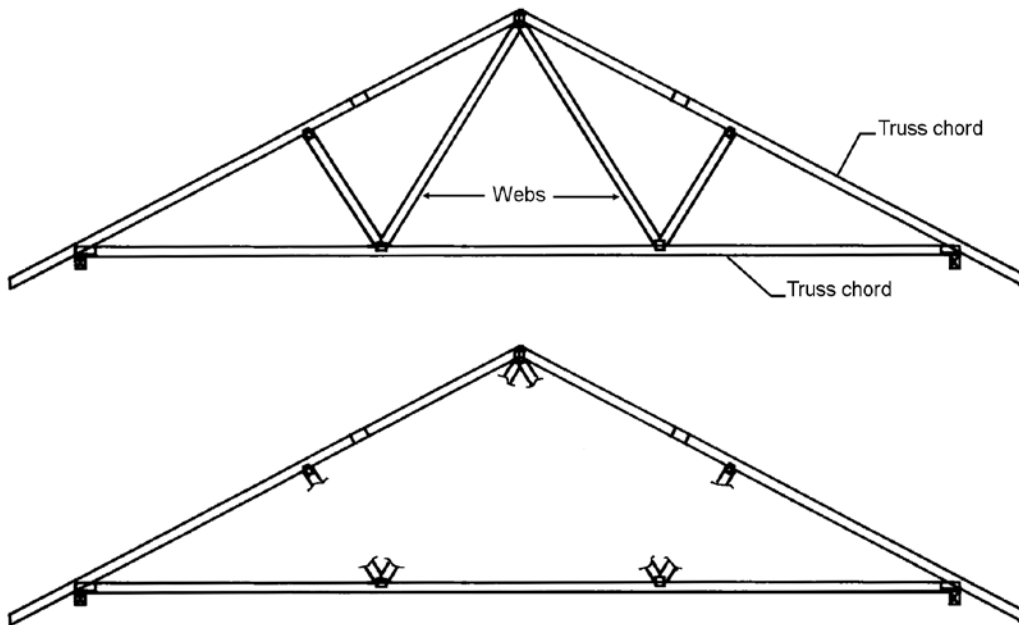
**Figure 1.12**—The homeowner removed the webs from the truss leaving only the chords to support the roof. This should never be done.

This should *never* be done and *must* be noted in any inspection report. Any change to web or chord members *must* be reported.

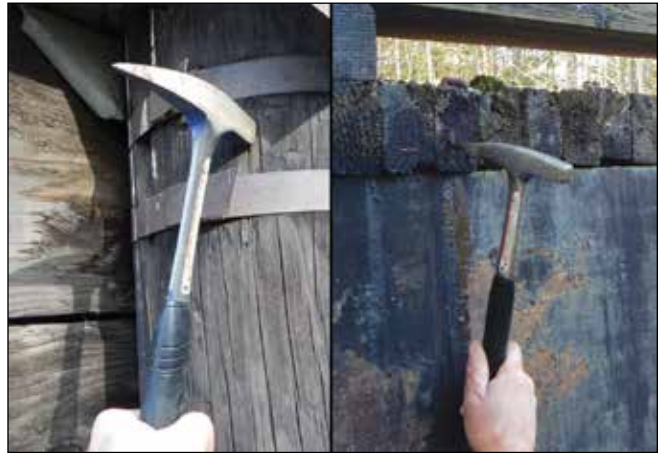
Figure 2.1—A hammer pick is an effective tool for initial assessments of timber bridge elements.

One of the most commonly used techniques for detecting deterioration is to hit the surface of a member with a hammer or other object. Based on the sound quality or surface condition, an inspector can identify areas of concern for further investigation using advanced tools like a stress wave timer or resistance microdrill. Deteriorated areas typically have a hollow or dull sound that may indicate internal decay. A pick hammer commonly used by geologists is recommended for use in timber structures because it allows inspectors to combine the use of sound and the pick end to probe the element (Fig. 2.1).

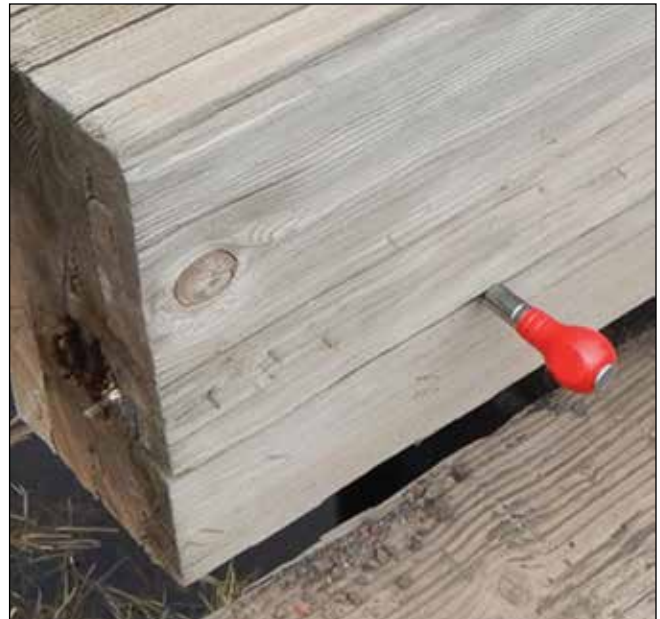
Figure 2.2—An awl is used to assess depth and presence of decay in a horizontal split.

Probing with a moderately pointed tool, such as an awl or knife, locates decay near the wood surface as indicated by excessive softness or a lack of resistance to probe penetration and the breakage pattern of the splinters. A brash, or brittle break indicates decayed wood, whereas a splintered break indicates sound wood. Although probing is a simple inspection method, experience is required to interpret results. Care must be taken to differentiate between decay and water-softened wood, which may be sound but somewhat softer than dry wood. Assessing damage in soft-textured woods, such as western redcedar, is sometimes difficult. Figure 2.2 shows an awl probe inserted into a split to assess decay that is visible on the railing end.

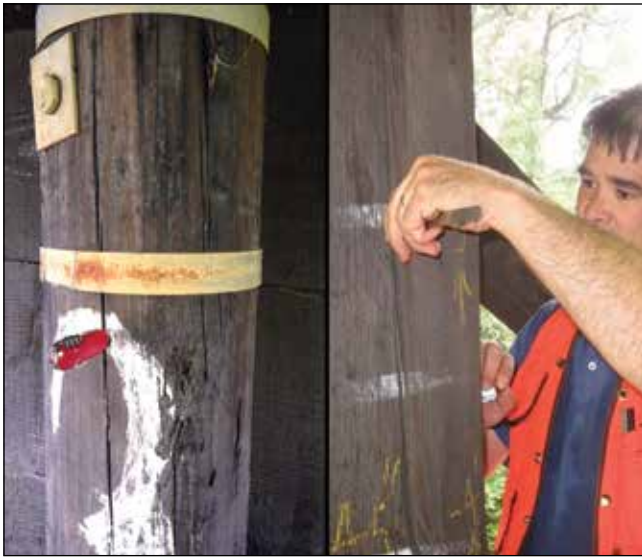
**Figure 2.3—Probes are used to assess depth of cracks, checks, and through splits in timber bridge elements.**

Probes can also be used to assess the depth of splits and checks in timber members. Flat bladed probes, such as pocket knives or feeler gauges, are recommended for use in this process. This is also important to understanding the effect of checks and cracks in other advanced techniques such as stress wave inspection. Figure 2.3 shows the use of probes to assess the depth of checks and cracks in timber bridge elements.

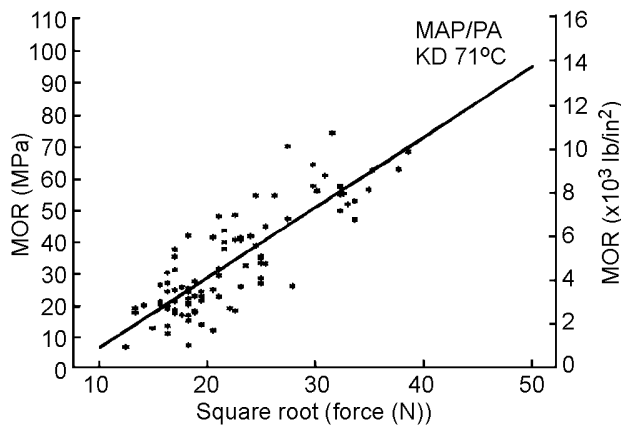
**Figure 2.5—Relationship of screw-withdrawal force to bending strength for 12-mm- (1/2-in.-) thick plywood. MAP, mono-ammonium phosphate; PA, phosphoric acid; KD, dry-kiln drying temperature; and MOR, modulus of rupture.**

A modification to Talbot's technique was developed for use in evaluating in-service strength of fire-retardant-treated (FRT) plywood in the early 1990s. A portable screw withdrawal system was utilized to inspect FRT plywood and identify substantial degrade. An extensive research effort was devoted to the use of Talbot's test for assessing residual strength of in-service panel products treated with fire retardant. Winandy et al. (1998) designed and conducted tests on a large sample of plywood specimens that were treated with fire-retardant chemicals and subsequently exposed to elevated temperatures. Screw withdrawal loads were determined for each specimen prior to static bending tests. Correlative relationships were then established between screw withdrawal strength and static bending properties (Fig. 2.5).

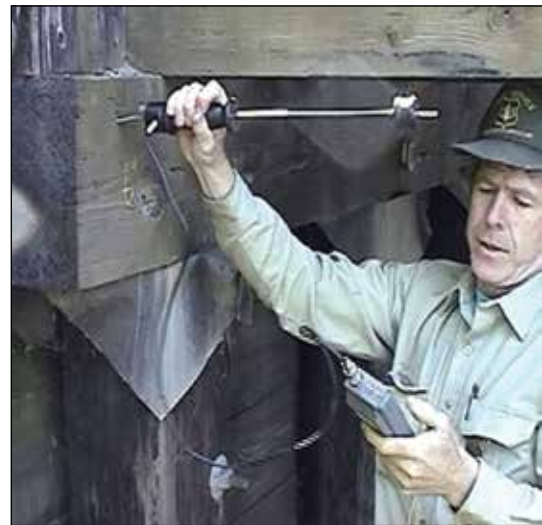
**Figure 2.7—A pin-style moisture meter is used to determine moisture content of timber elements.**

(75 mm) long) to assess moisture content of timber abutment caps. Pin-style moisture meters measure electrical resistance between two metal pins that are driven into the member and use this measurement to determine moisture content.

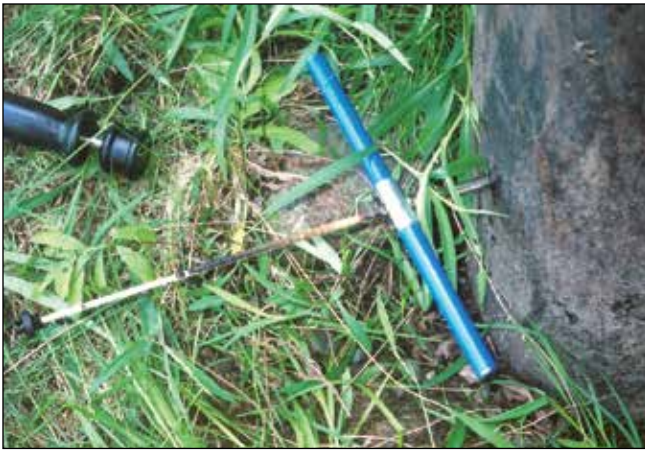
**Figure 2.8—An increment core can be used to conduct inspections of timber bridge elements. This image shows an extracted core from an in-service timber pile ready for examination.**

Coring with an increment borer (often used for determining the age of a tree) also provides information on the presence of decay pockets and other voids. The resultant solid wood core can be carefully examined for evidence of decay. In addition, the core can be used to obtain an accurate measure of the depth of preservative penetration and retention. Figure 2.8 shows an increment core tool and the extracted core. The core can also be used to determine the wood spe-

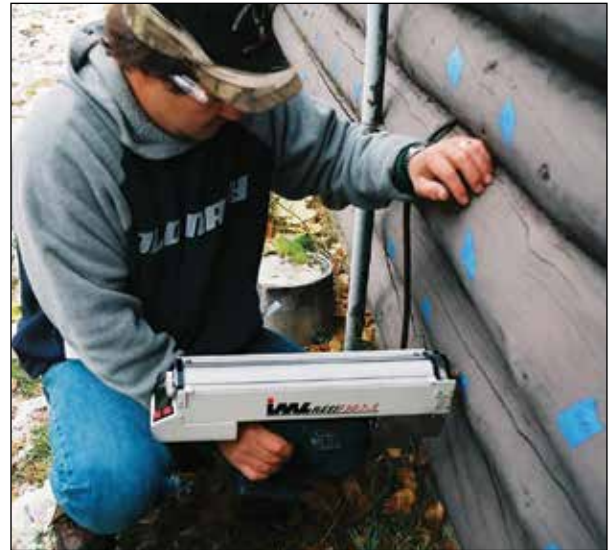
**Figure 2.9—A resistance microdrill used for inspection of a historic Civilian Conservation Corps log cabin.**

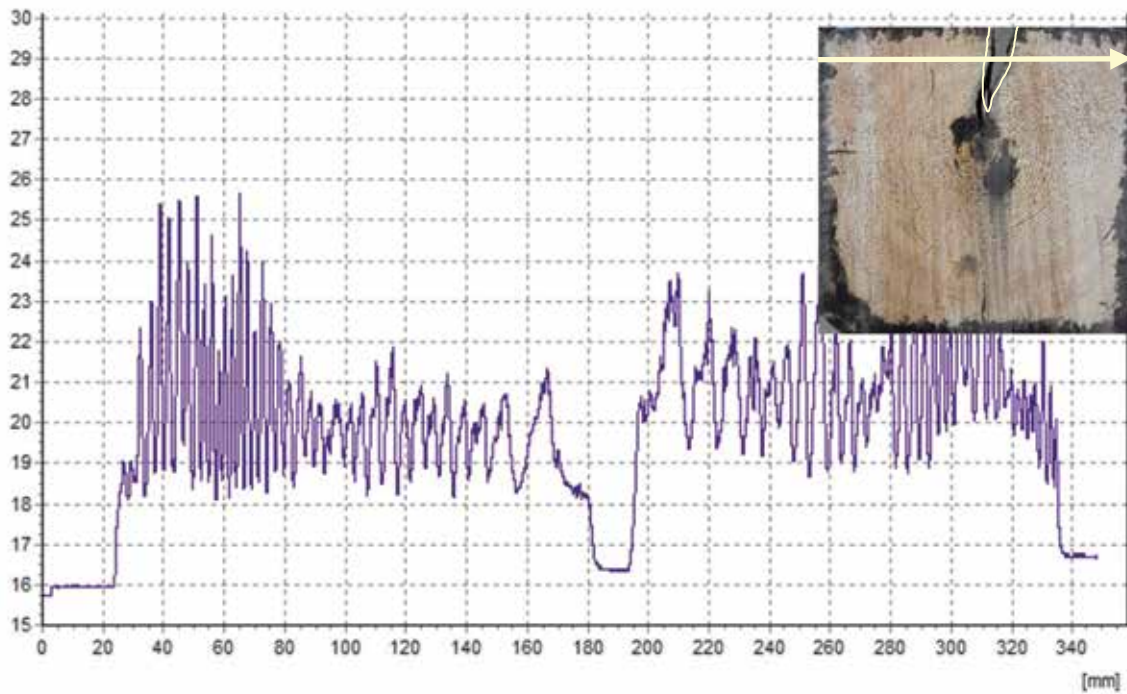
Figure 2.16—Electronic resistance chart of a Douglas-fir pile cap showing a large crack between 180 and 200 mm along the drilling path.

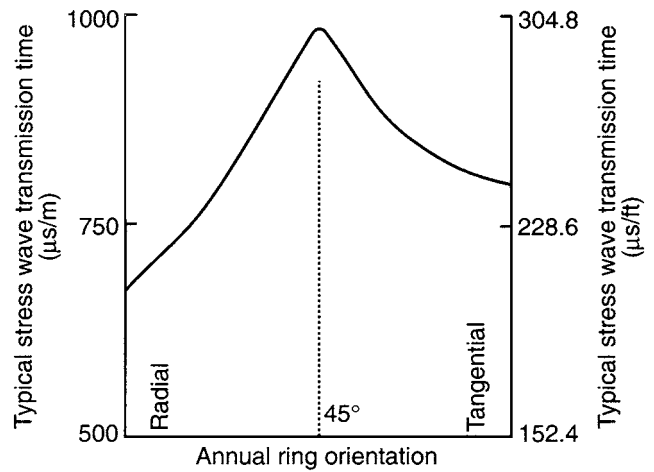
Figure 3.4—Transverse stress wave transmission time compared with annual ring orientation.

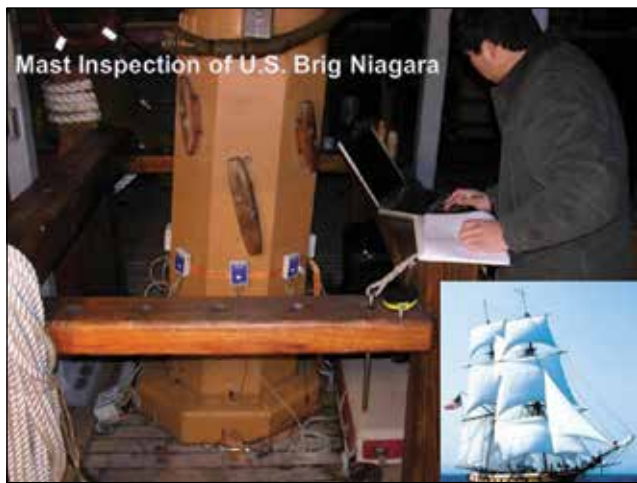
**Figure 4.5—Inspection of the masts of the U.S. Brig Niagara using acoustic tomography.**

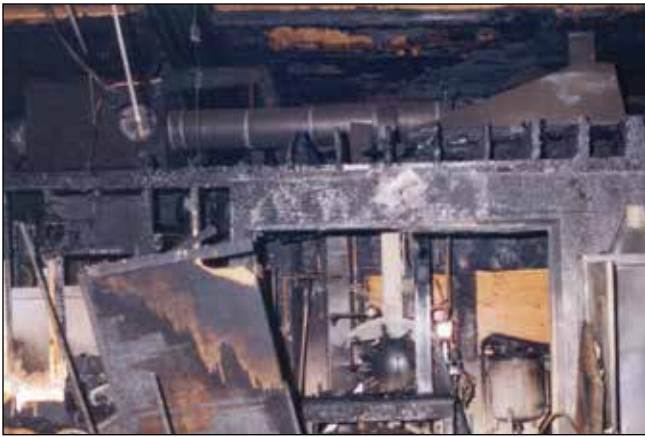
**Figure 5.3—Area of fire origin in Building 2 fire at the Forest Products Laboratory.**

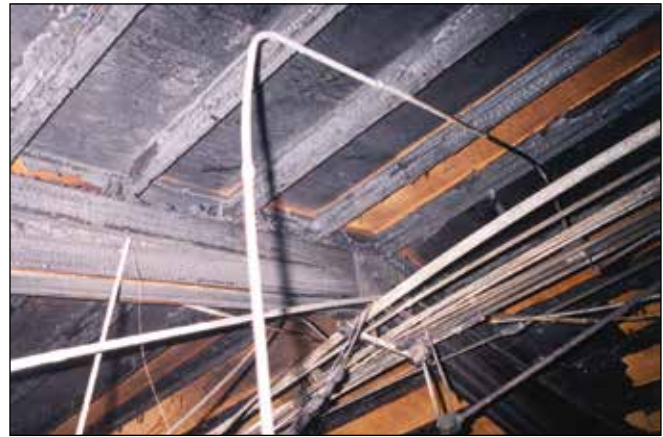
**Figure 5.4—Charred and uncharred wood members in the Building 2 fire at the Forest Products Laboratory.**

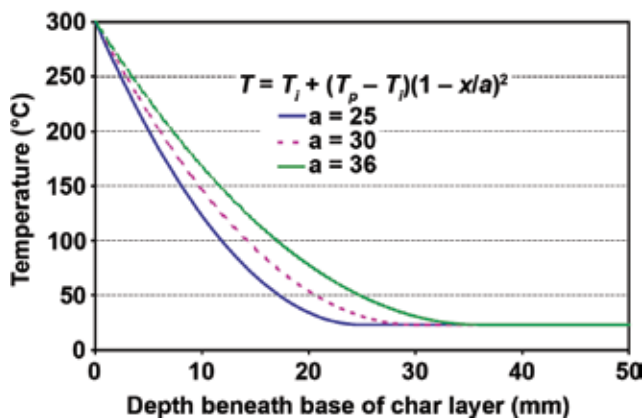
Figure 5.6—Temperature profile beneath the base of the char layer of a semi-infinite wood slab directly exposed to the ASTM E 119 standard fire exposure.

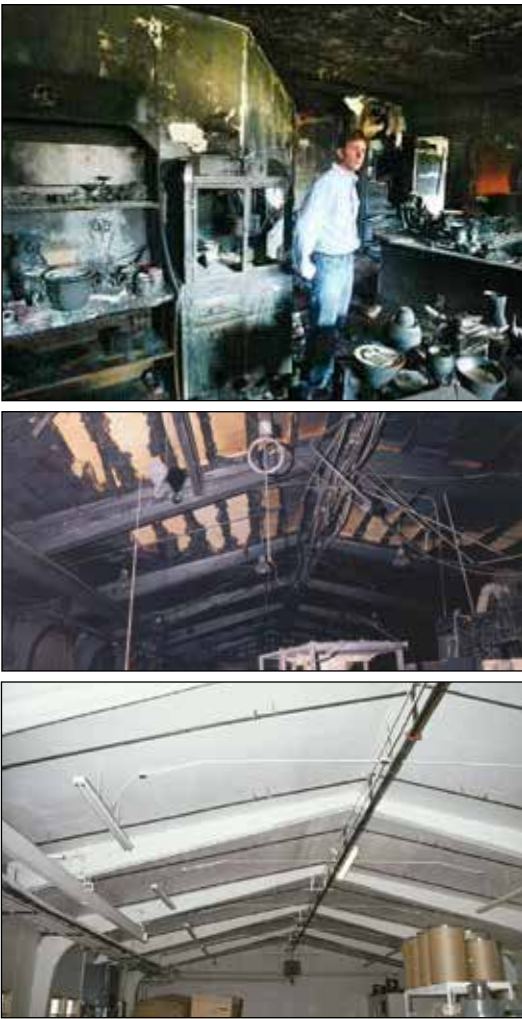
**Figure 5.10—Post-fire inspection (top) of residence; post-fire (middle) and post-repair (bottom) of Building 2 at the Forest Products Laboratory. Top photo courtesy Montana Standard; [www.mtstandard.com](http://www.mtstandard.com).**

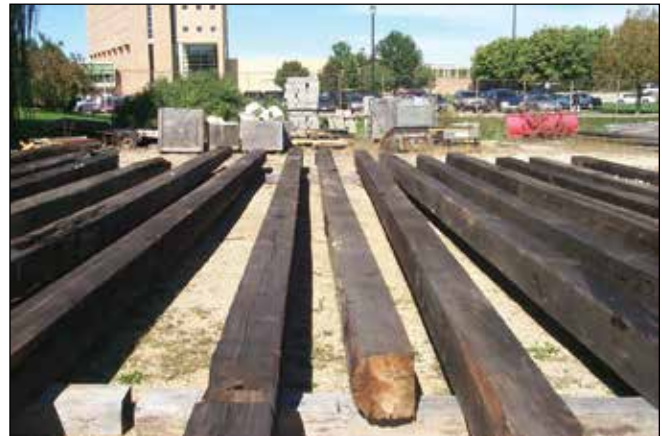
Figure 7.1—Fifteen 12- by 12-in. white pine timbers removed from the Quincy Mine Blacksmith Shop.

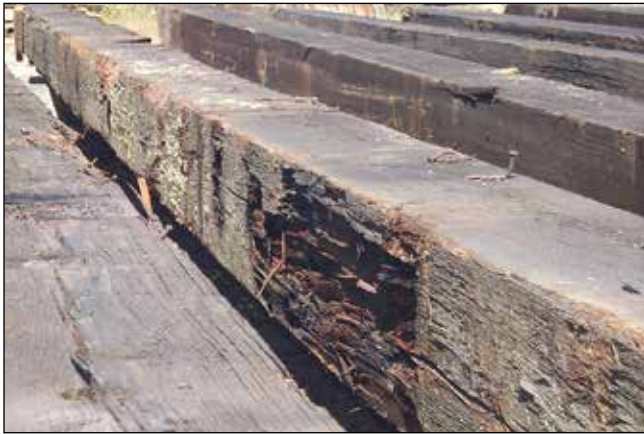
Surface decay

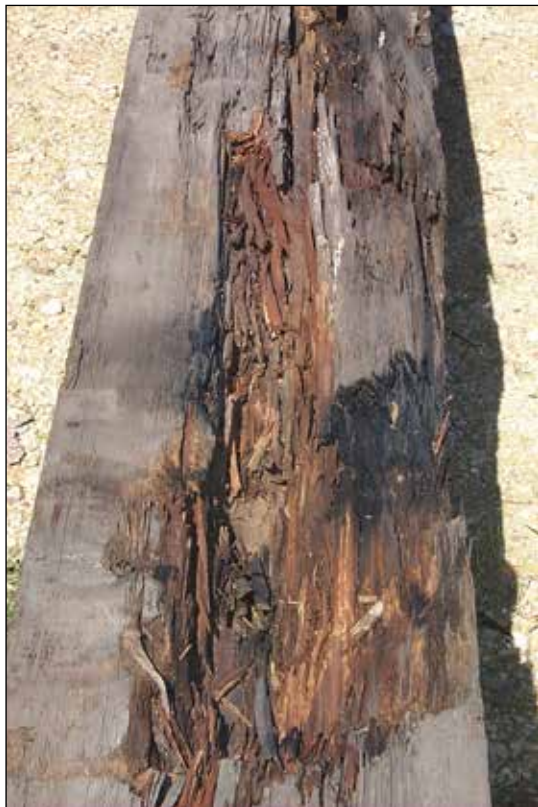
Severe decay damage

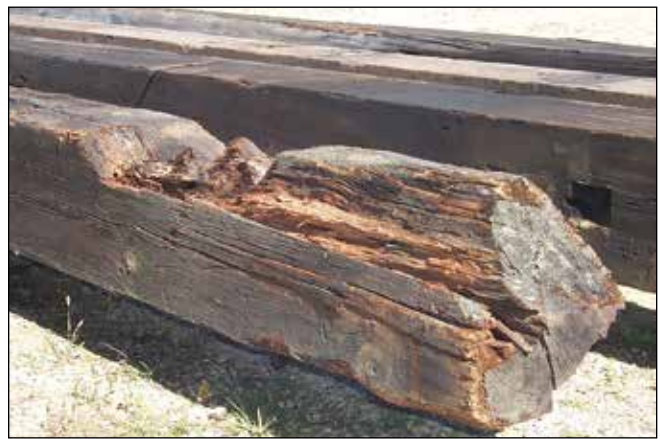
End decay

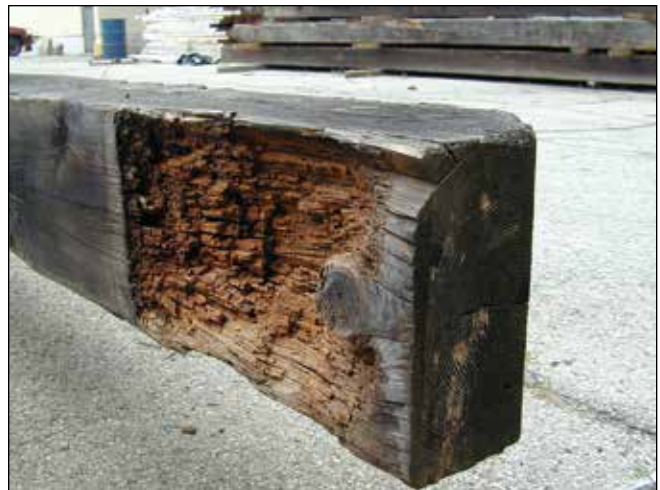
End decay

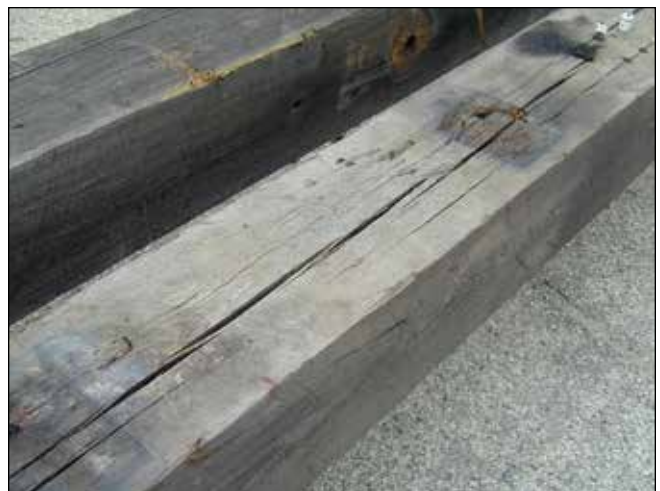
Large, deep check

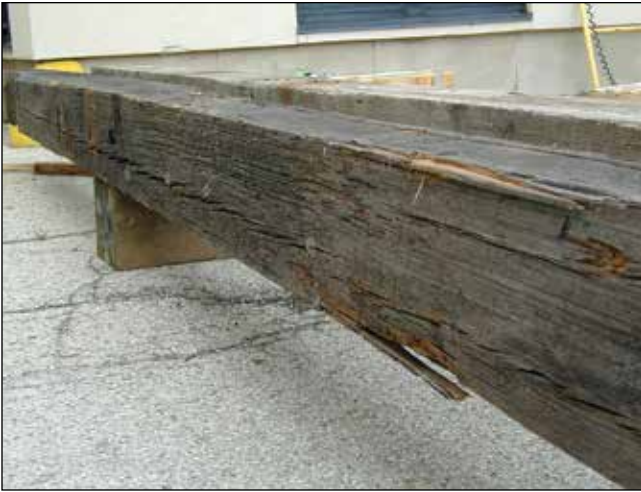
**Surface decay and multiple cracks**

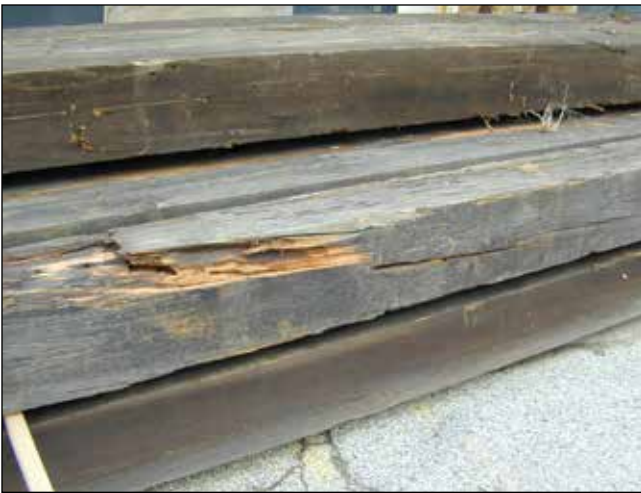
**Mechanical damage**
