## **Verification of Pervious Concrete Drainage Characteristics using Instrumentation**

Vimy Henderson, Ph.D., Golder Associates Ltd.  
Susan L. Tighe, Ph.D., P.Eng., University of Waterloo

Paper prepared for presentation at the Innovation in the Use of Instrumentation in Transportation Infrastructure Design and Construction Session of the 2013 Conference of the Transportation Association of Canada  
Winnipeg, Manitoba

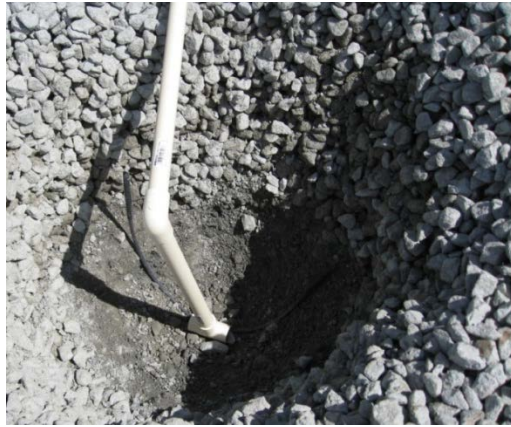
Figure 4: Temperature Probes Being Installed

Temperature probes, model 109B, supplied by Campbell Scientific, were included in the subgrade of the field site. The inclusion of this instrumentation was a necessity in order to interpret data recorded by the moisture gauges. Figure 4 shows a temperature probe during installation at the construction of the field site.

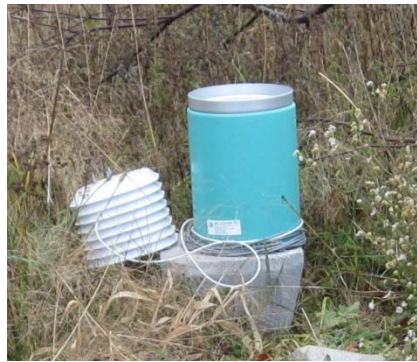
Figure 5: Weather Station at a Field Site

The field site included a weather station that recorded air temperature and the quantity of rainfall. An example of a weather station is shown in Figure 4.

The weather stations included a PVC tipping bucket rain gauge and a HOBO Pendant Event and Temperature Logger. The logger records rain events in the tipping bucket as well as temperature readings of the air. The temperature readings are taken from within the white housing shown in Figure 4, which is a solar radiation shield. The weather stations provide information regarding the weather activities occurring at each field site. It was intended that the data collected from the weather station would be used to compliment and better understand other data, such as instrumentation data collected in this project.
