Building Science Corporation

Water Management Details

Housewraps/Flashings/Windows

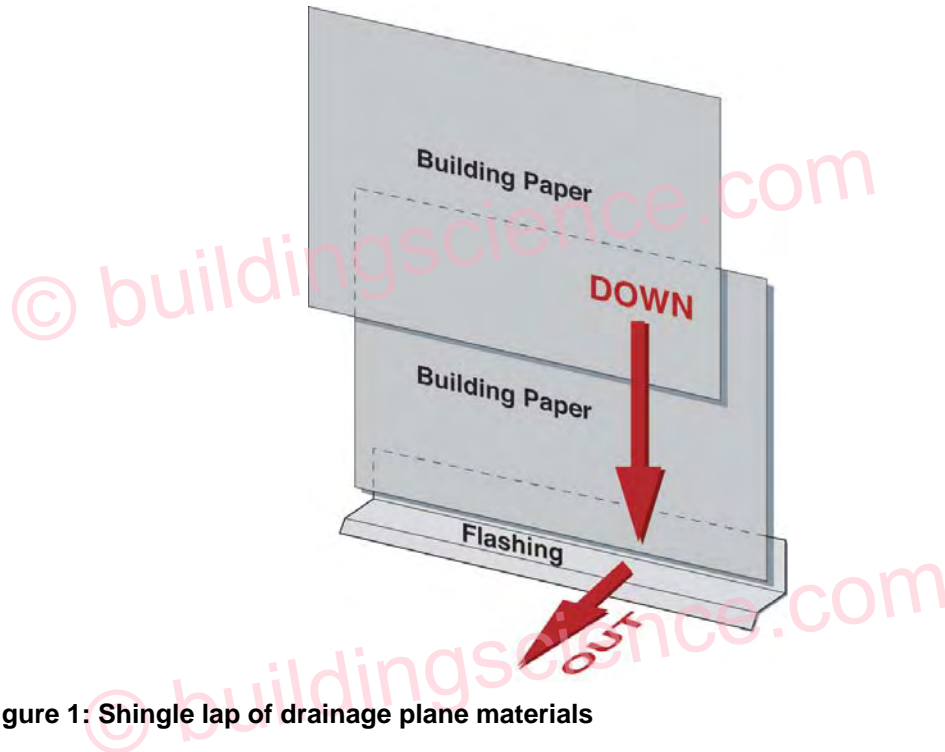
Figure 1: Shingle lap of drainage plane materials

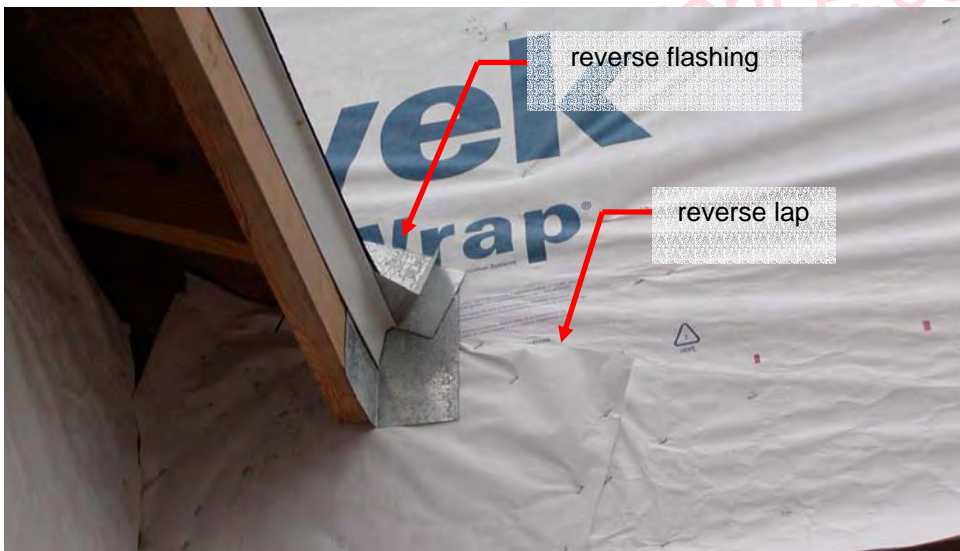
Figure 2: Improper installation of drainage plane materials

This occurs due to improper sequencing of the construction, or though the difficulty in installing the products at areas of more complicated geometry. Often at these locations the shingle installation ideal is exchanged for coverage (As long as we get the housewrap everywhere it should be fine, right? Wrong.). When roof overhangs, or other kick outs in construction occur, the installation of the house wrap must be considered carefully to ensure that a reverse flashing is not created. While taping the joints of housewraps can reduce the risk of water entry, it is no substitute for proper shingle lapping of the product.

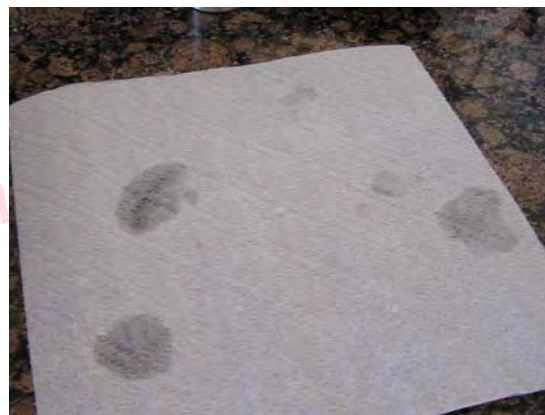
Figure 4: Failed water drop test of a housewrap

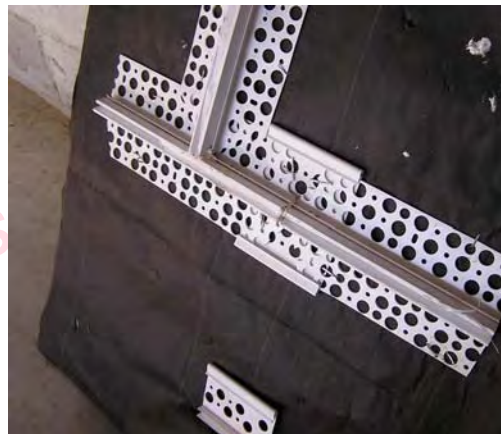
Figure 7: Control joint over top of building paper (not recommended)

Other drainage plane concerns with stucco can be created when there is a change in the back up wall construction. In Florida it is common for the main floor of the house construction to be concrete block while the top floor is wood frame. Stucco is commonly installed directly onto the concrete block with no building paper installed behind the stucco. This barrier cladding approach can be used successfully due to the capacity of concrete block to absorb water and dry out under more favorable conditions. The problem occurs at the transition between the drained and barrier cladding approach. Standard stucco installation practices have created a reverse flashing at this location. The stucco control joint is traditionally installed over top of the building paper. This directs the water towards the interior at the top of the masonry block.

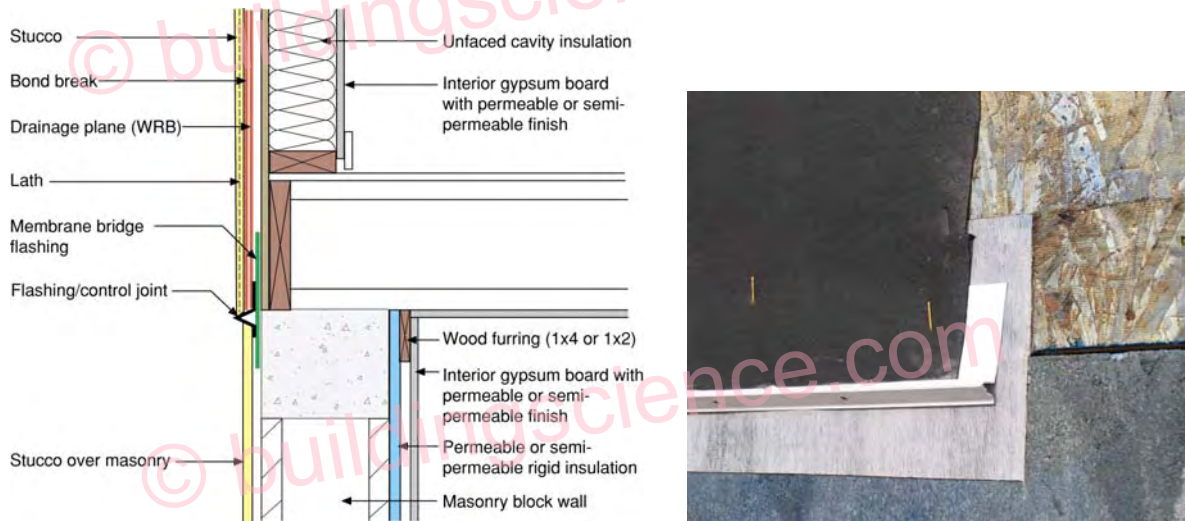
Figure 8: Weep screed used as a control joint with building paper shingle lapped over top of the flange

This problem can be corrected by using a weep screed for the control joint and ensuring that the building paper drainage plane is installed in a shingle lap fashion over the screed. In addition, the transition joint should also be protected by a strip of waterproof self adhered membrane. The membrane flashing will prevent moisture that builds up at the base of the stucco just above the screed from being driven to interior at this location.

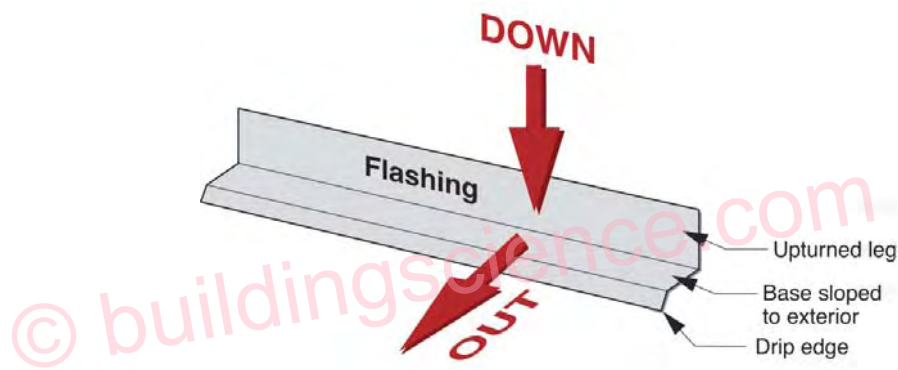
Figure 9: Basic flashing principles

Flashings should all be sloped in the direction of drainage. This may seem like a simple enough concept to incorporate into the design, however, surprisingly the most fundamental failure mechanism for a flashing installation is through installing the flashing with a reverse slope. With reversed sloped flashings water is held by the flashing and drains to the side and off the ends of the flashing back into the assembly. This can also hold water up against claddings and other materials, potentially reducing the service life of the products. All flashings should be installed with a positive slope to drain to the exterior.

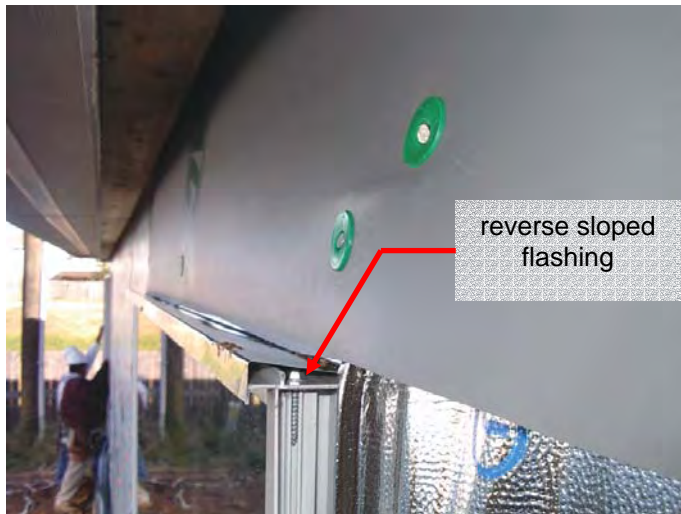
Figure 10: Reverse sloped flashing

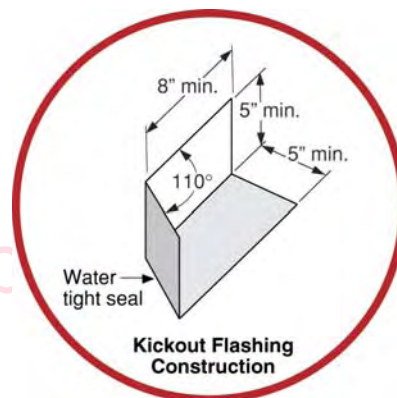
Figure 11: Kick out flashing conceptual design

Kick out flashings are used at the bottom edge of a roof to wall intersection, where the roof ends and the wall continues on. They are used to direct the water out from below the cladding at the step flashing plane and away from the wall. This prevents water from draining off the roof and into the wall system below. It also helps aesthetically, as it prevents unsightly stains on the wall cladding from roof drainage.

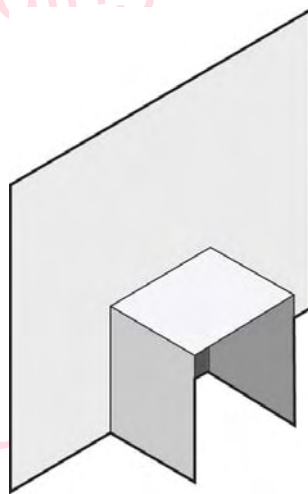
Figure 18: Saddle flashing conceptual design

Saddle flashings are used in locations where building elements penetrate through the cladding and are attached to the back up wall construction. This occurs at such places as balcony railings, porch framing attachments, retaining walls, and some mechanical penetrations.

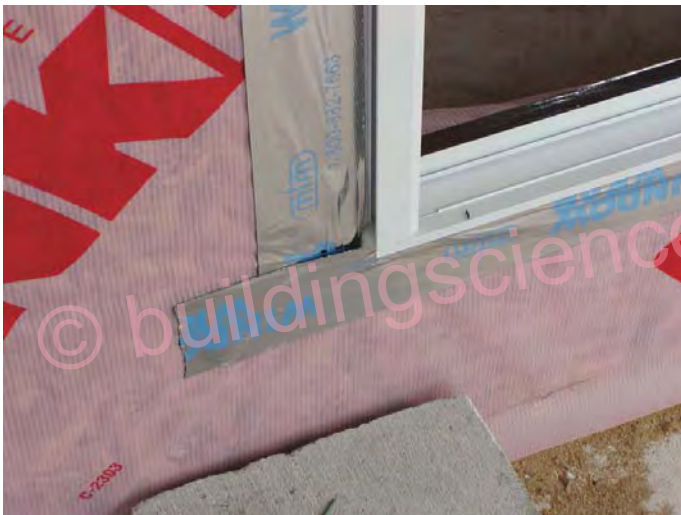
Figure 23: Reverse lap of self adhered membrane at window sill in a barrier installation

As long as the nailing flange is continuous and undamaged it can be effectively integrated into the moisture management of the wall assembly. Self adhered membranes are often used to integrate the nailing flange into the drainage plane of the water management system of the wall assembly. Self adhered membranes used to seal to the nailing flange must be installed, as with other water management concepts, in a shingle lap fashion to prevent reverse laps that can create paths for water intrusion. While this concept is generally understood, repetitive installations and requirements to complete the installations in a timely manner, has led to poor installations and problems with installation.

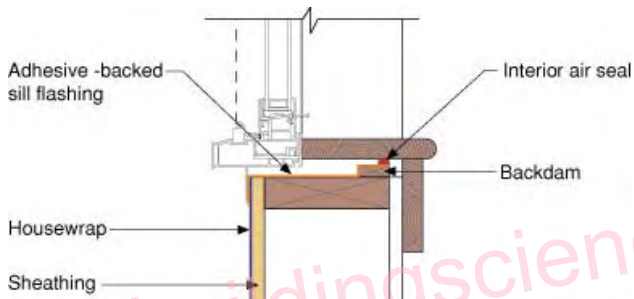
A strip of wood nailed at the back of the rough opening sill forms a dam to prevent water from draining into the interior

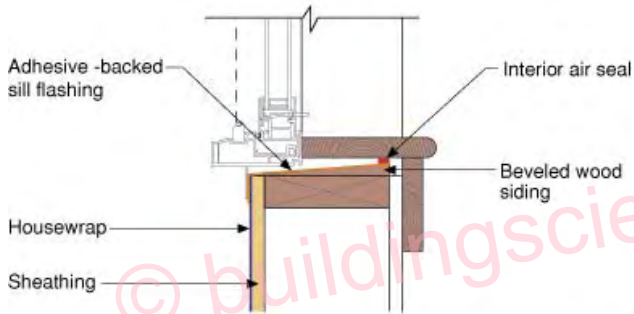
A piece of wood bevel siding nailed over the sill to create positive drainage toward the exterior is even better.

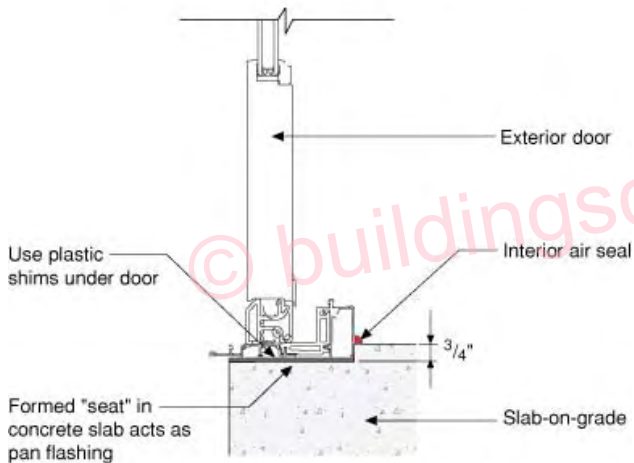
Figure 24: Sill and backdam options

Forming a depression in a cast-in-place floor slab creates a built-in drainage pan for mulled entry doors and sliders, which are prone to leakage at joints.

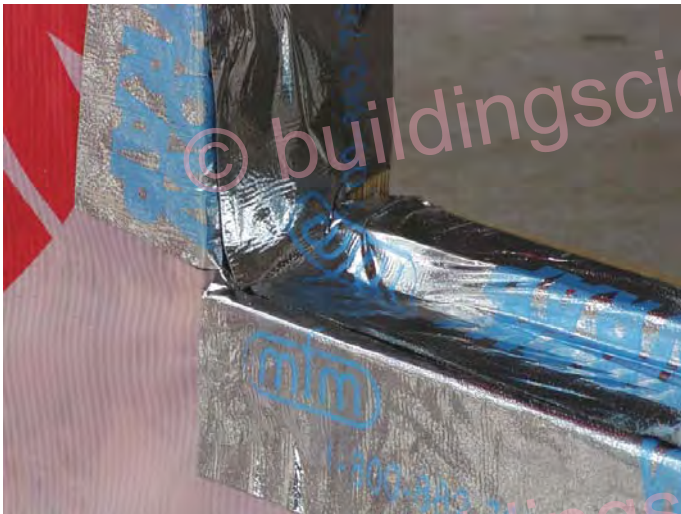
Figure 26: Tenting of the membrane pan flashing in the corner

Tenting of the membranes occurs when the membrane pieces are not seated properly into the corners of the sill rough opening. The result is a curved fillet, placing the flashing in tension with a void beneath. Because of this tearing of the membrane can occur during the installation of the pan flashing, or the sharp corners of the window frame can cut or damage the reinforcing of the membrane leading to failures in the integrity of the pan flashing.

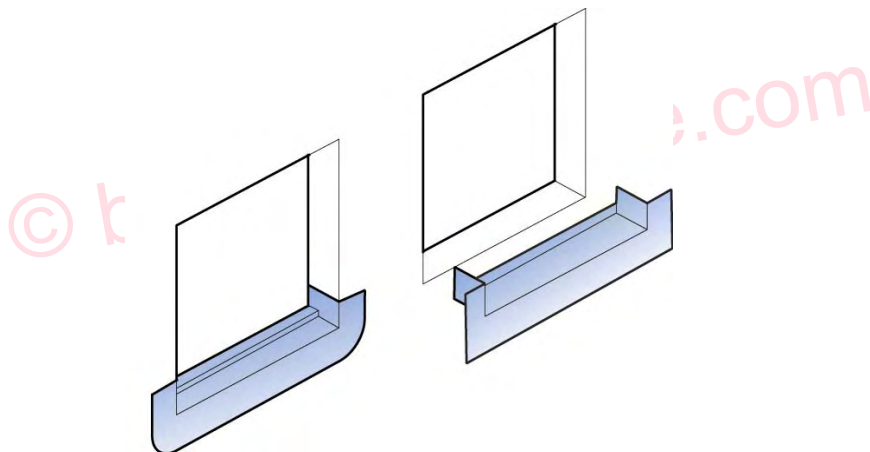
Figure 30: Moldable membrane and preformed plastic pan flashings

As a means to correct some of these concerns, other products available on the market such as moldable membrane flashings and preformed plastics can be used for the installation of the pan flashing. Moldable membrane flashings allow for a single piece of membrane to be installed at the corner of the sill as the membrane can stretch to fan out and curve around corners.

Preformed plastic pan flashings have also been developed to address this problem of time consuming and finicky work of creating pan flashings with membranes. The preformed plastic sections usually have integrated backdams as well. With these products the jambs and sill joint between the two pieces must still be sealed with membrane to prevent water intrusion below the pan flashing.

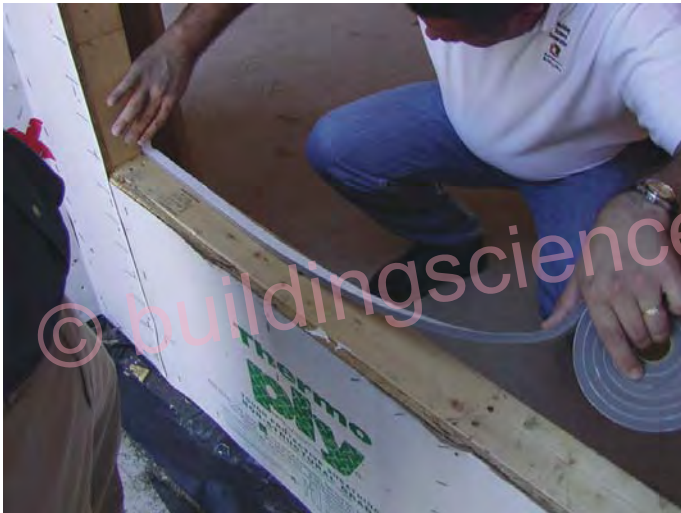
Figure 31: Weather seal gasket used as a backdam

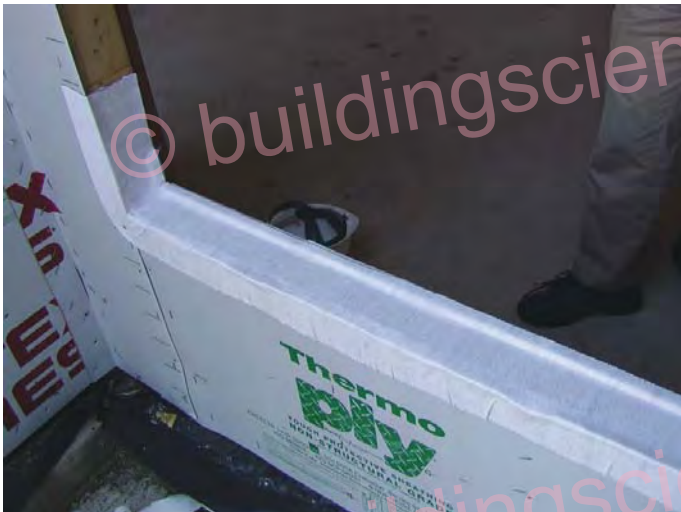
Figure 32: Single piece moldable membrane pan flashing with backdam

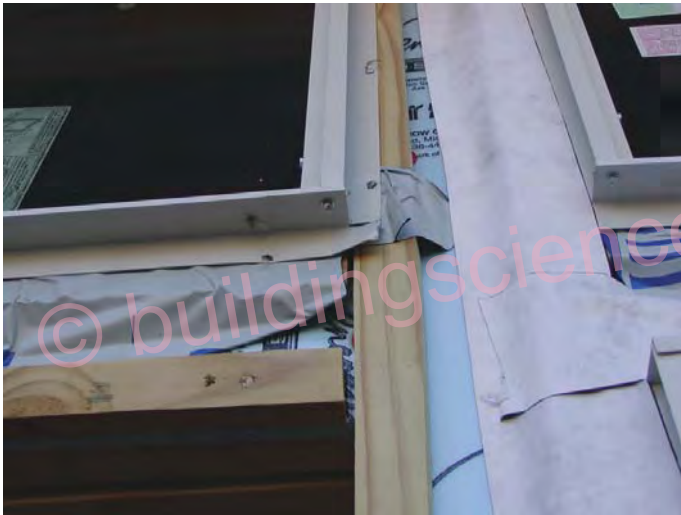
Figure 33: Window furred out from the drainage plane (not recommended)

The furring strips move the window out of the drainage plane of the wall assembly. This adds more three dimensional complexity to the window, flashing, and housewrap installation details. Clearance requirements between adjoining assemblies can also become an issue. Most sheet good products become difficult to install in locations where there are multiple changes in plane in a relatively small location, often leading to poor installations and discontinuities in the drainage plane.
