Waterproofing Concrete Structures

A Dynamic Systems Approach

George Reedy National Sales Director

Miracote Division Crossfield Products Corp.

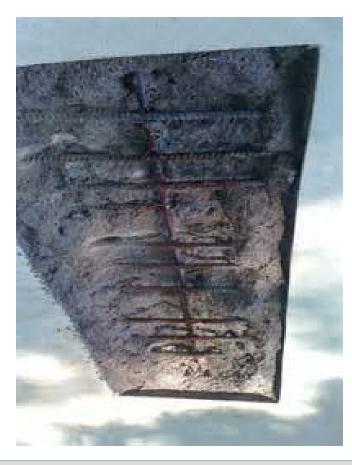
BEFORE CORROSION.

BUILD-UP OF

CORROSION PRODUCTS.

FURTHER CORROSION.

SURFACE CRACKS.

STAINS.

EVENTUAL SPALLING. CORRODED BAR. EXPOSED.

The corrosion cycle of steel begins with the rust expanding on the surface of the bar and causing cracking near the steel/concrete interface. As time marches on, the corrosion products build up and cause more extensive cracking until the concrete breaks away from the bar, eventually causing spalling.

Most Common Problems #3

Concrete spalling due to corrosion of steel
