WELCOME TO THE WORKSHOP!

Mosholu Parkway

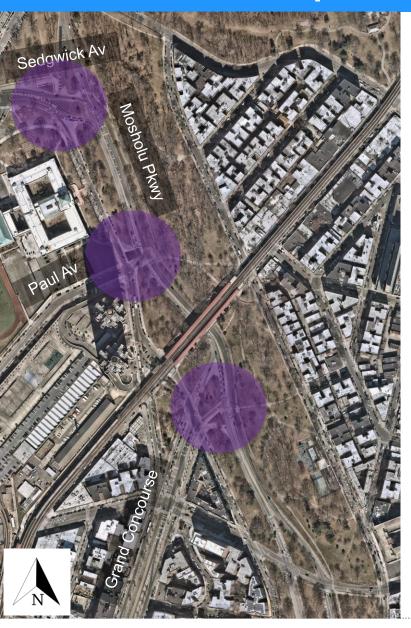
Past In-House Improvements

- Painted pedestrian space
- Signal infrastructure changes
- Lane adjustment on Mosholu Parkway at Sedgwick Avenue
- Painted pedestrian space
- Concrete island
- Bus boarding island

- Closed redundant street
- Concrete island
- Concrete sidewalk

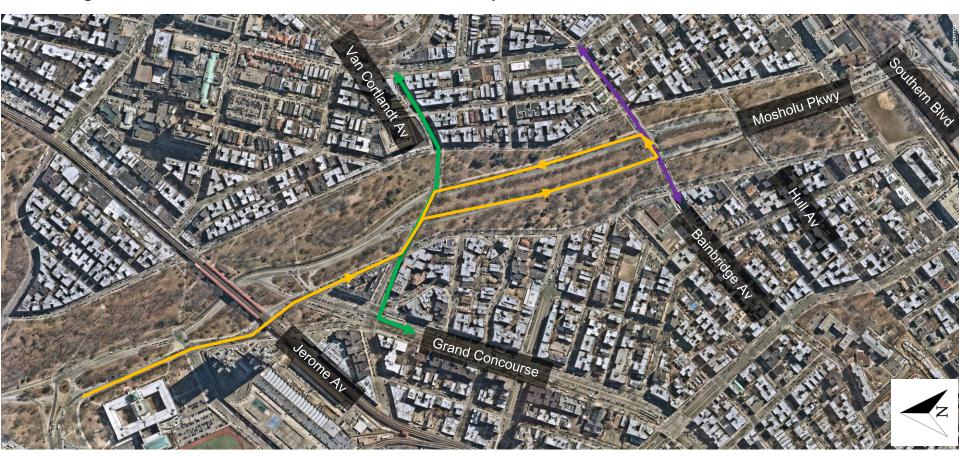
Existing Bus Movements on Mosholu Parkway

Bx28

BxM4

Bx34

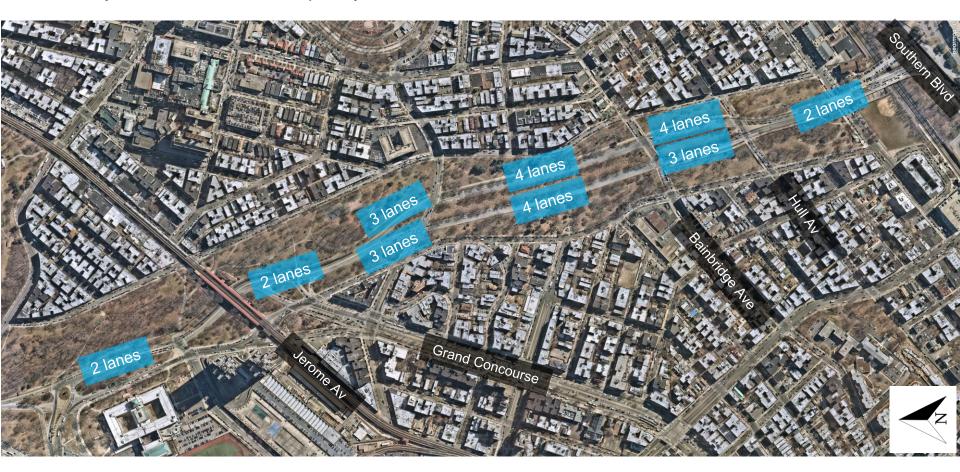
Existing Condition: Vehicles

- Inconsistent number of lanes throughout corridor
- Analysis shows excess capacity for corridor

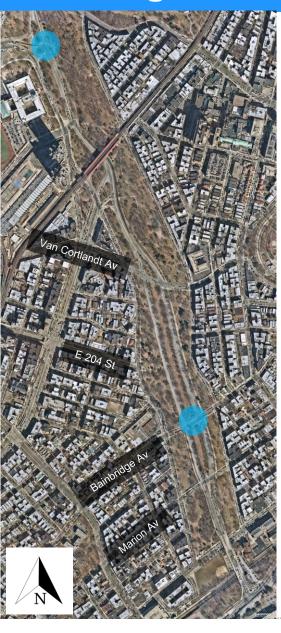
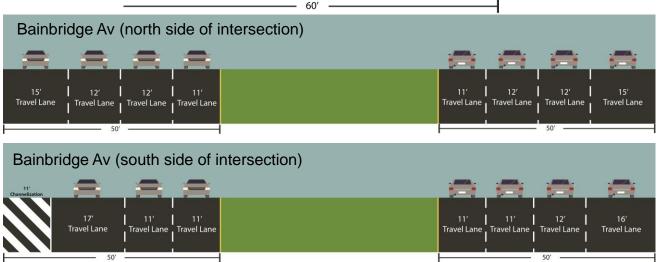
Existing Condition: Vehicles

- High turn volume at Sedgwick Avenue, but functions with two through lanes and a left turn lane
- Other intersections along the Parkway have lower turn volumes and more road space

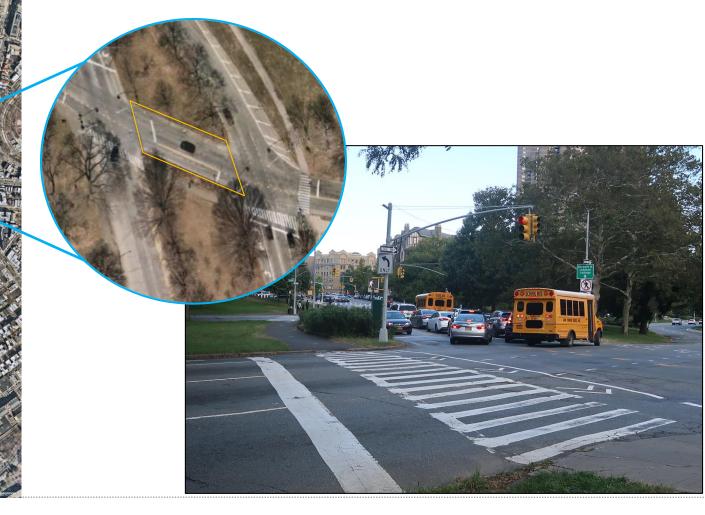
Existing Condition: Vehicles

Each intersection will be evaluated for a left turn lane
