Improving the resilience of buildings to severe wind events

Wind loads on low rise buildings

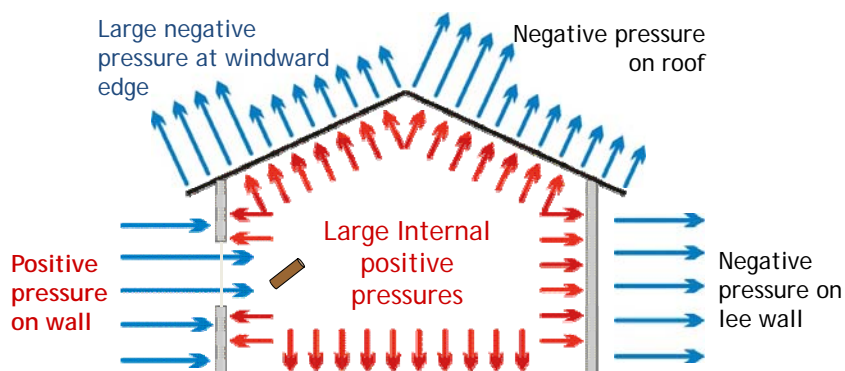
If an opening forms in the external envelope of the building
e.g. a window is broken or a door blows in...

Housing design standard AS4055 requires that a dominant opening is assumed in the design.
(for cyclonic regions, C and D, only)

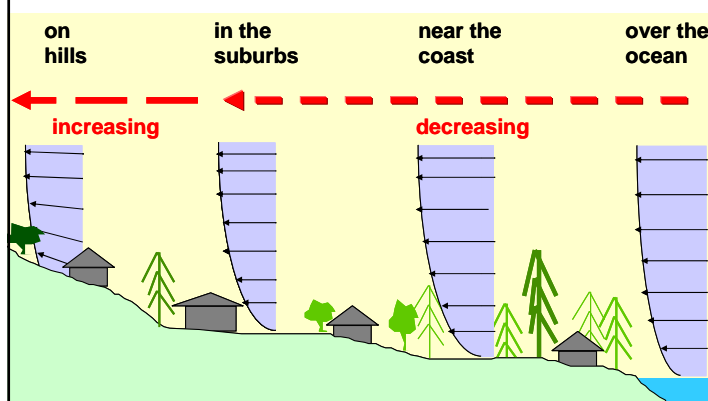
Local Wind Field Parameters

- approach terrain category
- shielding
- topography
- height of building
- orientation of building

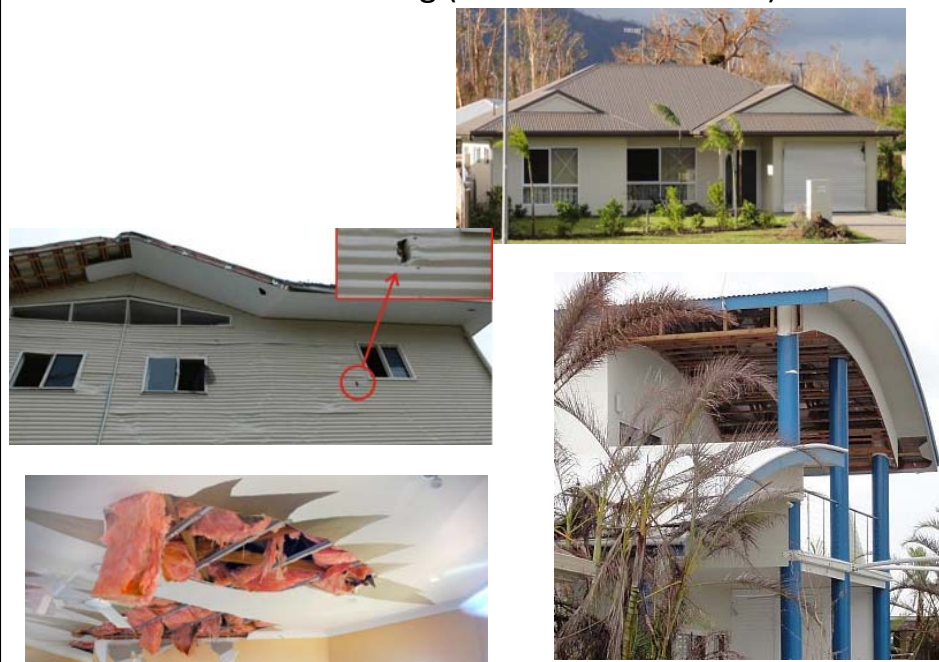
Post-80s housing (current construction)

- <3% major roof damage
- ~30% all roller doors damaged
- But many houses had water ingress

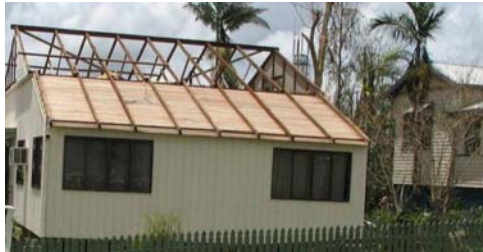
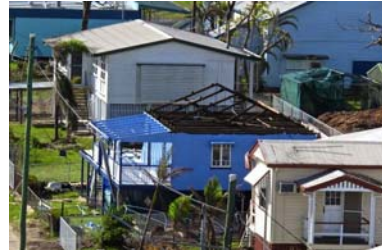
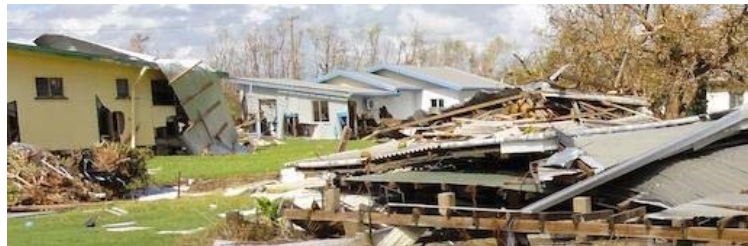
Pre-80s houses

- >12% major roof damage
- ~2% damaged by large debris
- May have hidden damage

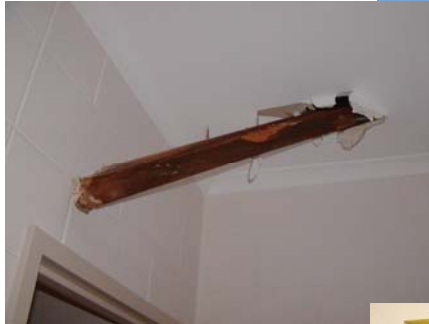
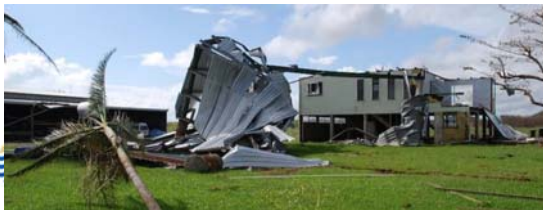
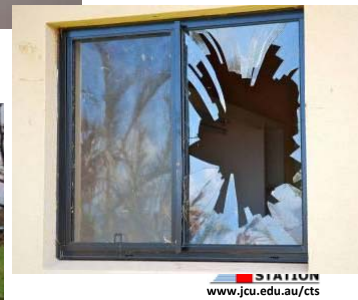
Wind driven debris

- Small
 - Tiles
- Medium
 - Battens
 - Sheets
- Large
 - Roofs
 - Sheds
 - Big consequences

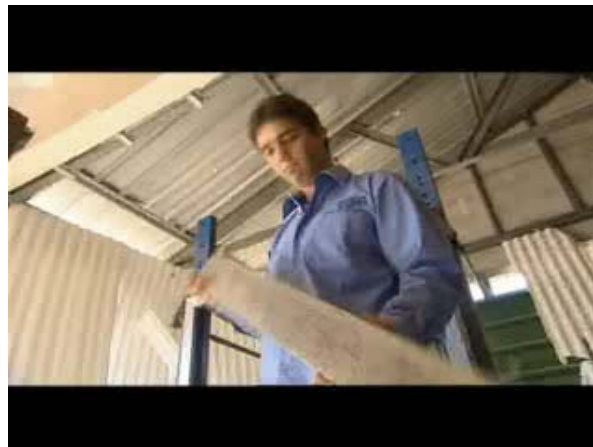
Wind driven debris test

Australian Standard Test (AS/NZS1170.2):
4 kg 100 x 50 mm timber travelling at > 28 m/s (100 km/h) (Region C house)

When selecting debris screens for window protection or cladding systems, make sure that the testing included at least impacts at centre span AND near an edge!!!

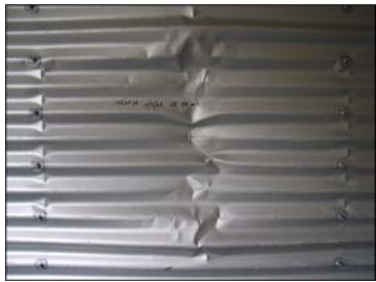
Impact at mid-span -> less deformation

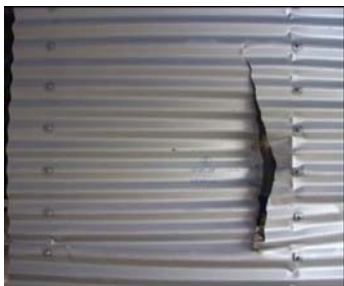
Near support -> more damage

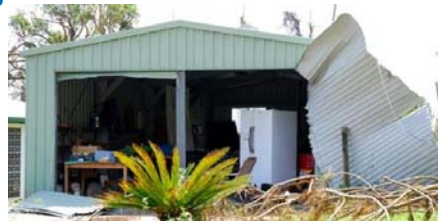
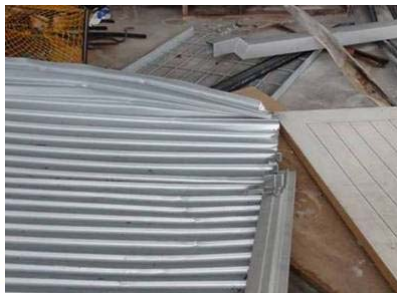
Roller Doors

Required:

- Wind ratings for doors exist (Specification /certification)
- All forces on supports to be resisted including wind lock tensions

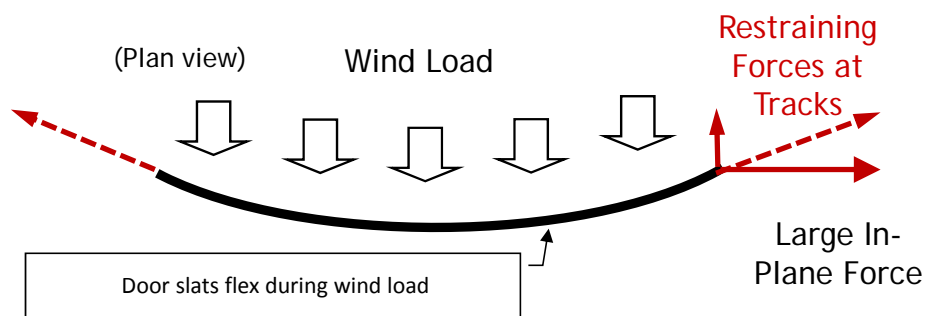
Roller Doors

Wind locks engage into tracks

Inwards (or outwards) deflection results in large in-plane forces in door skin

Large in-plane forces imposed upon the mullions and structure.

Appendix E of AS/NZS 4505 details methods for determining restraining forces for structure

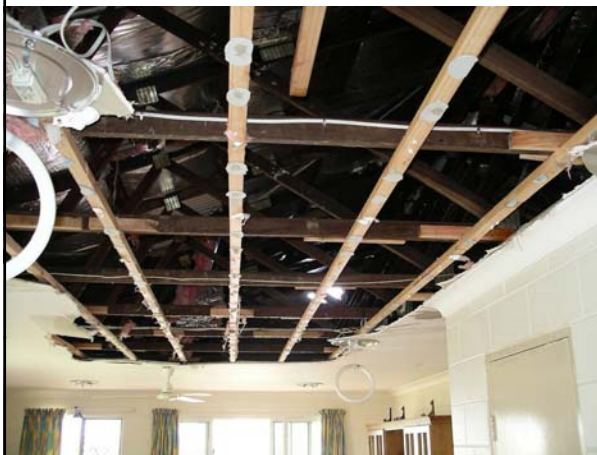
- Extensive damage to Plasterboard linings
- Corrosion of framing elements
- Non structural elements
- Mold and bacteria
- Odour

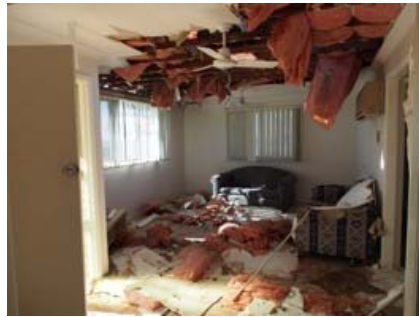
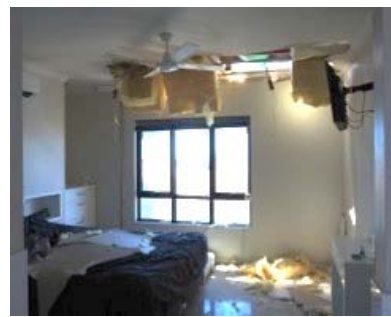
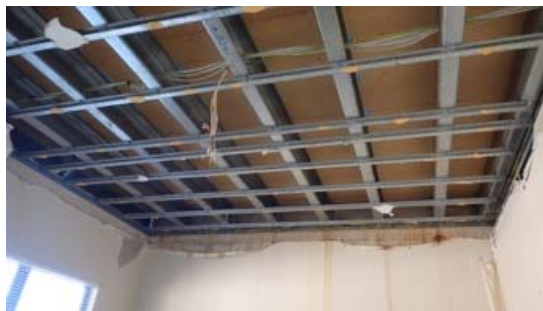
(slide from TC Larry CTS report)

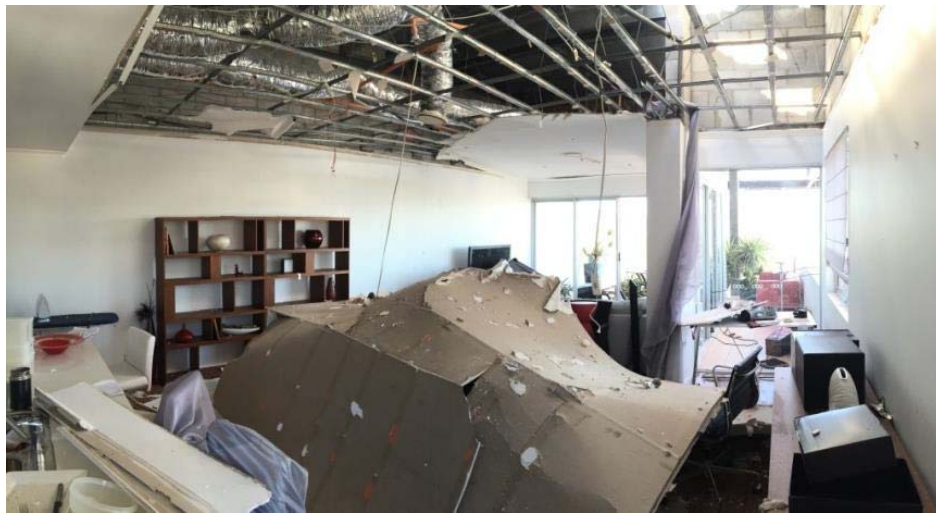
Internal damage from pressurised ceiling space

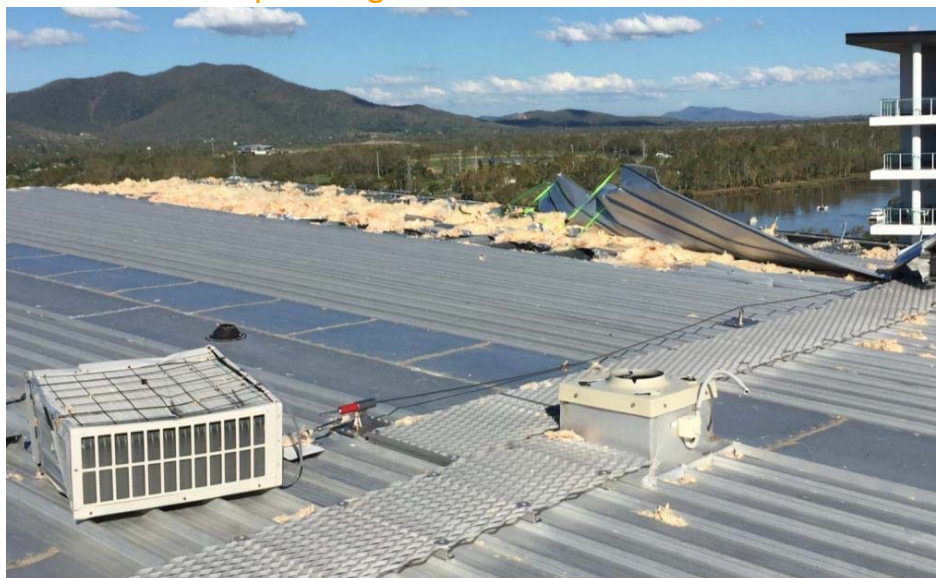
Roof top damage

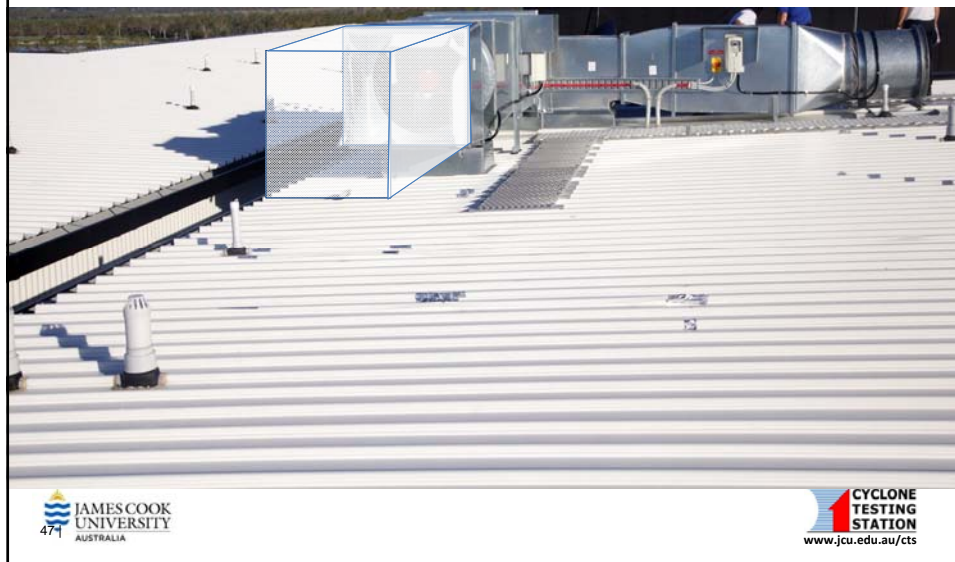
A/C Ducting lost

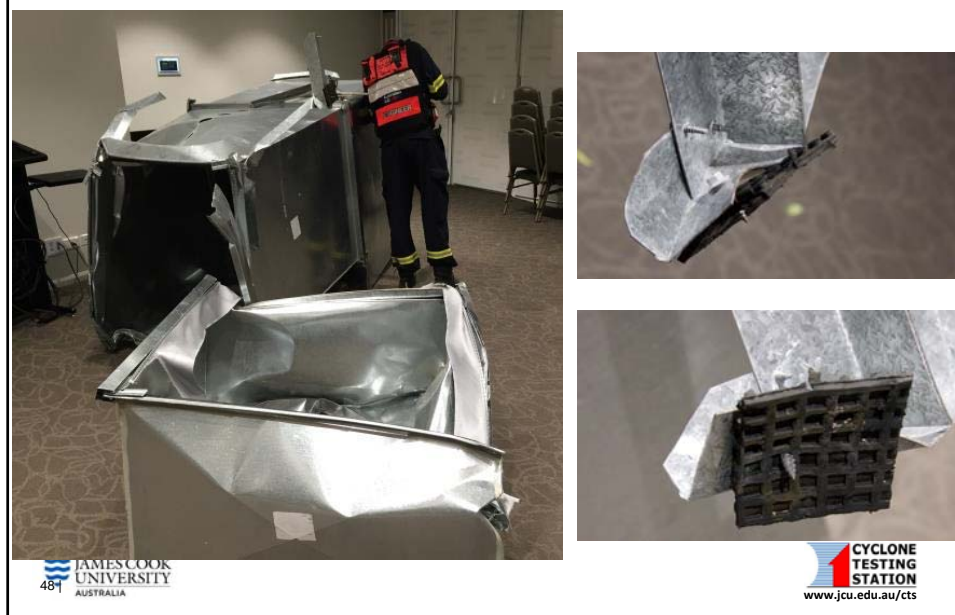
Recovered a/c duct

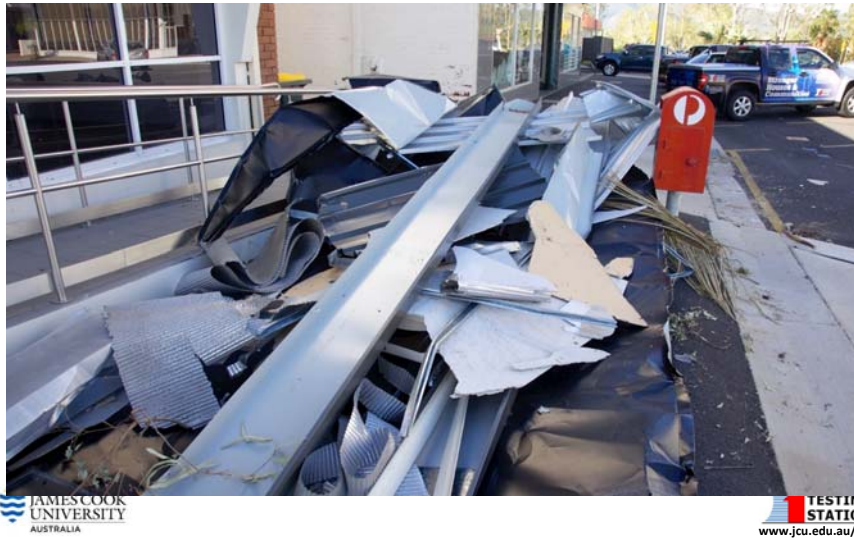
Debris from modern buildings

- Take control & engineer all exposed elements incl:
 - Fascias
 - Flashings
 - Ceilings
 - Vents
 - A/C plant...
- Redundancy (prevention of progressive collapse)
- Durability consistent with design life
- Incorporate additional reserves when elements cannot be readily inspected or maintained

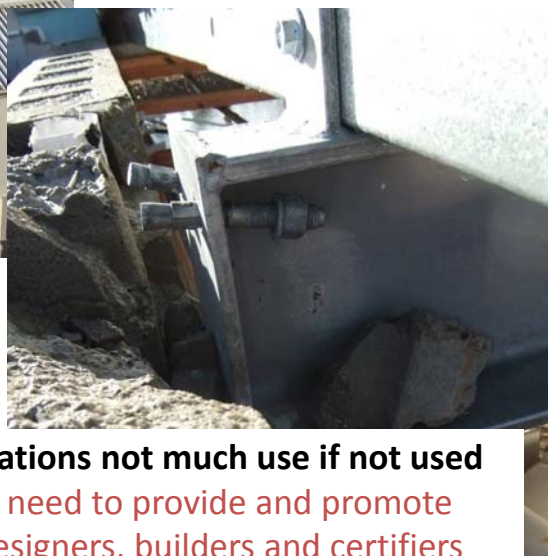
Edge distance?!?!?!?

All test data and Regulations not much use if not used
 Product manufacturers need to provide and promote
 installation guides to designers, builders and certifiers

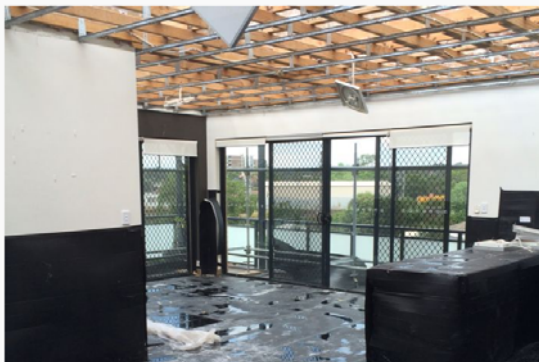
PHOTO: AIG found the roof damage was caused by inadequate structure strength. (Supplied)

- Roof structure with adequate strength would not have lifted, report said
