World Housing Encyclopedia Report

Country: Italy

Housing Type: Reinforced concrete frame building

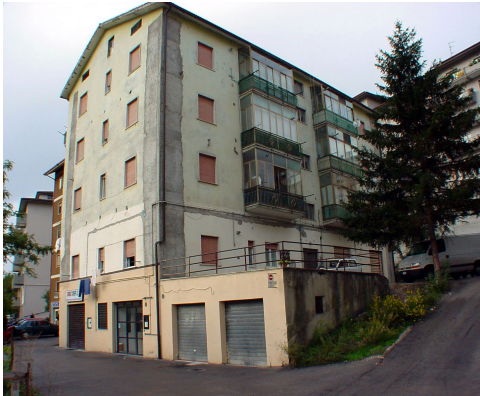
FIGURE 1A: Typical Building

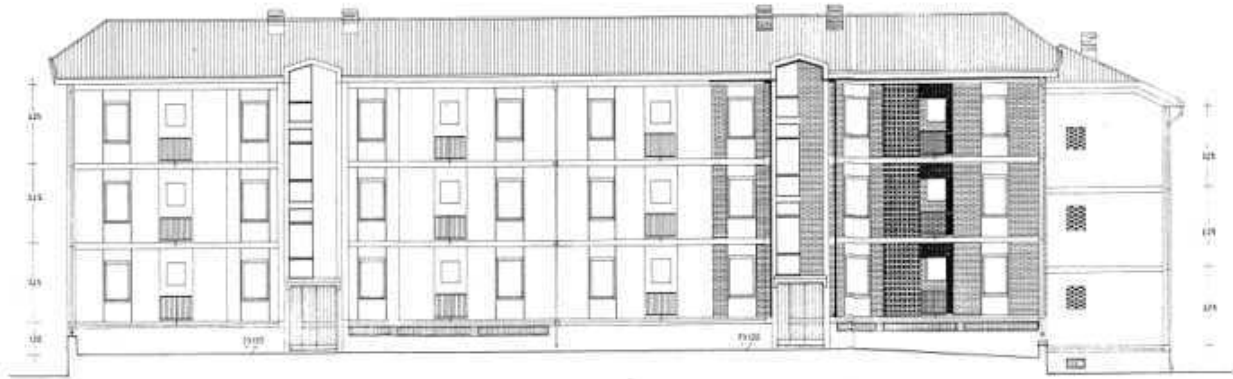
CARPENTERIA TIPO

FIGURE 2B: Key Load-bearing Elements (Building Shown on Figure 1D)

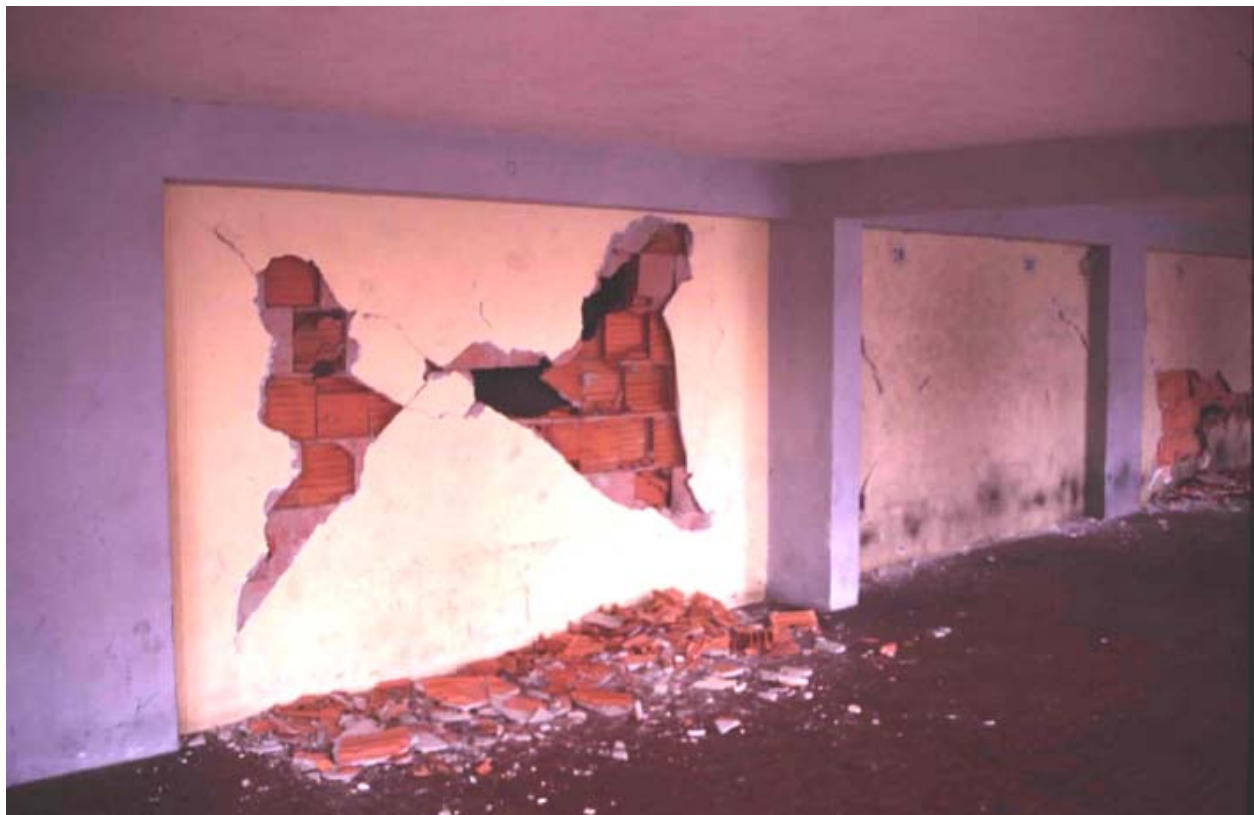
FIGURE 4A: Typical Earthquake Damage - Cracking of Hollow Clay Tile Partitions

Structural Element	Seismic Deficiency	Earthquake-Resilient Features	Earthquake Damage Patterns
Wall	Unreinforced hollow clay tile infill walls		Diagonal ("X"-cracking) and failure see Figure 4A and 4B.
Frame (columns, beams)	Designed for gravity loads only		
Roof and floors	Designed for gravity loads only

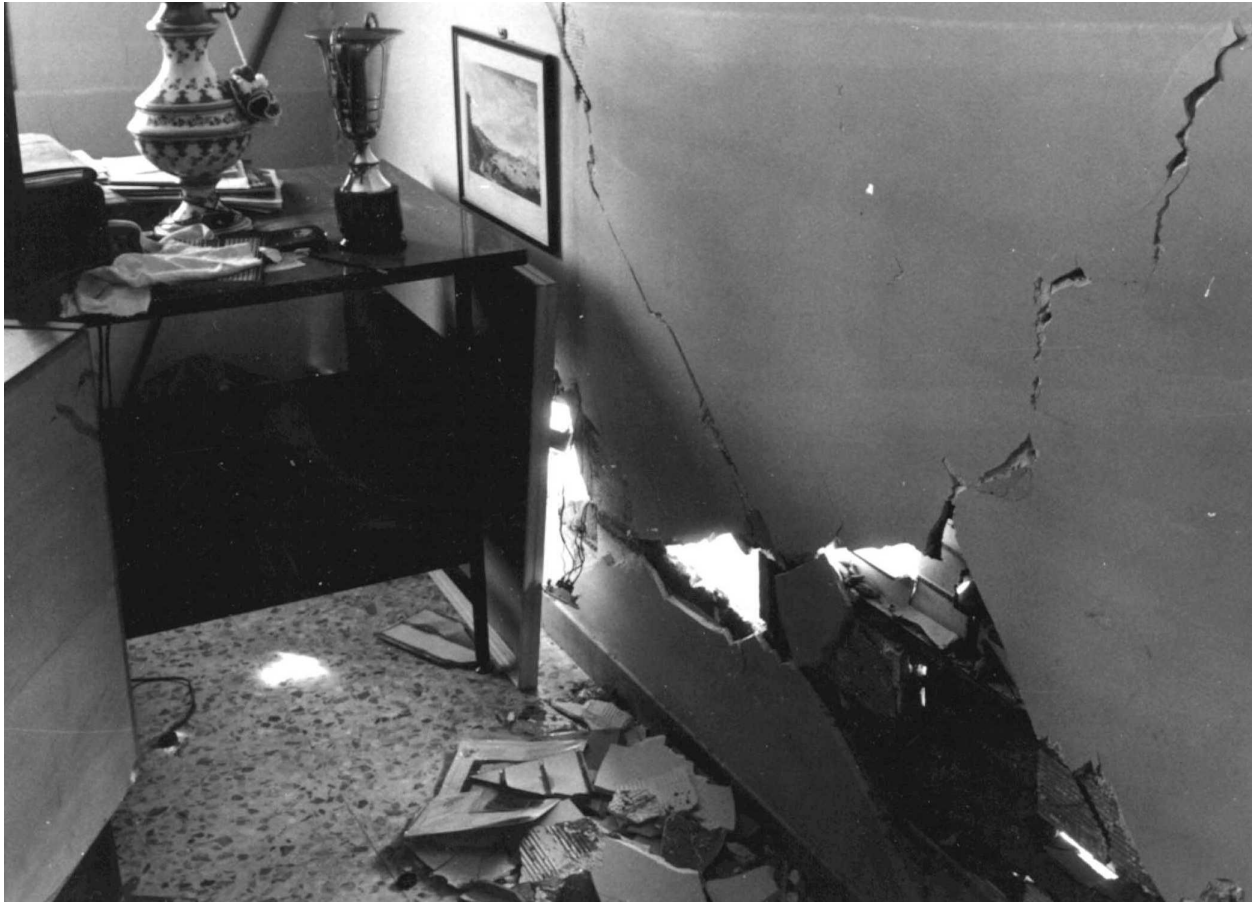
FIGURE 4B: Typical Earthquake Damage-Cracking of Masonry Partitions

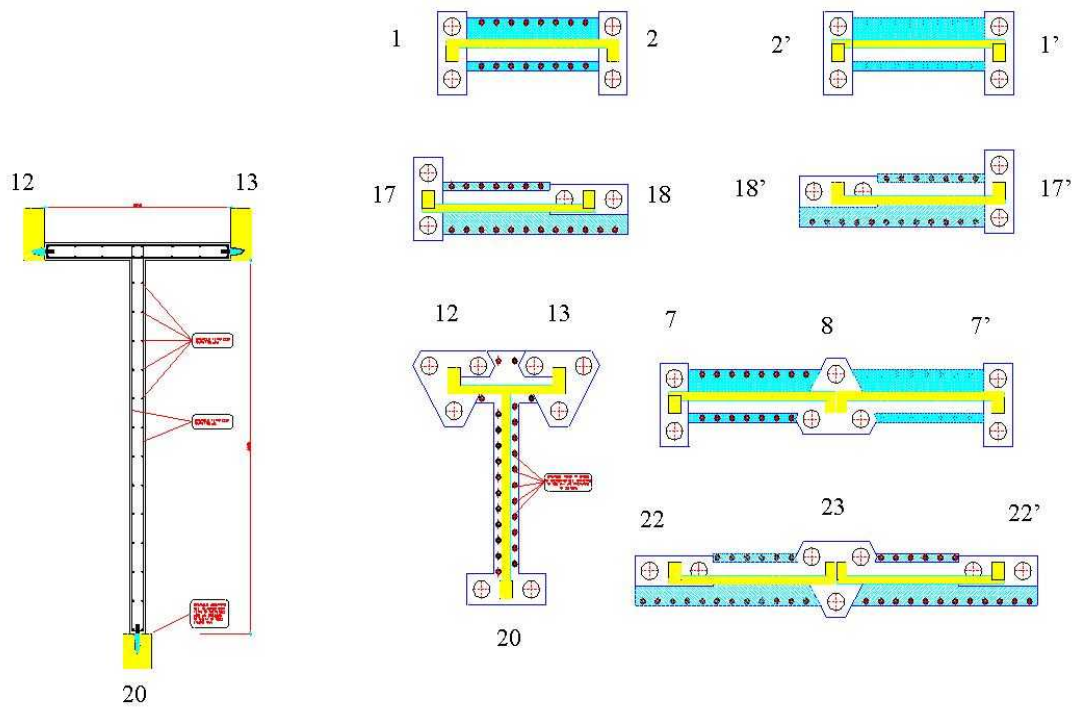
FIGURE 5E: Seismic Strengthening- Foundation and Wall Details

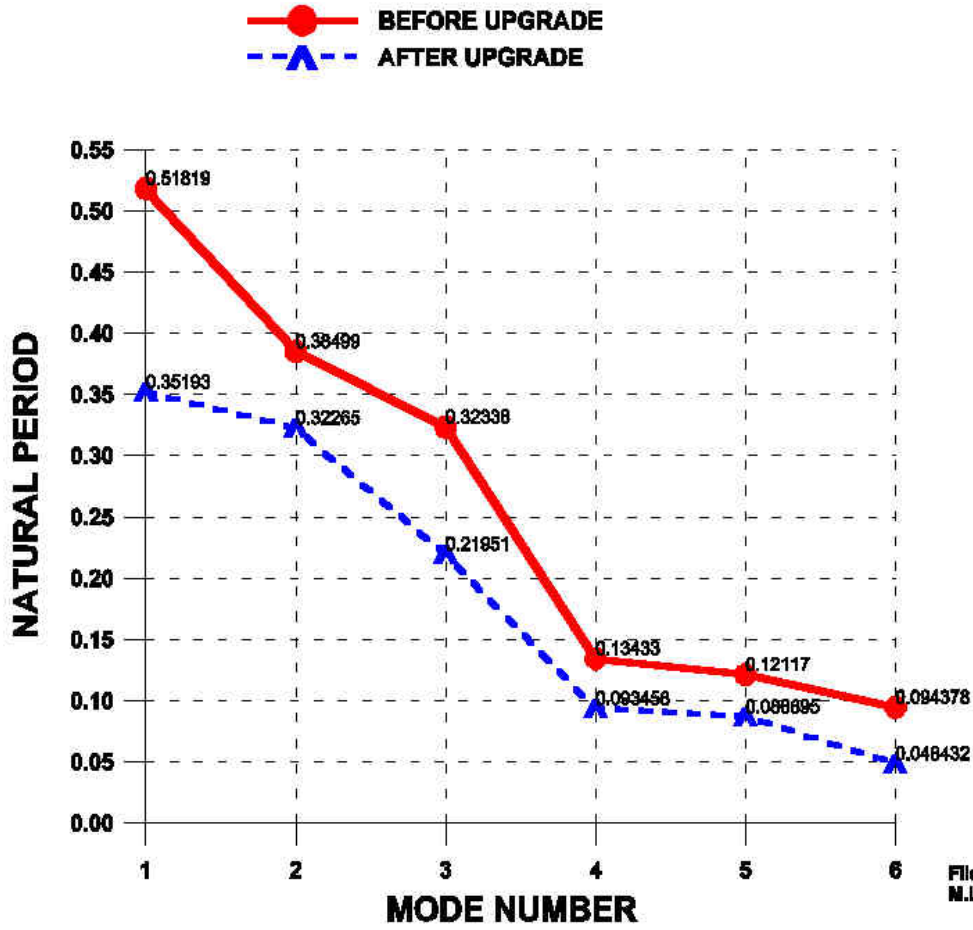
FIGURE 5H: Dynamic Characteristics (Natural Period) of a Five-Story Building Before and After the Retrofit (corresponding to the building shown on Figures 1A, 2A, and 3A)

Additional Comments: The initial phase of the seismic upgrade design included the evaluation of the existing building in order to identify seismic deficiencies. Dynamic analysis was performed using the Super ETABS software, and the natural periods of the structure for six different modes. After the strengthening design was performed, the new periods have been calculated, showing that the strengthened building is characterized with a significantly higher stiffness as compared to the original building. A chart showing the variation of natural vibration periods for the same five-story building before and after the retrofit is illustrated in Figure 5H (corresponding to the building shown in Figures 1A, 2A and 3A). A similar chart is presented on Figure 5I, corresponding to a four-story building shown in Figures 1E, 2B and 3.

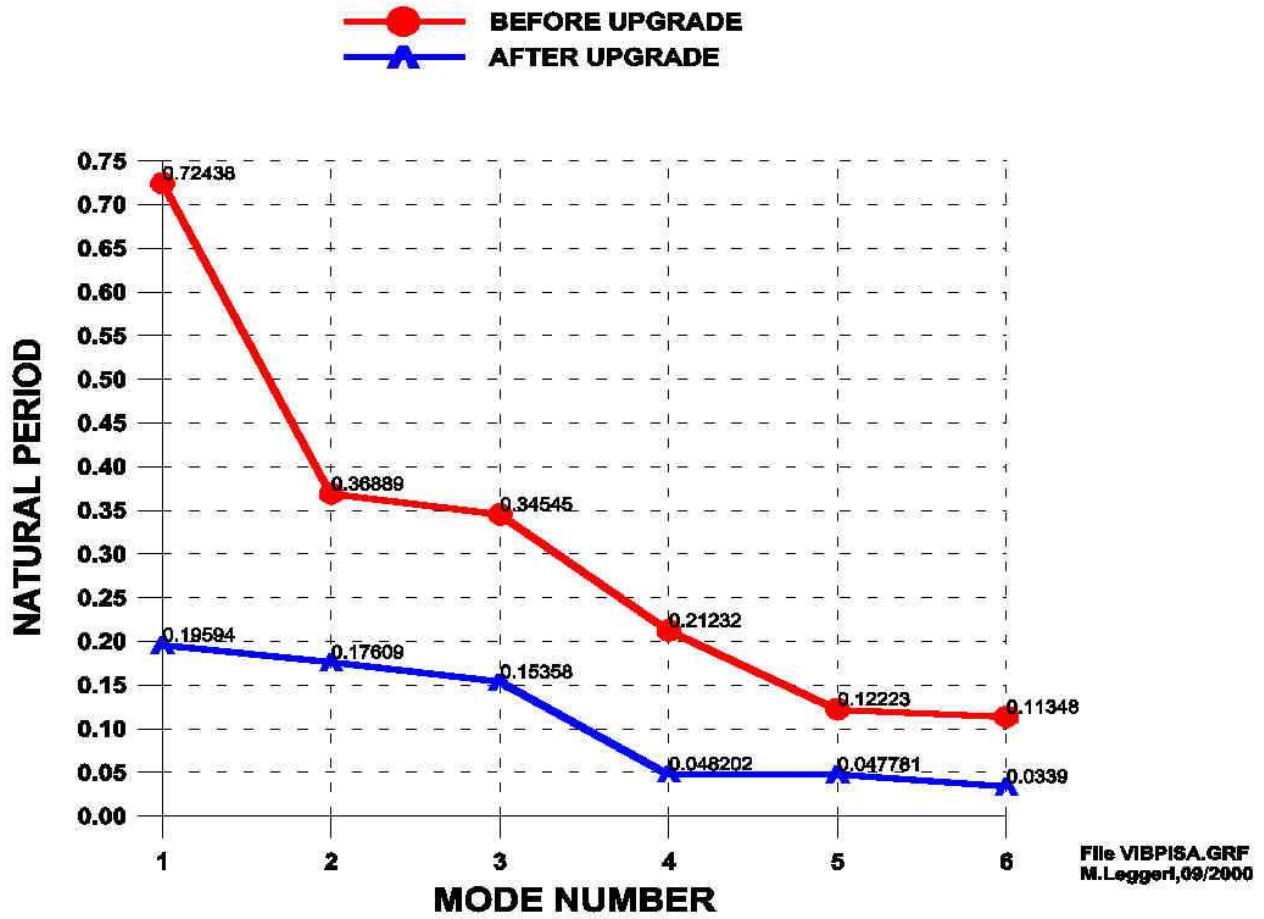
FIGURE 5I: Dynamic Characteristics (Natural Period) of a Four-Story Building Before and After the Retrofit (corresponding to the building shown on Figures 1E, 2B and 3B)
