World Housing Encyclopedia Report

Country: India

Housing Type: Unreinforced brick masonry building with reinforced concrete roof slab

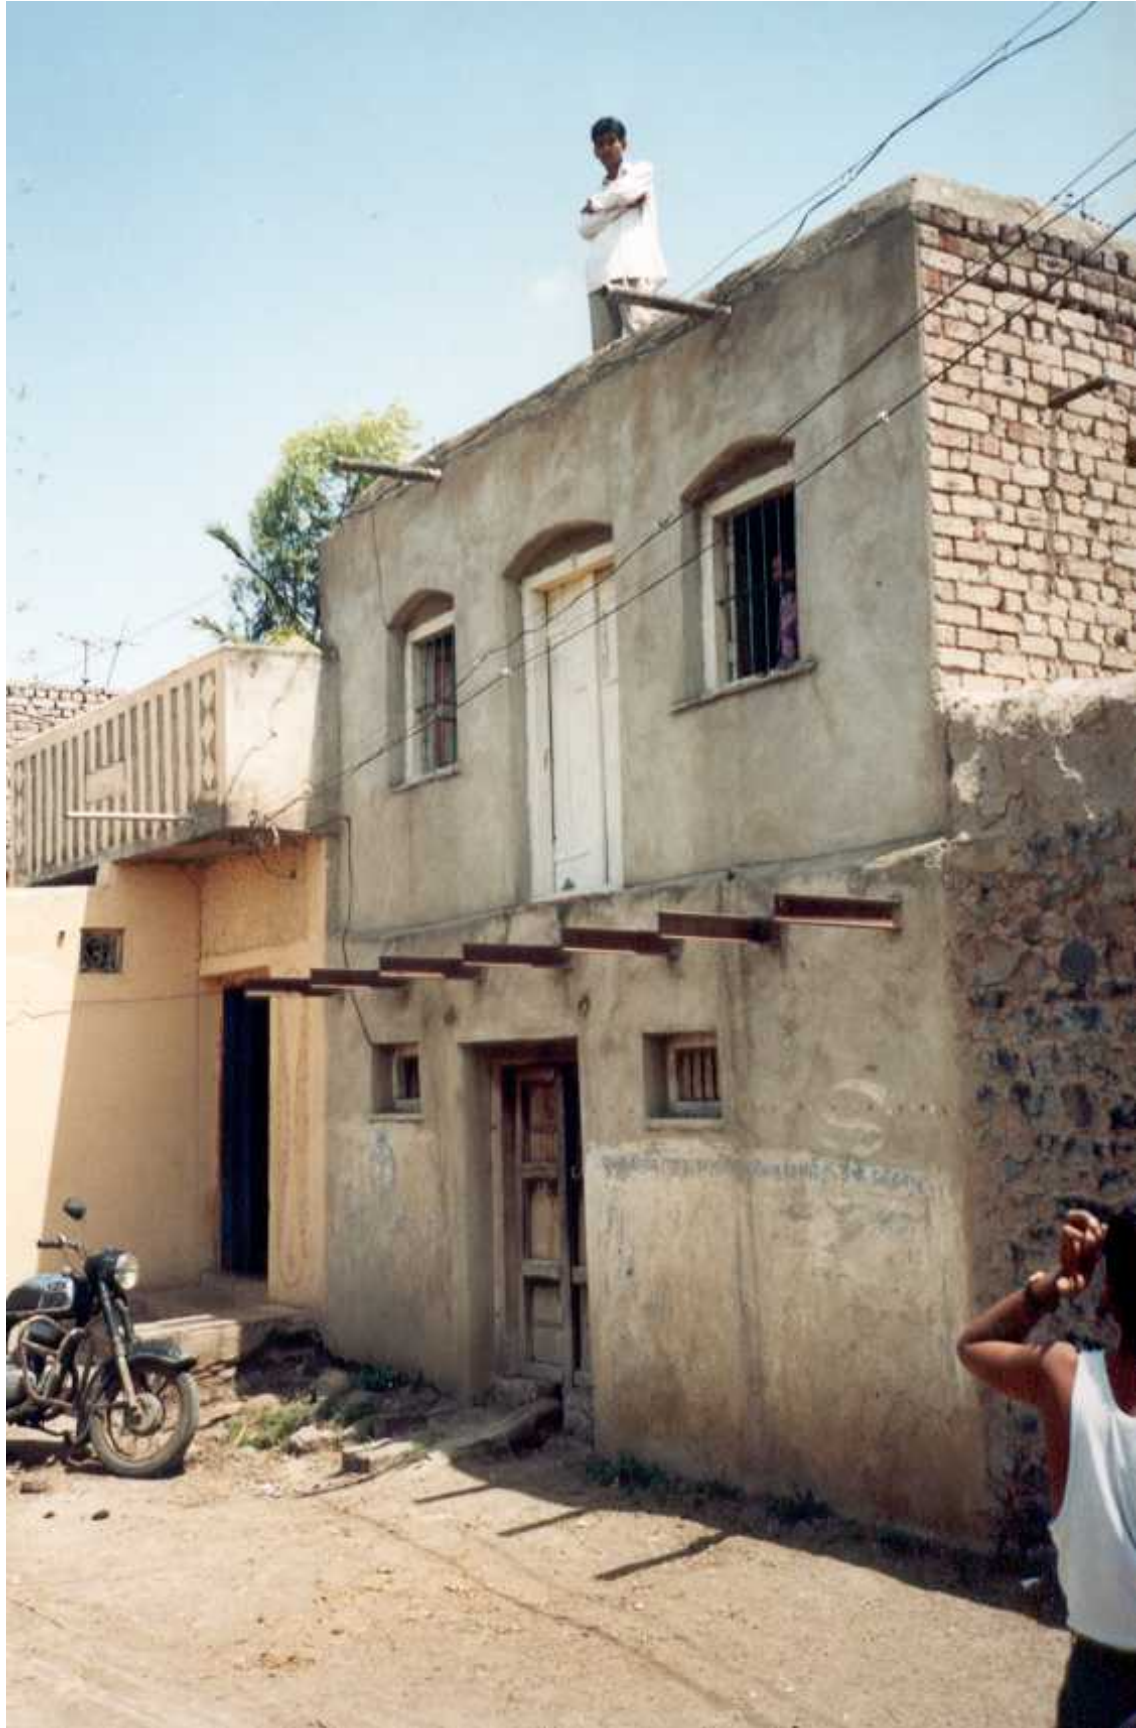
FIGURE 1: Typical Building

Typical rural and urban construction in western and southern India. This construction is widely prevalent among the middle class population in urban areas, and has become popular in rural areas in the last 30 years. Brick masonry walls in cement mortar are the main load bearing element in these buildings. Roof structure is a cast in-situ reinforced concrete slab. If constructed without seismic features, buildings of this type are vulnerable to earthquake effects, and had exhibited rather poor performance during the Koyna (1967), Killari (1993), Jabalpur (1997) and Bhuj (2001) earthquakes in India.

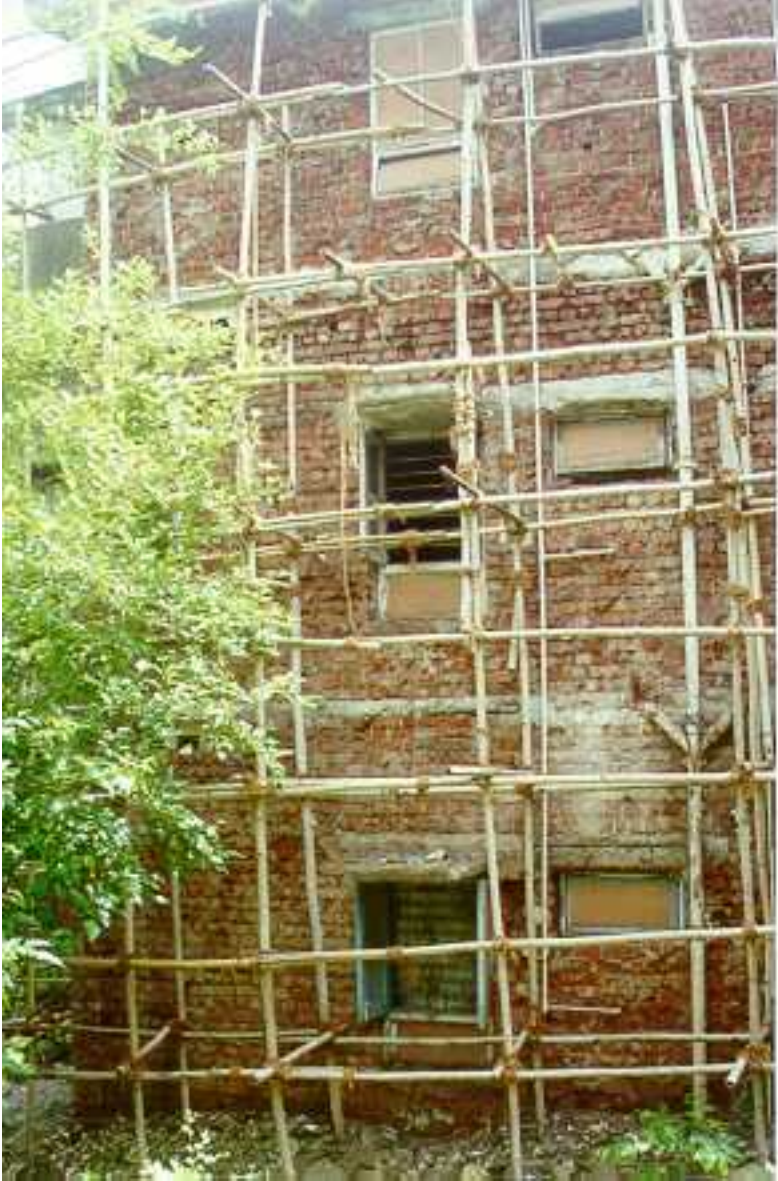
FIGURE 2A: Key Load-Bearing Elements - A Building Under Construction

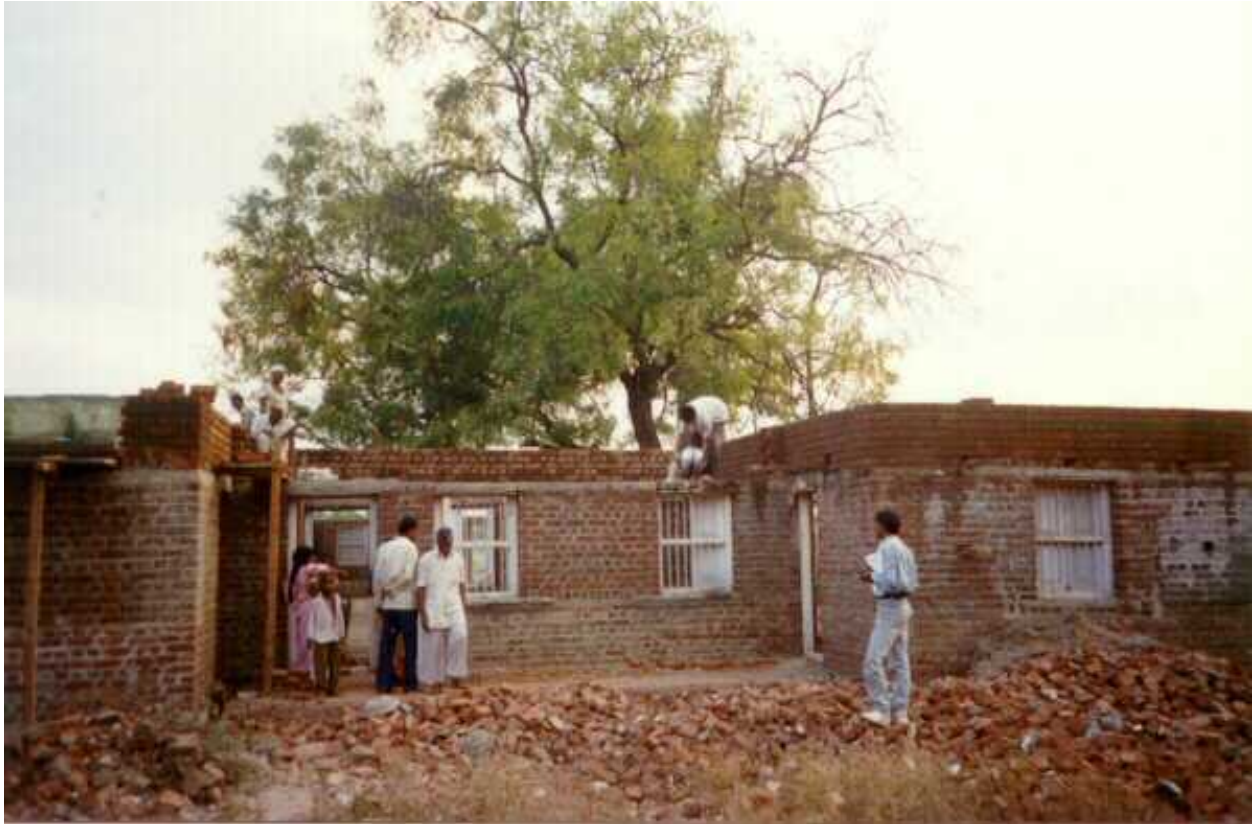
FIGURE 2B: Key Load-Bearing Elements - A Building Under Construction

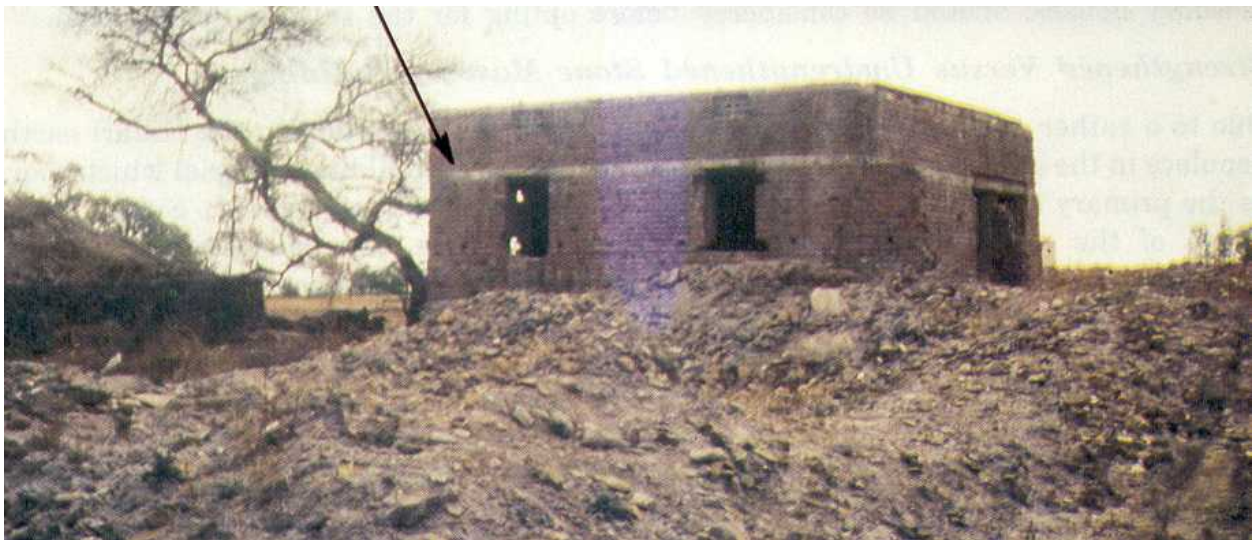
Figure 5A: Key Seismic Resilient Features - RC Lintel Band and Good Quality Construction; note example of a building that sustained the effects of the 1993 Killari earthquake (M6.4) without damage, although located very close to the epicentre

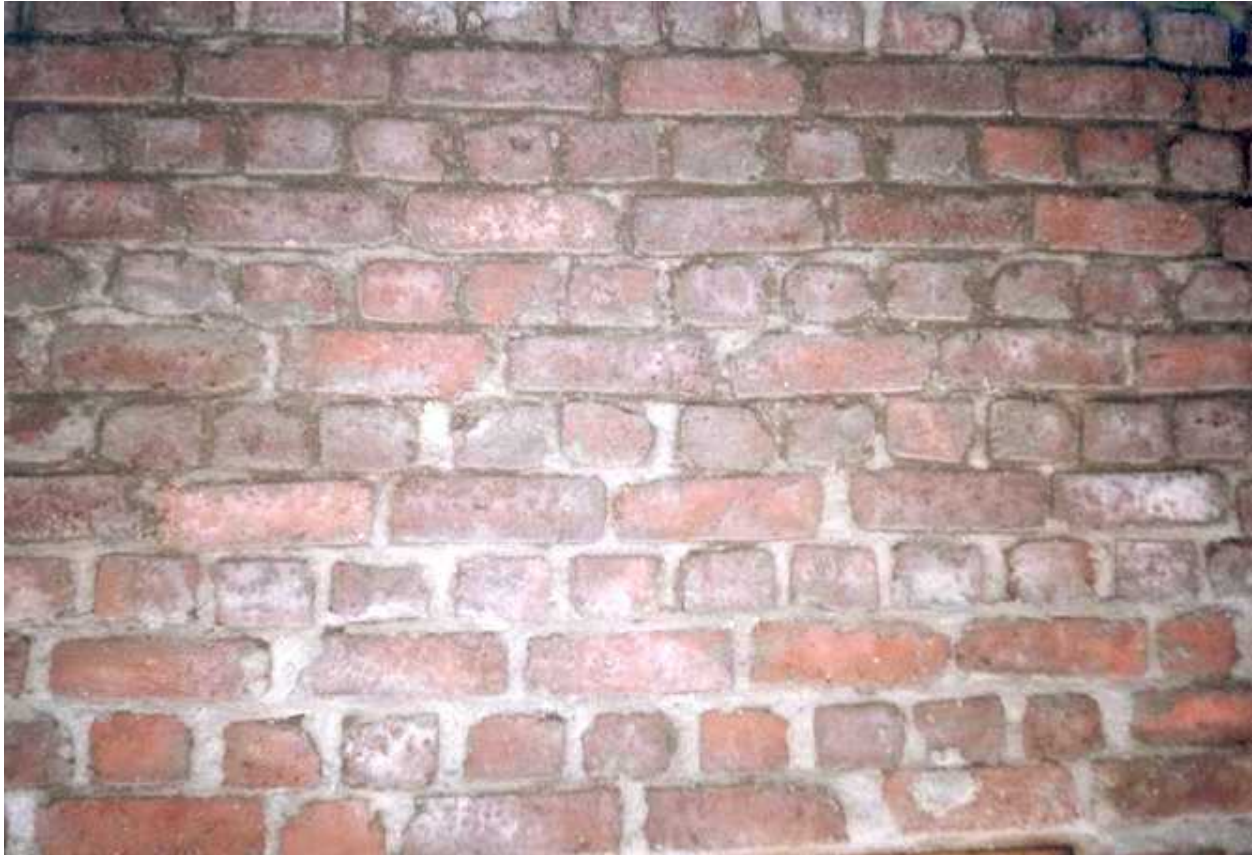
FIGURE 5B: Construction Deficiency - Excessively Thick Mortar Bedding Joints

Structural Element	Seismic Deficiency	Earthquake-Resilient Features	Earthquake Damage Patterns
Wall	- Absence of RC bands or poorly constructed bands - Brick masonry strength very low - Poor mortar quality; excessively thick bedding joints - load-bearing walls not properly interlocked - Poor quality of construction - Openings are not properly proportioned; the distance between corner and opening is not as per recommended practice	- When present, seismic features (in particular RC bands) are very effective in enhancing seismic resistance, as confirmed in the 1993 Killari earthquake (Figure 5A) and 2001 Bhuj earthquake (Figure 6j)	- Shear cracks in the walls, mainly starting from corners of openings. - Partial or complete out-of-plane wall collapse due to the lack of wall-roof anchorage and large wall slenderness ratio
Frame (columns, beams)			
Roof and floors	- Roof not integrally connected to walls (poor torsional resistance) - Poor quality concrete may compromise rigid diaphragm action - Poor maintenance		- Partial caving-in of roof due to collapse of supporting walls (Figure 6A) - Horizontal crack at the wall-roof connection (Figure 6E) - Shifting of roof from the wall due to torsional motion of roof slab

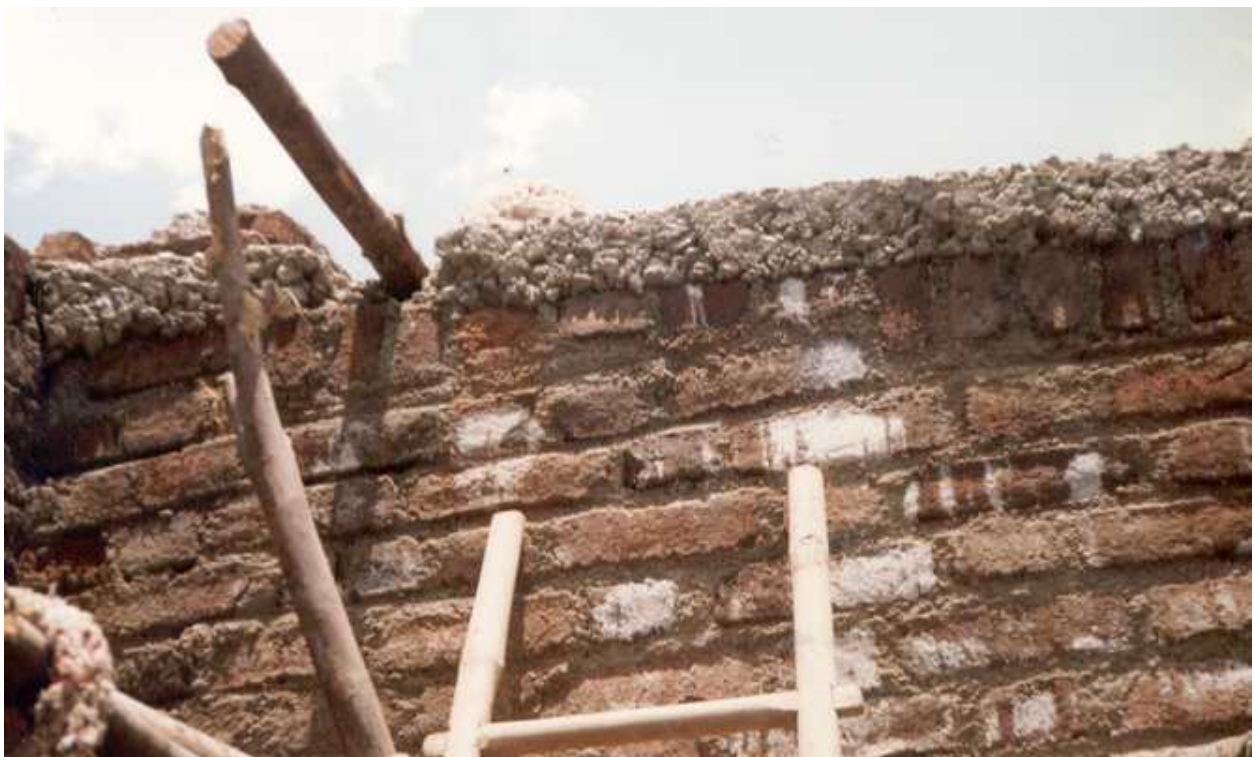
FIGURE 5C: Construction Deficiency - Discontinuous RC Lintel Band (bond beam)

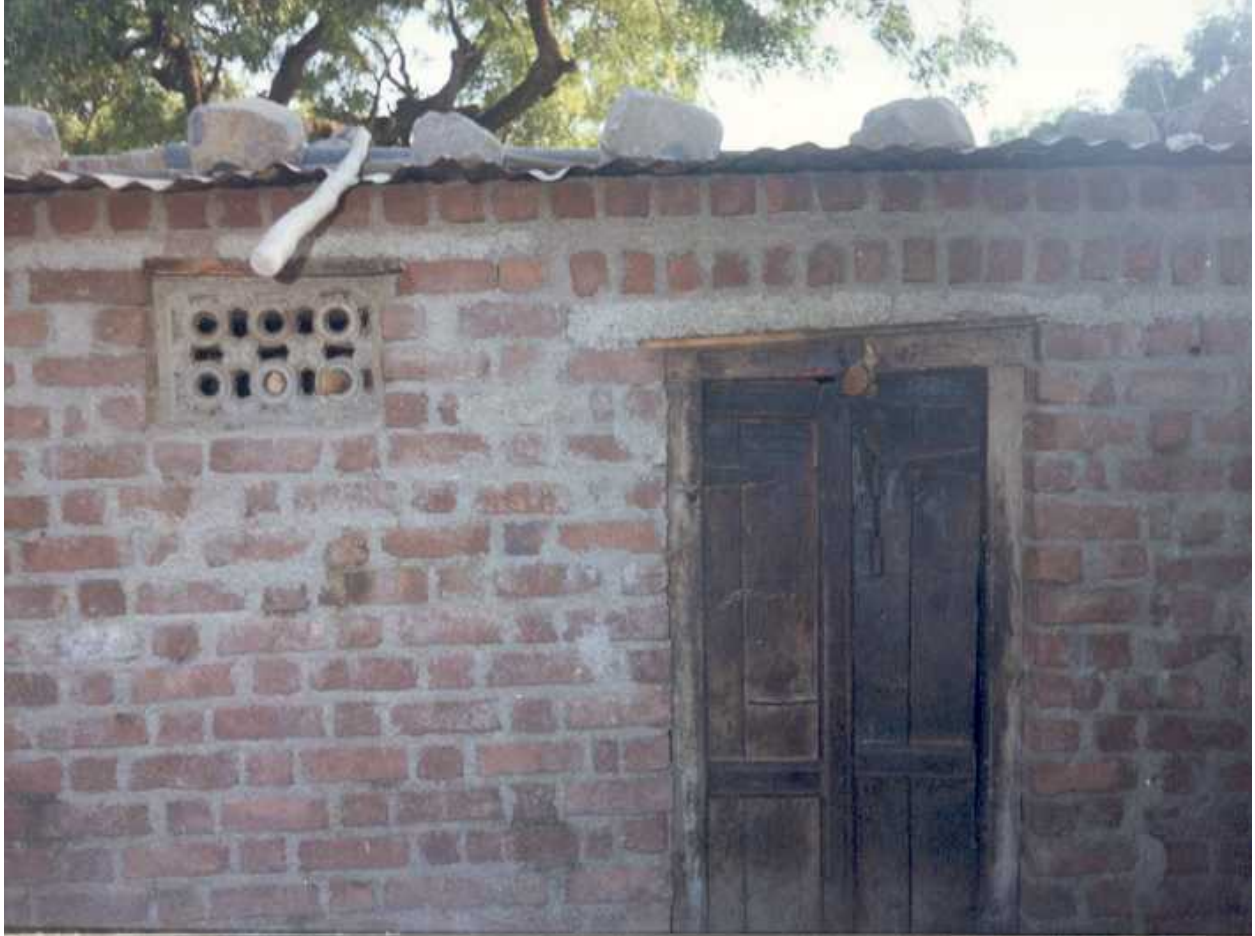
FIGURE 5D: Construction Deficiency - Discontinuous RC Lintel Band

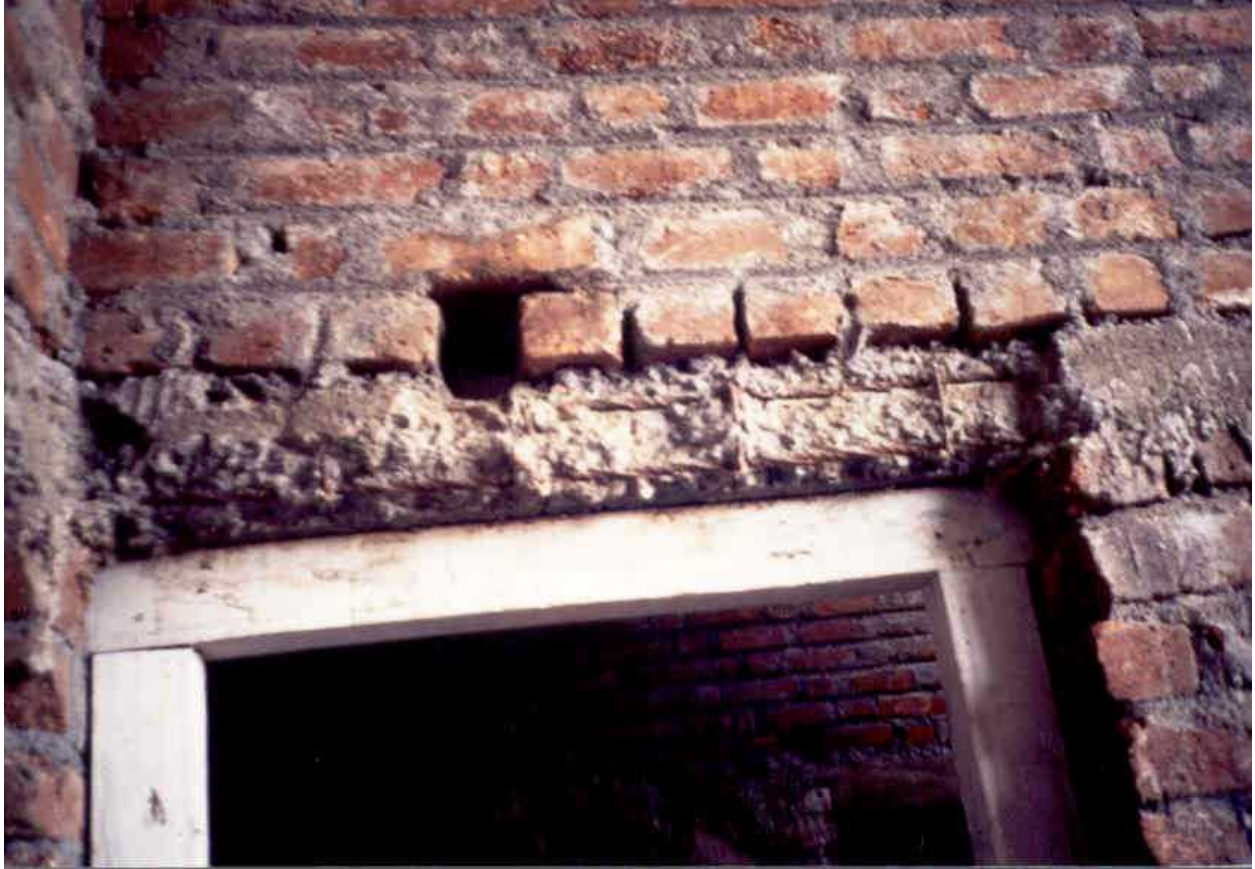
FIGURE 5E: Construction Deficiency - Exposed Steel Reinforcement in RC Lintel Band Construction

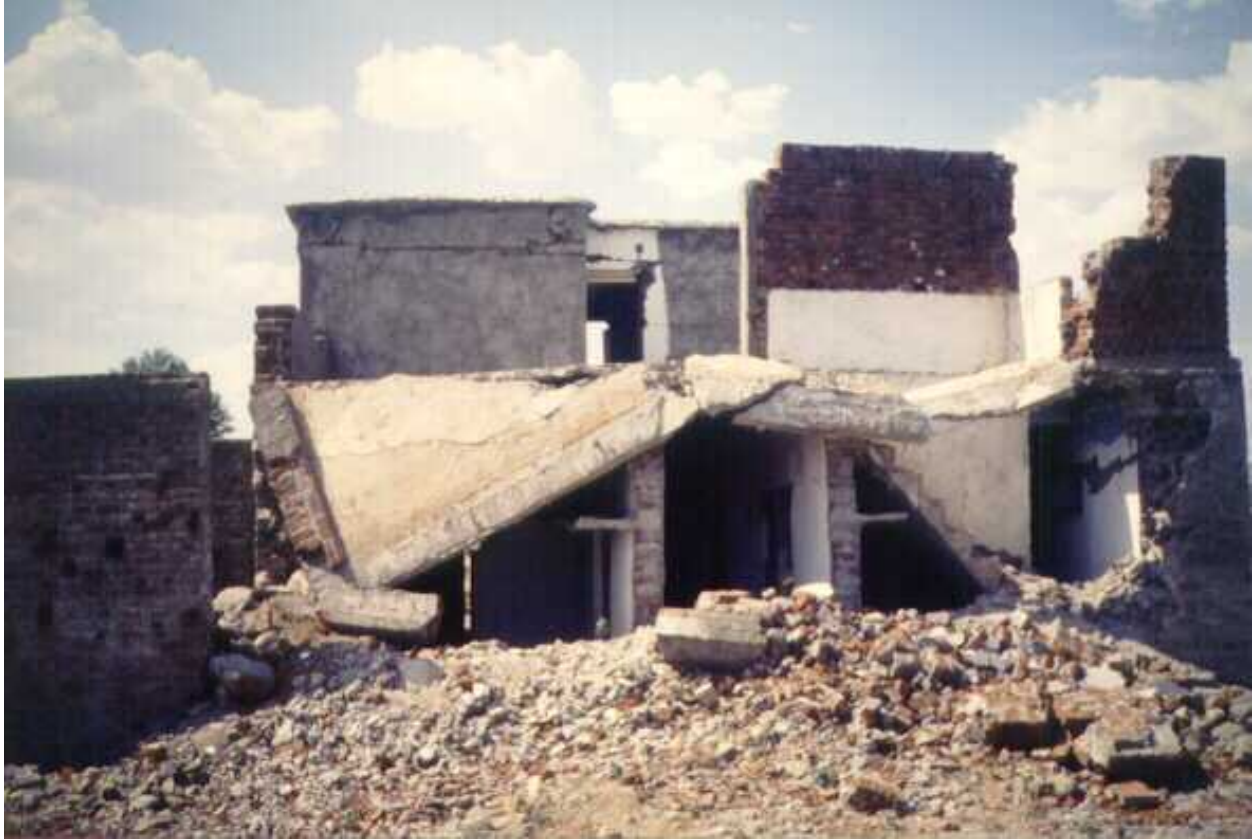
FIGURE 6a: Typical Earthquake Damage - Roof Collapse Caused by the Wall Collapse (1993 Killari earthquake)

Additional Comments: Building construction of this type (without seismic provisions) suffered significant damage during Koyna (1967) and Killari (1993) earthquakes. Some damage was also observed during Jabalpur (1997) earthquake. The main damage patterns consisted of: shear cracks in walls, mainly starting from corners of openings; partial out of plane collapse of walls; partial caving-in of roofs due to collapse of supporting walls, and shifting of roof from wall due to torsional motion of roof slab. This construction has experienced moderate to very heavy damage in the 2001 Bhuj earthquake (M 7.6). In the epicentral region several buildings of this type suffered total collapse of the walls resulting in the death and injury to a large number of people. The overall building performance was dependent on the type of roof system: buildings with lightweight roof suffered relatively less damage while buildings with RC roofs suffered much greater damage (Source: IIT Powai 2001). Importance and effectiveness of seismic provisions was confirmed both in the 1993 Killari earthquake and the 2001 Bhuj earthquake. A building with RC lintel band (located in the Killari village only few kilometers away from the epicentre) shown on Figure 5a sustained the earthquake effects with a minor damage while large majority of other buildings in the same village collapsed, causing over 1,400 deaths. Similarly, unreinforced masonry buildings with RC bands sustained the effects of the 2001 Bhuj earthquake with moderate damage while the neighbouring buildings of similar construction without seismic provisions collapsed (see Figure 6J).

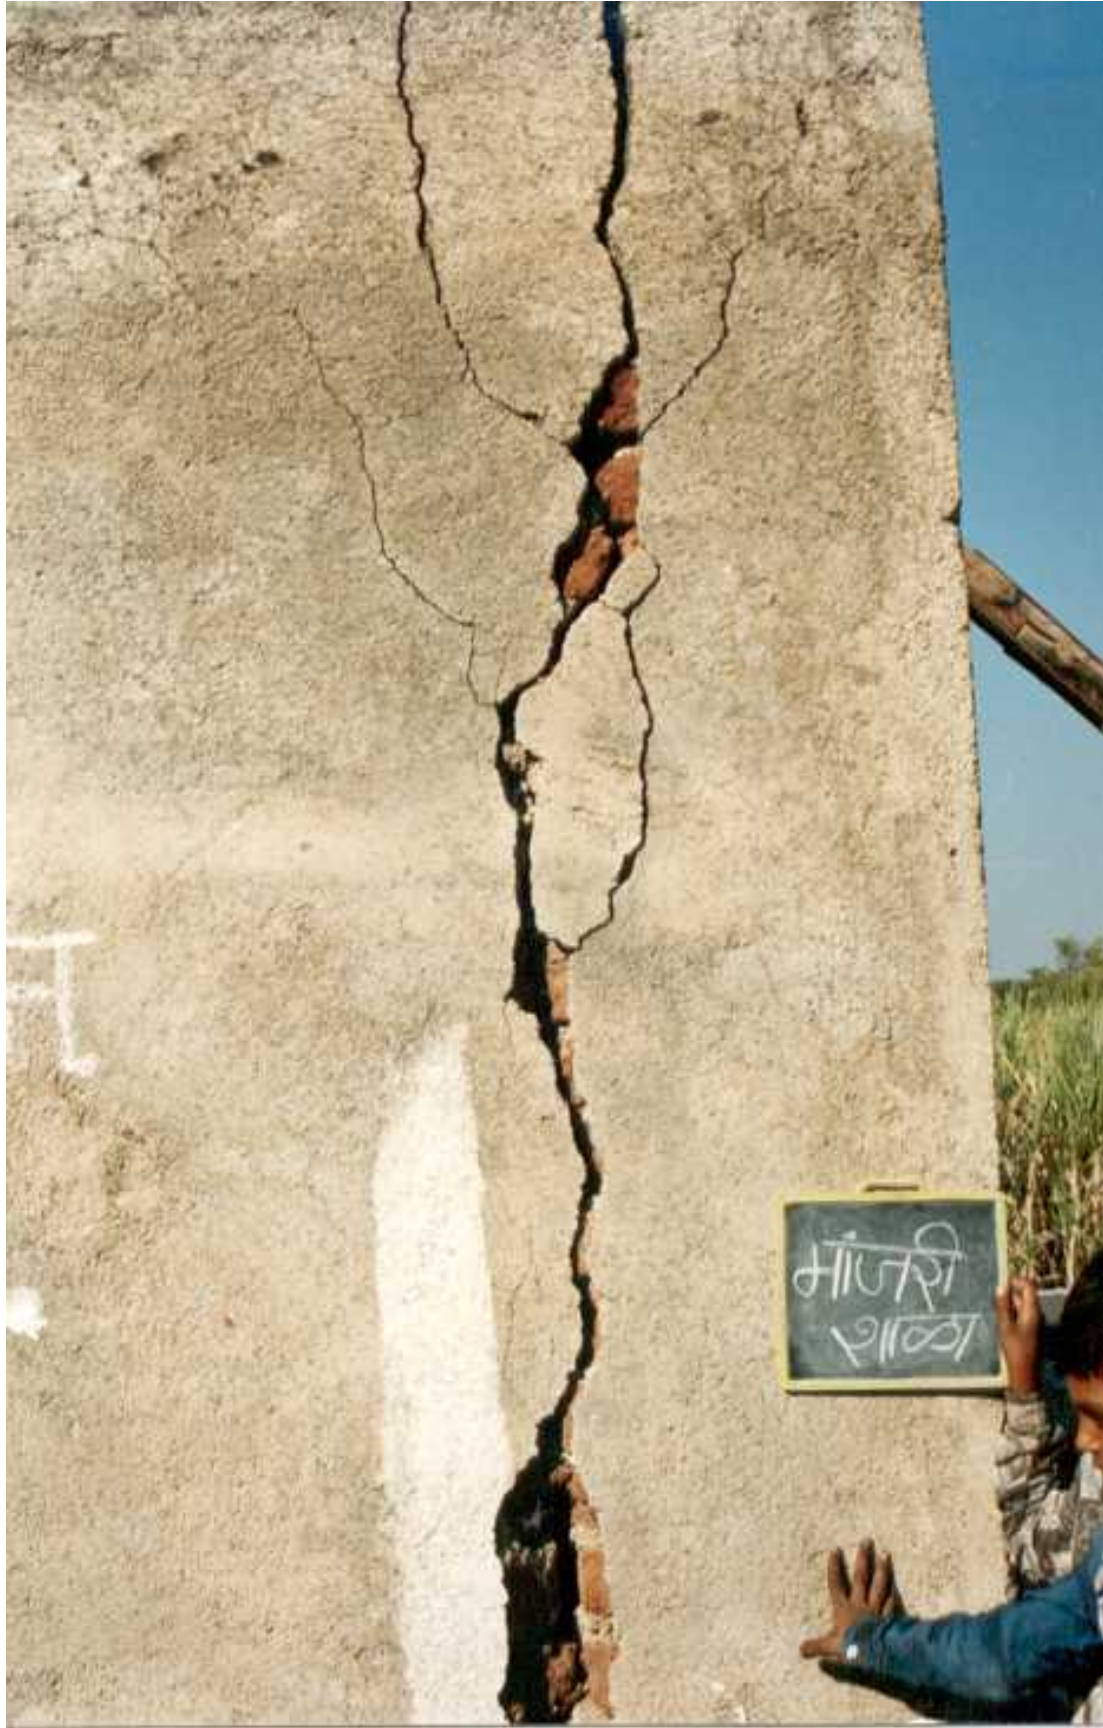
FIGURE 6B: Typical Earthquake Damage - Wall Corner Cracking (1993 Killari earthquake)

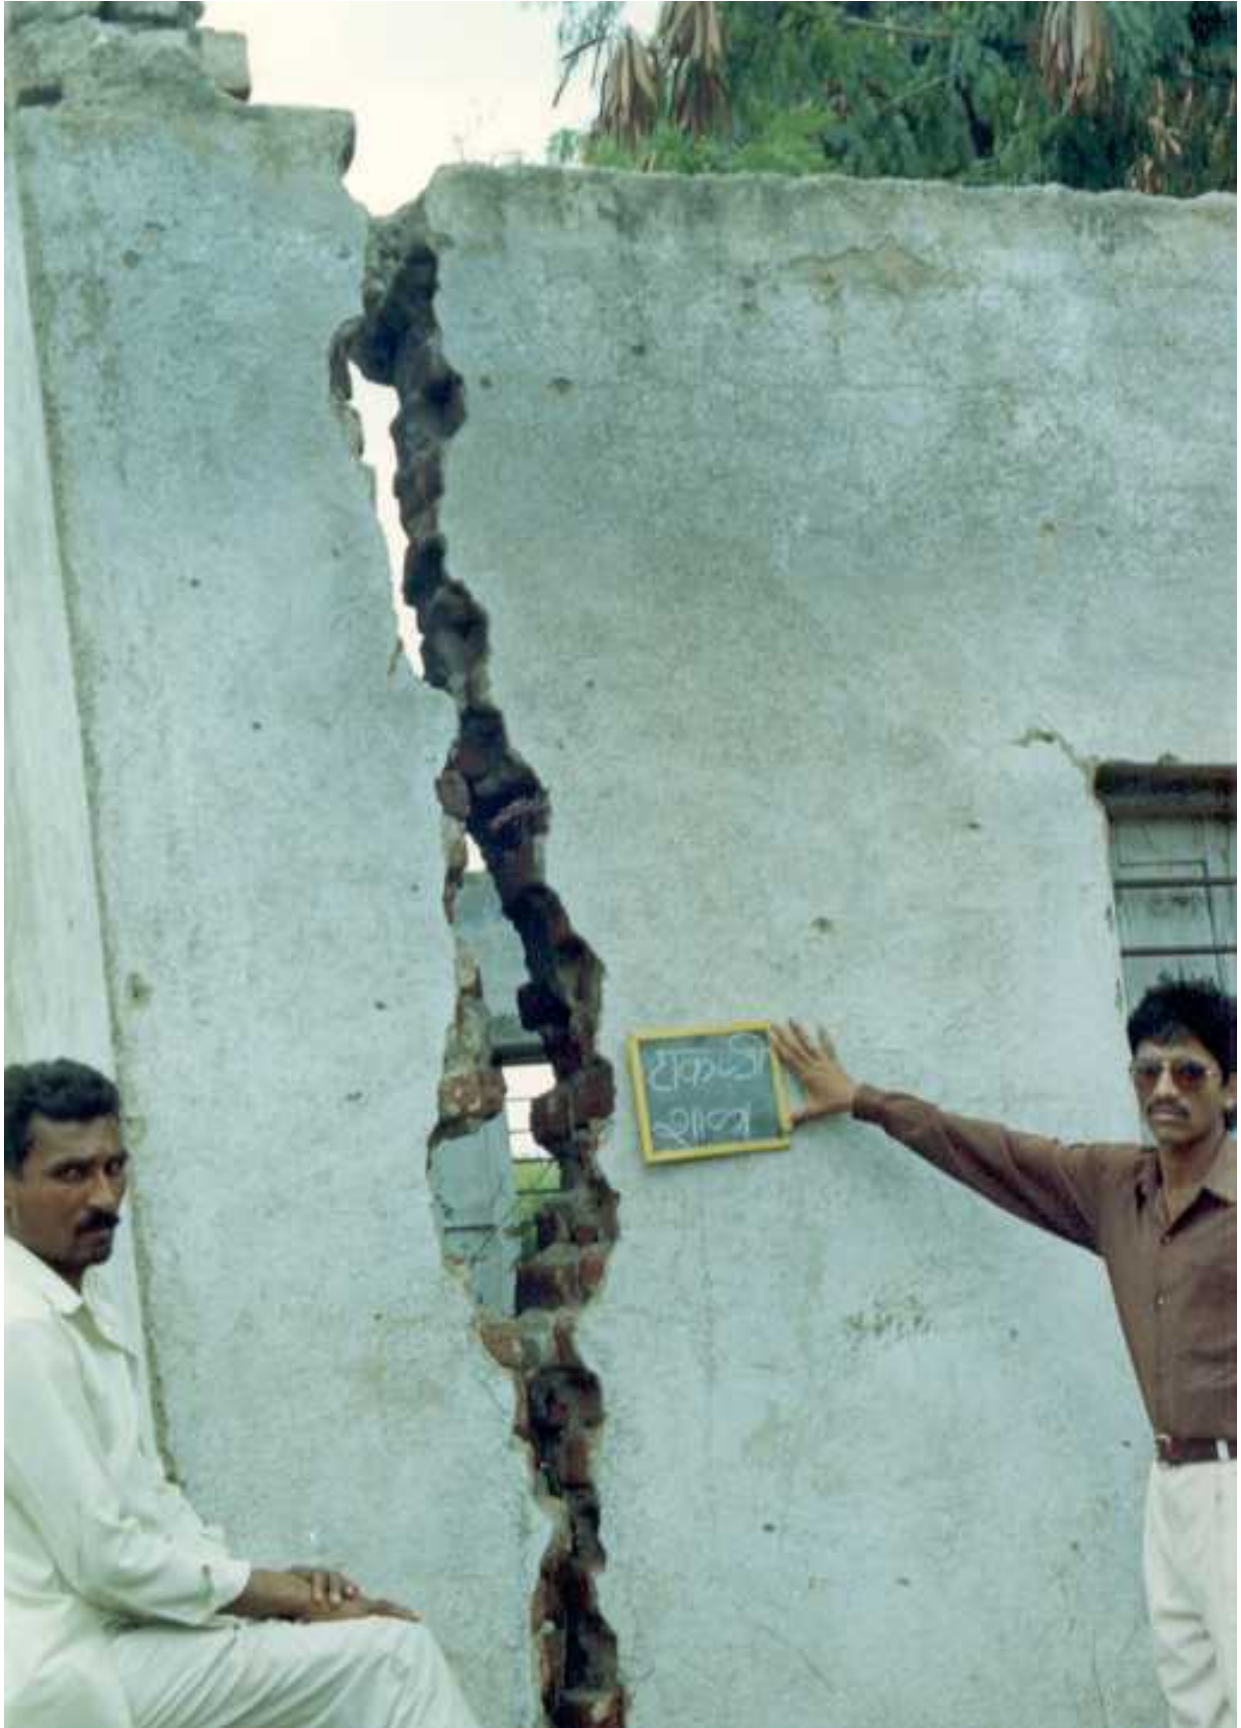
FIGURE 6D: Typical Earthquake Damage - Wall Corner Failure(1993 Killari earthquake)

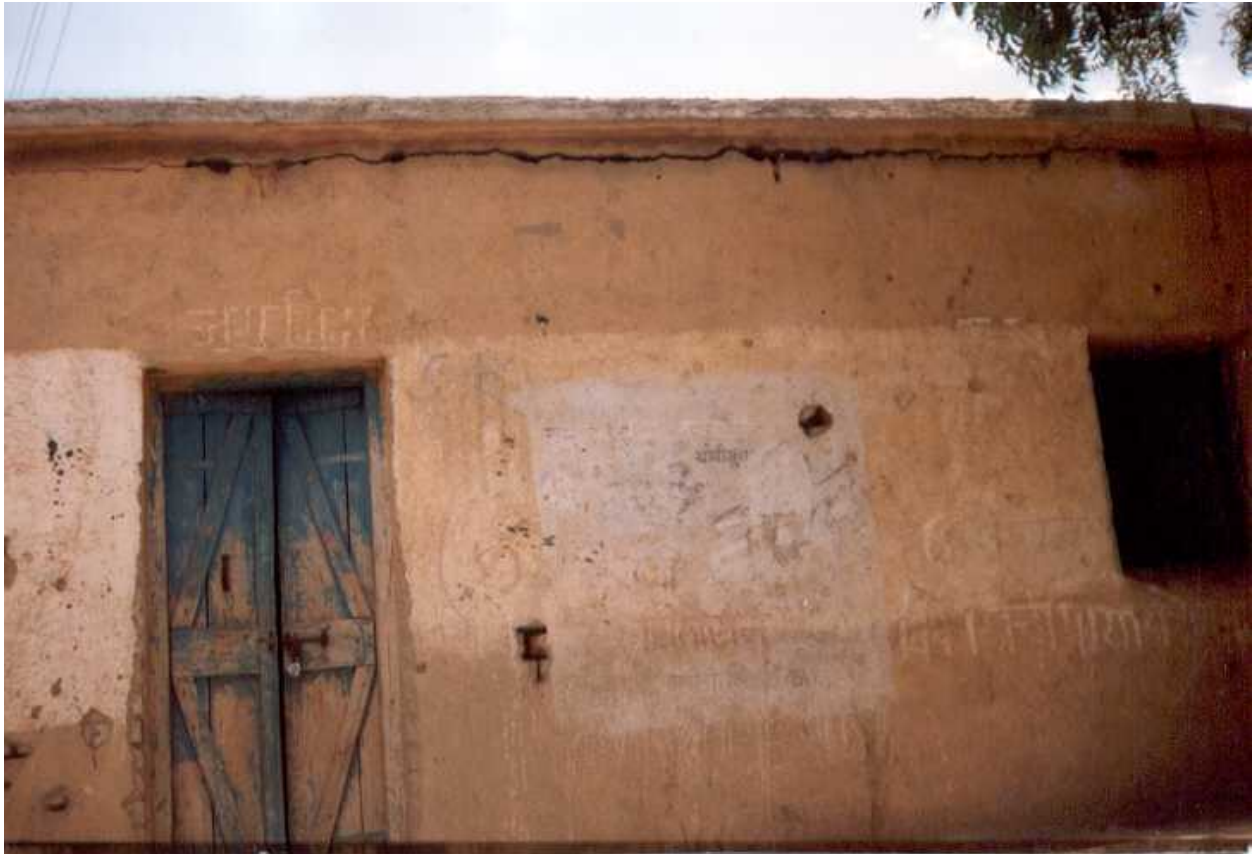
FIGURE 6E: Typical Earthquake Damage - Sliding Failure of Roof-Wall Connection Due to the Absence of Wall Reinforcement(1993 Killari earthquake)

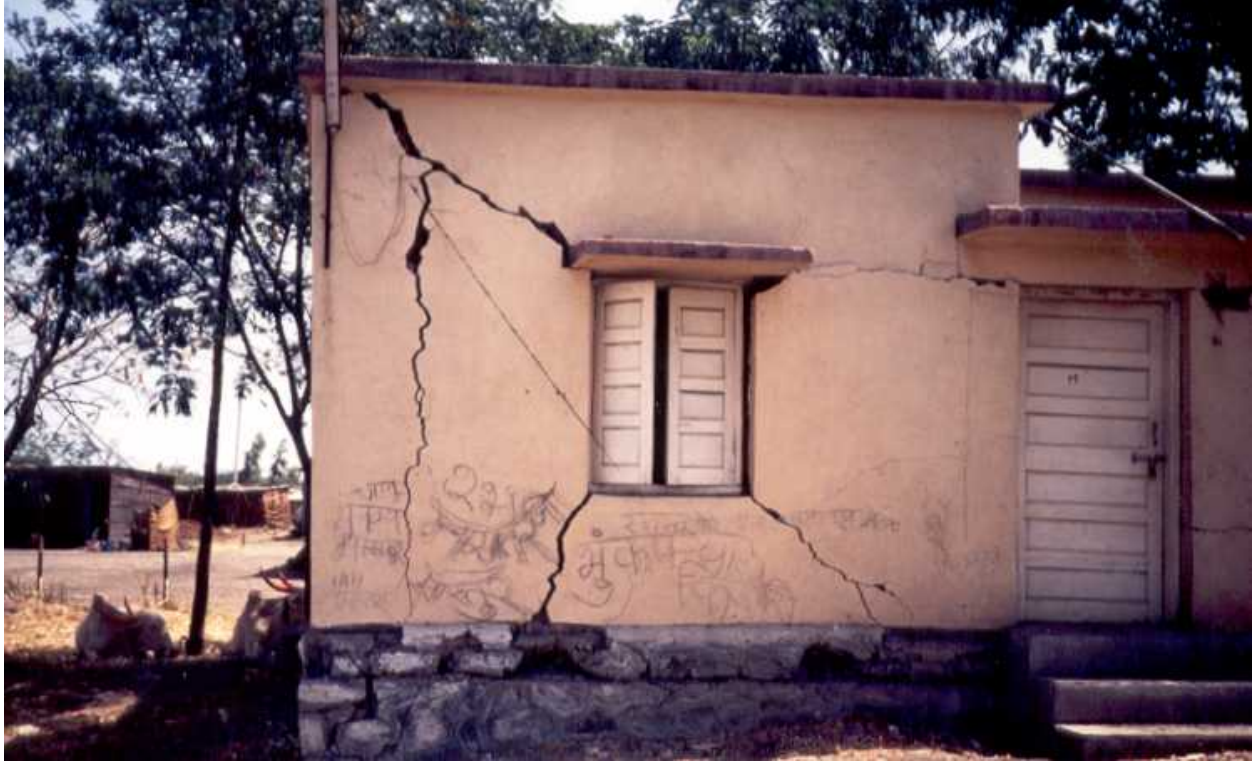
FIGURE 6F: Typical Earthquake Damage - In-Plane Wall Cracking(1993 Killari earthquake)

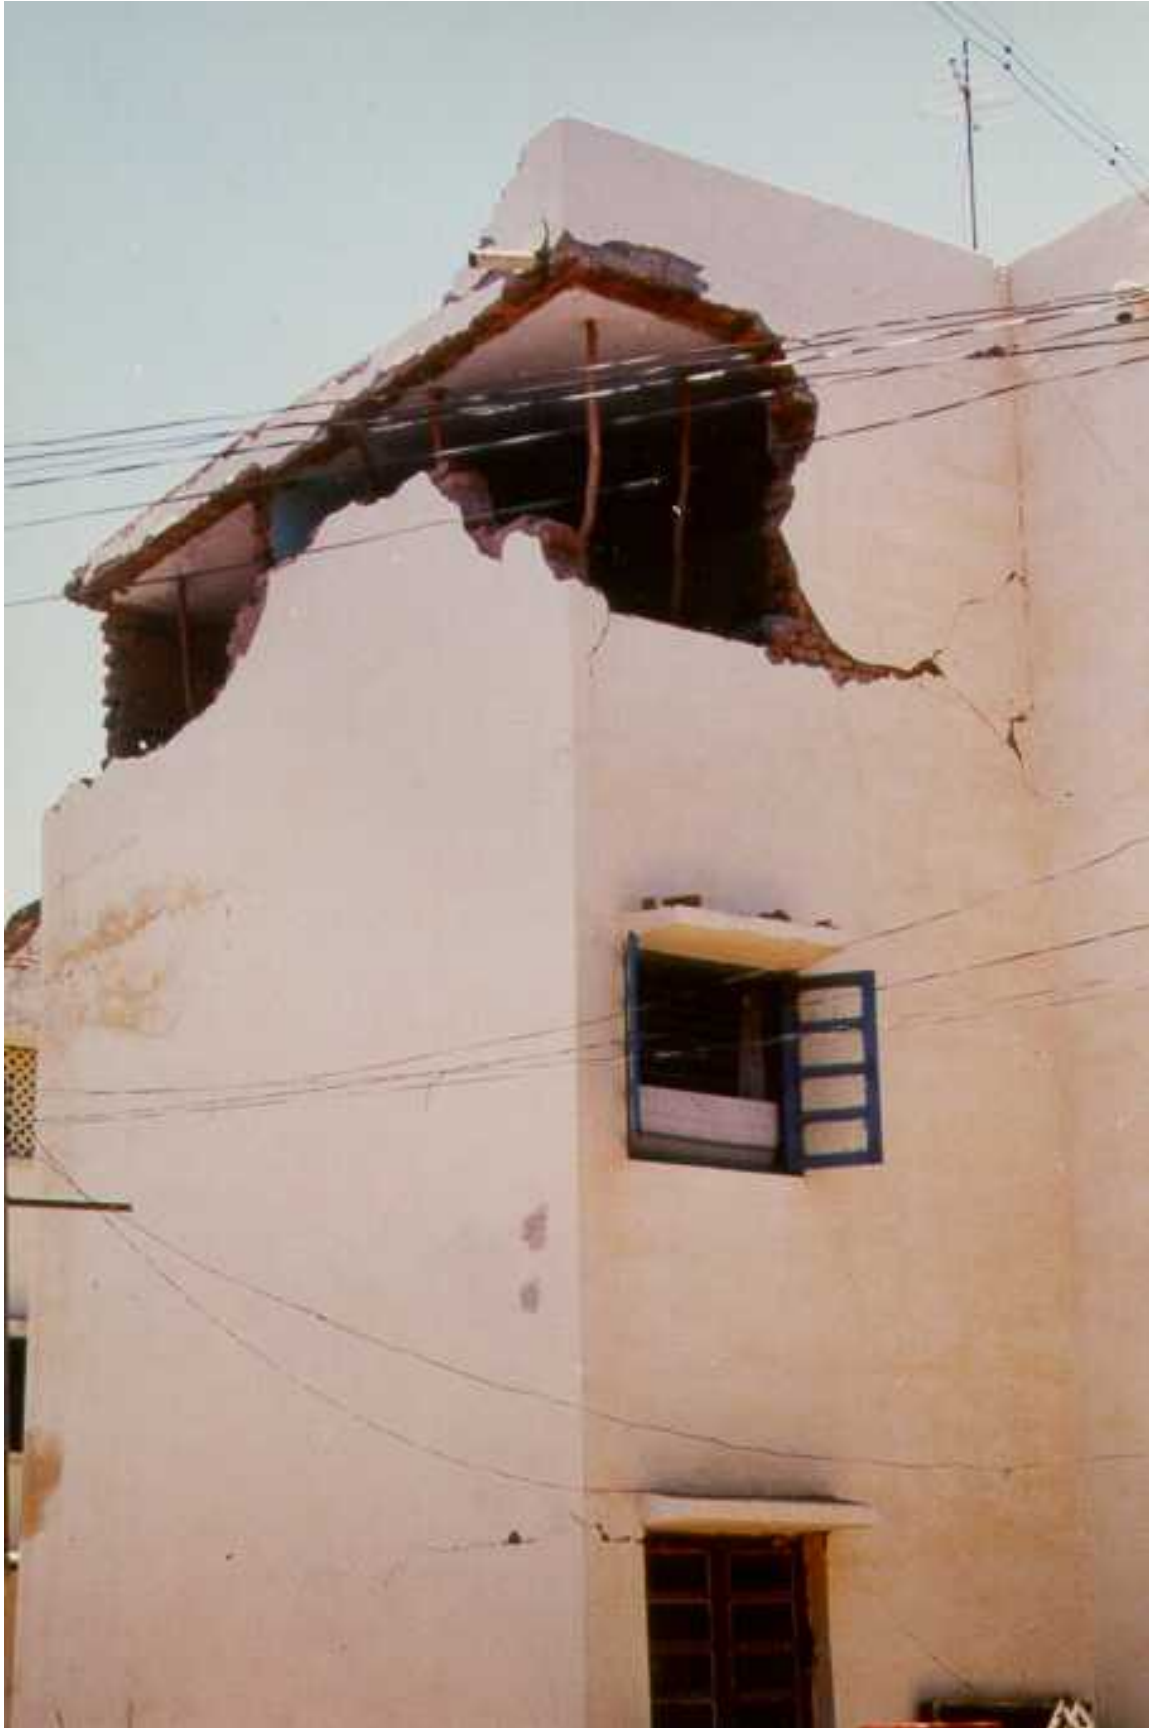
FIGURE 6G: Partial Building Collapse in the 1997 Jabalpur earthquake

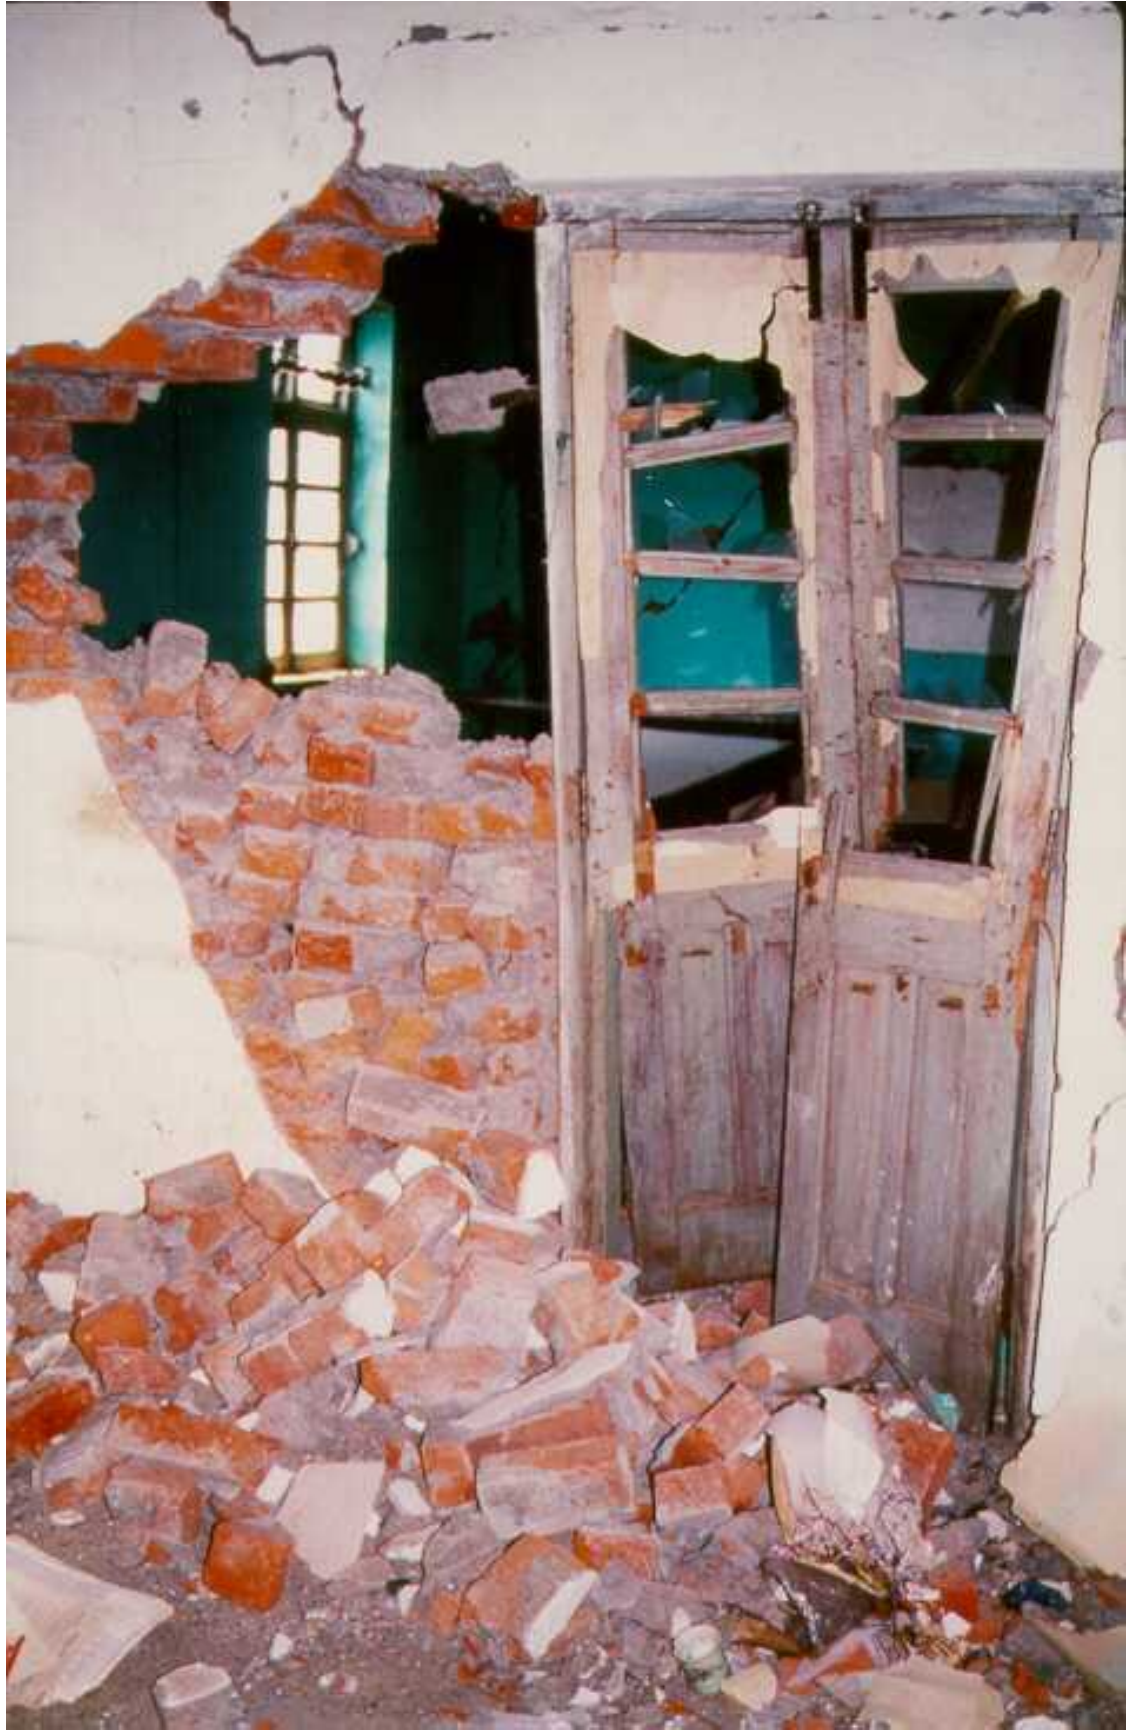
FIGURE 6H: Failure of Brick Masonry Walls in the 1997 Jabalpur Earthquake

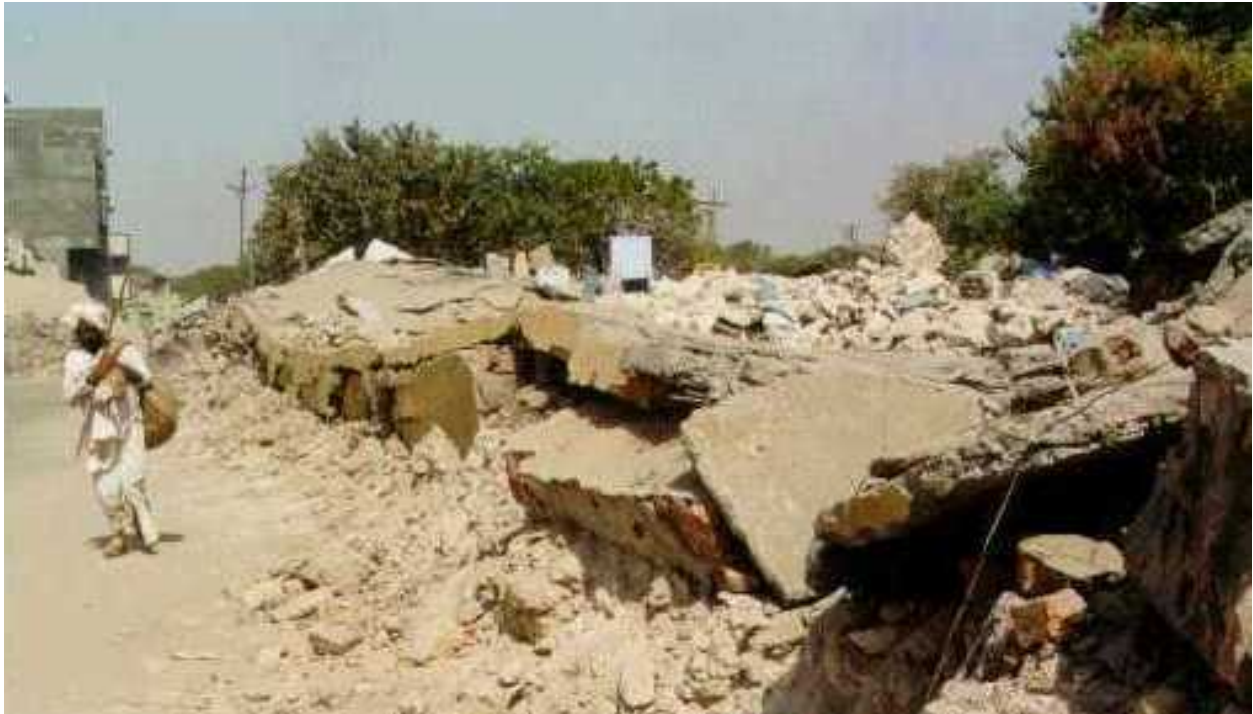
FIGURE 6I: Collapse of Brick Masonry Buildings in the 2001 Bhuj earthquake (Source: IIT Powai, 2001)
