World Housing Encyclopedia Report

Country: India

Housing Type: Unreinforced brick masonry building with reinforced concrete roof slab

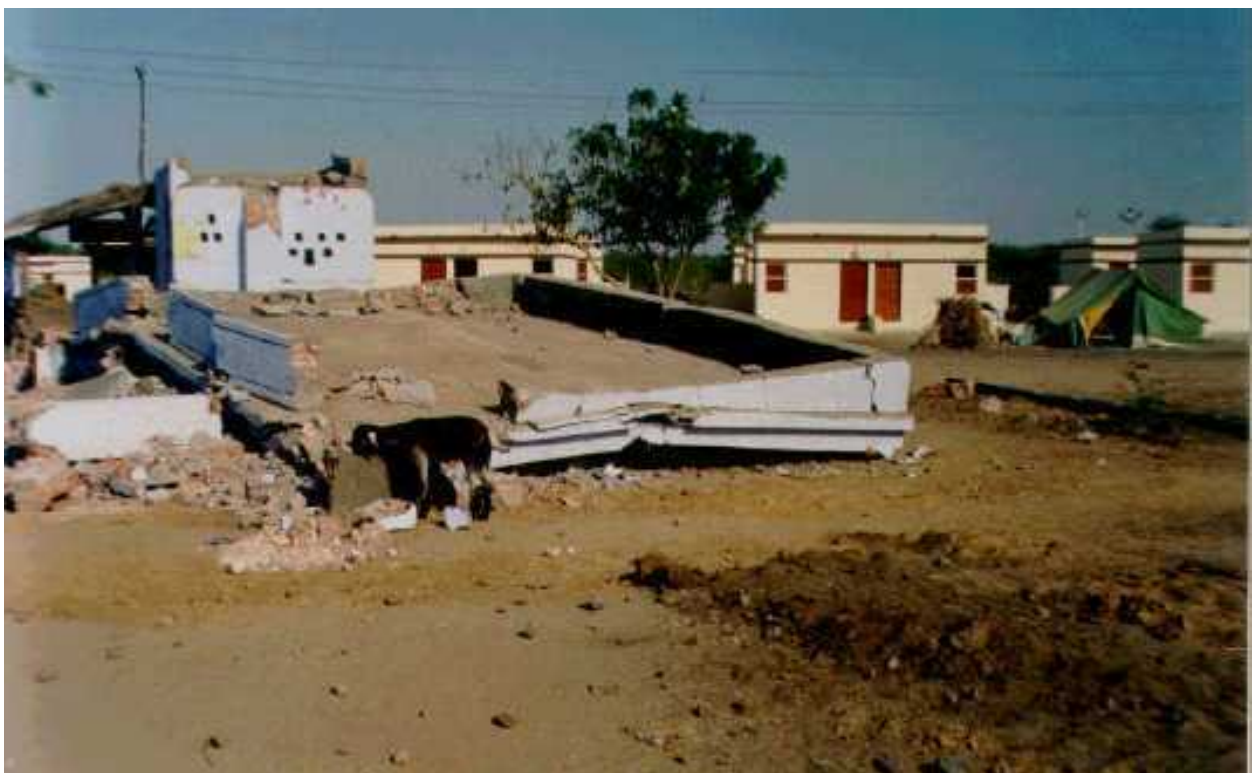
FIGURE 6J: View of a collapsed traditional brick masonry building in cement mortar (foreground) and masonry building with lintel bands which sustained only a moderate damage in the 2001 Bhuj earthquake (Source: IIT Powai, 2001)

Additional Comments: Building construction of this type (without seismic provisions) suffered significant damage during Koyna (1967) and Killari (1993) earthquakes. Some damage was also observed during Jabalpur (1997) earthquake. The main damage patterns consisted of: shear cracks in walls, mainly starting from corners of openings; partial out of plane collapse of walls; partial caving-in of roofs due to collapse of supporting walls, and shifting of roof from wall due to torsional motion of roof slab. This construction has experienced moderate to very heavy damage in the 2001 Bhuj earthquake (M 7.6). In the epicentral region several buildings of this type suffered total collapse of the walls resulting in the death and injury to a large number of people. The overall building performance was dependent on the type of roof system: buildings with lightweight roof suffered relatively less damage while buildings with RC roofs suffered much greater damage (Source: IIT Powai 2001). Importance and effectiveness of seismic provisions was confirmed both in the 1993 Killari earthquake and the 2001 Bhuj earthquake. A building with RC lintel band (located in the Killari village only few kilometers away from the epicentre) shown on Figure 5a sustained the earthquake effects with a minor damage while large majority of other buildings in the same village collapsed, causing over 1,400 deaths. Similarly, unreinforced masonry buildings with RC bands sustained the effects of the 2001 Bhuj earthquake with moderate damage while the neighbouring buildings of similar construction without seismic provisions collapsed (see Figure 6J).

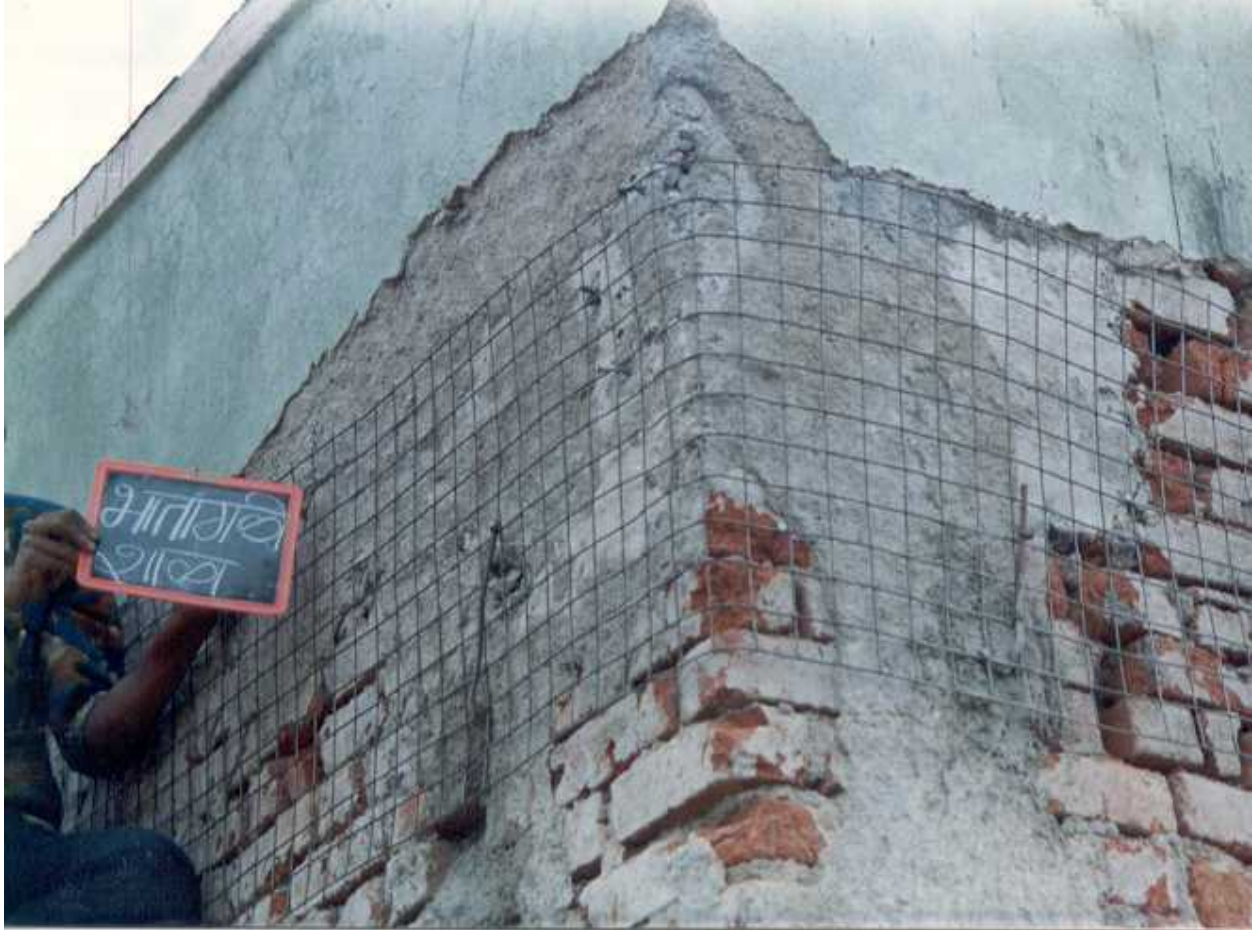
FIGURE 7B: Seismic Strengthening Techniques - Lintel Bandage

Type of intervention	Structural Deficiency	Description of seismic strengthening provision used
Retrofit (Strengthening)	Lack of integrity (box-type action)	Installation of seismic belt (bandage) at the lintel level; it consists of welded wire mesh installed above the lintel level and anchored to the wall. The mesh is covered with a thin cement plaster overlay (see Figure 7B)
	Cracks in the walls	In case of small cracks, pressure injection of epoxyh grout; in case of large cracks, filling the gaps with cement grout and jacketing with reinforced cement overlay. (Source: IAEE 1986), see Figure 7H.
	Inadequate wall resistance (shear and tensile)	Reinforced concrete jacketing. Difficult to find skilled labor and materials for welded wire mesh in rural areas
	Flexible floor/roof diaphragm (Corrugated metal sheets/timber)	Installation of RC roof band (bond beam). Provision of roof band is expected to enhance the overall integrity and improve torsional resistance of building

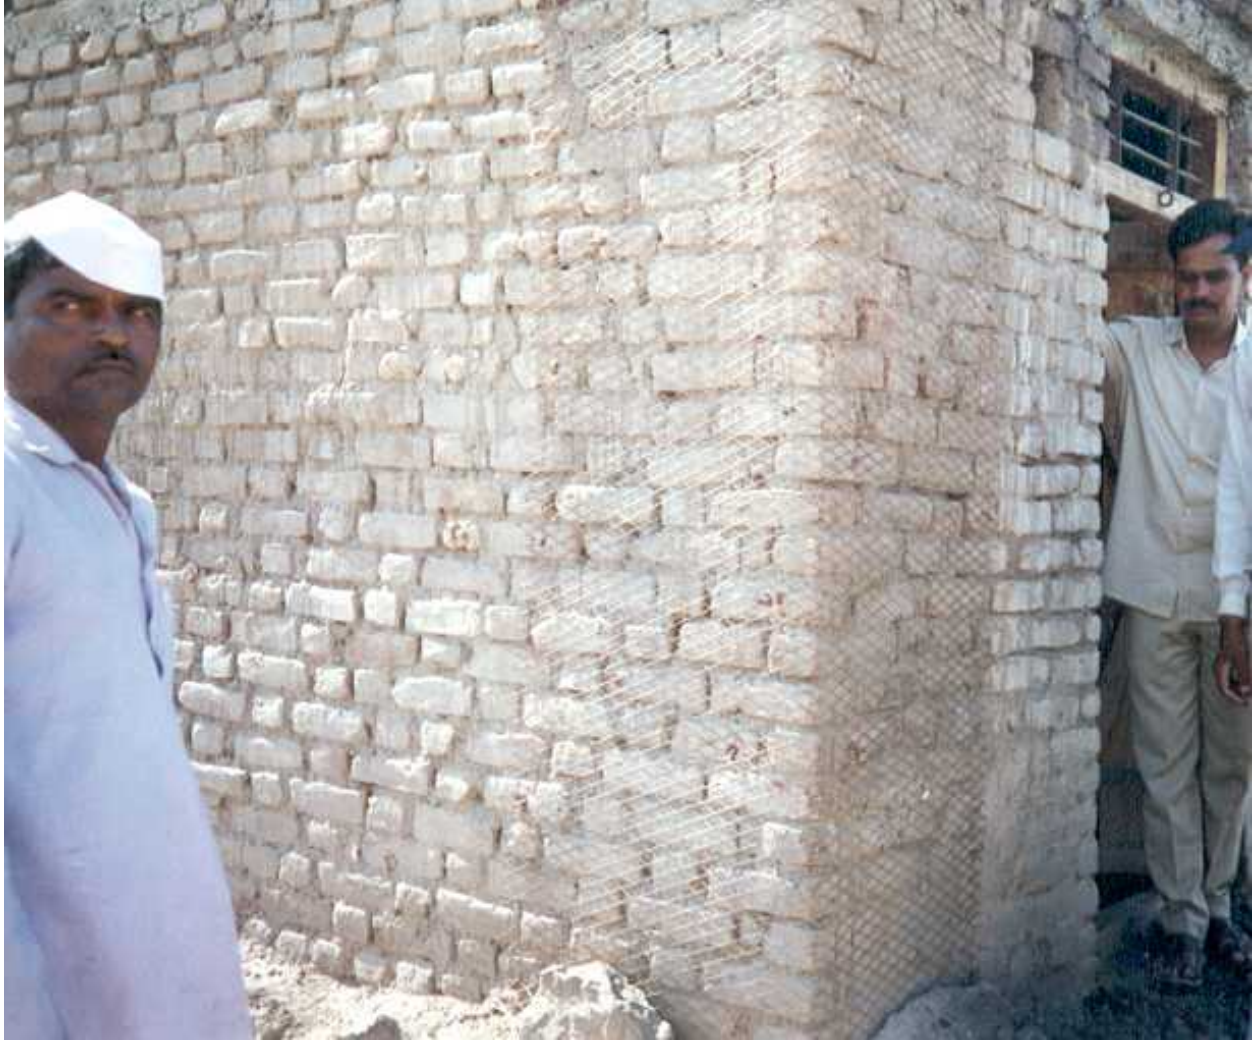
FIGURE 7C: Seismic Strengthening Techniques - Corner Strengthening

Cracking/damage of wall corners (due to improper interlocking of cross walls)	Corner strengthening of wall corners - installation of welded wire mesh anchored to the walls with steel dowels and covered with a thin cement plaster overlay (GOM 1998), see Figure 7C.
New Construction	Roof	Reinforced concrete roof band; provision of roof band results in an improved overall integrity and torsional resistance of the building.
	Wall	RCC lintel band; very effective, however skilled labour and materials may not be available, see Figures 7D, 7E and 7F
	Wall	Improved quality of masonry (bricks and mortar) use of better quality bricks will drastically improve the wall seismic resistance; use or richer cement/sand mortar will improve wall shear resistance.
	Wall	Provision of vertical reinforcement at wall corners and intersections, see Figure 7G (Source: IAEE 1986)

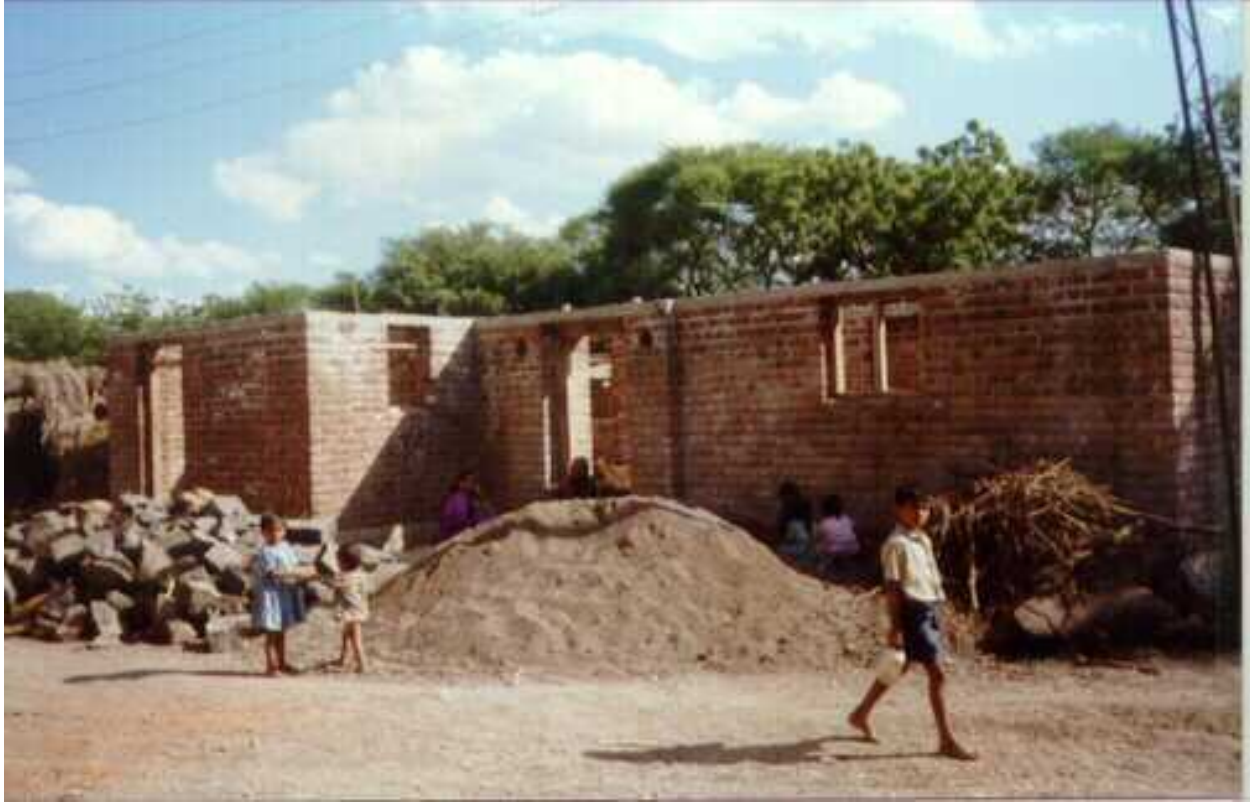
FIGURE 7D: An Example of New Construction with Seismic Features (note RC lintel band)

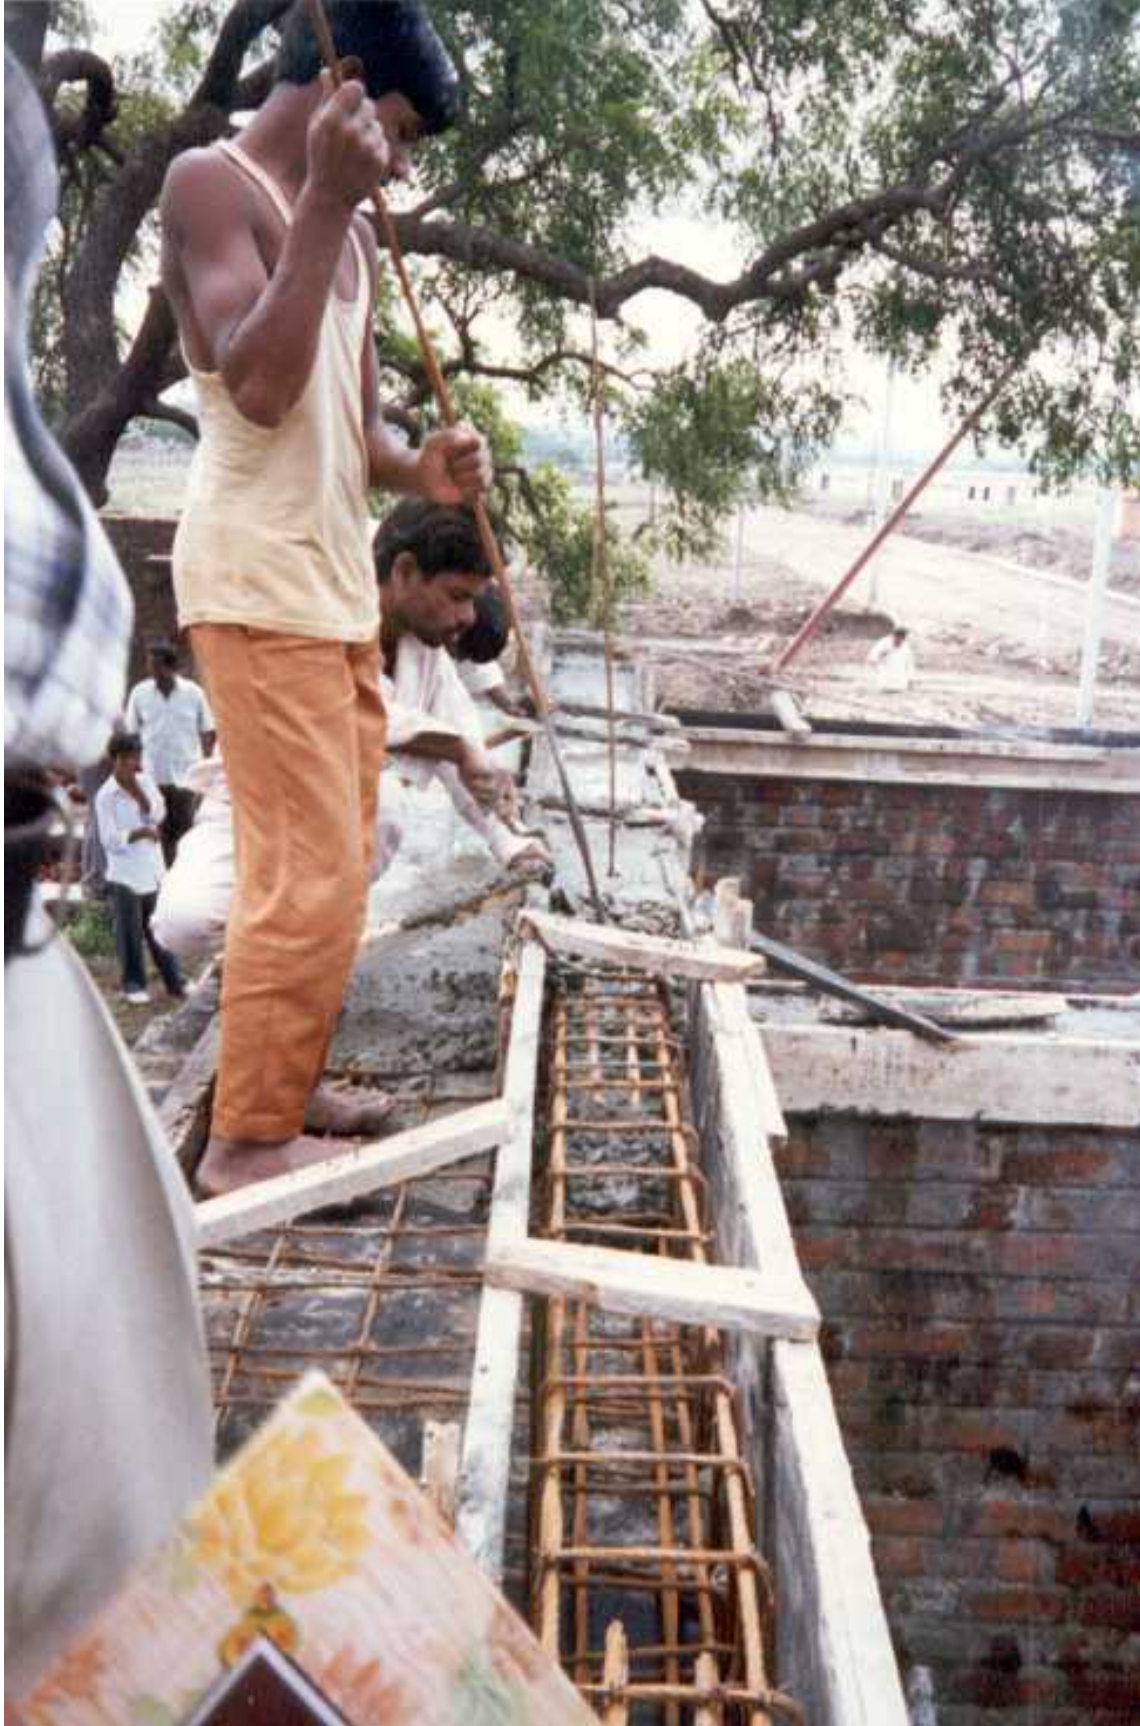
FIGURE 7E: Construction of RC Lintel Band

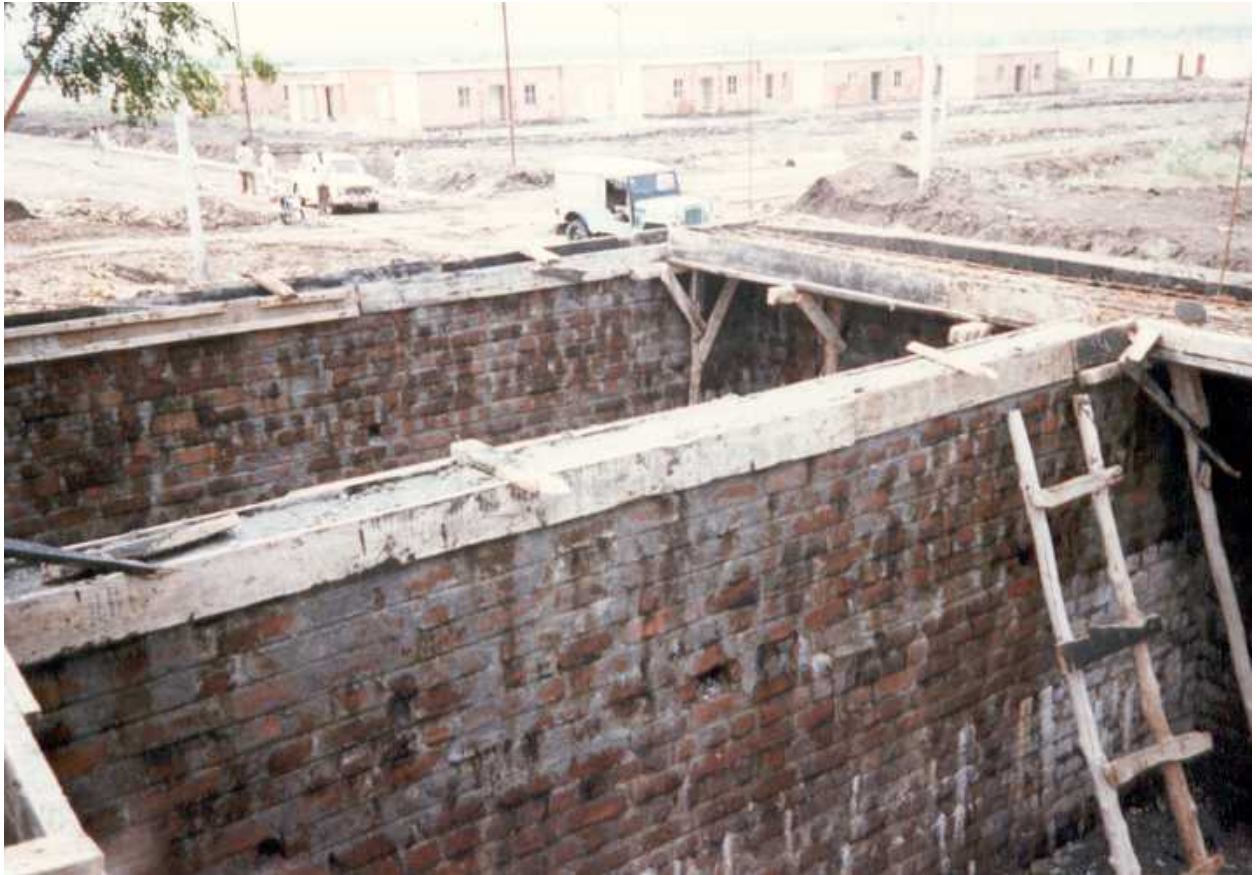
FIGURE 7F: Construction of RC Lintel Band - Pouring of Concrete Completed
