#05068C: Product Safety - Front Wheel Speed Sensor Corrosion - (Mar 6, 2008)

Subject:	05068C FRONT WHEEL SPEED SENSOR CORROSION
Models:	1999-2002 CHEVROLET SILVERADO
	2000-2002 CHEVROLET TAHOE, SUBURBAN
	2002 CHEVROLET AVALANCHE
	1999-2002 GMC SIERRA
	2000-2002 GMC YUKON, YUKON XL
	LOCATED IN THE SEVERE CORROSION AREAS LISTED
	BELOW

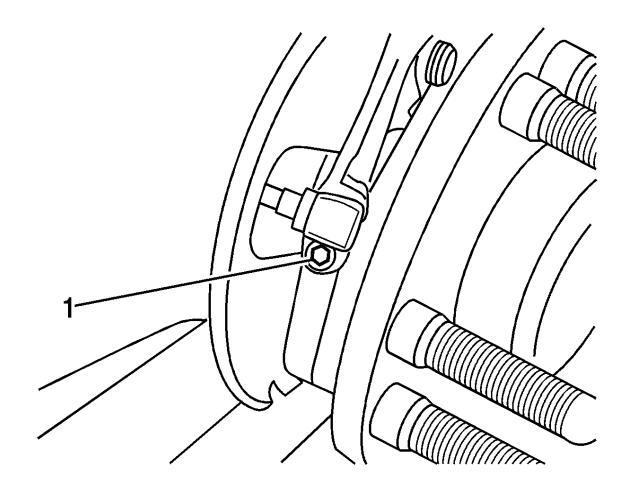
9. Remove the bolt (1) that attaches the wheel speed sensor to the bearing hub.

Notice: Carefully remove the sensor by pulling it straight out of the bore. DO NOT use a screwdriver or other device to try to pry the sensor out of the bore. Prying will cause the sensor body to break off in the bore.

10.Remove the wheel speed sensor from the bearing hub assembly.
