#08-07-30-021H: Loss of High Speed GMLAN Communications, Intermittent No Crank, IP Gauge Fluctuation, Intermittent Door Lock Cycling / Chime Operation, Various IP Warning Lamps Illuminated, Transmission May Not Shift, Communication DTCs U0073, U0100, U0101, U0102, U0109, U0121 or U0140 Set - (Jun 25, 2015)

Subject: Loss of High Speed GMLAN Communications, Intermittent No Crank, IP Gage Fluctuation, Intermittent Door Lock Cycling, Intermittent Chime Operation, Various IP Warning Lamps Illuminated, Transmission May Not Shift, Engine May Stall, Communication DTCs U0073, U0100, U0101, U0102, U0109, U0121 or U0140 Set (Repair Terminals in Transmission Harness Connector, Repair Open or Shorted GM High Speed LAN Circuits, Open or Shorted Data Link Resistor, Corrosion or Poor Connections in Various Control Module Connectors)

Models: 2007-2009 Cadillac XLR

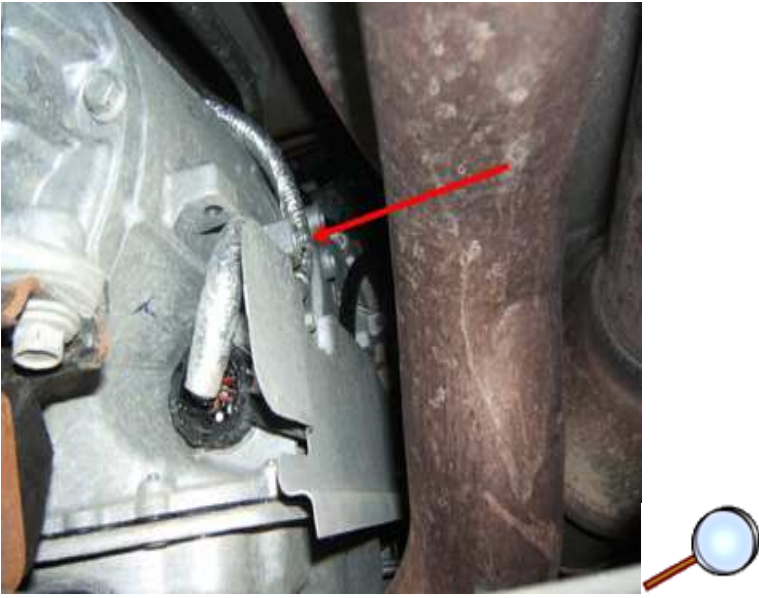
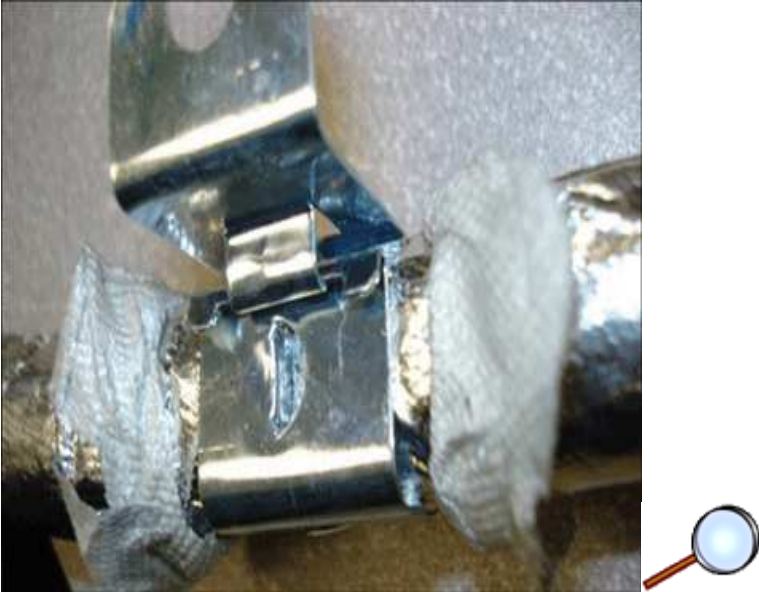
3. Locate the 16-way electrical connector on the right side of the automatic transmission as shown.
4. Inspect for chafed, damaged, pinched, open or shorted wiring within the conduit of the harness where it is secured at the transmission by a metal attachment clip as shown. Inspect any wiring harness where these metal attachment clips are used on the vehicle as needed.
 - ⇒ If the wiring is damaged, repair as needed. Refer to Power and Signal Distribution > Wiring Systems and Power Management > Diagnostic Information and Procedures in SI. Protect the conduit by covering any sharp edge with butyl tape and the conduit and wiring harness with woven polyester (PET) electrical tape. Secure the harness as needed.

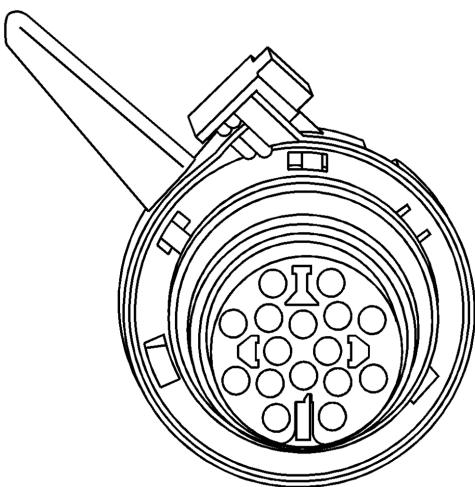
5. **Before** disconnecting the 16-way connector, **inspect** for any backed out terminals (1) as shown. Fully seated terminals (2,3) are shown for comparison.
 - 5.1. If a backed out terminal (1) is found, identify the terminal(s) on the **repair order**.
 - 5.2. Look at the connector in order to identify the number of the cavity with the backed out terminal. Refer to Wiring Systems and Power Management > Component Locator > Master Electrical Component List in SI.

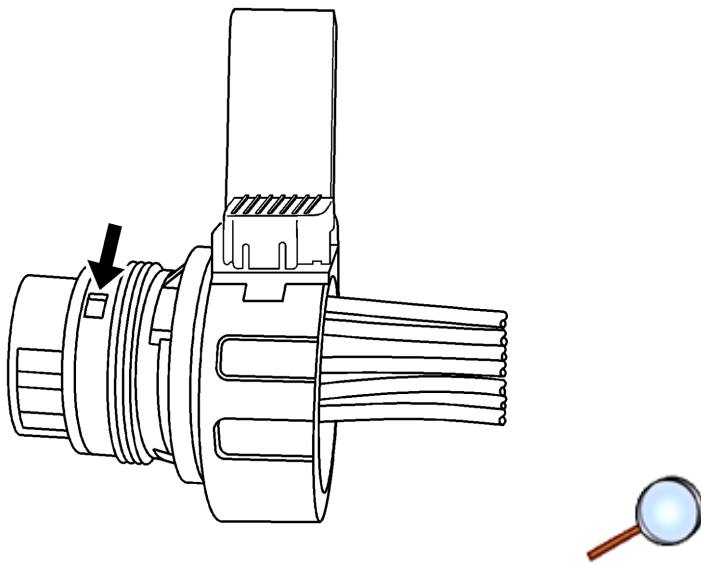
7. **Inspect** for any backed out terminals (3) as shown. Fully seated terminals (1,2) are shown for comparison.
 - 7.1. If a backed out terminal (3) is found, identify the terminal(s) on the **repair order**.
 - 7.2. Look at the connector in order to identify the number of the cavity with the backed out terminal. Refer to Wiring Systems and Power Management > Component Locator > Master Electrical Component List in SI.
8. Repair or replace the terminal(s) as necessary using the following procedure:

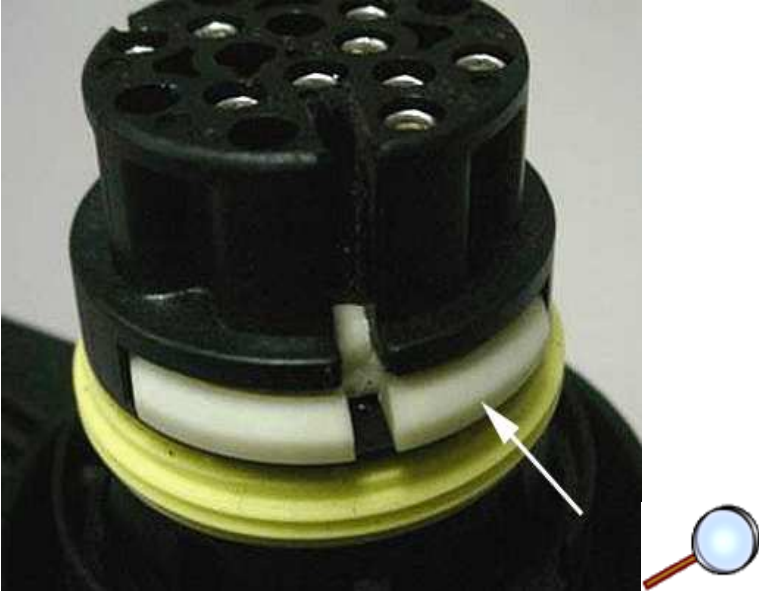
Locate the TPA lock in the reassembled transmission connector. Refer to the arrow in the illustration above, which points to a TPA lock. This one is in an unseated position. Using a small flat blade tool, push to seat the TPA until it bottoms out. Verify the TPA is fully seated.

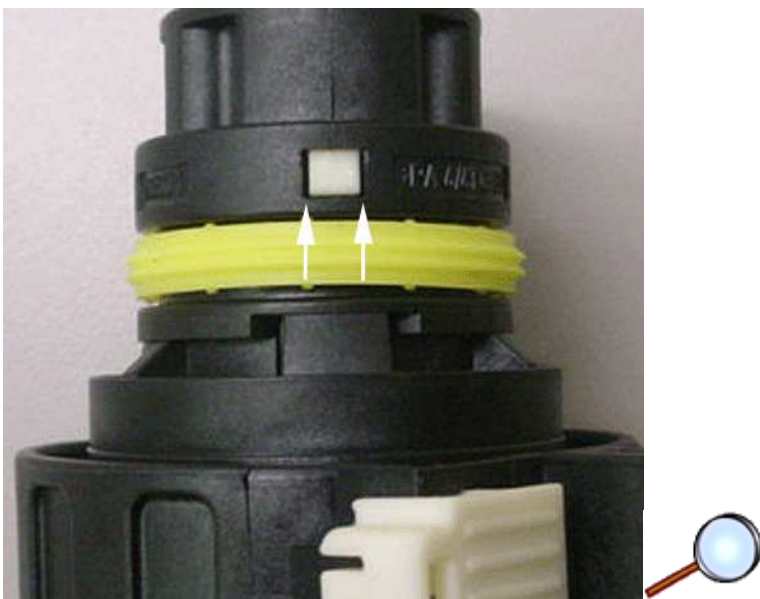
- If the TPA lock is centered in the window as shown, then it is fully seated. The gaps shown by the arrows should be even on both sides.

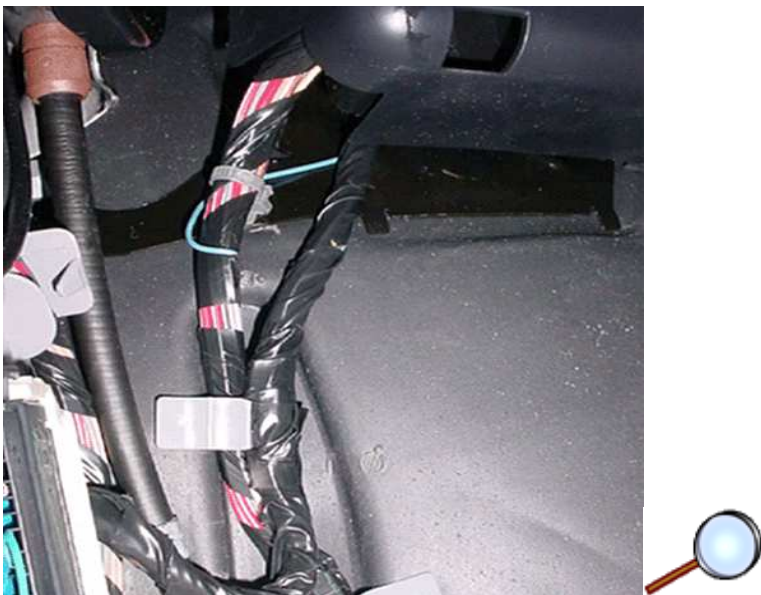
4. Inspect how the IP branch to C202 is routed. Route the harness as necessary to match the correct routing in the photo as shown. In order to route the IP harness branch correctly (behind the junction block-left I/P), remove the cover from the junction block-left I/P and unseat the junction block from the bracket.
5. Disconnect C202. Route the harness so that it lies between the "goalposts" of the junction block bracket. Seat the junction block to the bracket. The harness will now be under the junction block.
6. Secure the harness by seating the grey offset retaining clip to the dashmat (or brown "buddy clip" if present - usually on SUV's only). Reconnect C202.
7. Clear any DTCs that may be present with a scan tool and verify the proper operation of the vehicle.

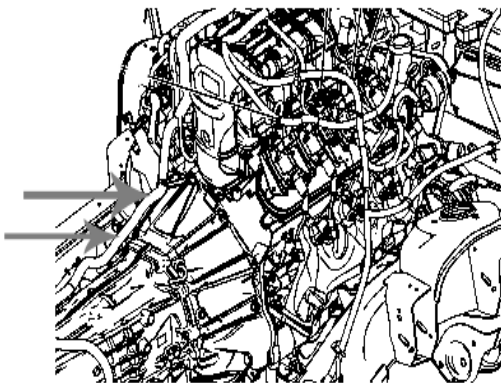
Chafed Wiring Harness at Transmission

6. Lower the transmission sufficiently to provide access to the engine wiring harness where it routes from the engine intake manifold to the transmission bell housing as shown.
7. Release the wiring harness conduit from the retainers that secure it to the transmission and/or transfer case.

8. Examine the harness for wiring that may be exposed outside of the conduit. Inspect all areas for chafed, damaged, pinched, open or shorted wiring as shown. If damage to the wiring is not observed, then extract the wiring from the conduit and inspect all remaining areas as needed.

- ⇒ If the wiring is damaged, repair as needed. Refer to Power and Signal Distribution > Wiring Systems and Power Management > Diagnostic Information and Procedures > Wiring Repairs in SI. Protect the conduit by covering any sharp edge with butyl tape and the harness with woven polyester (PET) electrical tape. Secure the harness as needed.

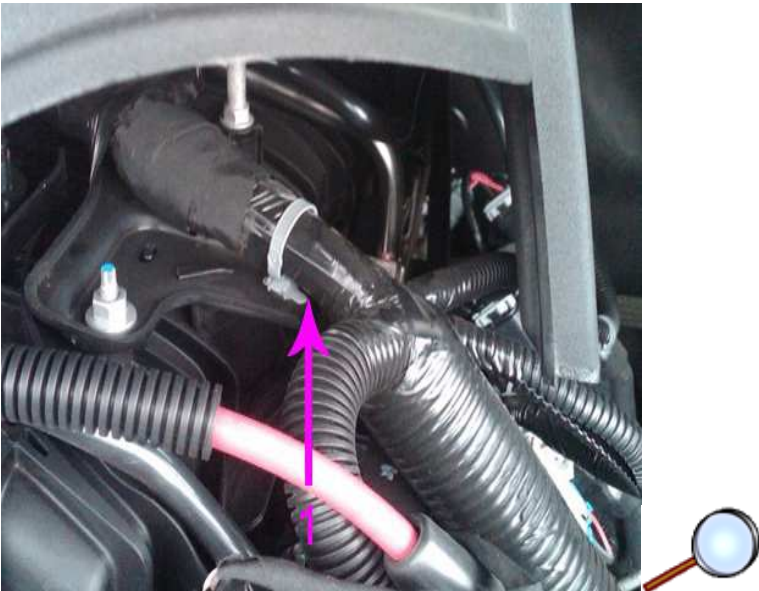
Chafed ECM Wiring Harness From Bracket Contact Near Engine Intake Manifold

3. Locate the portion of the engine wiring harness where it branches off from the intake manifold to the ECM in the area shown (1).

4. Inspect the wiring harness for damage from contact with the steel bracket (1).
⇒ If the wiring is damaged, repair as needed. Refer to Power and Signal Distribution > Wiring Systems and Power Management > Diagnostic Information and Procedures > Wiring Repairs in SI.
5. Cover any sharp edge on the bracket with butyl tape and the harness with woven polyester (PET) electrical tape.

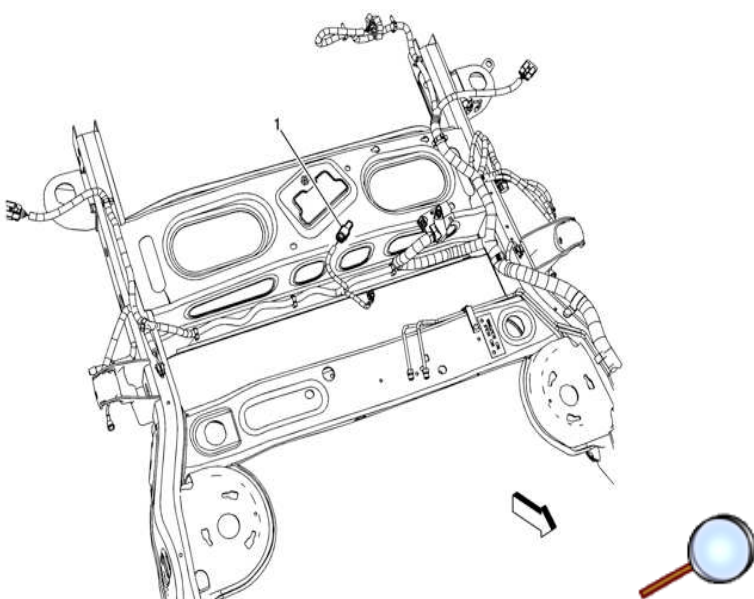
Typical Location of Terminator Resistor (1) Short Wheel Base Vehicle

3. On the vehicle being serviced, observe the location of the terminator resistor. Inspect the wiring harness leading to the terminator resistor, for chafed, damaged, pinched, open or shorted wiring.

- ⇒ If the wiring is damaged, repair as needed. Refer to Power and Signal Distribution > Wiring Systems and Power Management > Diagnostic Information and Procedures. Protect the conduit by covering any sharp edge with butyl tape and the harness with woven polyester (PET) electrical tape. Secure the harness as needed.

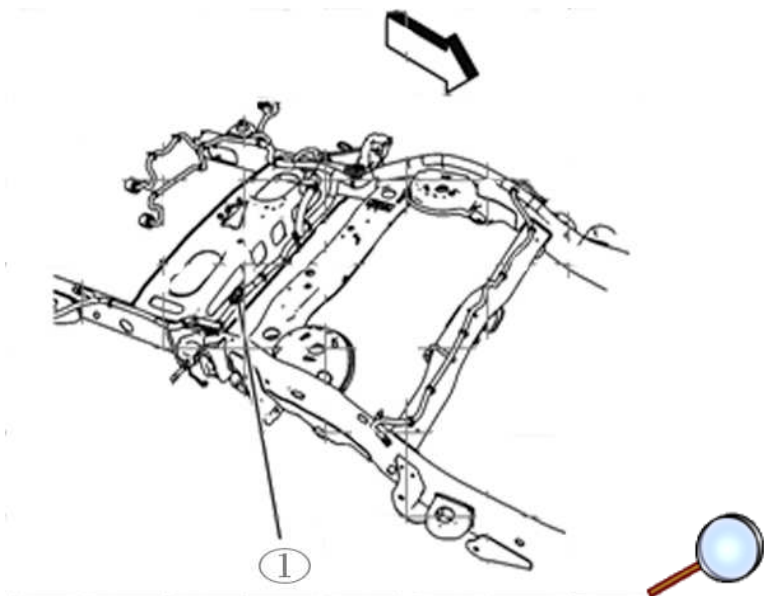
Typical Location of Data Link Resistor 1 (1) Short and Long Wheel Base Vehicles

3. On the vehicle being serviced, observe the location of the data link resistor 1 (1). Inspect the wiring harness leading to the data link resistor 1, for chafed, damaged, pinched, open or shorted wiring.

- ⇒ If the wiring is damaged, repair as needed. Refer to Power and Signal Distribution > Wiring Systems and Power Management > Diagnostic Information and Procedures. Protect the conduit by covering any sharp edge with butyl tape and the harness with woven polyester (PET) electrical tape. Secure the harness as needed.

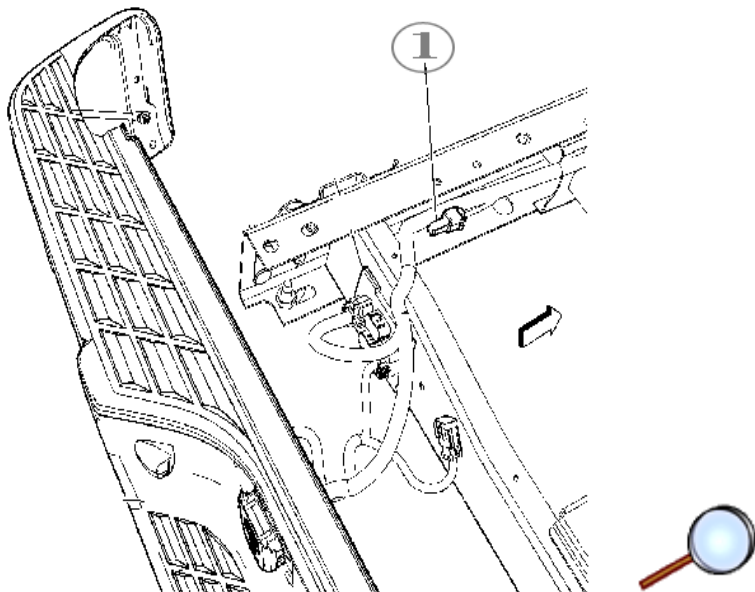
Rear Chassis Mounted Data Link Resistor 1 Chafed Wiring Harness Causing Intermittent No/Crank and/or Scan Tool Does Not Communicate with High Speed GMLAN Device

3. Typical location of a data link resistor 1 (1) mounted on the rear of the chassis.

4. Inspect the wiring harness leading to the rear data link resistor 1, between the truck box and frame for chafed, damaged, pinched, open or shorted wiring as shown.
 - ⇒ If the wiring is damaged, repair as needed. Refer to Power and Signal Distribution > Wiring Systems and Power Management > Diagnostic Information and Procedures. Protect the conduit by covering any sharp edge with butyl tape and the harness with woven polyester (PET) electrical tape. Secure the harness as needed. Proceed to Step 9.
 - ⇒ If the wiring is not damaged, proceed to Step 5.
5. Disconnect the electrical connector from the data link resistor 1.
6. Test the data link resistor 1 for 110–130Ω.
 - ⇒ If the resistance is not within the specified range, replace the data link resistor 1 and proceed to Step 7.

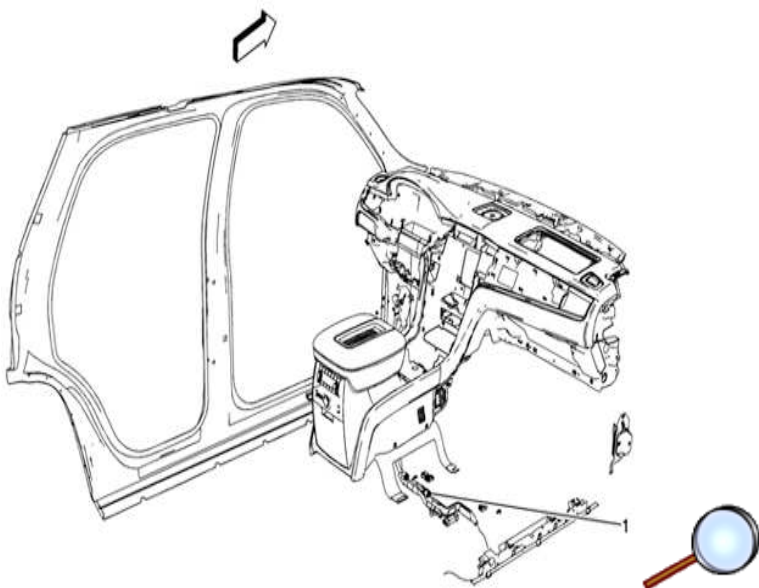
Hybrid Models (RPO HP2) Data Link Resistor 2

2. Inspect the harness leading to the data link resistor 2 (1) for chafed, damaged, pinched, open or shorted wiring. Refer to Power and Signal Distribution > Data Communications > Schematic and Routing Diagrams > Data Communication Schematics.
 - ⇒ If the wiring is damaged, repair as needed. Refer to Power and Signal Distribution > Wiring Systems and Power Management > Diagnostic Information and Procedures. Protect the conduit by covering any sharp edge with butyl tape and the harness with woven polyester (PET) electrical tape. Secure the harness as needed.
 - ⇒ If the wiring is not damaged, proceed to Step 3.
3. Disconnect the electrical connector from the data link resistor 2.

4. Test the data link resistor 2 for 110–130Ω.
 - ⇒ If the resistance is not within the specified range, replace the data link resistor 2 and proceed to Step 5.
 - ⇒ If the resistance is within the specified range, connect the electrical connector to the terminator resistor. Refer to Power and Signal Distribution > Data Communications > Scan Tool Does Not Communicate with High Speed GMLAN Device **OR** Diagnostic Trouble Code (DTC) List - Vehicle in SI.
5. Connect the electrical connector to the data link resistor 2. Secure the resistor as needed.
6. Clear any DTCs that may be present with a scan tool and verify the proper operation of the vehicle.
