#10-08-67-001C: Headliner Wet, Water Leak from Front or Rear Sunroof Glass or Rear Compartment Carpet Wet - (May 22, 2015)

Models: 2008-2016 Buick Enclave
2009-2016 Chevrolet Traverse
2007-2016 GMC Acadia
2007-2010 Saturn OUTLOOK

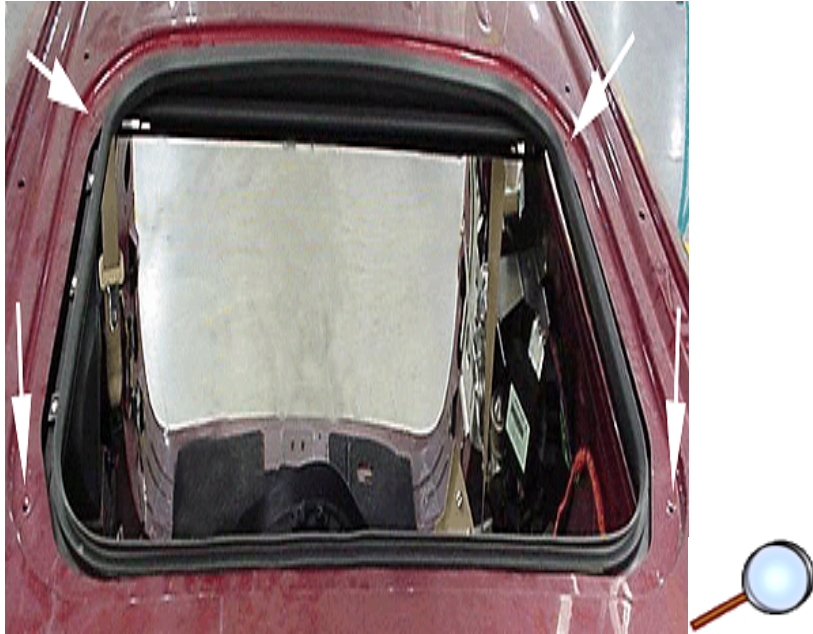
The primary cause of the leaks in this area could be a result of the rear stationary glass to body weather-strip, front glass weather-strip, or rear roof drains allowing too much water for the sunroof drain system to manage. When exceeding this threshold, the water overflows onto the headliner and into the vehicle.

Important: The sunroof fixed rear panel glass has been removed for illustration purposes.

Whether two or four holes are present, plug the stationary glass drain holes in the roof sheet metal using the following steps:

1. Lower the headliner following the procedure in SI.

2. Loosen the front sunroof module bolts half way. Remove the sunroof drains. Remove the remaining sunroof module bolts and lower the rear of the sunroof module assembly following procedures in SI.
