4R44E/55E and 5R44E/55E TCC Concerns How to Test the system

Torque converter concerns on 4R44E/4R55E/5R55E have been a constant concern. In recent years there have been a number of concerns related to torque converter apply as well as No cooler flow, Harsh TCC and Soft TCC engagement, No Lock-up or loss of TCC when hot. Diagnosing torque converter problems can be troublesome. The following pages have tips you can use to determine the fix.

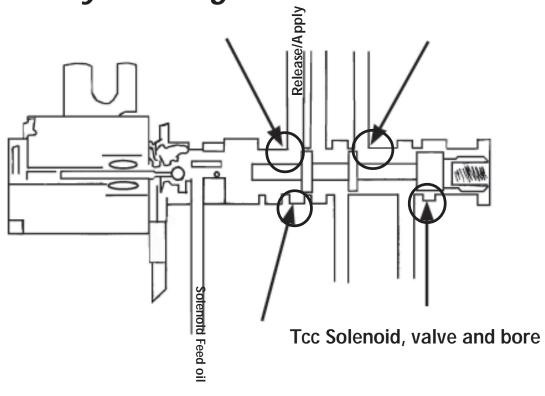
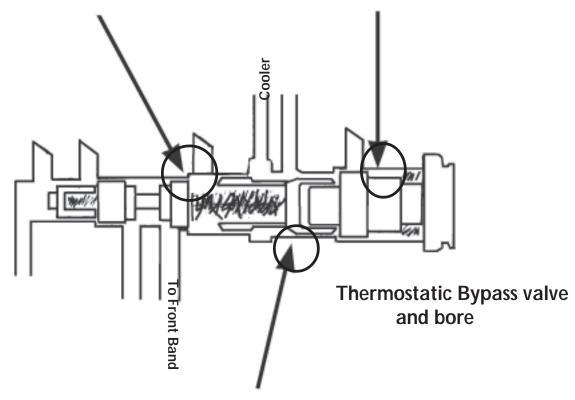
TCC Concerns (continued)
Valve Body Damage

Common Cause: Wear in the Valve Body.

Repair: Repair or Replace Valve Body.
