Remarkable case histories regarding S. Vitale church, Ravenna, Italy

A. Mazzucato^a, G. Ricceri^a, F. Selleri^b, M. Soranzo^c

The article presents a critical analysis of the results achieved in the study regarding the properties of the subsoil, the foundations and the evolution of the cracking phenomena occurring on the monument, enabling us to make plans concerning possible consolidation measures.

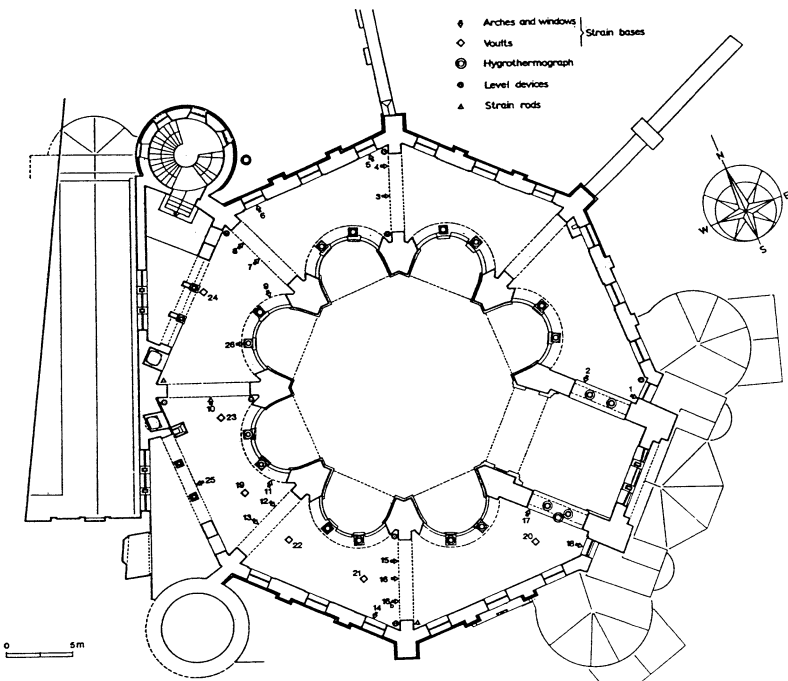
Fig. 5 - Floor plan of basilica of S. Vitale, indicating installation sites of survey instruments.

In order to check the movements of the buildings, a thorough analysis of cracking was performed. On the basis of the results, a certain number of cracks were chosen as sites for installing 27 strain bases, two hygrothermographs, eight level measurement devices and two deformation measurement rods set in place from the floor to the roof of the women's gallery (Fig.5). Deformation measurements were taken once a month. Temperature, relative humidity and sinking values were checked during the week in which the above deformation tests were performed.

Fracture movement trends on the various structural components ranged from 0.20 to 0.58 mm for the cross-arches, from 0.20 to 0.25 mm for the windows, from 0.10 to 0.20 mm for the cross-vault, and from 0.25 to 0.45 mm for the arches supporting the vaults between the central pillars.
