5ET50 Transmission Part Restriction

Secure Components Properly to Prevent Shipping Damage

The 2016-2017 Volt and Malibu Hybrid use the 5ET50 continuously-variable electric transmission (RPO MKE). As part of GM's process to gather important feedback for engineering improvements, the 5ET50 transmission is currently part of the component restriction program.

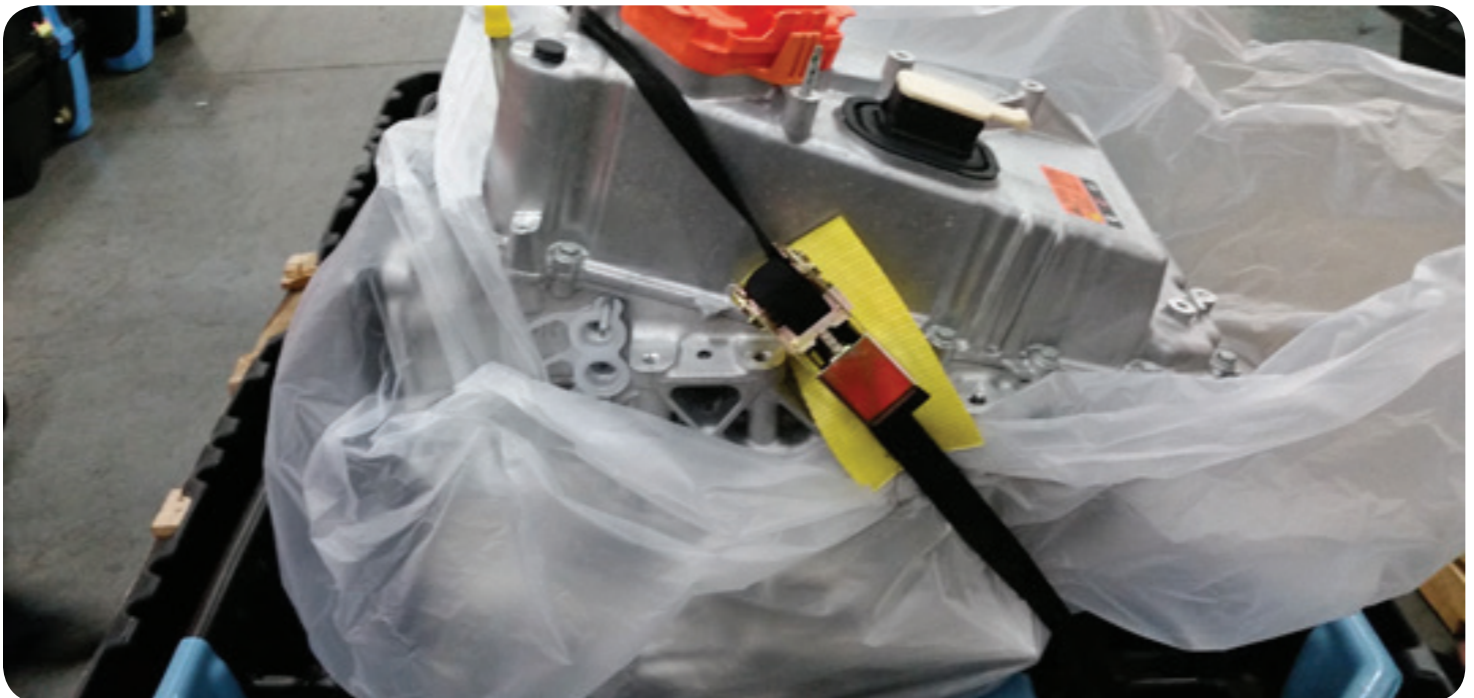
If the transmission is not secured properly in the shipping container, the connectors and other assembly components may be damaged.

Many returned transmissions have sustained damage during shipping, which hinders the diagnosis that can be performed on the transmission. Damage most often occurs due to the transmission moving in the shipping case.

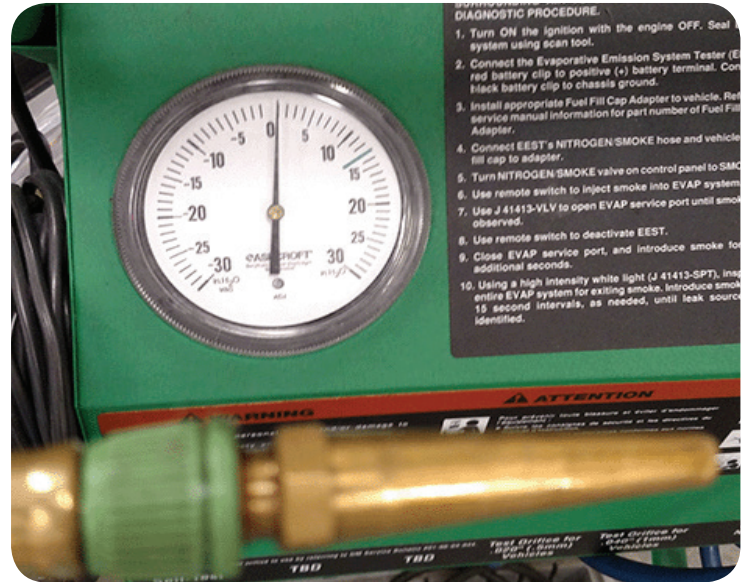
When testing for oil leaks, check for excessively positive or negative crankcase pressures using the Evaporative Emissions System Tester (EEST), J-41413. The EEST should be connected at the engine oil dipstick port.
