5R55S/W HD2 Reprogramming Kit ®

Fits: 5R55S/W 2002-10 Does NOT fit 5R55N

This kit is about: Upgraded Performance,
Reduces/Prevents: Won't Move - Pump Noise,
No Lockup Hot, Lockup Slip/Shudder
Prevents Band failure common after adding Horsepower.

Trouble Codes: P1740, P0732, 733, 735

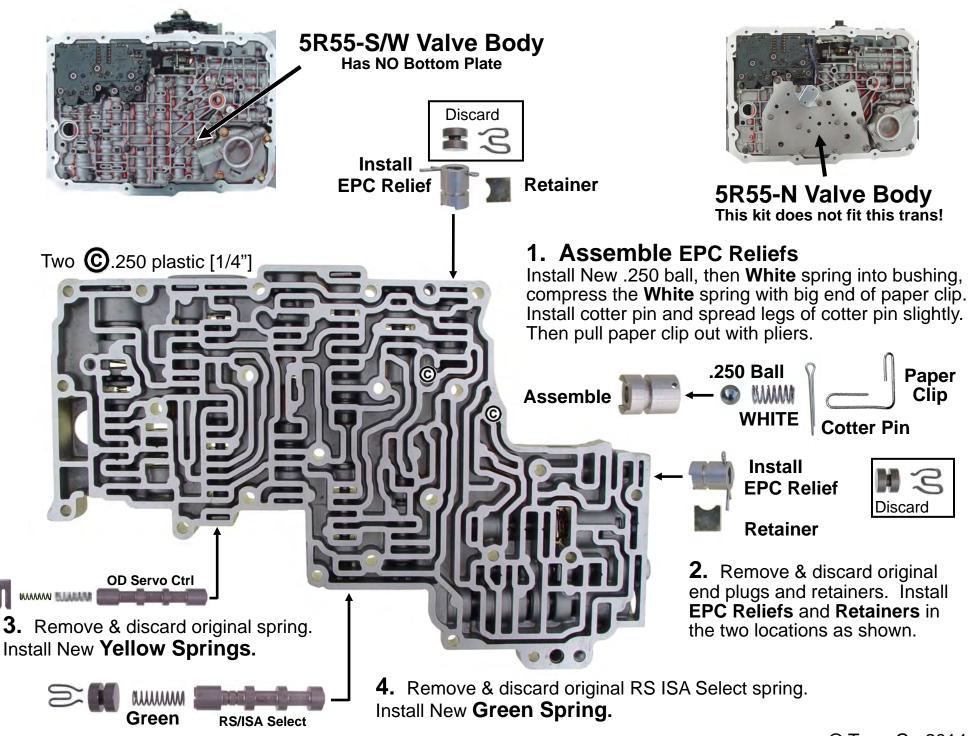
Lockup Valve Upgrade

IMPORTANT: The "W" retainer makes small burr on the inside edge of bushing groove. Using sharp end of a drill bit or sharpened screwdriver, carefully scrape off burr. Then remove bushing by **GENTLY** prying thru opening in bottom of VB.

of new valve into spring then original end plug and clip.
