ATRA WEBINAR

6L50-6L80-6L90 Updates and Product Issues

**Presented by:
Steve Garrett
ATRA Presenter**

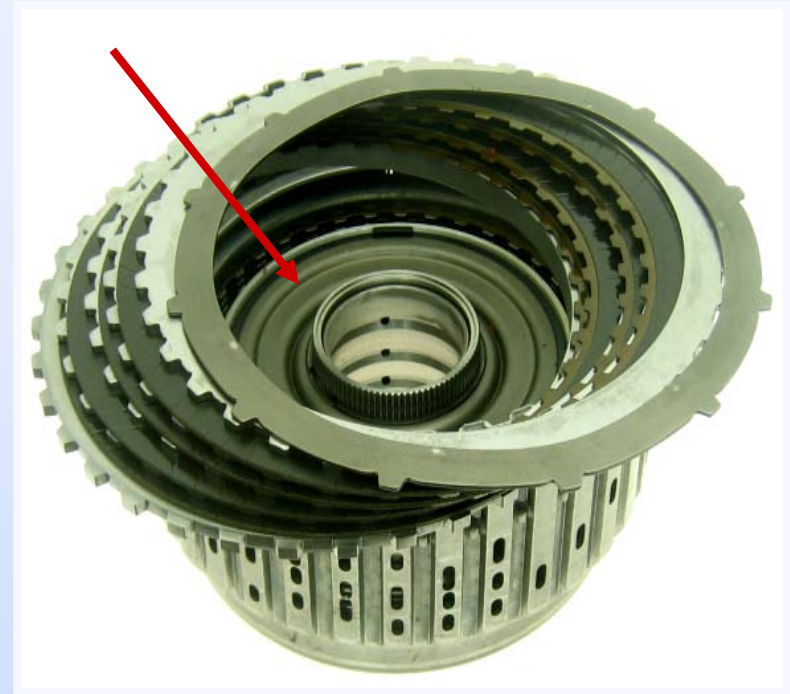
- 24238696 – 3-5-R Clutch Piston
- 24238700 – 1-2-3-4 Clutch Piston
- 24243898 – 1-2-3-4/3-4-R Drum

Note: Will NOT back service previous model years

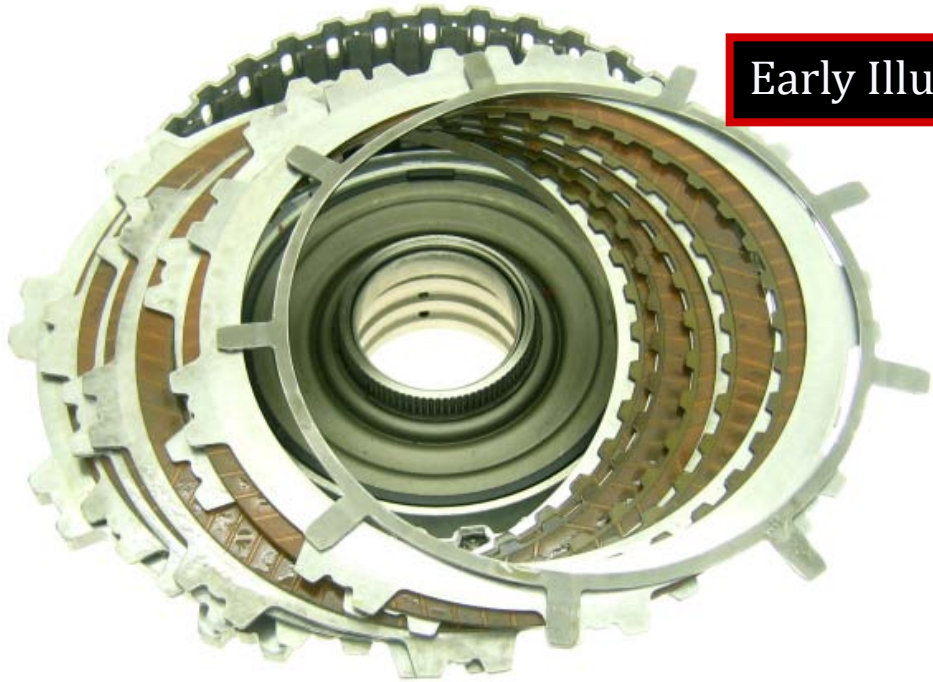
1-2-3-4/3-5-R Clutch Housing was updated mid 2007 to address a NO FORWARD condition. The root cause is the snap ring popping out of the housing. The housing has been updated to prevent this. Additionally the 3-5-R waved plate was updated from 12 to 18 teeth and the 1-2-3-4 wave plate was updated from 9 to 18 teeth.

No Forward Movement

- 24239828 – 3-5-R 18 tooth wave plate
- 24239615 – 1-2-3-4 18 tooth wave plate
- 24240194
- 24240201 – Selective Snap Rings
- 24241232 – Clutch housing Kit
(Includes Housing and Snap Rings)

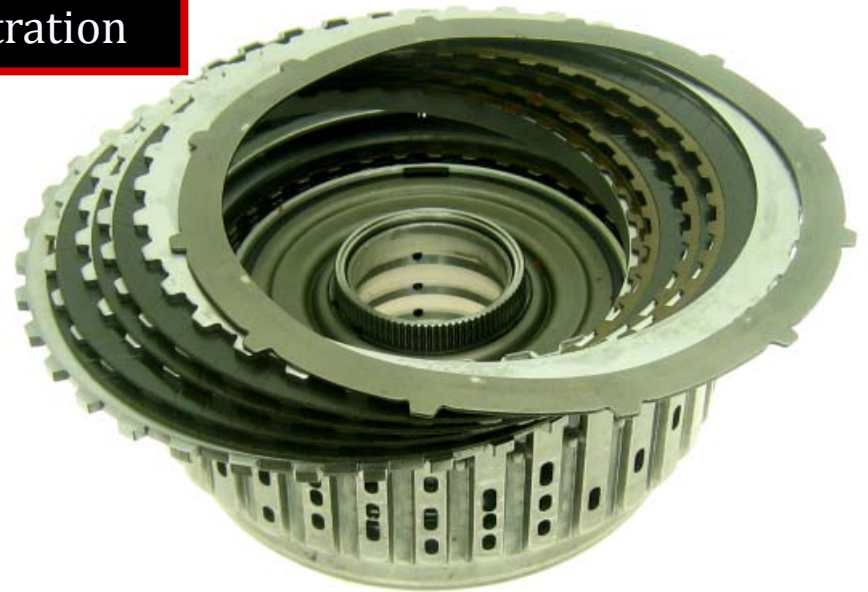
1-2-3-4 Clutch

CONCERN: 6L80/6L90 (RPO MYC, MYD) applications built before June of 2010 may exhibit a slip condition related to the operation of the 1-2-3-4 clutch. This condition may be present in more than one forward gear or if the condition is bad enough, it may result in a no movement forward condition.

CAUSE: The 1-2-3-4 piston may be broken or cracked

CORRECTION: Replace the piston with the new design, The updated piston has 22% more rib area when compared to the previous design piston. The updated piston is sold under part number 24258159

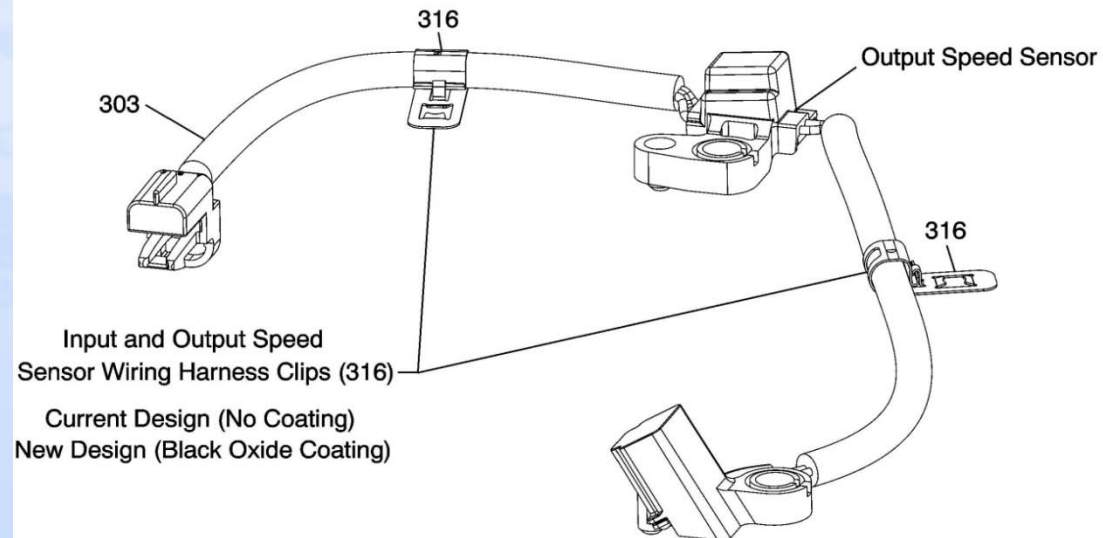
NOTE: If the previous design sensor is used with the Unigear design assembly damage to the sensor WILL occur and DTCs' will result as a result of the sensor damage. If the new design sensor is used with the previous design planetary/output shaft components Speed Sensor DTC's will result, as the air gap will be too wide.

Output Speed Sensor
Current Design

Output Speed Sensor
New Design

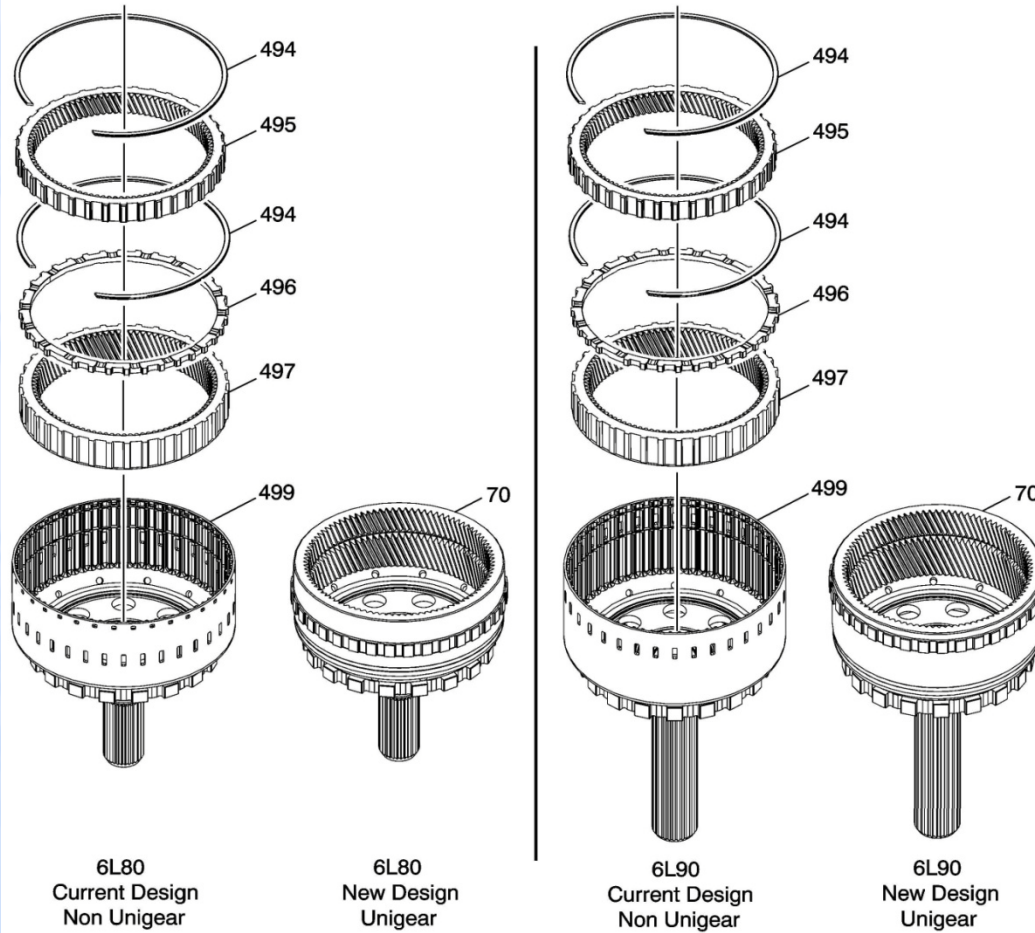
Unigear update

An update to the 6L80 and 6L90 (RPO MYC, MYD) transmission output ring gear and output shafts began to enter production starting with the March 2012 applications. All 6L80/6L90 transmissions will utilize the new design by the end of 2012. Known as a “UNIGEAR” design, the updated parts will incorporate the output ring gear and the output shaft into one assembly. The update was incorporated as a cost reduction measure and had nothing to do with durability. The new design will backservice the previous design applications as long as the speed sensor is replaced with it. The updated speed sensor is a different height because of the design of the unigear.

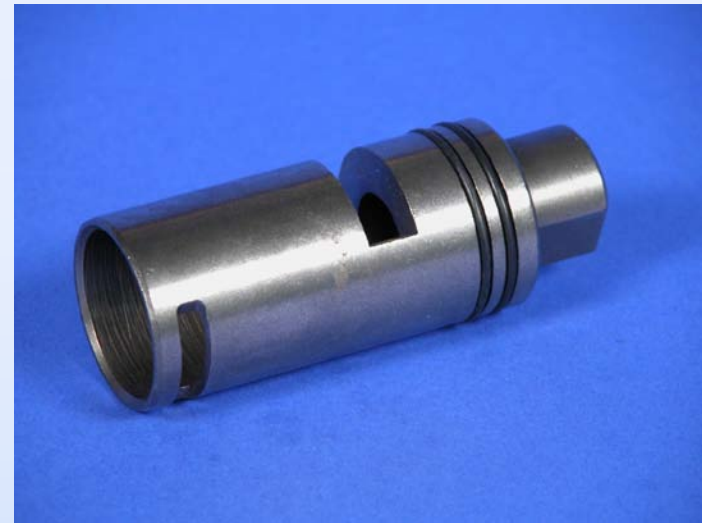
Park Pawl Actuator Guide

Update was related to supplier Request, to improve production Volume. Part number changed For all models

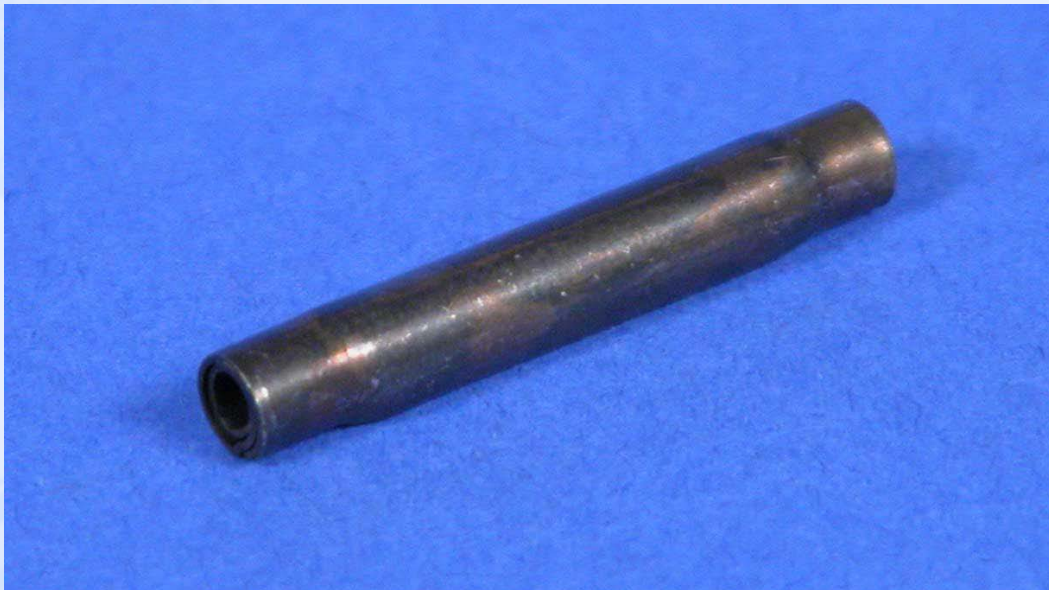
Manual Shaft Pin Update 6L50 6L80 6L90

**Length changed 5mm (.19"), taper changed 2.5mm (.09")
Part numbers were updated, shaft will backservice**

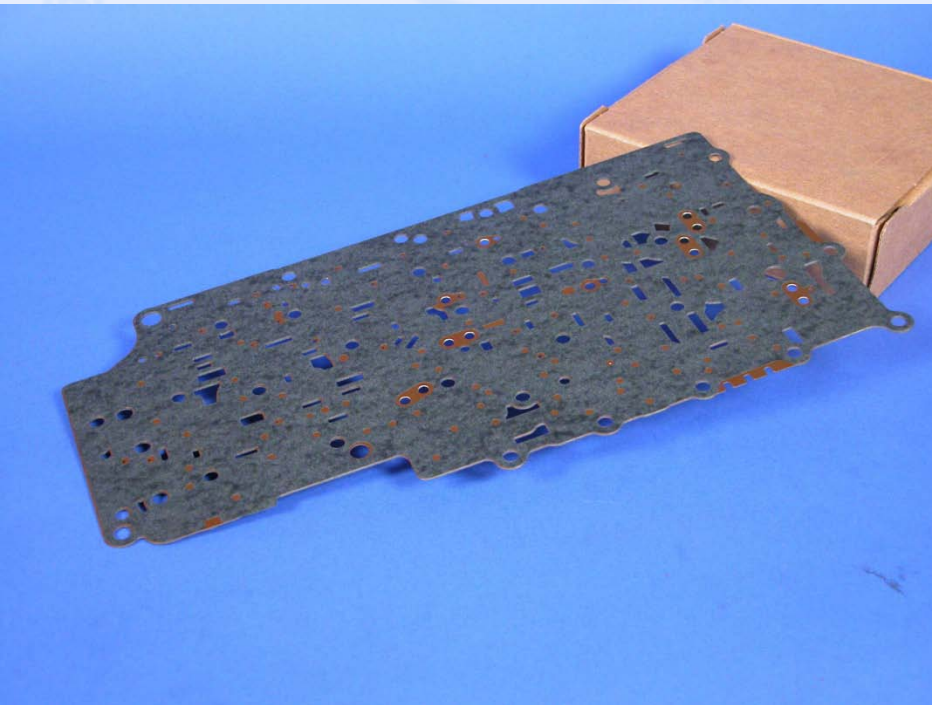
24245720

- Debris in pan
- Cracks in filter
- Debris in Separator plate as well as check ball problems
- Clutch Select valve #2 bore plug improper size
- CBR1/C456 regulator valve sticking
- Calibration updates
- Updated Separator Plate and Valve Body Springs (previously covered)

Updated Spacer Plates All Models For a P0751

**(2007-08 MYD) (2008 MYB, MYC) Plate,
Control Valve Spacer**

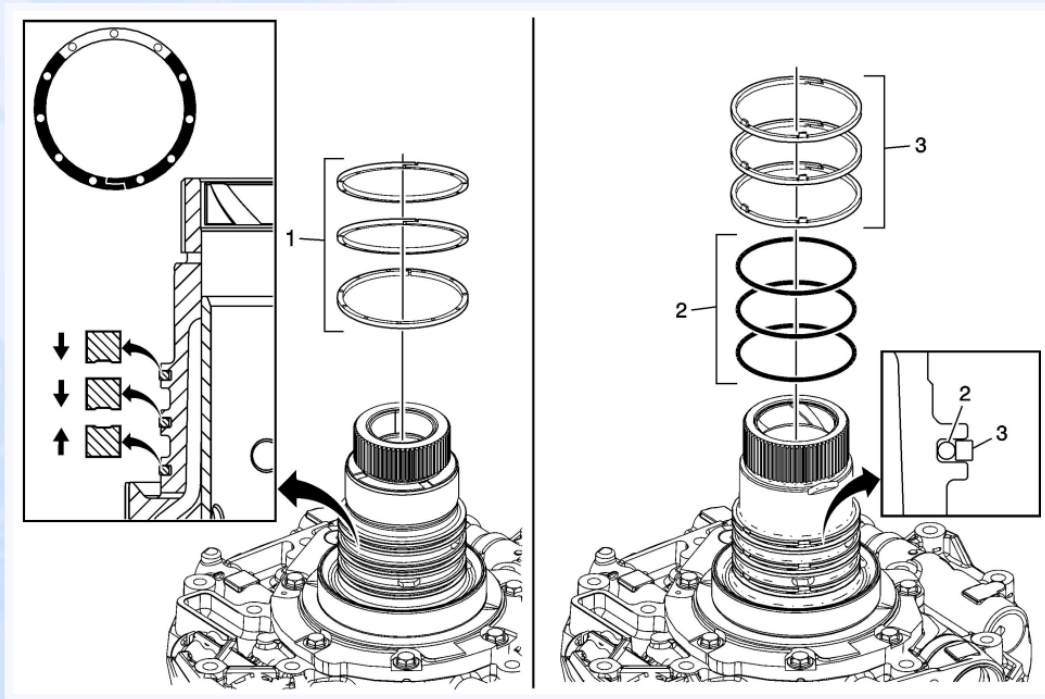
1-2-3-4 / 3-5-R Clutch Pump Cover Seal Update P0776 Slip
Design Change for mid 2009, Interim 2009. Update includes the grooves and seals that are located on the back of the pump cover. Update address's 2-3 shift complaints. The depth of the groove is deeper to allow for a rubber o-ring under the seal.

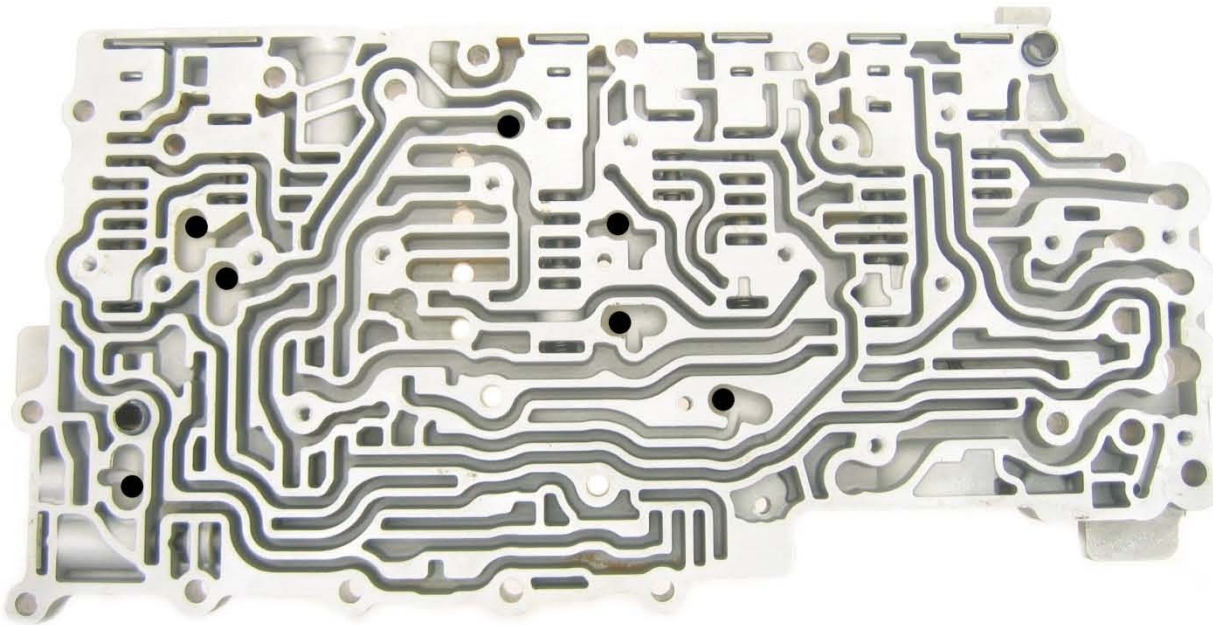
Clutch Select Valve #3

Clutch Pressure Control Solenoid Stuck Off Codes Caused by Valve Body Issues (continued)

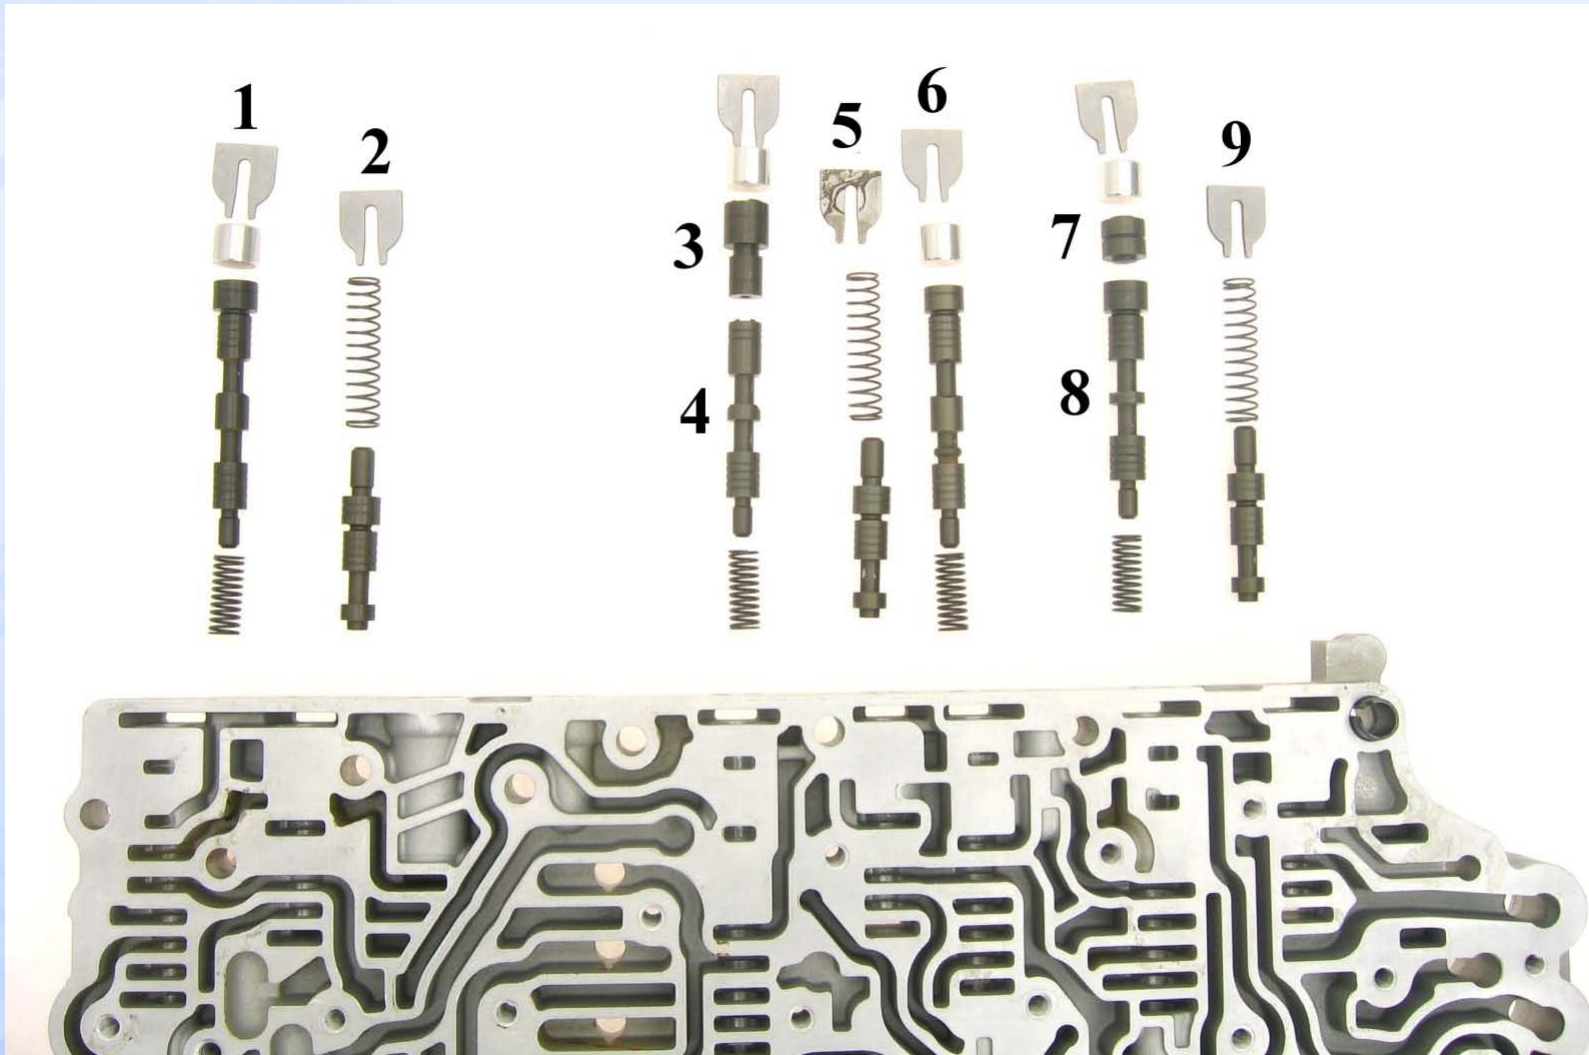
Clutch Pressure Control Solenoid Stuck Off Codes Caused by Valve Body Issues (continued)
