A CRITICAL FUEL IMBALANCE !

From London to Athens : how a fuel imbalance lead to control difficulty !

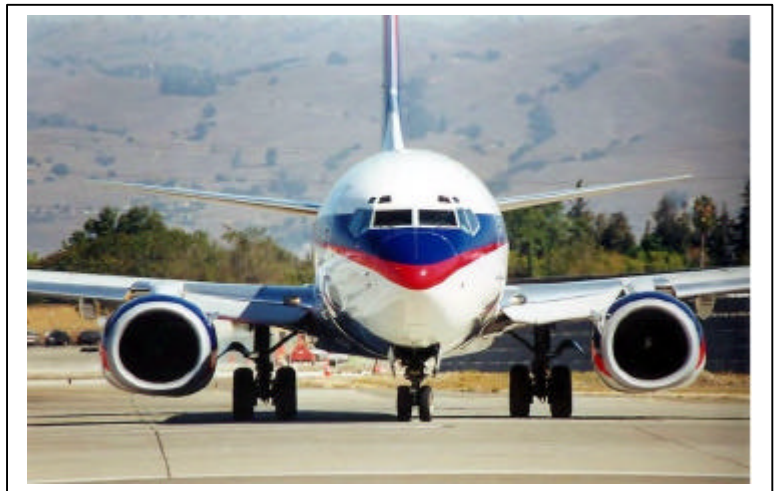
The B737-400 departed from London Gatwick for a scheduled flight to Athens with the first officer as Pilot Flying (PF). A fuel load of 13,200 kg had been selected by the captain and this resulted in full wing tanks and 4000 kg in the center tank. In accordance with standard operating procedures, all six booster pumps (two in each of the three fuel tanks) were selected on prior to start. With these switch positions, pressure differentials within the fuel system would mean that the center tank fuel would be used before the fuel in the two wing tanks. A fuel schematic diagram is shown in Figure 1.
