# ***AAIB Bulletin***

***1/2016***

1/2016 - Airworthiness of Aircraft Registered Overseas and Resident in the UK 3

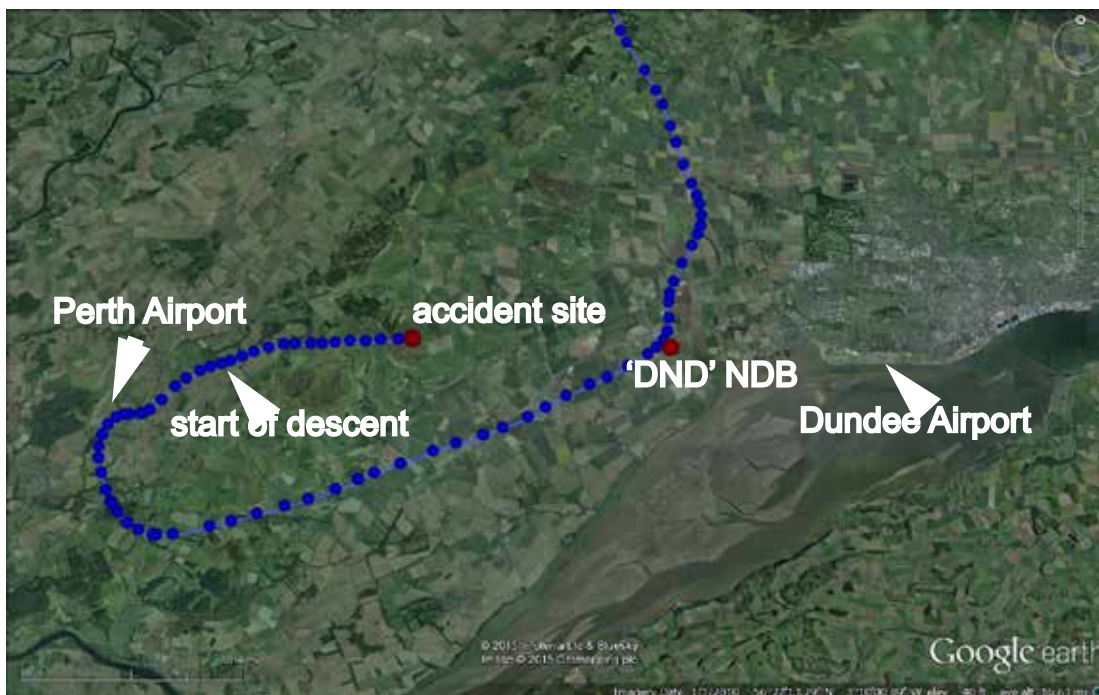
**Figure 1**

Final 8 minutes of G-RICK's ground track recorded by the GPSMAP 696

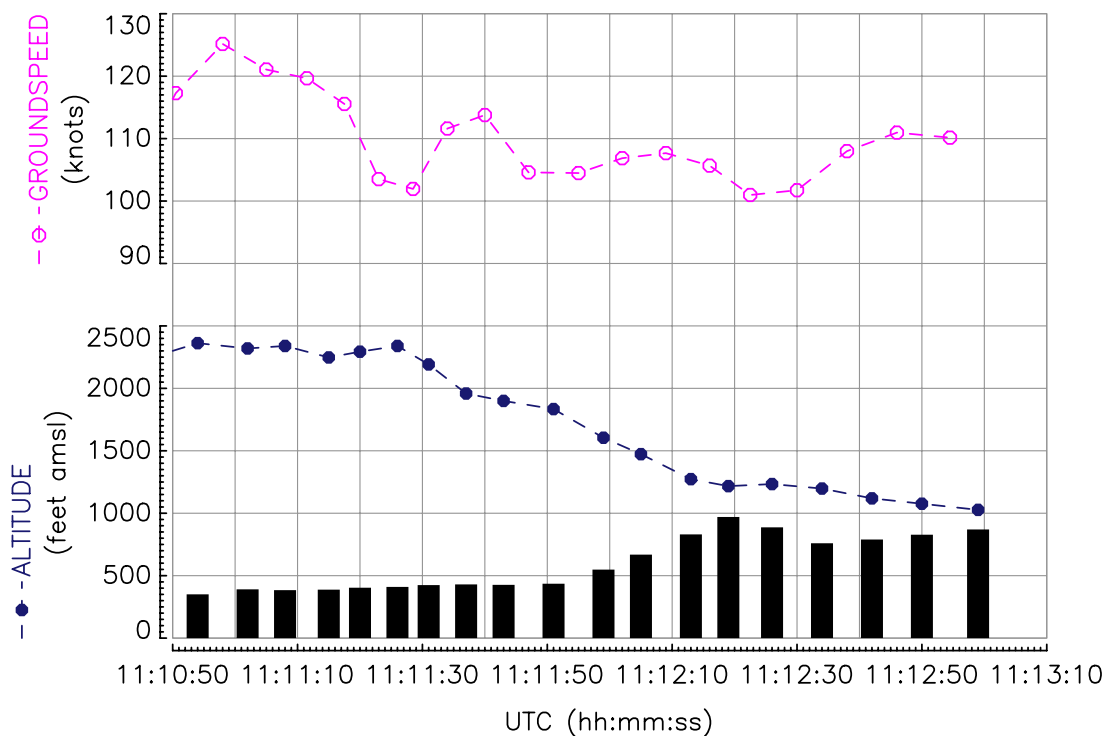
**Figure 2**

Altitude recorded by the GPSMAP 696 (with ground elevation indicated by black bars) and calculated groundspeed (averaged between points)

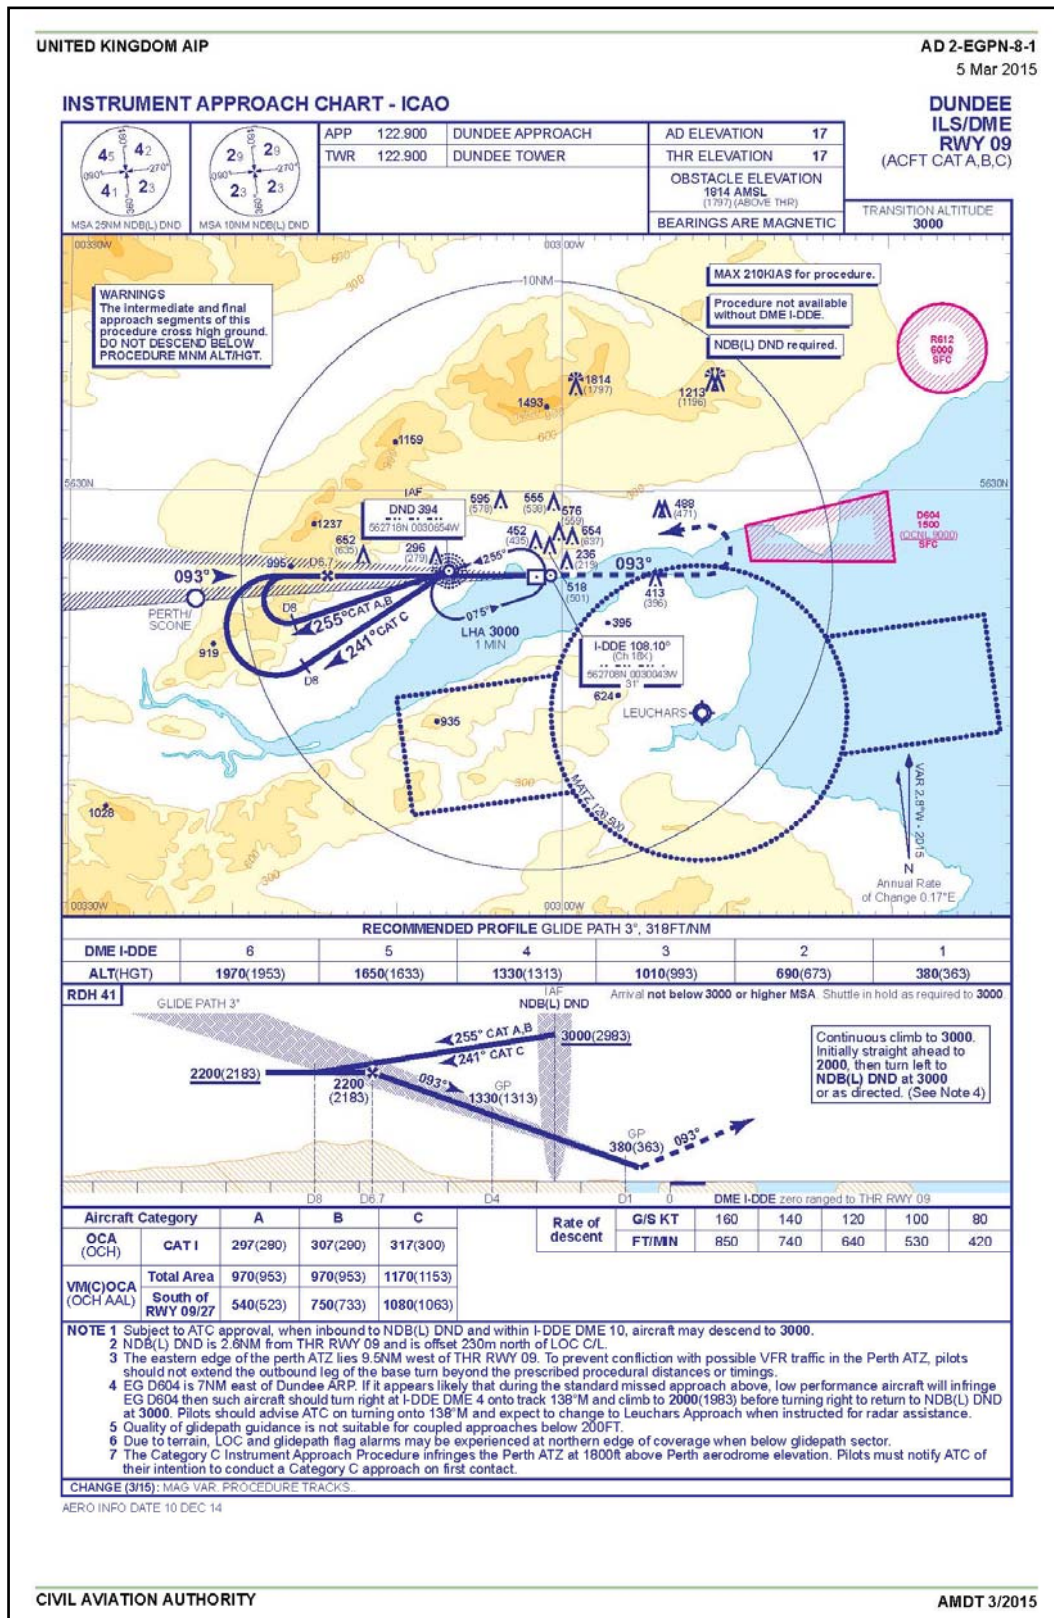
**Figure 6**

The published procedure (Figure 6) required the aircraft to fly over the 'DND' beacon at an altitude of 3,000 ft, then turn onto an outbound track (255° for this category of aircraft) and descend to 2,200 ft amsl. At a distance of 8 nm from the DME, pilots should commence a level right turn and use ILS guidance to intercept the localiser. Pilots should continue to fly level until they intercept the glidepath. As a cross-check, the approach chart indicates that glidepath interception at 2,200 ft should occur when the aircraft is 6.7 nm from the DME. The pilot should then follow the localiser and glidepath guidance down to the decision altitude. There are additional advisory heights on the approach chart at each nautical mile from touchdown.

Dundee ILS/DME RWY 09 approach, dated 5 March 2015

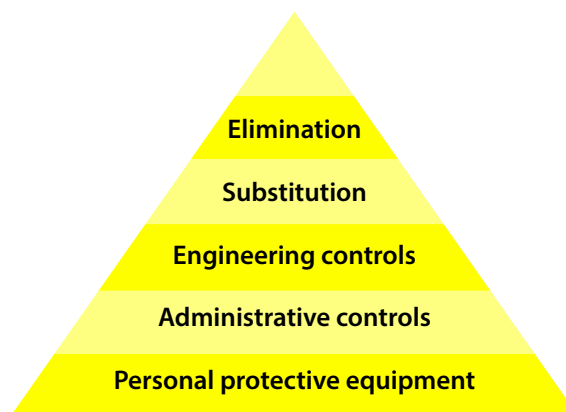
**Figure 7**  
Hierarchy of hazard control

In the Bowtie model for this accident, the controls that failed to prevent the threat escalating into an unsafe condition were related to pilot performance, which can be mitigated by training. However, training is an 'Administrative' control in the hierarchy of hazard control and is therefore not the most effective. A more effective way of minimizing the hazard would be by 'Substitution'; for example, a redesigned instrument approach at Dundee that is more tolerant of human error.

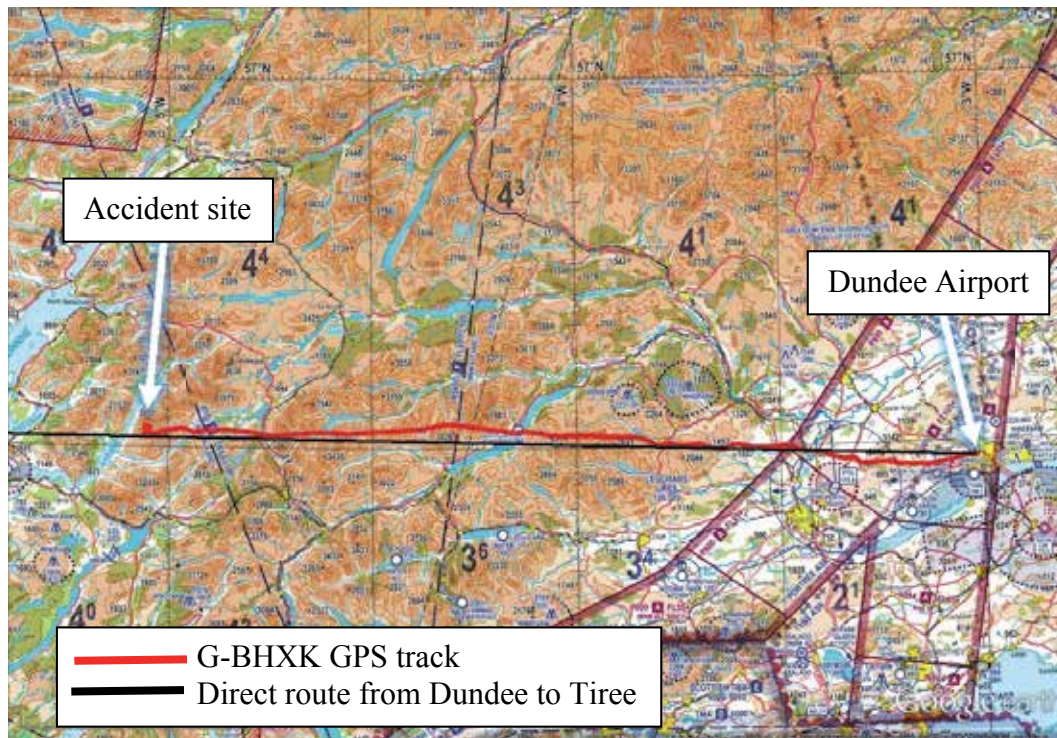
**Figure 1**

At 10:28:28 hrs, as the pilot of G-BHXX acknowledged the weather report, the aircraft commenced a gentle turn to the right, maintaining its altitude. After some 40 seconds, the rate of turn increased and the aircraft entered a tightening turn to the right, with a significant rate of descent. If not already in cloud, at some point during the descent the aircraft would have entered IMC which would have persisted all the way to the ground.

1:500,000 chart showing MSA, G-BHXX track (red) and direct route to Tiree from Dundee (black)

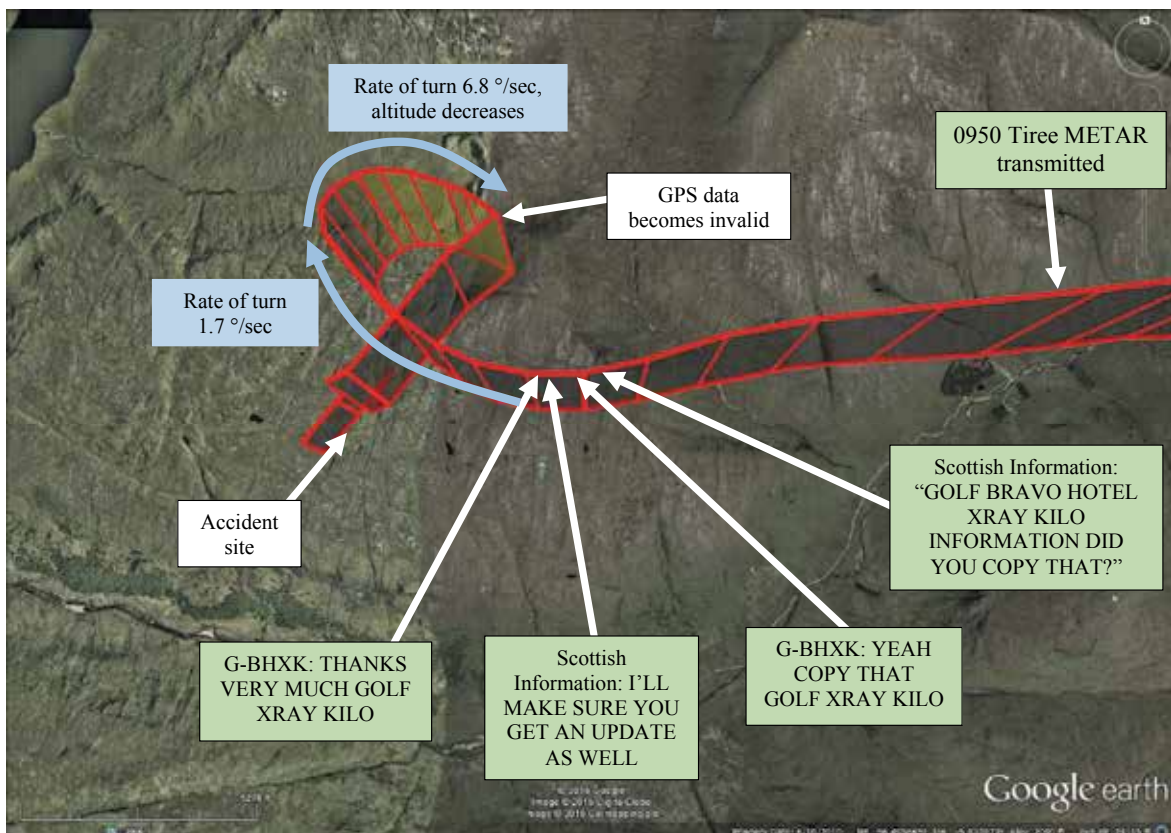
**Figure 2**

Final stage of the G-BHXX GPS track

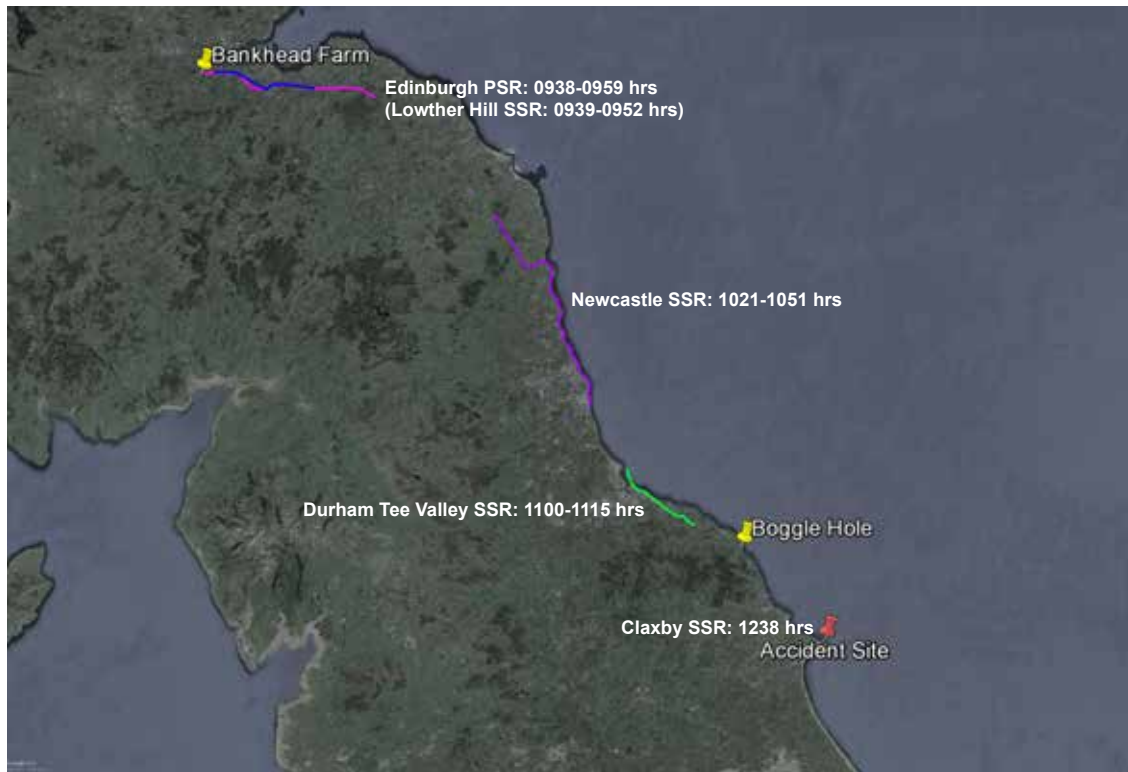
**Figure 2**

Radar data was recovered from Edinburgh, Newcastle and Durham Tees Valley Airports, together with various elements of the NATS operated en-route system. For significant portions of the flights on 16 September, no radar contact was made with G-SUEX due to line-of-sight limitations when the helicopter was below radar coverage. An overview of the recorded track is at Figure 2

Overview of radar recorded tracks

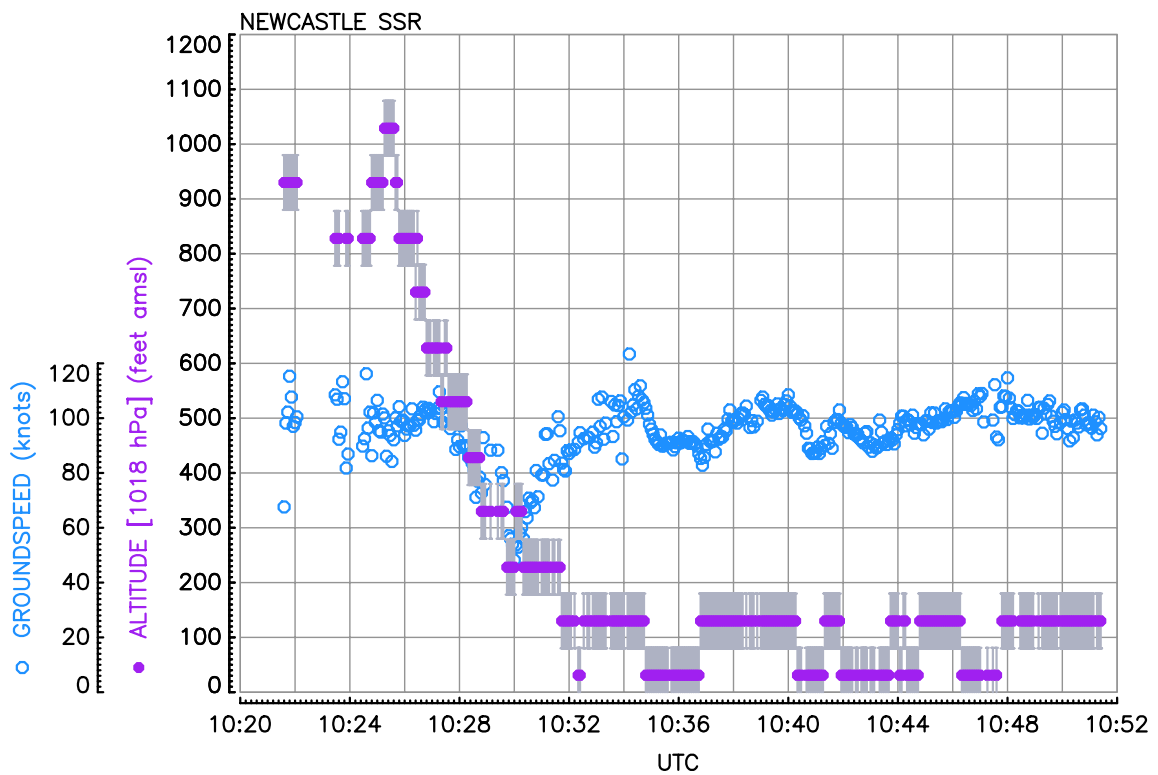
**Figure 3**

G-SUEX was next detected by Newcastle Airport radar, between 1021 hrs and 1051 hrs (see Figures 2 and 3). At 1025 hrs the helicopter was at 1,000 ft amsl. Then, over the next seven minutes, it descended to below 200 ft amsl. Between 1032 hrs and 1051 hrs the helicopter’s reported altitude varied between 130 ft amsl and 30 ft amsl and the groundspeed was 100 kt  $\pm 10$  kt.

Mode C altitudes and calculated groundspeed from Newcastle Airport radar ( $\pm 50$  ft error bars, indicating Mode C accuracy, are shown)

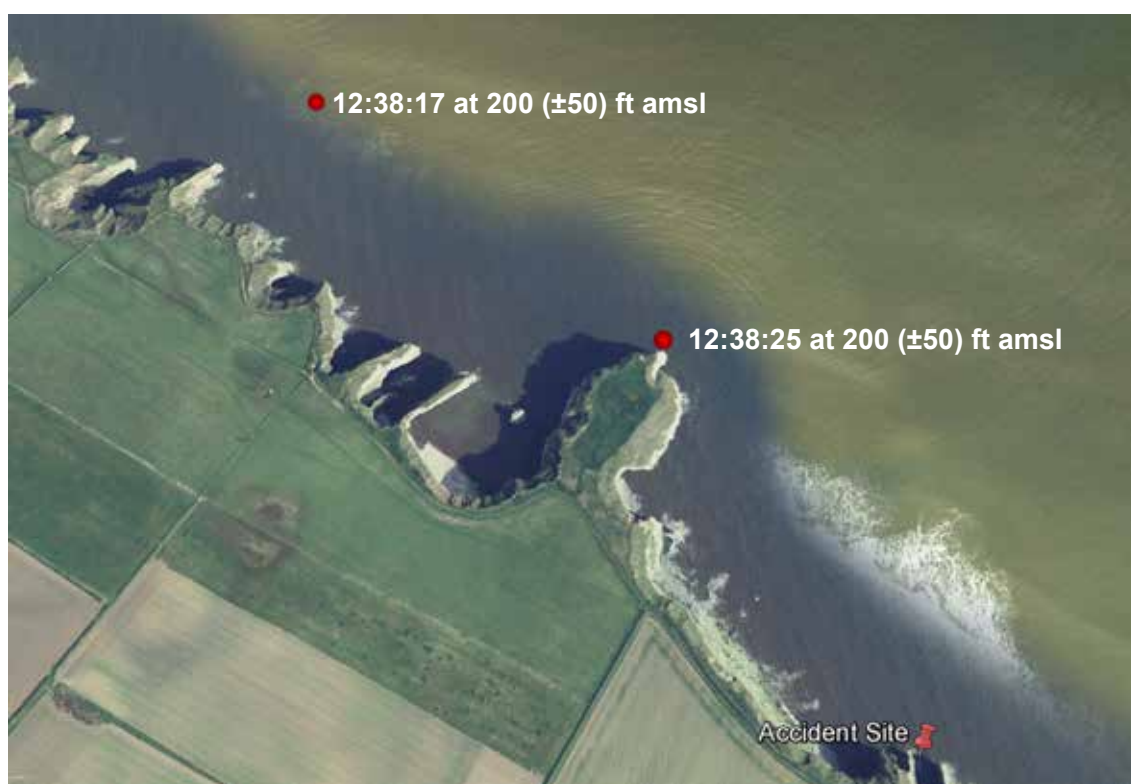
**Figure 4**

The final two contacts were from the Claxby SSR (Figure 4) at 1238:17 hrs and 1238:25 hrs, when the helicopter was within 800 m of the accident site. The reported Mode C altitude, corrected for QNH, was 200 ft amsl for both contacts and the groundspeed was calculated to be about 90 kt. However, as this was based on just two points, whose positional accuracy is unknown, it is approximate.

Claxby SSR contacts near the accident site

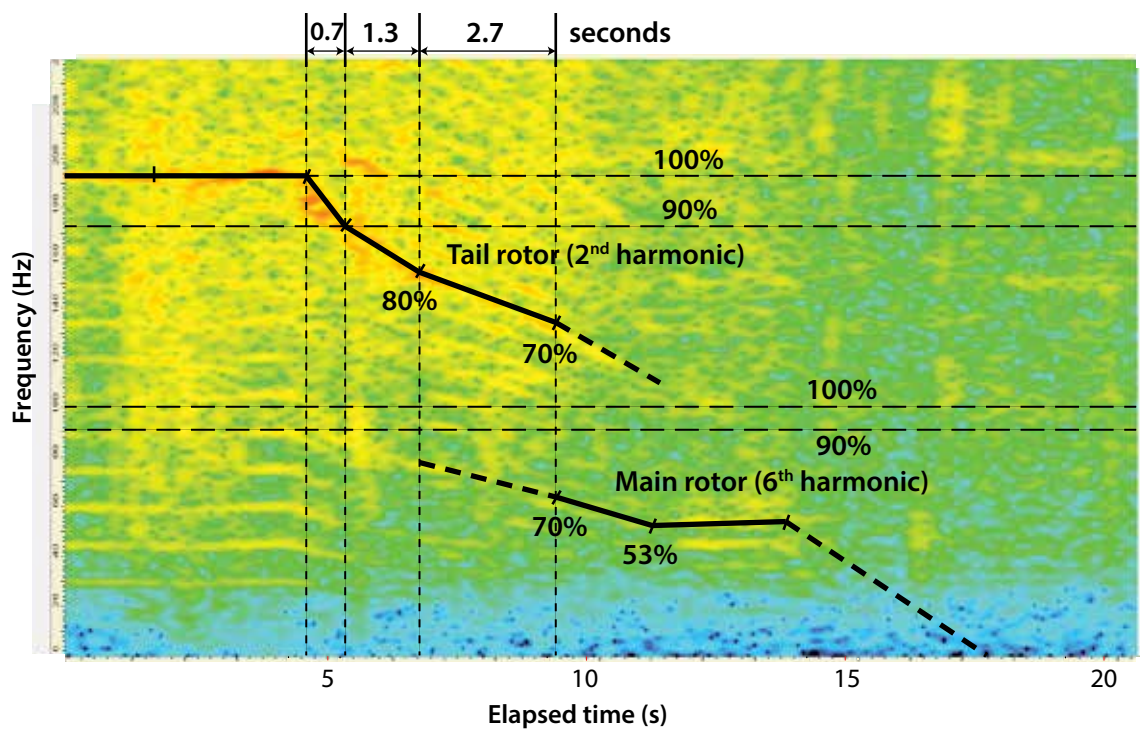
**Figure 5**

A witness, who was approximately 800 m to the south of the accident site, had inadvertently activated the video recording feature on their camera while it was in their pocket. It was subsequently possible to isolate the audio of the helicopter's rotor system from the recording and conduct frequency analysis (Figure 5). Of note, no loud, sharp noises, such as bangs, were found on the audio. Also, the higher frequencies generated by the engine were beyond the frequency range of the audio recording.

Frequency analysis of witness audio recording showing main and tail rotor rpm decay

This report included a graphical display of the main and tail rotor rpm decay, based on the frequency analysis of the witness audio recording (see Figure 5 on page 55). Figure 5 was incorrectly labelled. Reference to the tail rotor should have been to the main rotor, and vice versa. The time axis labels and harmonic references were also incorrect. However, the supporting text, analysis and conclusions were unaffected by these labelling errors.

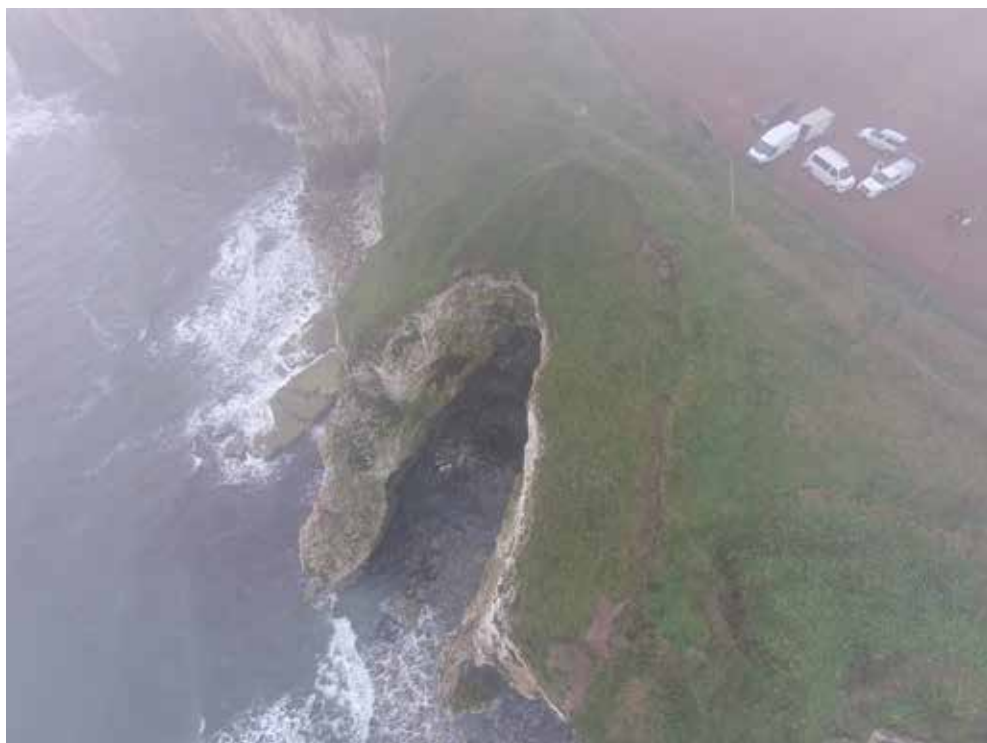
**Figure 7**

The cliff face above the accident site was largely undercut and the top edge of the cliff was unstable, making access difficult (Figure 7). The wreckage was initially accessible for a short period either side of low tide, by abseiling down the cliff to an adjacent beach and walking around an outcrop. An assessment of the wreckage was made and photographs were taken but no attempt at recovery was made, due to the incoming tide. It was evident that, due to the action of the waves, the wreckage had been moved and was broken into smaller pieces. When the weather and sea conditions became less favourable, this route was no longer available.

General view of the accident site

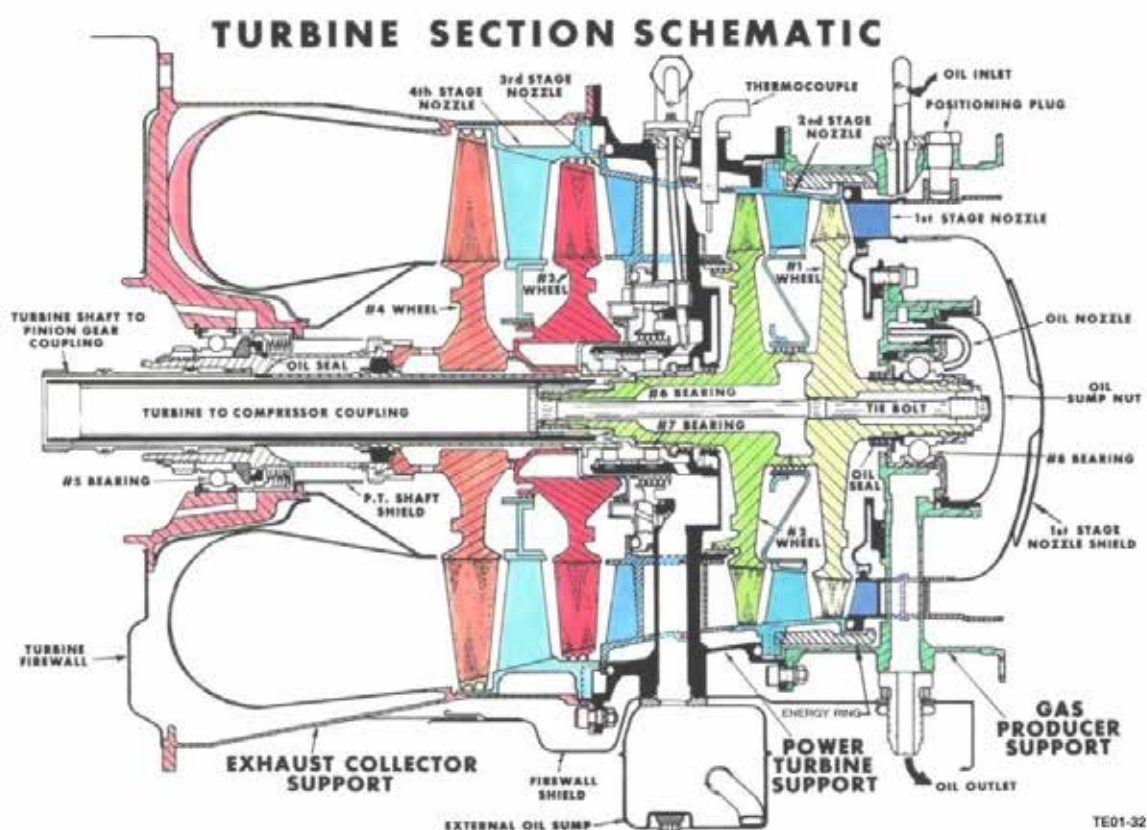
**Figure 9**

When the turbine assembly was dismantled, the No 5 and No 8 bearings (Figure 9) were found to have suffered severe thermal distress (see Figure 10). The No 6 and No 7 bearings had also suffered damage. The No 5 bearing and No 8 bearings are ball bearings and provide axial and radial location for the turbine assembly. Damage to the turbine rotors and adjacent components indicated they had come into contact with each other.

General arrangement of turbine assembly and bearings

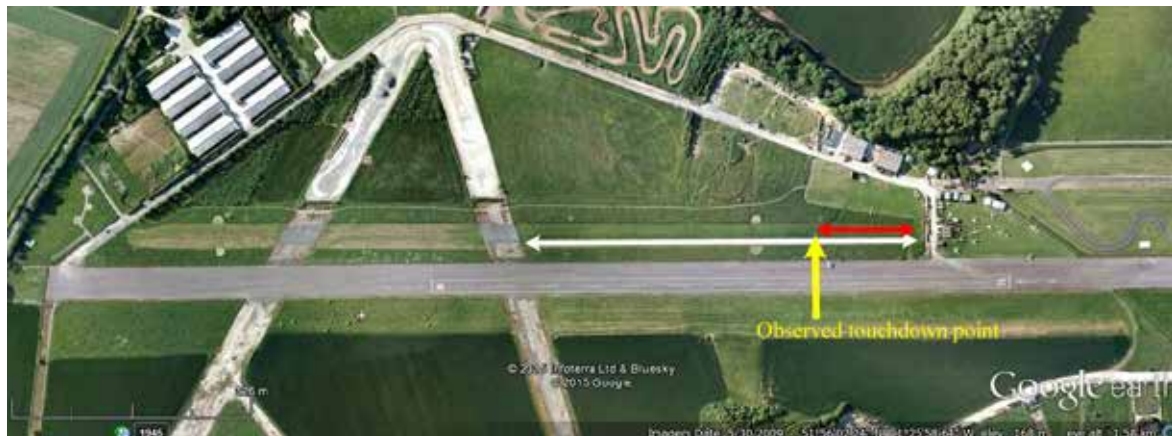
**Figure 3**

The three people working on the microlight outside the Northside Grass maintenance hangar had seen the aircraft take off. One of them was facing west and spotted it again during the latter stages of its approach and brought it to the others' attention. They watched it touch down in a position that was later measured to be approximately 145 m before the end of the grass runway (Figure 3).

Google Earth image of Enstone Airfield.

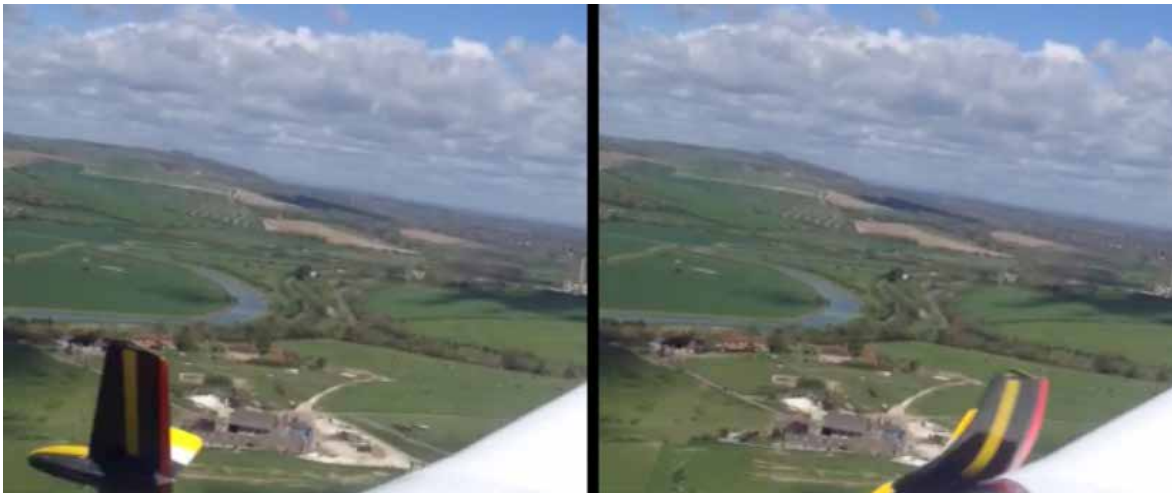
**Figure 1**

While on the base leg, at an estimated altitude of 600 to 800 ft amsl, the aircraft's right wing struck a model glider. The pilot initially thought he had been hit by a large bird, but the collision was caught on a passenger's video camera which revealed that it was a model glider (Figure 1). The aircraft continued to handle normally and the pilot turned final and landed uneventfully. He had not been aware that there was a model glider flying site on the base leg to Runway 20.

Moment before and at the time of the mid-air collision as captured from a video camera on F-GSBM

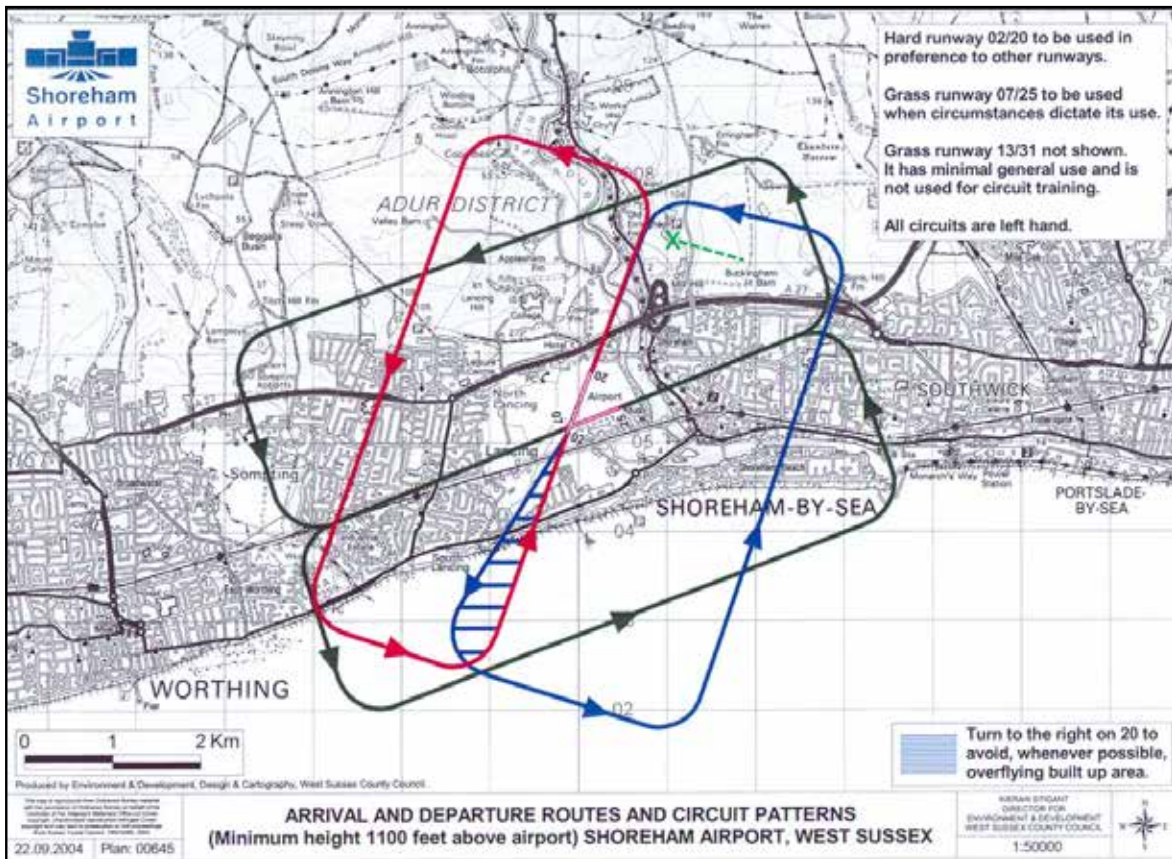
**Figure 5**

The Shoreham Airport (also known as Brighton City Airport) website, flybrighton.com, contained a 'General Information' section for pilots. This section did not refer to the model aircraft site and it contained a circuit diagram (Figure 5) which did not highlight the location of the model aircraft site. The estimated track of F-GSBM has been added, as a dashed green line, in Figure 5 and the location of the mid-air collision has been added as a green 'X'.

Circuit diagram from Shoreham Airport website with location of mid-air collision marked with a green 'X' and F-GSBM's estimated track marked with a dashed green line
