Advanced Materials For Mercury 50 Gas Turbine Combustion System

Final Report

Report SR01-R-6187-25

Solar Turbines Incorporated

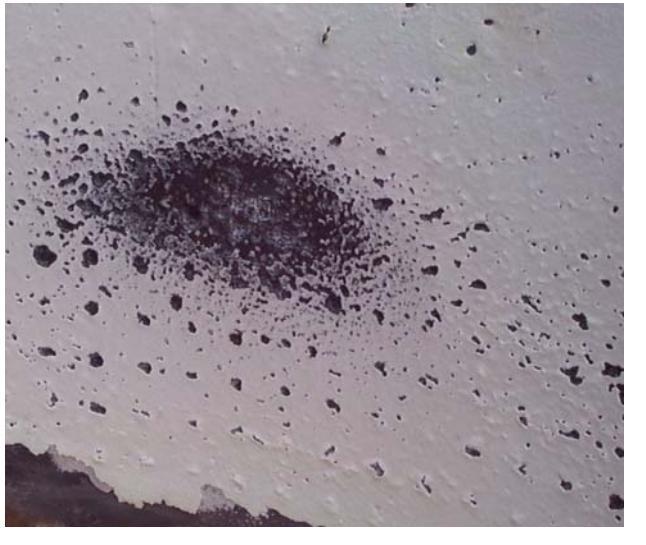
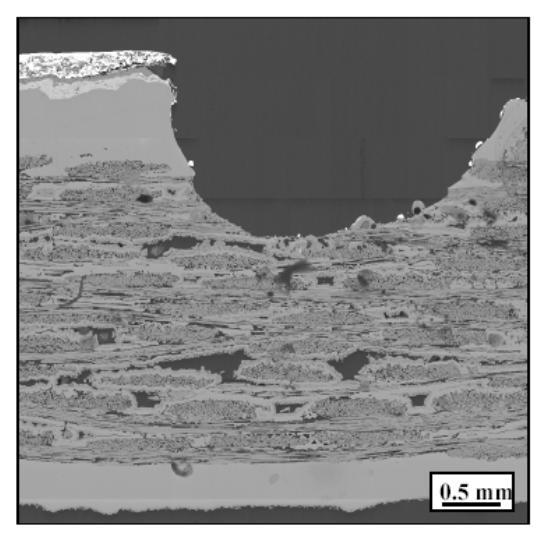
Other modes of degradation with time included: (1) pitting near surface asperities from processing tooling marks (Figs. 5.14a and 5.14b), (2) surface recession of the BSAS topcoat (which was more severe for the highest temperature regions of the EBC, eventually resulting in localized removal of the BSAS), (3) phase separation of the mullite $(3Al_2O_3.2SiO_2)$ intermediate layer into Al_2O_3 and SiO_2 upon exposure to the combustion environment following BSAS removal, and (4) oxidation of the EBC Si bond coat. It was noted that EBC spallation tends to occur at the interface of the SiO₂ layer formed through oxidation of the Si, and the mullite intermediate layer. It was observed that regions of the BSAS topcoat that were most heavily degraded were enriched in strontium aluminum silicate (SAS) suggesting that the Sr-phases were more stable [15].

Figure 5.14 Pitting on the HiNi SiC/PyC/E-SiC (CVI) Outer Liner (a) Area A in Figure 5.13a (b) Pitting Microstructure after 13,937-hour Test (CT-5)

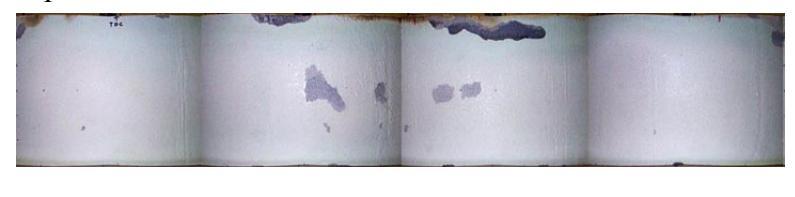
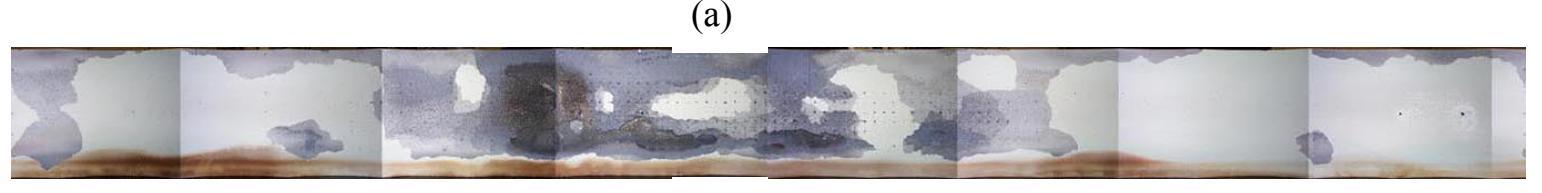
engine field test. This mixed-layer EBC was selected because it provided better protection than the baseline Si/mullite/BSAS EBC. The test was terminated in October 2000 after 7,238 hrs and 159 starts due to an engine problem not associated with the CFCC liners. Composite digital photographs of inner and outer liner are shown in Fig. 5.15 [5,16]. The outer liner had significantly more EBC spallation than the inner liner. The CFCCs were in relatively good condition since the EBCs had been largely protective, and a decision was made to strip the EBCs from the CFCC liners, recoat the liners with new EBCs, and resume liner testing [17,18]. The refurbished EBC for the outer liner was similar to that for the MM-1 test, but the inner liner had a Si/BSAS EBC, to evaluate if the mullite layer could be eliminated, since which would simplify the EBC application process.

Figure 5.15 Digital Photographs of (a) HiNi/BN/SiC-Si (MI) Inner Liner and (b) HiNi/PyC/E-SiC (CVI) Outer Liner after 7,238-Hour Field Test (MM-1)

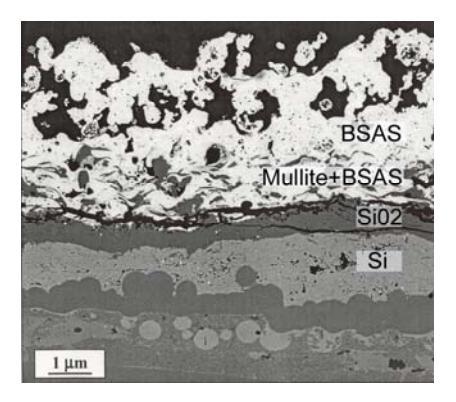
Figure 5.18 SiO₂ Layer on EBC at the (Si/Mullite+BSAS) Interface – Inner Liner after 15,144-hour Test

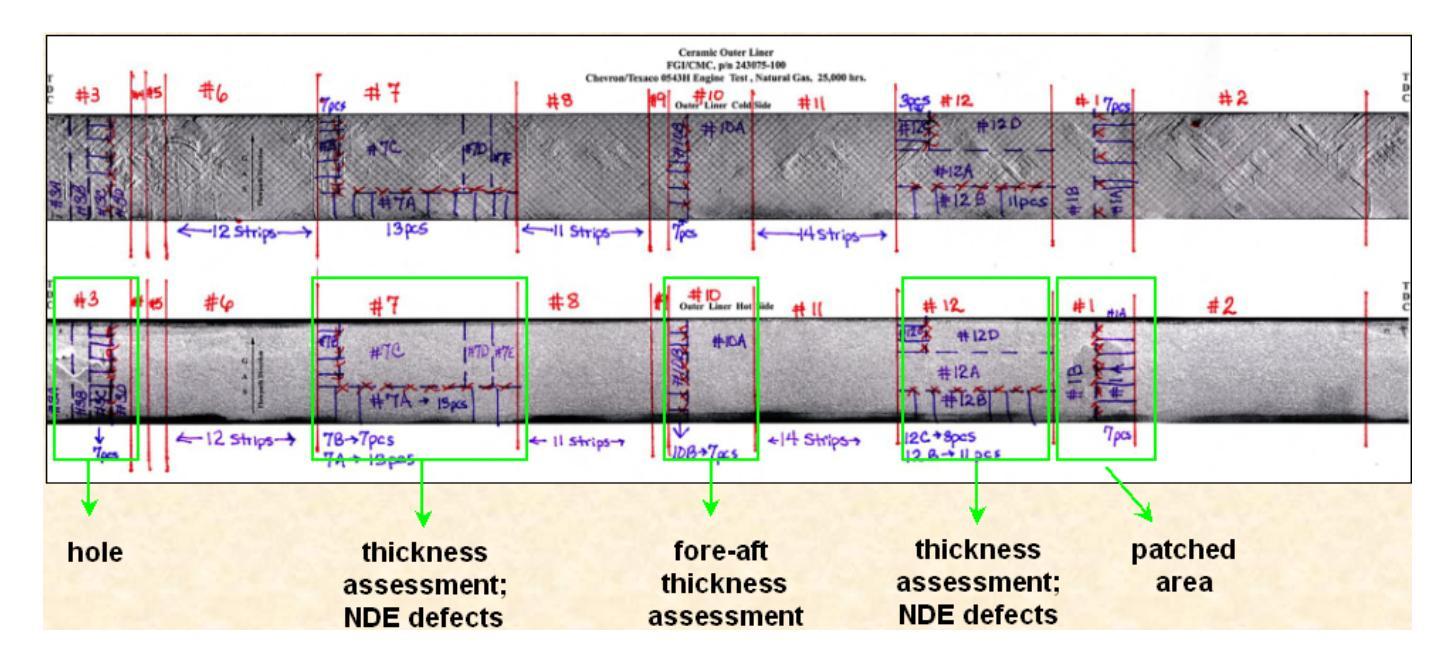
A meeting was held between technical personnel of Solar, COIC, SPG, ORNL and ANL to review the results of visual inspection of the hybrid oxide CFCC outer liner and to discuss an initial sectioning plan in preparation for metallographic examination and residual property The liner was subsequently shipped from Solar to ORNL where the liner analysis. characterization was conducted under ORNL's contract with DOE. The objectives were to examine the microstructure and mechanical properties of the tested liner, and compare these with those of an as-processed liner of the same composition, which was fabricated at the same time and using the same fabrication process as was used for the tested liner. CMM fore-to-aft thickness profiles of the engine-tested liner were measured. The microstructure-related degradation mechanism that contributed to surface/thickness loss was characterized. Bulk liner features such as eroded areas, holes and patches were also examined. Figure 5.33 shows the liner sectioning plan. Specific areas were selected for residual thickness measurements, examination of patched areas, a hole in the liner and to elucidate defects that had surfaced in NDE scans.

Figure 5.33 Hybrid Oxide CMC Liner Sectioning Plan, Showing Hole and Patch Features and Areas Delineated for Thickness Measurements and Examination of Defects that Showed in NDE – Photo courtesy of ORNL

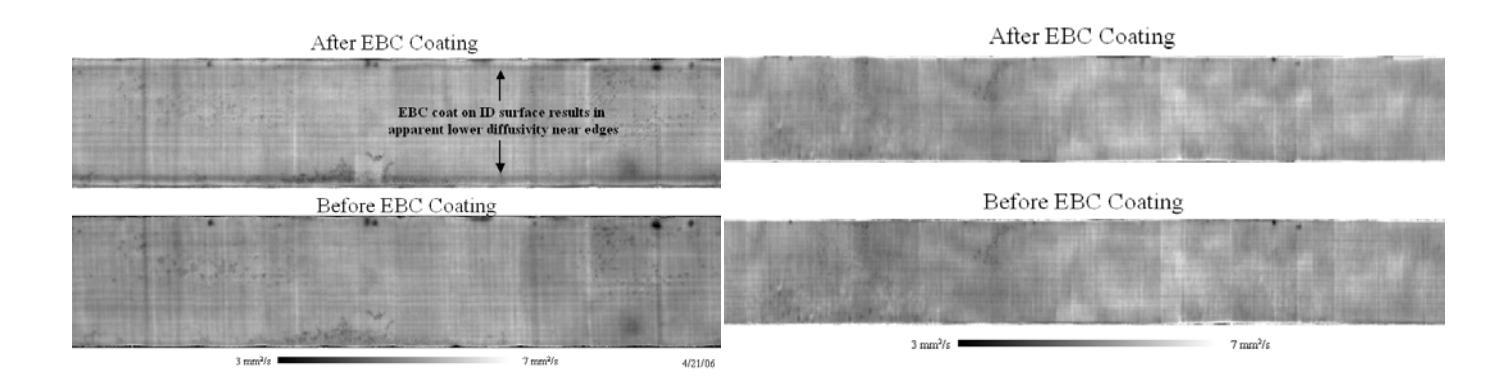
Figure 5.40 Thermal Diffusivity NDE Scans for GE TyZMI/BN/SiC-Si MI Inner (Left) and Outer (Right) As-processed Liners Prior to and After EBC Application (Liners Not to Same Scale) – NDE Scans Courtesy of ANL

The NDE scans indicated the absence of significant defects in the liners. It was noted that some EBC overspray on the inner diameter surface of the inner liner resulted in apparent lower thermal diffusivity for this liner near the edges. Borescope inspections were conducted after ~1,250, ~2,750, and ~5,535 hours. Figures 5.41 and 5.42 show borescope images taken after ~1,250 and ~5,535 hours of engine testing. The surface of the outer liner with the Si/YS EBC appeared in excellent condition, but the surface of the inner liner with the Si/Mullite/SAS EBC shows heavy degradation even after the 1,250-hour borescope. Since the inner liner was assesses to be at risk for failure a program decision was made to terminate the test in August 2007 after 7,784 hours and 43 starts.

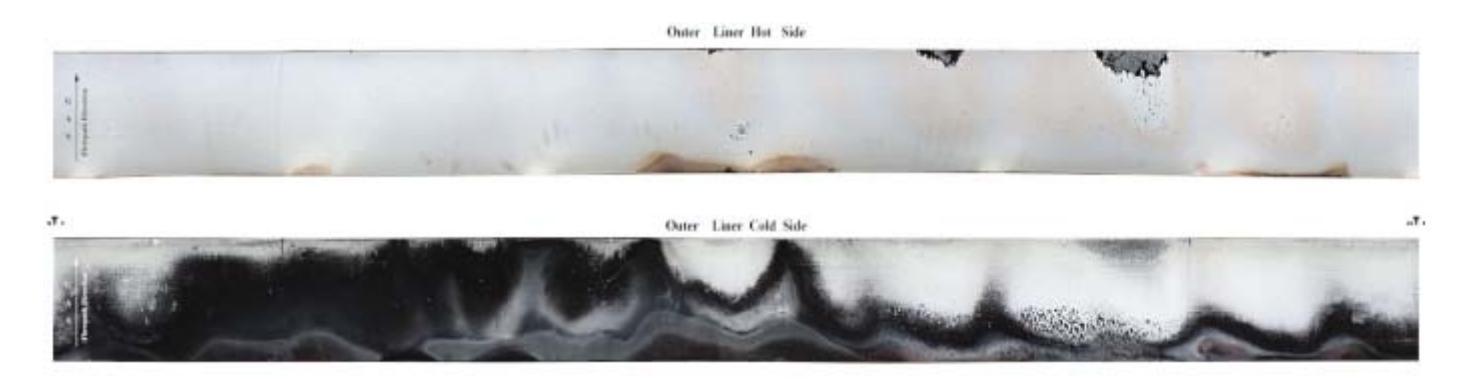
Figure 5.43 is digital photographs of the hot side (EBC-coated) and cold side (uncoated) of the outer liner. There is some discoloration at the bottom (aft) edge of the liner and localized EBC degradation at the top (fore) edge and towards the center of this liner. But otherwise the liner is well preserved. The Si/YS EBC has provided the best protection of any EBC for SiC/SiC tested thus far. The inner liner shows very heavy surface degradation with EBC spallation over the entire liner surface, except near the edges. It was concluded that a SAS surface coat does not appear to give the protection afforded by a BSAS top coat, a finding also indicated by the results of the MM-3 test (Si/SAS EBC), but unexpected because in laboratory testing SAS had less surface recession than BSAS.
