AAIPU# A14-005111

AIRCRAFT ACCIDENT REPORT

**CONTROLLED FLIGHT INTO TERRAIN (OBSTACLE)
DIPLOMAT AVIATION (BAHAMAS) LTD.
GATES LEARJET MODEL 35A**

**GRAND BAHAMA SHIPYARD
FREEPORT, GRAND BAHAMA, BAHAMAS
NOVEMBER 9, 2014**

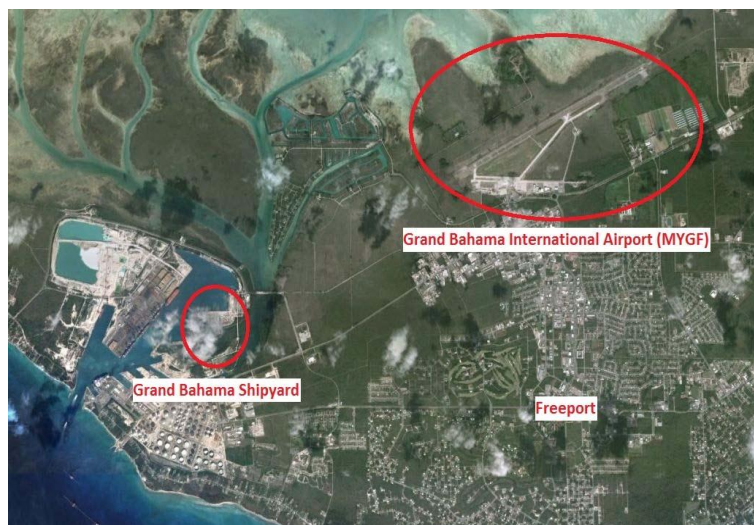
The crew continued the descent while looking visually for the runway until the aircraft right wing struck the crane positioned at Dock #2 of the Grand Bahama Shipyard, some 3.2 nautical miles (nm) from the runway threshold. The impact occurred with two support beams above the crane operator’s cab, approximately 115 feet above the base of the loading dock which was an additional 90 feet above sea level.
