Subject: - Interim Investigation Report of accident 737-8 MAX ET-AVJ, ET-302

**Aircraft Accident Investigation Bureau
Interim Investigation Report on
Accident to the B737-8 (MAX) Registered ET-AVJ operated by
Ethiopian Airlines
On 10 March 2019**

09 March, 2020

Report No. AI-01/19

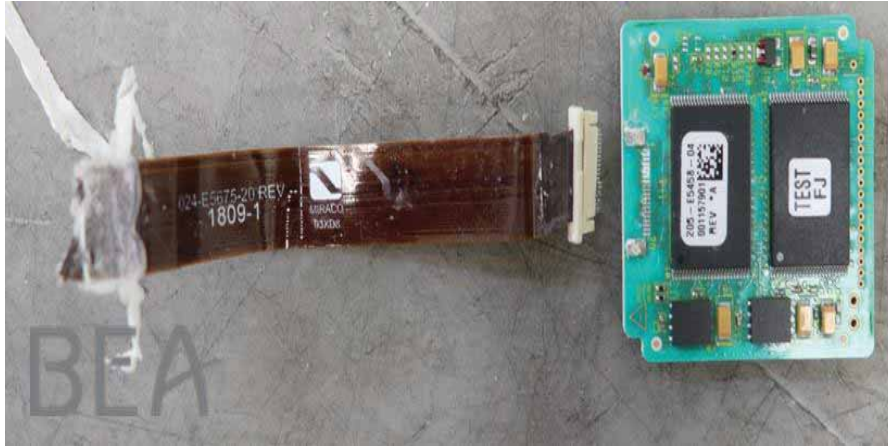
FIGURE26 : FDR MEMORY BOARD, FLEX AND CONNECTOR

The memory puck was opened and the electronic board containing the memory component support was extracted. The memory board identification was P/N 205-E5458-04, S/N 001157901 and the flex identification was 024-E5675-20 REV, 1809-1.

The memory board was visually inspected with a Keyence microscope. Apart from the connector pads, the memory board was in good condition. There was no trace of impact. The two memory chips as well as the micro-processor were found in good condition.

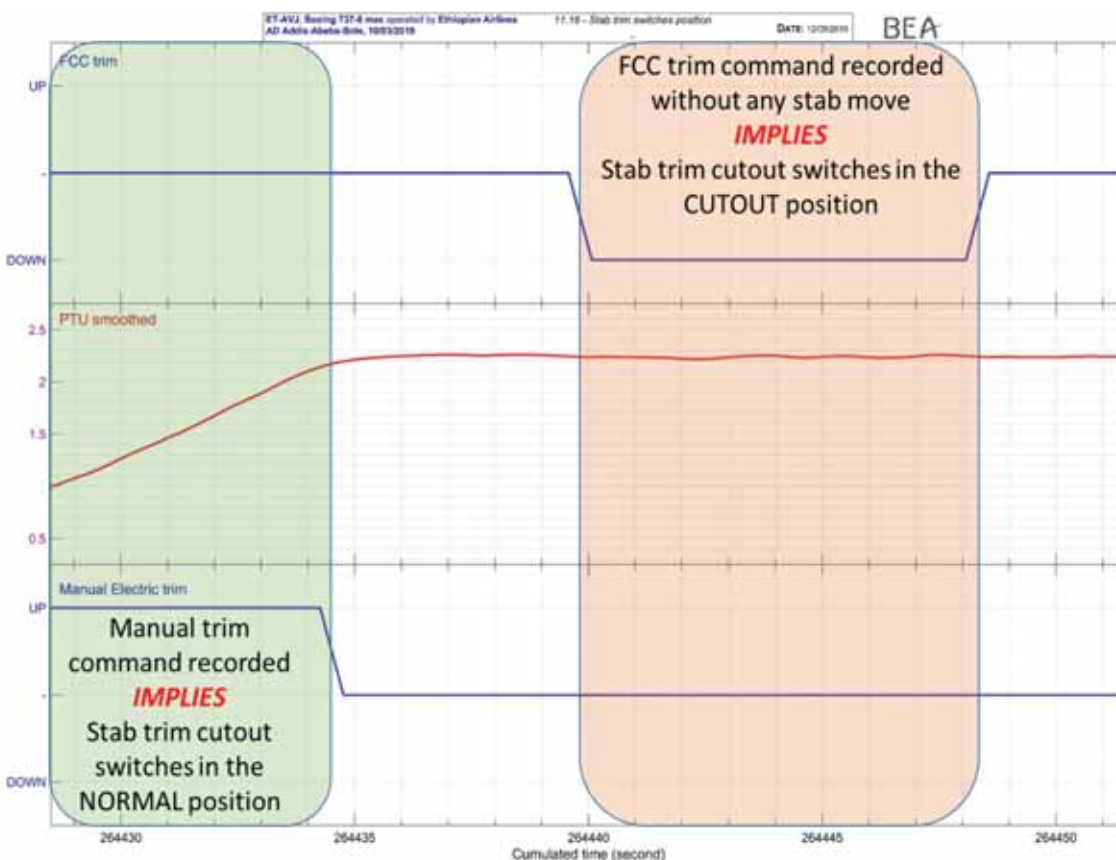
FIGURE 28: STAB TRIM CUTOUT SWITCHES POSITION

No discrete parameter records the positions of the stab trim cutout switches. However, some recorded parameters provide information on these positions:

- The discrete parameter of the manual electric trim command records command (up or down) only when both stab trim cutout switches are in the normal position.
- The discrete parameter of the FCC trim command records command whatever the positions of the stab trim cutout switches are. When FCC commands are recorded, if no stabilizer motion is recorded, it means that at least one stab trim cutout switch is in the CUTOUT position.

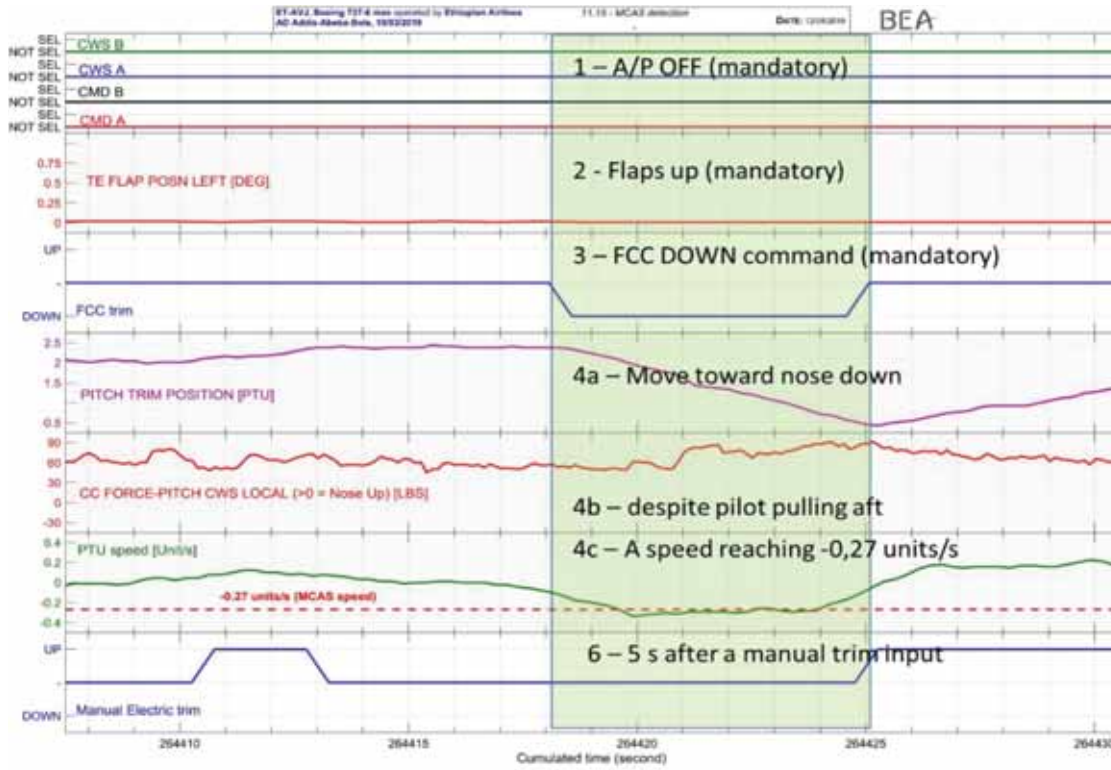
FIGURE 29: MCAS DETECTION WITH FDR DATA

No discrete parameter records the MCAS activation. However, MCAS activation can be detected with the following recorded information:

1. The autopilot is not engaged
2. The flaps are retracted
3. The stabilizer move is commanded by the FCC in the “down” position
4. If stabilizer moves,
 - The stabilizer moves toward aircraft nose down command.
 - This move of the stabilizer, if it is in opposition with the pilot command (pilot pulling aft), is only possible under MCAS activation.
 - The speed of automatic moves of the stabilizer is typically limited when flaps are up. This speed reaches $0.27^\circ/\text{s}$ only under MCAS activation.
5. If stabilizer did not move, the FCC command shall last during a time consistent with the MCAS computed duration.
6. If a manual trim command was performed before, MCAS triggers after a delay of 5 s.

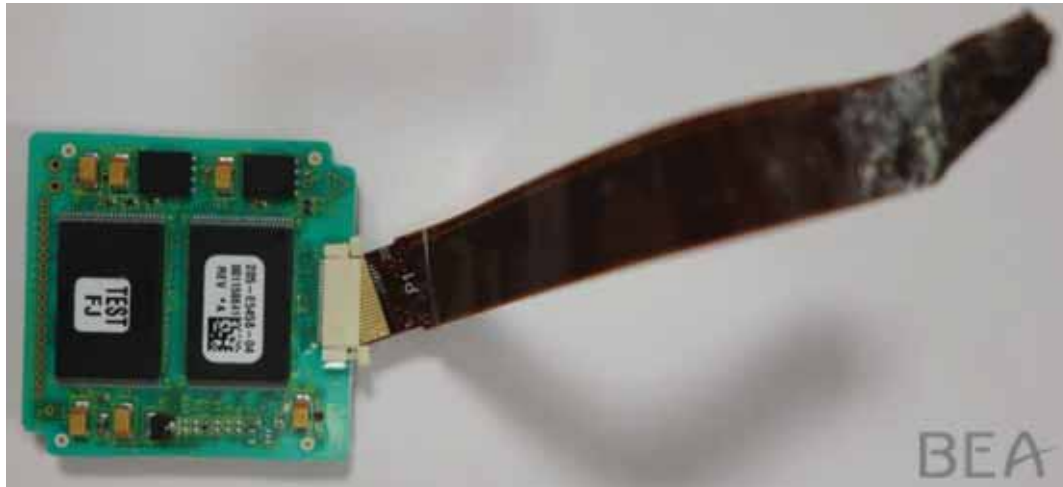
FIGURE 31: CVR MEMORY BOARD AND FLEX

The CVR memory board and flex were visually inspected with the Keyence microscope. There was no damage on the board and the connector was in good condition. A second observation with the X-ray was made, which confirmed that the connector soldering were in good condition.

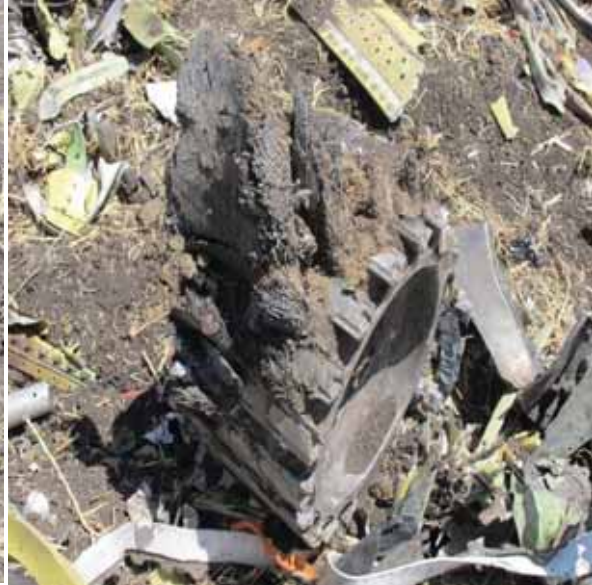
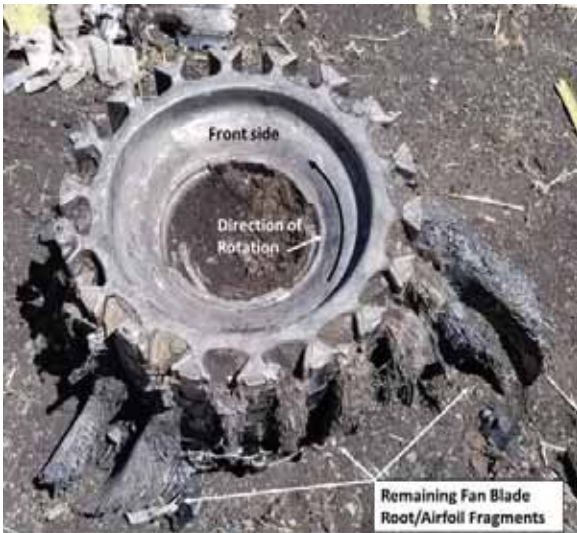
FIGURE 37: - R/H ENGINE - S/N 602695 – FAN DISK

The right engine core was recovered from the site and examined by the group. The recovered core of the right engine was more damaged than the left-hand engine. The engine was reportedly recovered at a depth of approximately 10 to 15 meters depth on the right side of the excavation site.

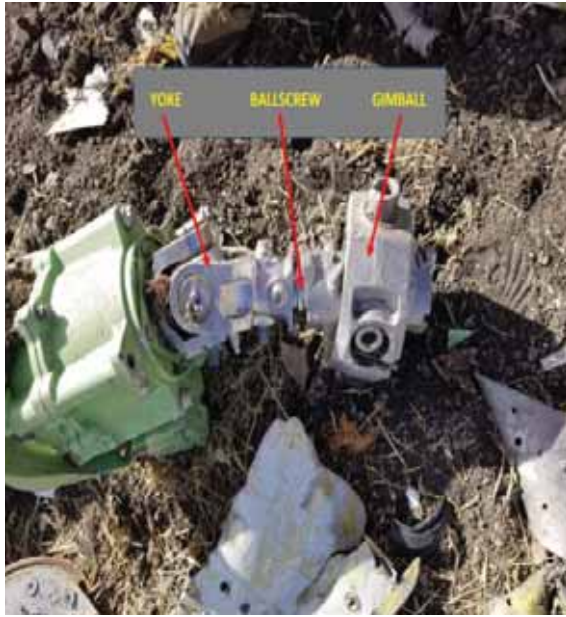
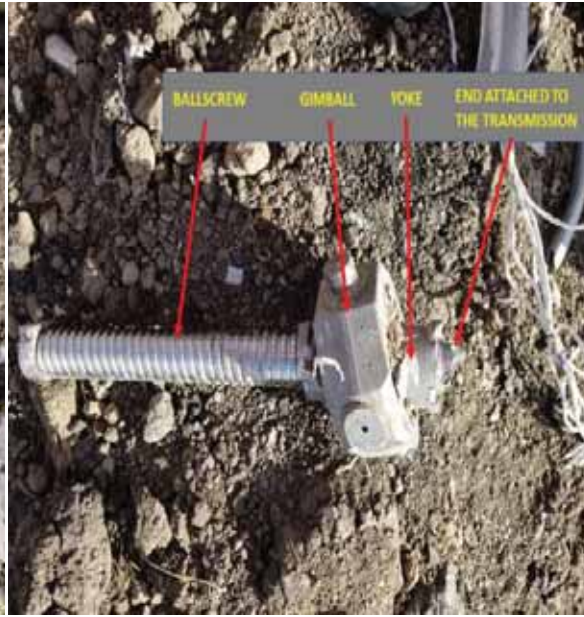
FIGURE45: FLAP TRANSMISSION & BALLSCREW

Two parts of the actuation system were located and examined at the impact site. One consists of the ballscrew, yoke, gimbal and flap transmission; the other consists of just the ball screw, yoke, and gimbal (see **Figures** respectively).

The installed location of each unit has not been identified. The position of each gimbal is consistent with the flaps in the fully retracted position.

Again, all three were found in the fully retracted position. There was one additional transmission portion that was found as well as three ball screw segments. All examined damage appears consistent with high energy impact.

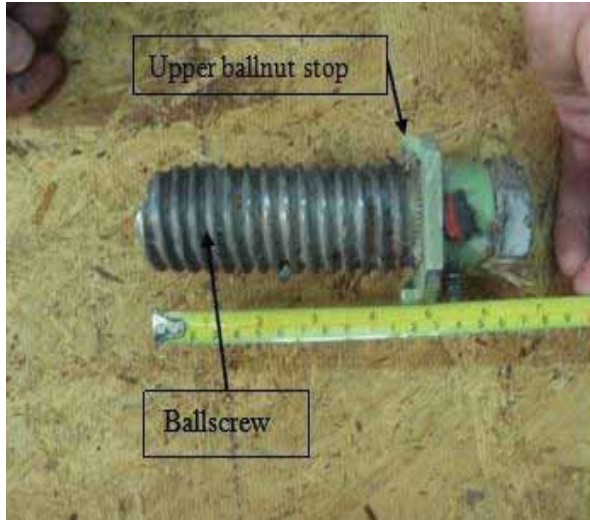
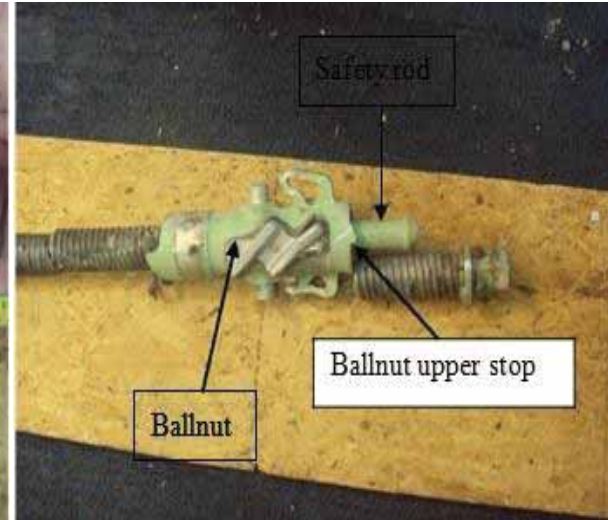
FIGURE53:UPPER BALLSCREW SEGMENT

The figure below shows the relationship of the ballnut position along the ball screw. There is a safety rod which acts as a secondary load path should the ball screw fracture in service for any reason. It is attached to a separate set of secondary gimbals below the primary support gimbals on the primary brake housing and to the top of the ball screw. Figure 54 shows the safety rod and that it protrudes out from the ball nut. However, the fracture faces on the 5" long upper screw portion (note the measurement in Figure 53) match those found near the ballnut upper stop. This is consistent with the safety rod being pulled out several inches prior to final fracture.

Examining the fracture surfaces, the upper screw segment fits with the fracture face just inside the ballnut giving a measurement between the stops on the ballnut and the upper ballnut stop of ~5". Referencing Boeing document D251A122 (737NG Control Position Data), this measurement equates to a stabilizer trim setting of 1.5 degrees Airplane Nose Down (AND) or an indicated position of 2.5 units of trim. Although the data is for the 737NG, the position of the MAX stab trim holds the same relationship. According to Boeing:

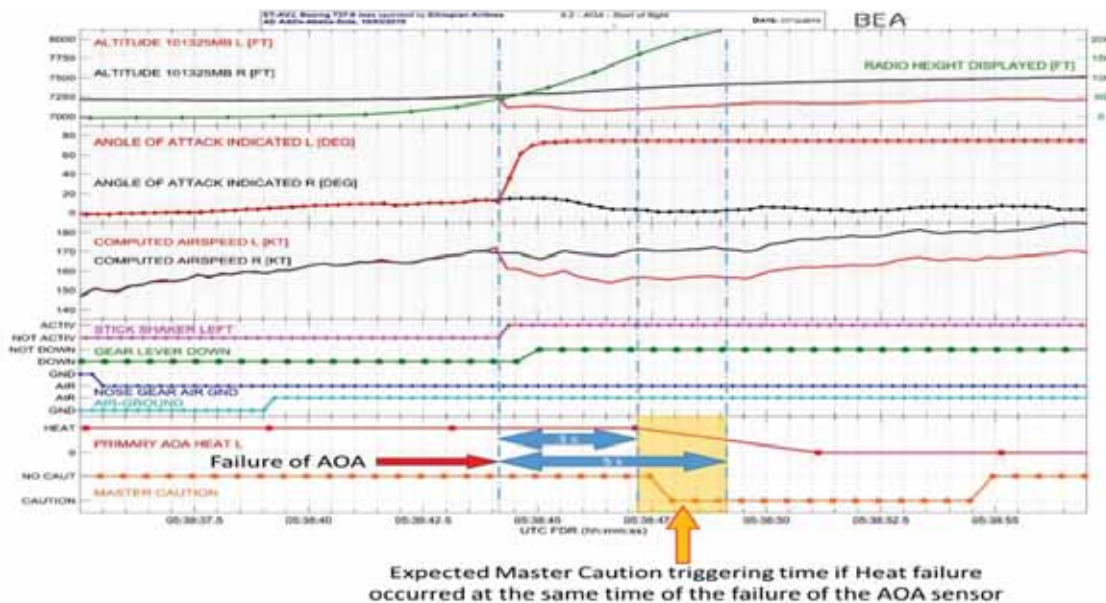
FIGURE 56:

At 5 h 38 min 48 s, a master caution triggered. From that time, the primary AOA heat LH recorded values underlined a failure of the vane heating (first recorded OFF value at 5 h 38 min 51s, sampling rate of the parameter: 0.25 Hz). The reason of the master caution was the anti-ice left alpha vane indication.

AOA VALUES DURING THE BEGINNING OF THE FLIGHT

The recorded computed airspeed values and the recorded corrected pressure altitude values were computed with the signal coming from the AOA sensor resolver No2. Their values were consistent with the shape of the LH AOA recorded values (for both parameters, an increase followed by a decrease). The triggering of the stick shaker underlined that the signal coming from the resolverNo1 matched also the LH AOA recorded values. Due to the way the AOA values were recorded, both resolvers of LH AOA sensor provided similar values. The failure impacted the signals provided by both resolvers of the LH AOA sensor.

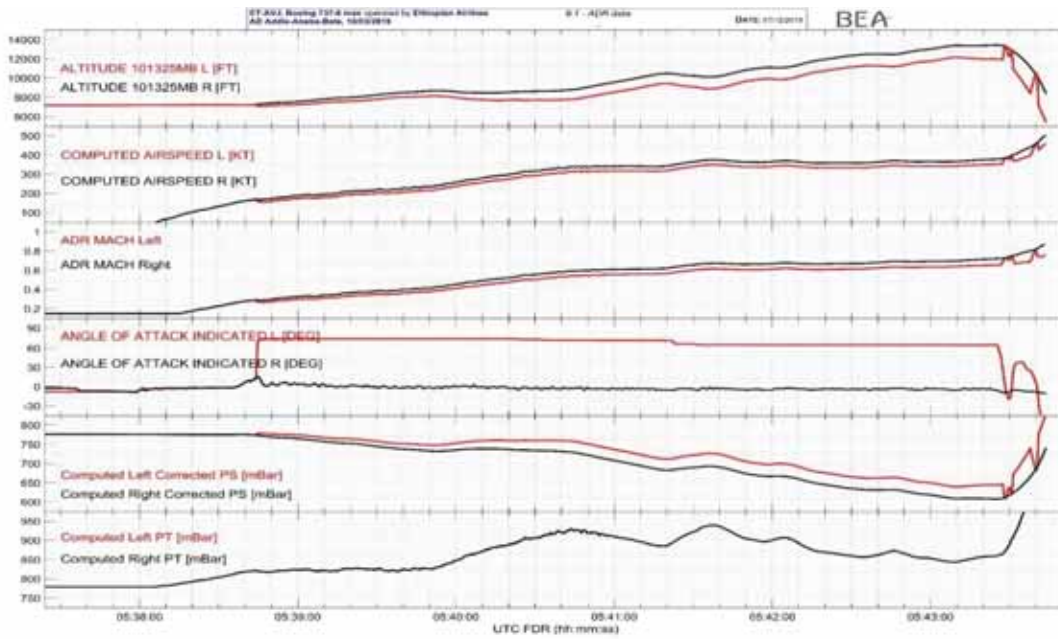
FIGURE 57: AIR DATA PARAMETERS

During the flight of the event, the recorded altitude values, the recorded CAS values and the recorded Mach numbers diverged after LH and RH AOA values divergence.

The RH and LH computed total pressure values were identical. The difference between the recorded Mach number and between the recorded computed airspeed values were due to the difference of the corrected static pressure values.

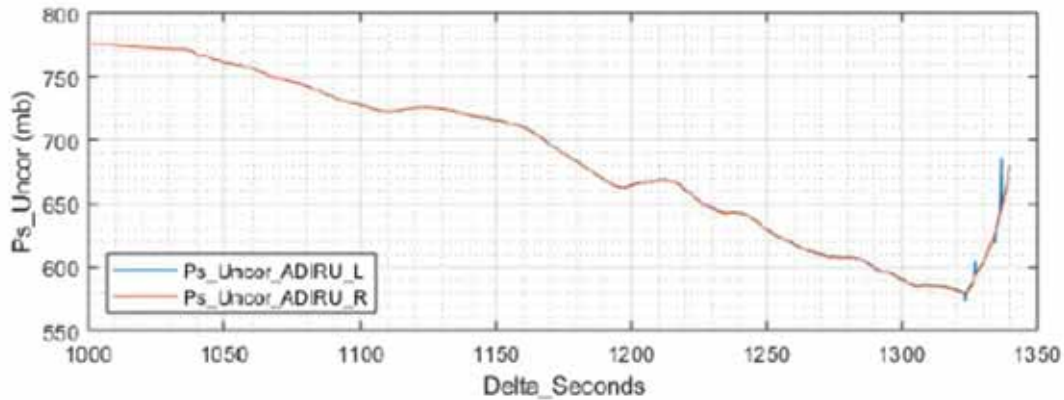
FIGURE 58: UNCORRECTED STATIC PRESSURE COMPUTED BY THE AIRPLANE MANUFACTURER

Uncorrected static pressure values from both sides were identical. The difference between the LH and RH side corrected pressure values were therefore only due to the AOA correction.

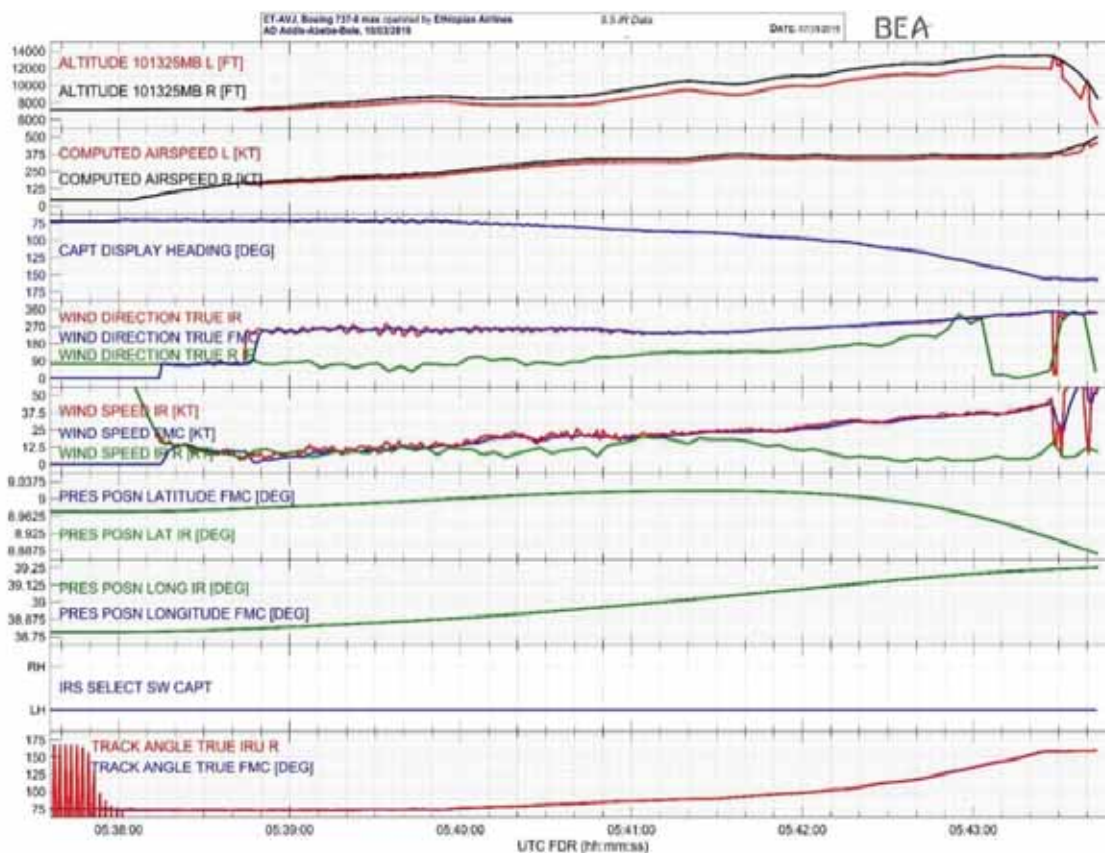
FIGURE 59: IMPACT OF AOA FAILURE ON THE WIND COMPUTED VALUES

Most of the recorded IRS parameters did not show any variation following the AOA failure. On the contrary, the computed wind, on the left side, was clearly affected by that failure.

The LH IRS was selected for the flight of the event. The invalid wind computed values impacted also the FMC that smoothed the values coming from the selected IRS.

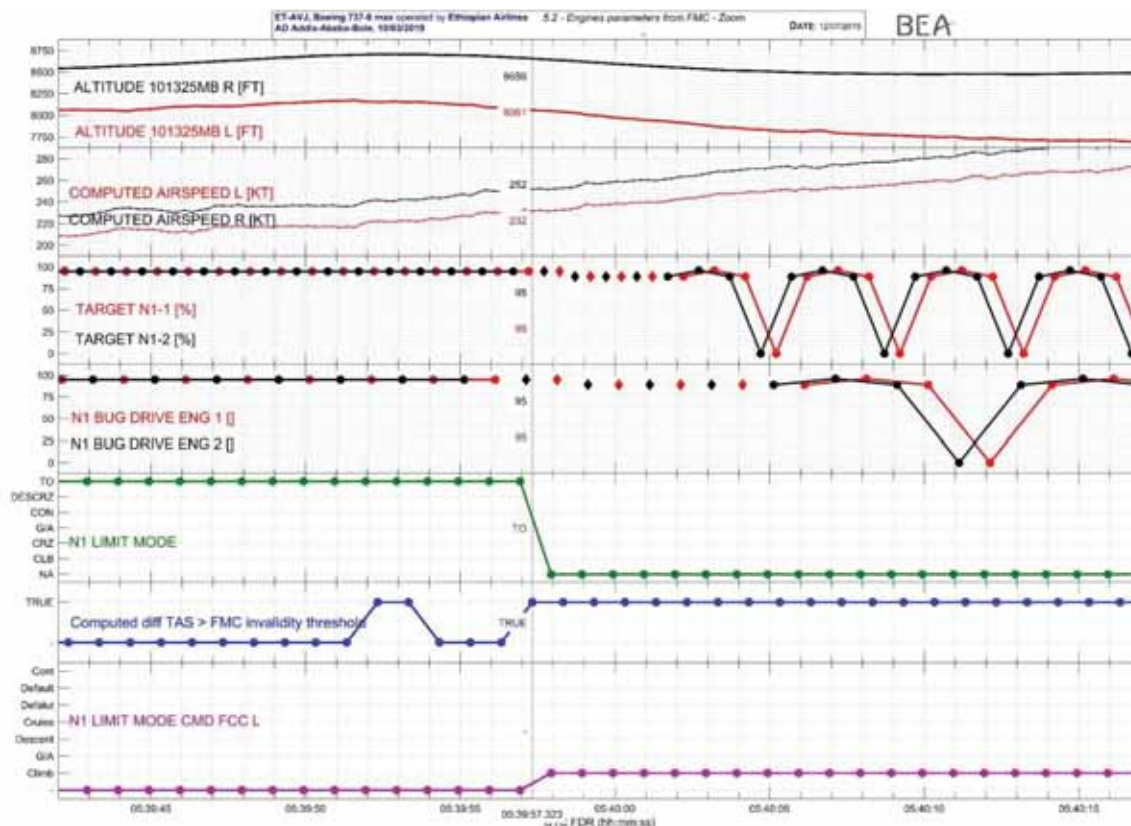
FIGURE 61: FOCUS ON INVALID N1 DATA FROM FMC

- At 05 h 37 min 53 s, the TO/GA switch was pushed. A/T switched to the N1 mode. The automatic takeoff and climb was engaged. A/T moved automatically the throttles forward (*THRUST RATE CMD-[1/2]* values, *THR TORQUE-[1/2]* values were positive). TRA did not move anymore until the end of the flight because the FMC used the LH baro corrected

altitude values, which were lower than the true ones. Thus, FMC did not detect the thrust reduction altitude when it was sending valid engine commands. And LH and RH TAS diverged by more than 25 kts the FMC did not send any valid N1 target values

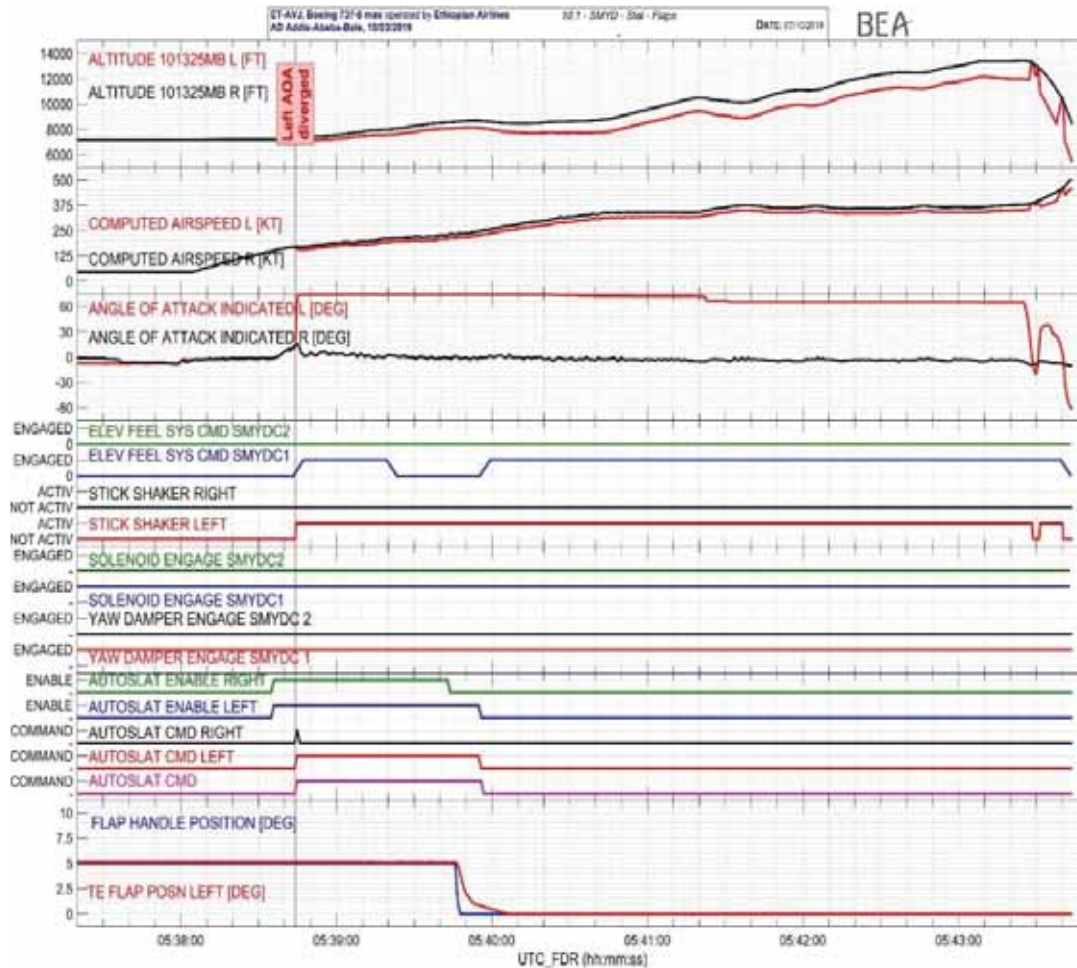
FIGURE63: AUTOSLAT, LEFT STICK SHAKER AND ELEVATOR FEEL SYSTEM

- the autoslat system triggered (SMYDC 1),
- the LH stick shaker engaged
- the LH elevator feel shift triggered.

At 5 h 39 min 56 s, the autoslat system stopped and the flap handle was at 0 position and flaps were moving up (flaps position lower than 1) with LH computed airspeed values reaching 230kt and RH computed airspeed value 250kt.

At 5h 39 min 44s SMYDC-2 disabled the RH autoslat function due to the RH computed airspeed (230kt reached). SMYDC1 disabled the LH autoslat function 12 s later due to the invalid LH computed airspeed.

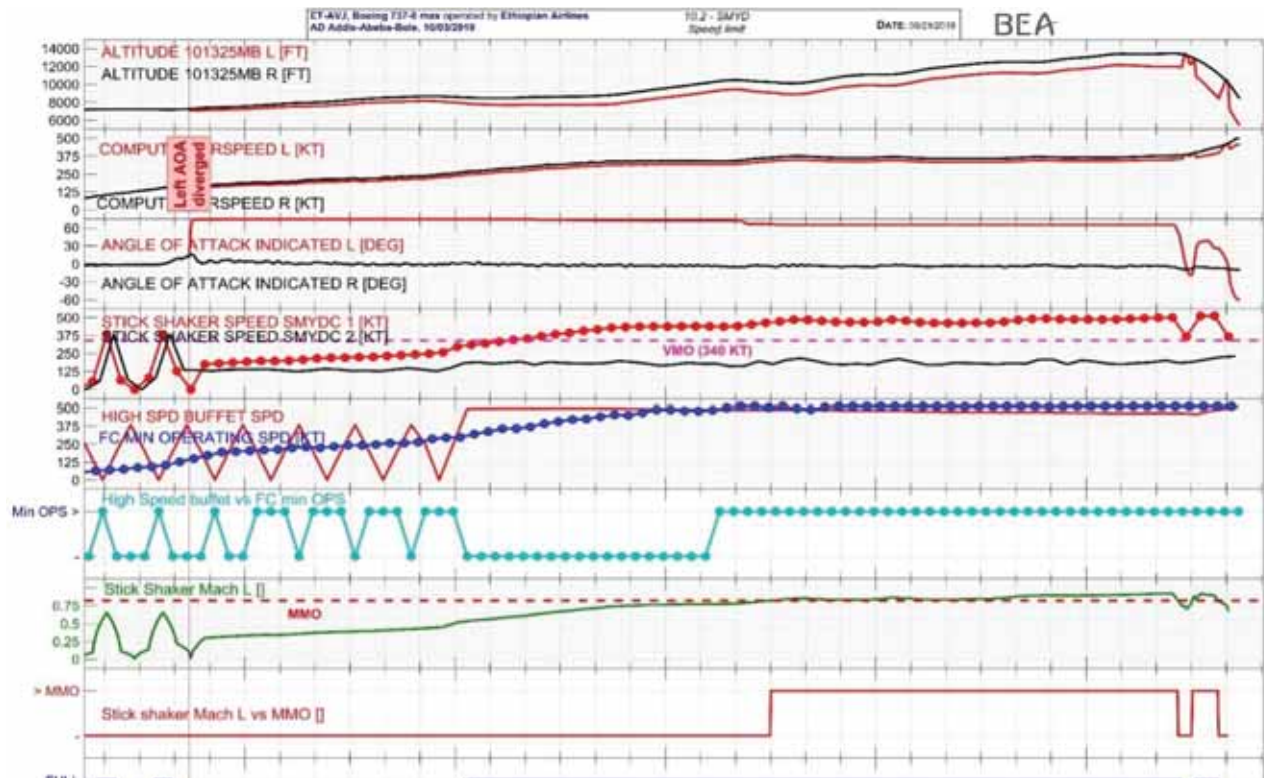
FIGURE 64: SMYD COMPUTED SPEEDS LIMITS

From 5 h 41 min 30 s until the end of the flight by computing the equivalent Mach number, the left Stick Shaker Mach computed numbers were greater than the MMO (0.82) ;

At 5 h 41 min 17 s, SMYDC1 computed FC minimum operational speed values greater than High speed values. Both values were computed by the same computer SMYDC 1.

The speed tape of the airplane had a range of 120kt (60kt above and below the actual computed airspeed). As soon as the stick shaker speed reached values higher than the actual computed airspeed plus 60kt, red and black stripes are displayed all along the border of the speed tape.

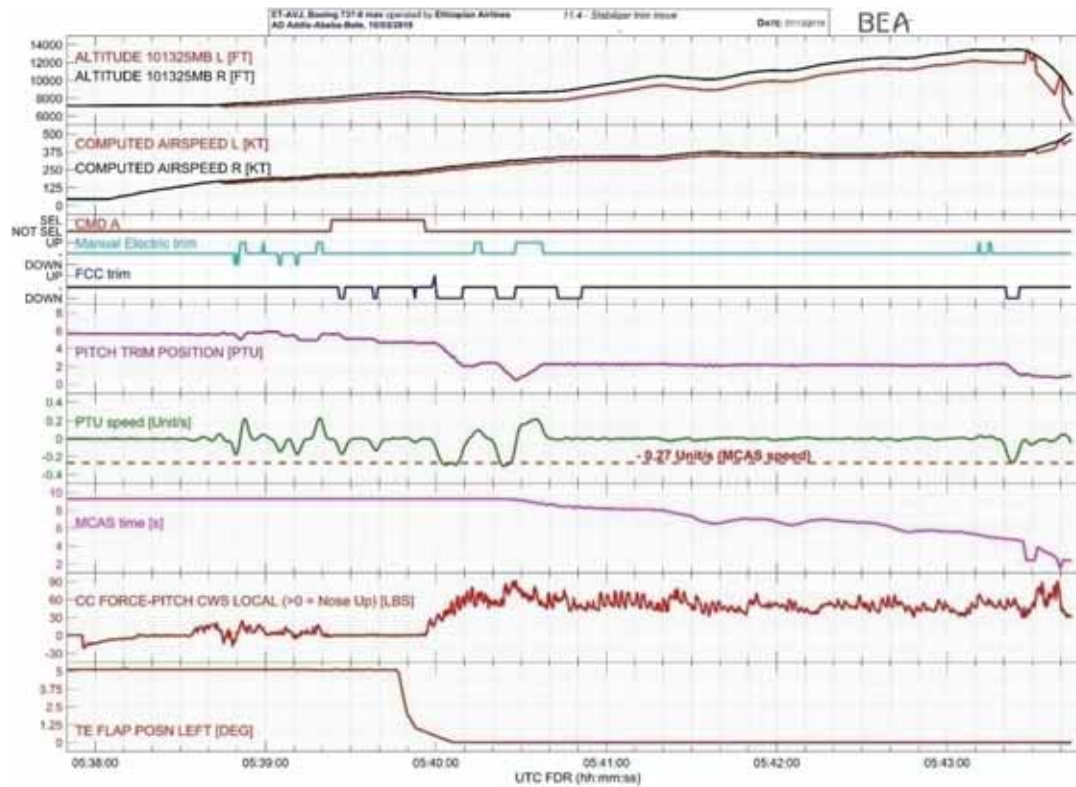
FIGURE 65: STABILIZER COMMANDED MOVES

During the beginning of the flight, several manual electrical trim inputs were recorded. These inputs limited the force the captain applied to the control column. Between the lift off and the engagement of CMD A, the stabilizer moved between 4.9 and 5.9 units. When A/P was engaged, the stabilizer was at 5.6 units.

Under A/P, 3 FCC A/P trim down commands were recorded and the stabilizer trim values decreased to 4.6 units. When A/P disengaged, one single sample of FCC trim UP was recorded (Speed Trim activation).

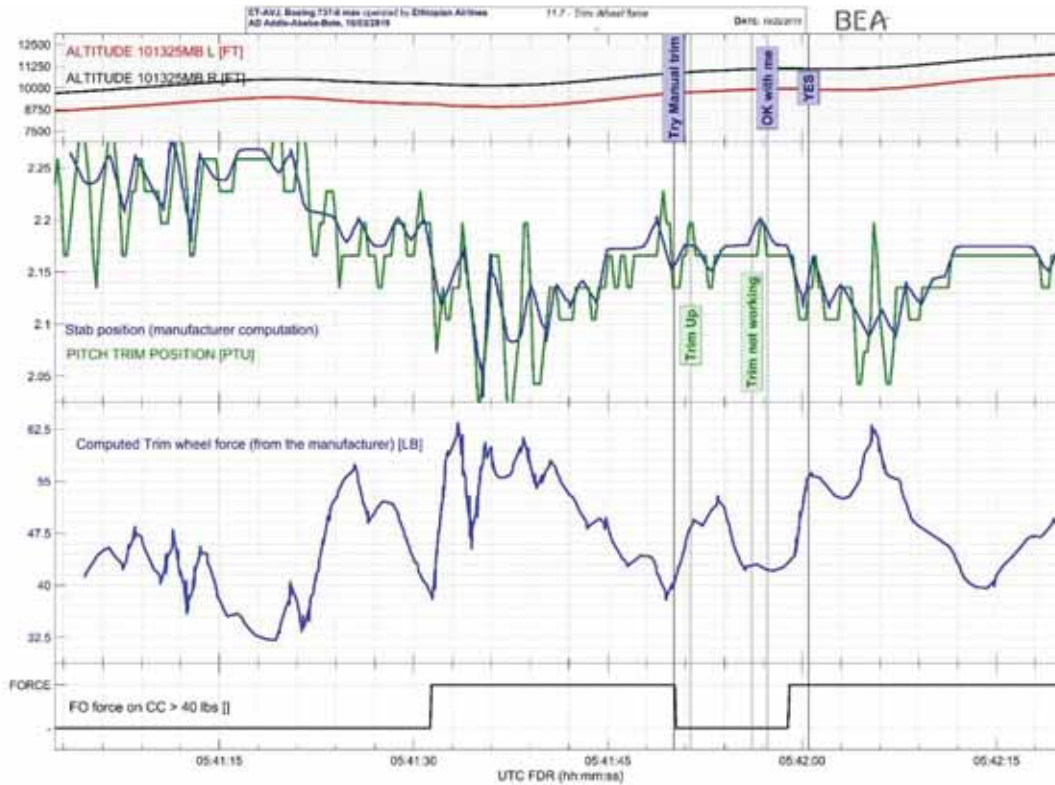
FIGURE 66: FORCE NEEDED TO MOVE THE TRIM WHEEL

- At 5 h 41 min 50 s, the captain requested the F/O to try moving the trim manually.
- At 5 h 41 min 50.5 s: a sound similar to the trim wheel handle extension was detected.
- At 5 h 41 min 51 s, the copilot confirmed “Trim up”
- At 5 h 41 min 55.5 s, the captain used an “expression of expectation”
- At 5 h 41 min 56 s, the copilot stated: “it is not working”.

By the time the FO tried to move the trim wheel manually a force between 42 lbs and 53 lbs was required according to the aircraft manufacturer computation, (see Figure 6).

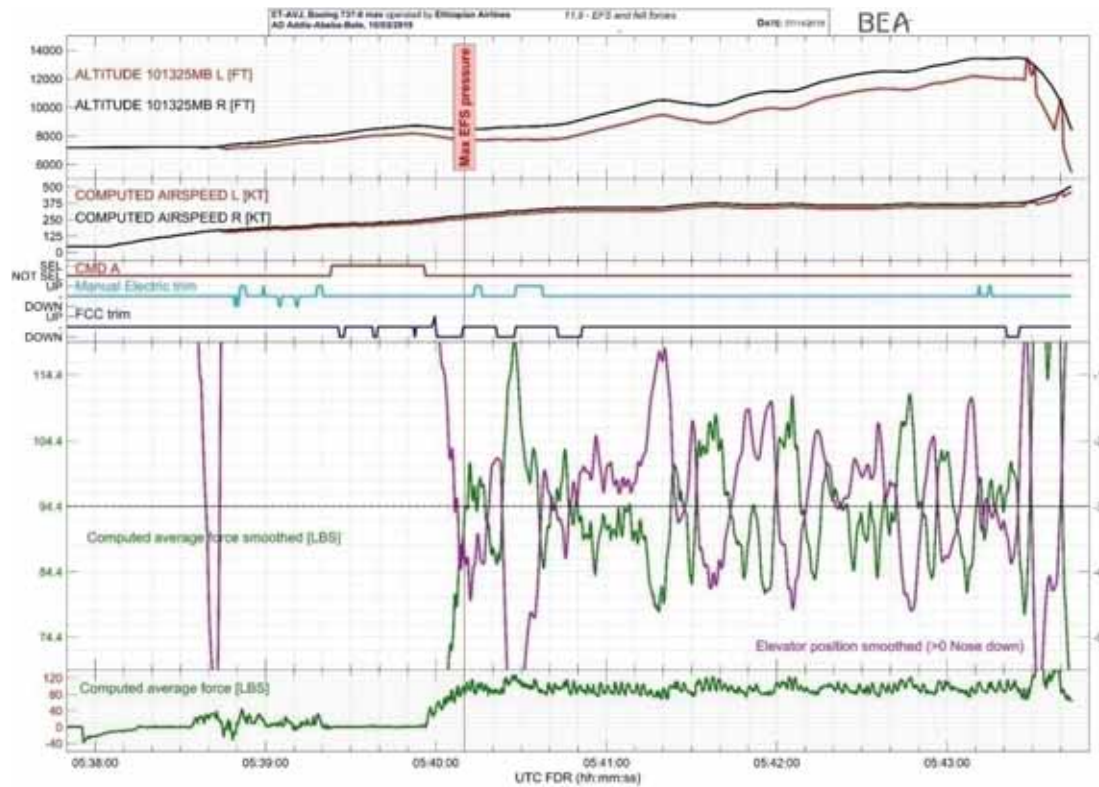
FIGURE 68: FELT FORCE AND ELEVATOR POSITION

Note1: the airplane manufacturer computed the pressure the elevator feel system delivered during the flight of the event. After the A/P disconnection, from the end of the 1st FCC trim down command until the end of the flight, the Elevator Feel system delivered a constant pressure that was the maximum pressure.

The gradient of force felt by the crew can be illustrated by the comparison between the force applied on the control column and the position of the elevator.

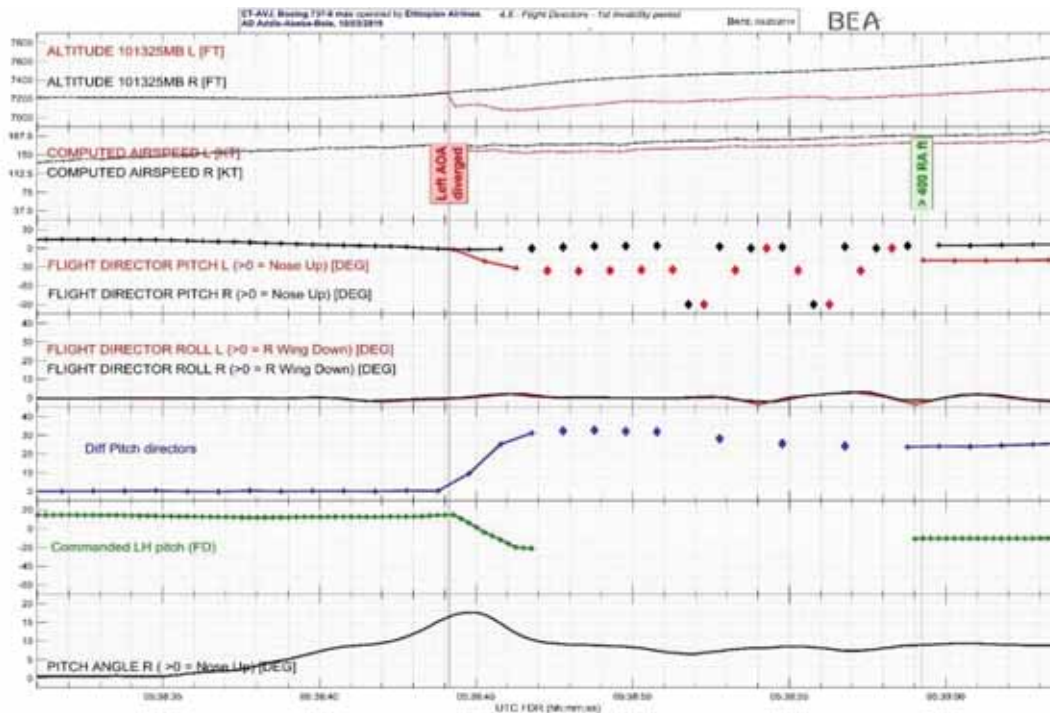
FIGURE 70: FLIGHT DIRECTORS - START OF THE FLIGHT

When the LH and RH AOA values diverged, LH pitch F/D commands recorded values quickly decreased to -32° while RH pitch F/D recorded values slightly increased to -0.4° . The difference between LH pitch F/D values and RH pitch F/D values were greater than the threshold above which FCCs comparators triggers and both F/D pitch were biased out of view.

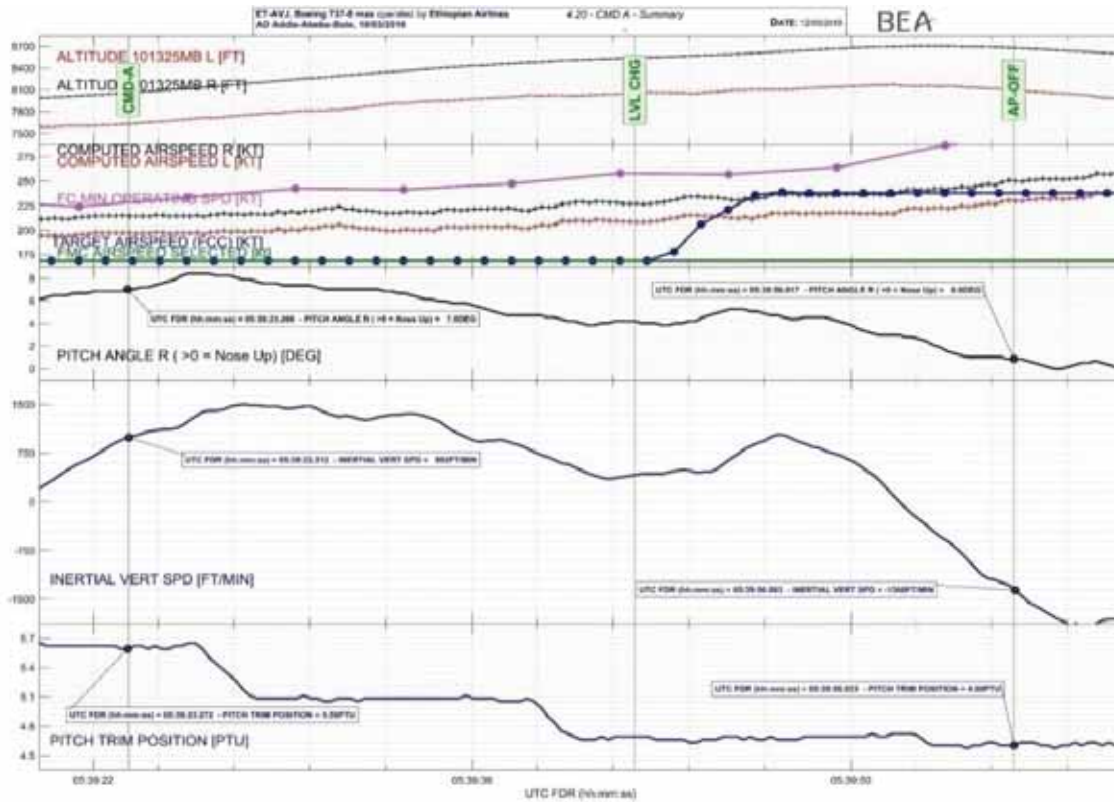
FIGURE74: CMD A - SUMMARY

At the connection of CMD A, the airplane was climbing with a vertical speed of around 1,000 ft/min increasing, a pitch value of around 7° increasing and a stabilizer position of 5.6 units.

When CMD A automatically disconnected, the airplane was descending with a vertical speed of around -1,400 ft/min, a pitch angle of around 1° and a stabilizer position of 4.6 units.

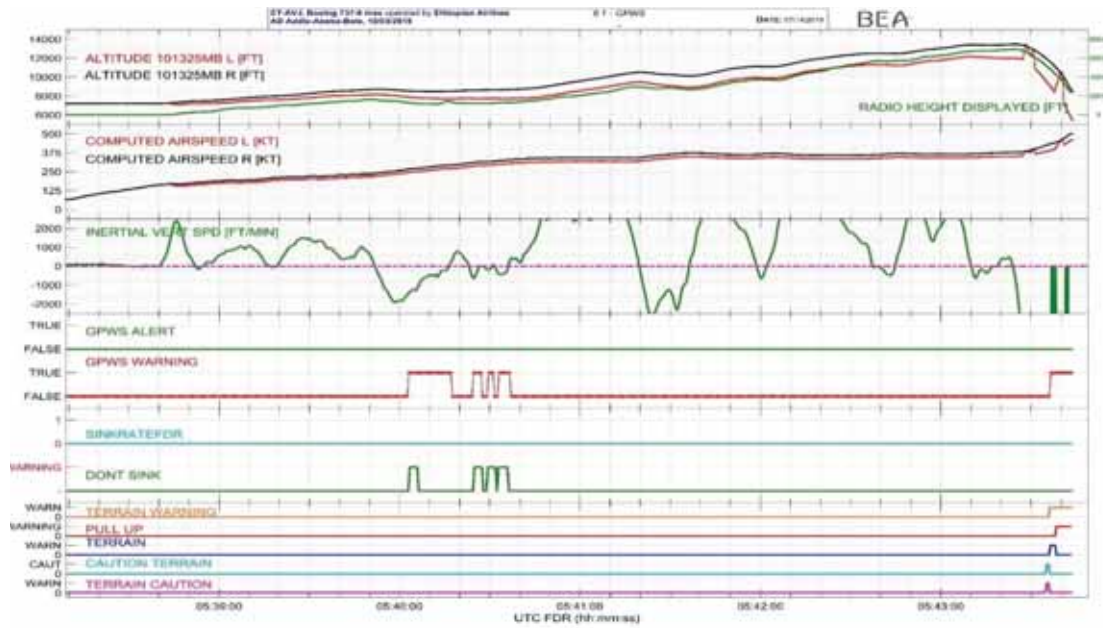
FIGURE 76: GPWS ALERTS

At the end of the flight, the combination of the vertical speed and the height of the airplane made the terrain and pull up warning trigger.

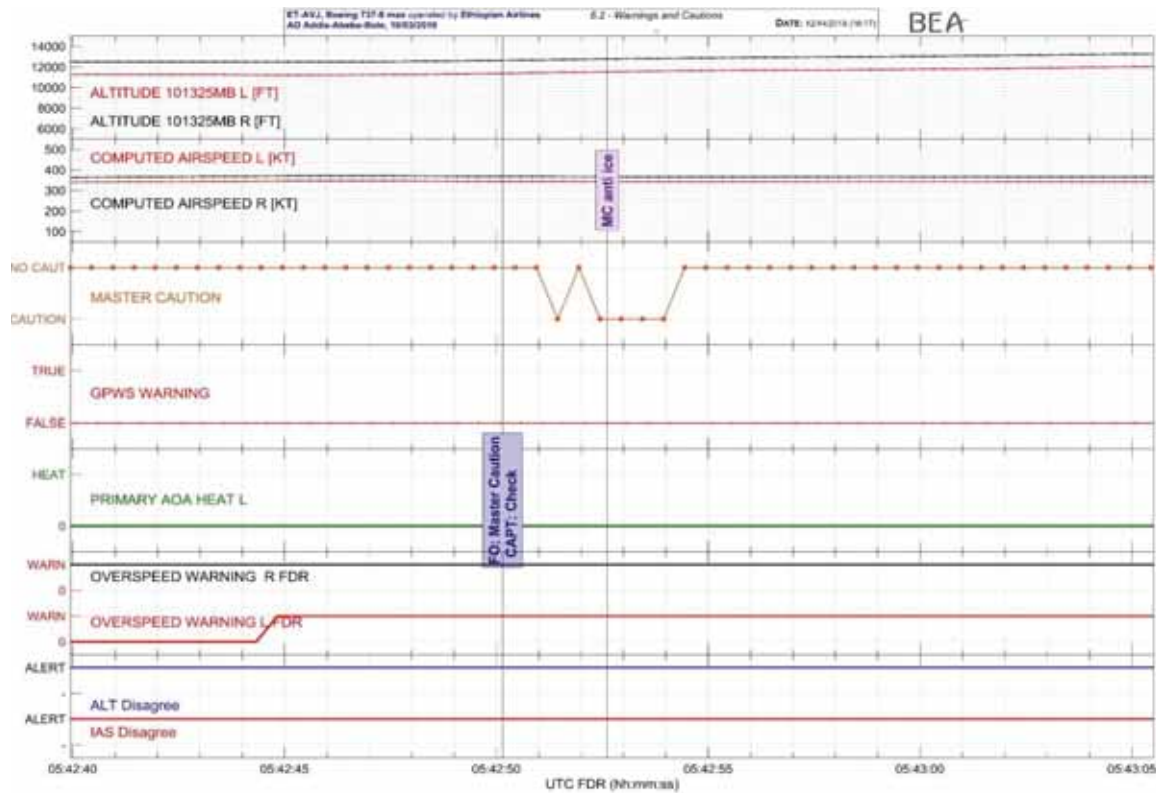
FIGURE 78: MASTER CAUTION RECALL

Then master caution triggered a second time at 5 h 42 min 51 s during 2.5 s. The crew detected: “Master Caution/anti Ice/left Alpha Vane”.

The third master caution triggered at 5 h 43 min 40 s. This master caution is still under investigation.

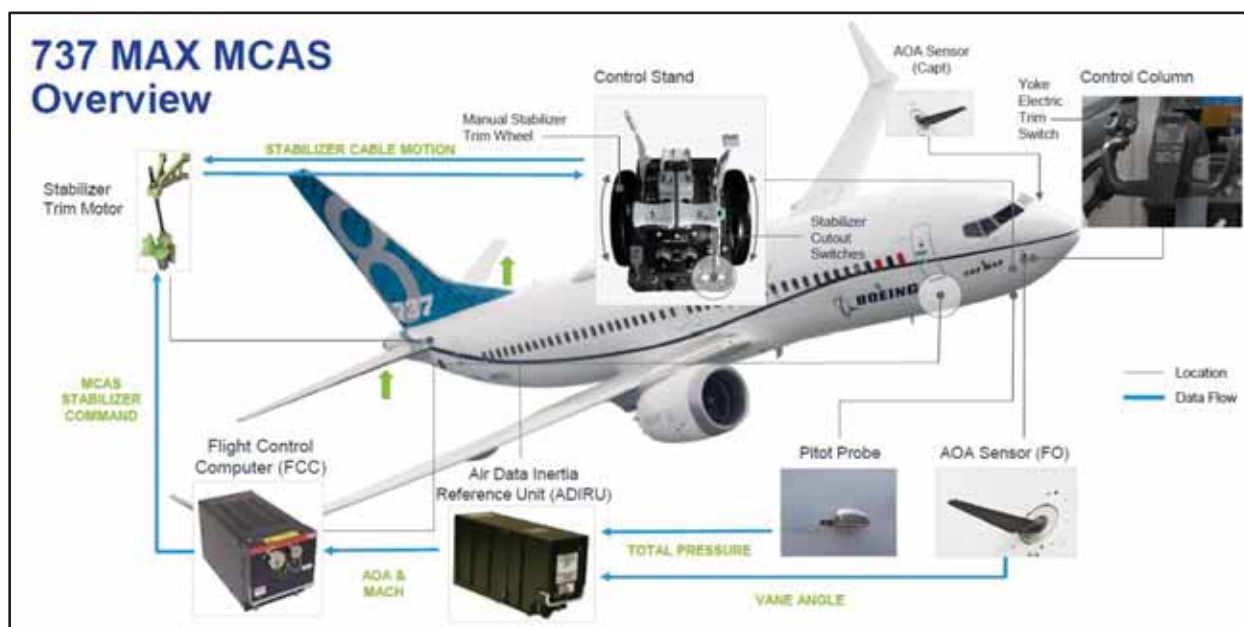
FIGURE 81: MCAS OVERVIEW

As originally delivered, the MCAS became active during manual, flaps-up flight (autopilot not engaged) when the AOA value received by the master FCC exceeded a threshold based on Mach number. When activated, the MCAS provided a high rate automatic trim command to move the stabilizer AND. The magnitude of the AND command was based on the AOA and the Mach. After the non-normal maneuver that resulted in the high AOA, and once the AOA fell below a reset threshold, MCAS would move the stabilizer ANU to the original position and reset the system. At any time, the stabilizer inputs could be stopped or reversed by the pilots using their yoke-mounted electric stabilizer trim switches, which also reset the system after a 5 second delay.

The latter behavior is based on the assumption that flight crews use the trim switches to completely return the airplane to neutral trim. In the FCC software version current at the time of the accident, if the original elevated AOA condition persists for more than five seconds following an MCAS flight control law reset, the MCAS flight control law will command another stabilizer nose down trim input (with the magnitude based on the AOA and Mach sensed at that time).
