Erik Serrano

**An overview of failures in
large-span timber structures**

SP AR 2006:14
Bygg och Mekanik
Borås 2006

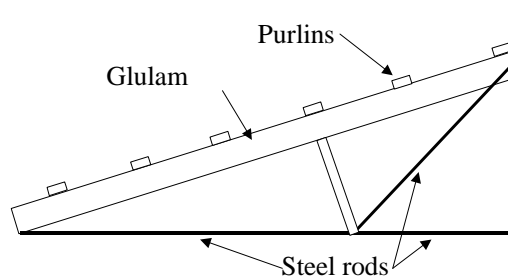
Figure 7. Combined glulam-tension rod truss (not to scale).

The roof structure of a complete building was assembled on the ground. The structure consisted of four trusses according to Figure 7. The trusses were joined by purlins, no additional lateral bracing was present. The total span of the trusses was approximately 42 m and the distance between the trusses was approximately 7,2 m.

After finalising the roof structure with four trusses and purlins, a crane was used to raise it in place on top of supporting columns. The straps used during rising of the structure were placed according to Figure 8. The forces in the straps lead to a compressive force in the glulam parts, as indicated below. In addition, the purlins are also subjected to compressive forces, see Figure 9. Just before putting the roof structure down on its supports, the structure collapsed. According to witnesses, one of the outermost trusses tilted and the structure failed.

The conclusion from the original investigation was that buckling of the purlins caused the failure, due to an excessive compressive force being applied. A simple hand calculation of the forces was made showing that the normal force in the mostly stressed purlin exceeded the design value by a factor of 3. The positions of the straps during the raise were possible to determine due to local compressive failure of the wood.

The conclusions from the original investigation seem adequate. The failure can be classified as being due to poor handling during erection. The roof structure should have been further stabilised during the raising. The local crushing of the wood at the straps should alone be a reason for stopping the raise.

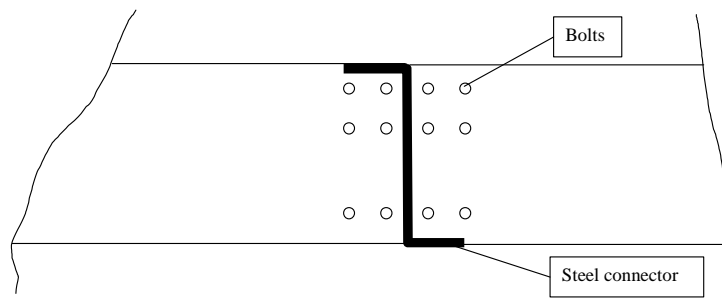
Figure 12. Schematic of beam connection.

The roof structure of this library and lecture hall consists of primary load bearing glulam beams of depth between 855 and 1350 mm. The beam width is 215 mm. The beams are connected at supports with a steel connector, schematically shown in Figure 12. The structure was erected during March – April.

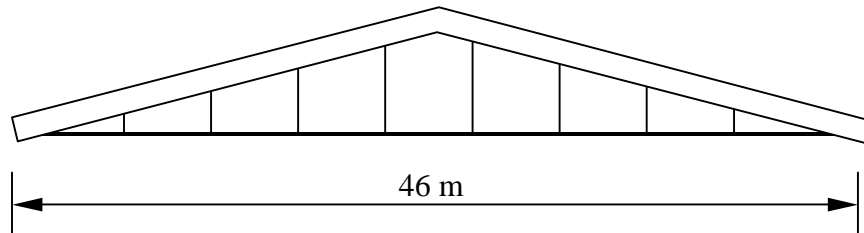
Figure 14. Roof structure.

This structure is a roof structure of an ice-hall. The structure is a three-hinged roof truss with a tensile rod as depicted in Figure 14. A total of 11 roof trusses at a spacing of 6 m make up a total of 60 metres length of the building. The building was erected in 1964.

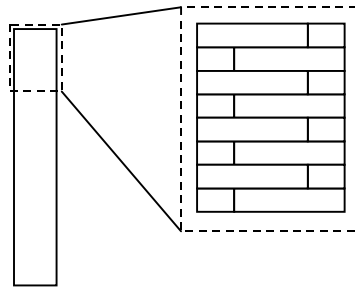
Figure 15. Beam cross-section built up from edgewise glued laminations.

Each of the 190 mm wide roof beams was made up from two laminations, edgewise glued to each other. The two laminations had widths of 45 and 145 mm respectively. This is shown in Figure 15.

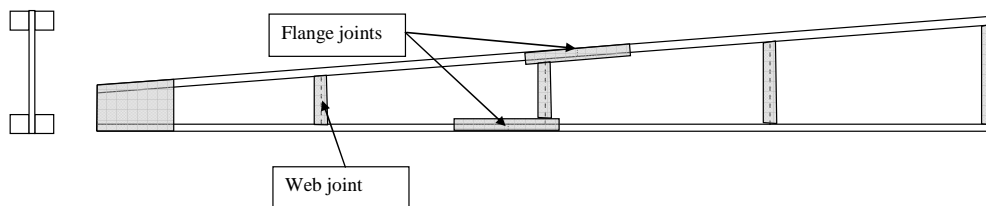
Figure 16. Beam with joint reinforcements.

The roof structure of the school building was made from single tapered beams, made from solid wood flanges glued to a plywood web. The flanges were glued-nailed to the web using a phenol or possibly a phenol-resorcinol adhesive. The flanges consisted of two timber members, one glued to each side of the web. The web had joints, which were reinforced by vertical wood members, also glued-nailed to the web. The flanges were also lengthwise joined by glued-nailed, overlapping wood members. The flange joint was located at the same section for both timber members in the flange. The roof beam is schematically depicted in Figure 16. The span of the roof beams was approximately 7,9 m.

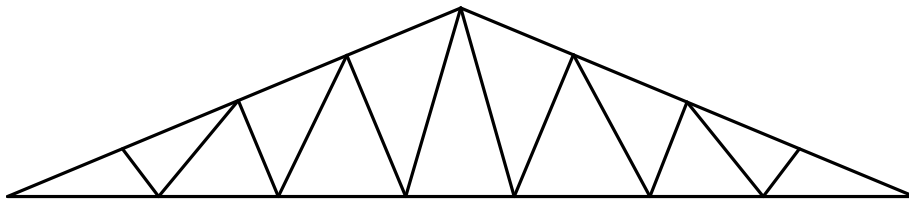
Figure 17. Exemple of roof truss

A large number of similar structures were built in Sweden for a chain of stores. The structure is based on nail-plate connected roof trusses. The battens, for support of the roof tiles, are nailed directly to the upper chord of the roof trusses. The roof structure also includes a reinforced plastic sheeting or a hard fibre board, covering the roof trusses, for draining of rain water. At least 26 cases have been documented, where the same principle was used for the load bearing structure. The buildings are relatively large, with free spans of 20-25 m and lengths of up to 65-70 m.

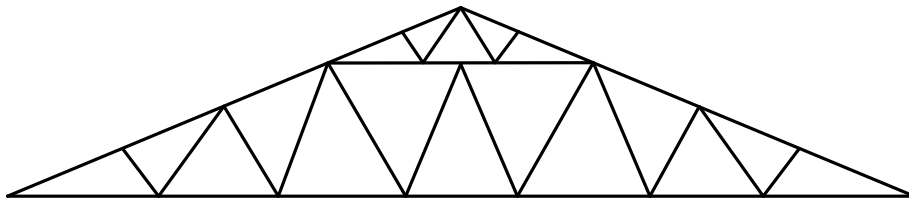
Figure 18. Truss divided in two parts for transportability.

Sometimes, the trusses have been manufactured in two parts, for transportability, see Figure 18

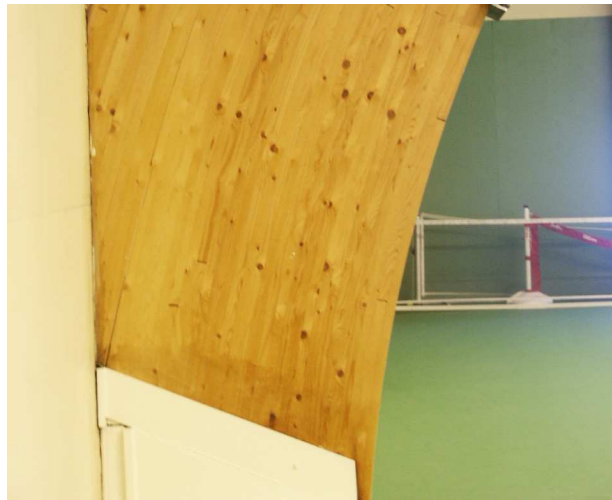
Figure 20. Arched column with steel parts (in white).

This structure is a tennis hall built from 3-hinged glulam frames, placed at 9 m distance. The columns are curved, and attached to the ground by steel parts, see Figure 20.
