CERN
CH1211 Geneva 23
Switzerland

EDMS NO.
1724436

Metallurgy Report

Analysis of ITER Axial Insulation Break (IBDH251)

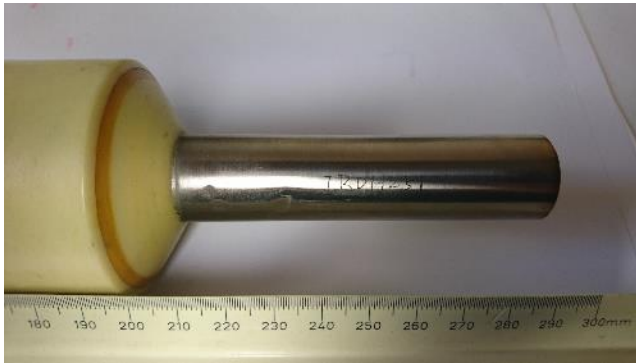
Figure 3: Marking specifying the IB identification (IBDH251).

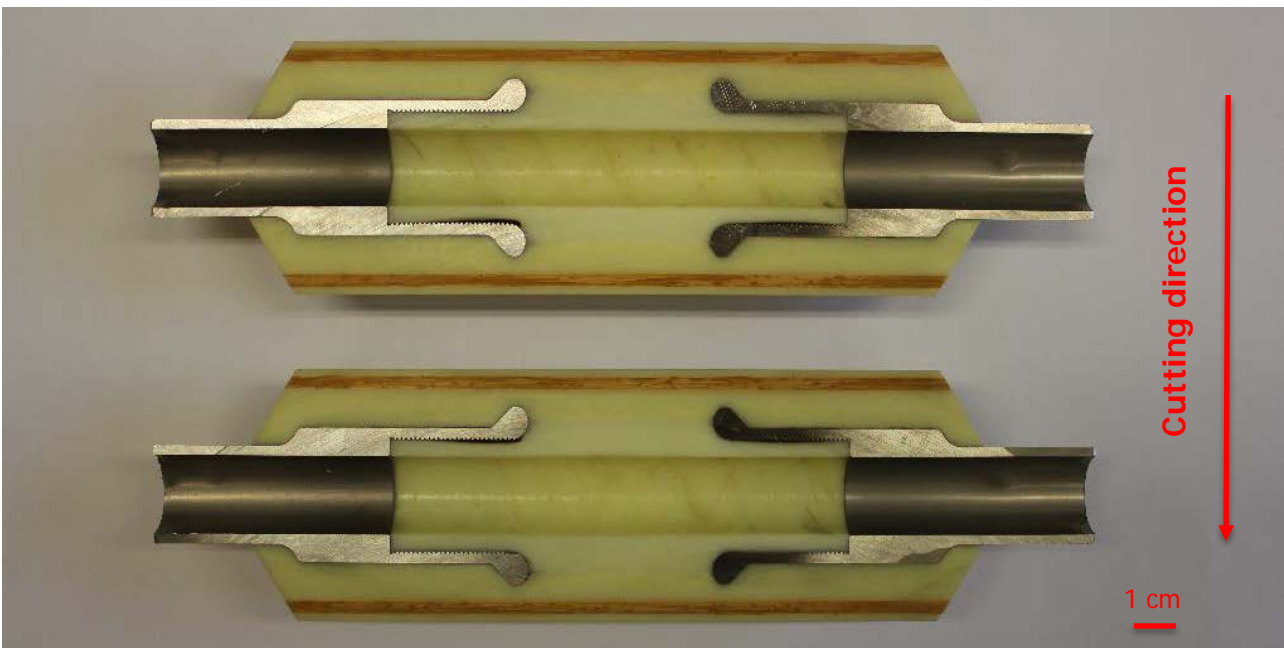
One half of the insulation break was inspected microscopically for any flaws in the structure. Since the cutting operation might have induced minor localized damage in the surface as the slightly burnt regions in the composites (dark regions close to the stainless steel fittings in Figure 6) one of the halves was manually polished to a final 1200 mesh size, what was considered sufficient to remove the affected regions and to reveal the relevant structure of the insulators (see Figure 7). However, as it can be observed in the micrographs, some slightly burnt regions still remain after the polishing.

Figure 6: Insulation break after axial sectioning. Cutting direction is shown for reference.

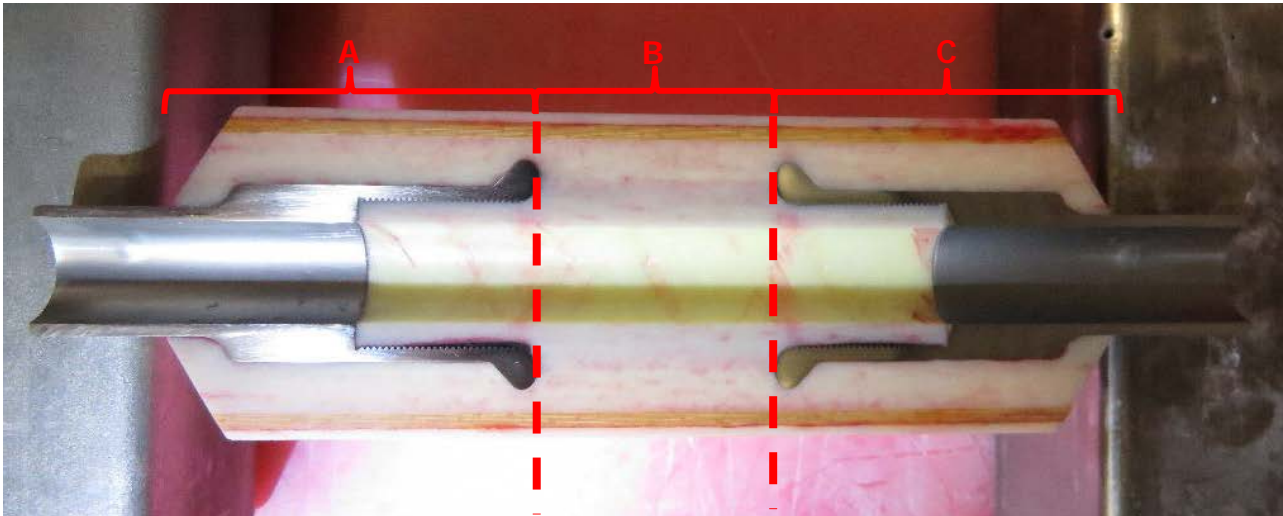
It was sectioned in three portions on a cutting wheel (Figure 5) as sketched in Figure 17: portion A was used for the cross sectional inspection, from portion B the inner composite was extracted, and from portion C the outer composite was extracted. Inner composite and outer composite from portions B and C, respectively, were used for measuring the relative density, for the calculation of the fibre content in the composite, for the estimation of the fibre angle and for measuring the glass transition temperature.

Figure 17: Three portions distinguished in each non-polished half of the insulation break.

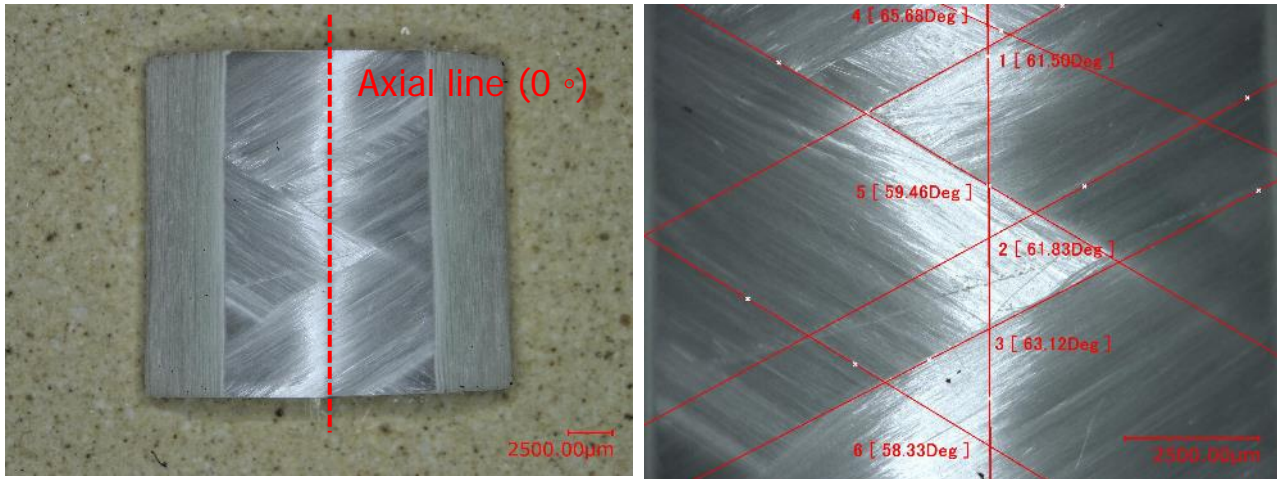
Figure 29: Fibre angle measurement. As an example, the sample 1 of the inner composite after firing is shown (left). Fibre angle with respect to the axial line of the insulation break (vertical red line) are observed (right).

The orientation of the fibres was also determined with a reasonable accuracy via optical microscopy as required in the technical specification. It resulted in $60.8 \pm 2.2^\circ$ for the inner composite and $73.5 \pm 4.4^\circ$ for the outer, which fairly agrees with the ones obtained for the insulation break identified as DL09, previously analysed at CERN (EDMS no. 1678587), where an angle of $60.6 \pm 3.3^\circ$ and $70 \pm 3.1^\circ$ were observed for the outer and inner composite respectively.
