# Appendix: Physical Assessment

**Del Valle Sports & Fitness Clubhouse**

**2015-0123**

April 10, 2015

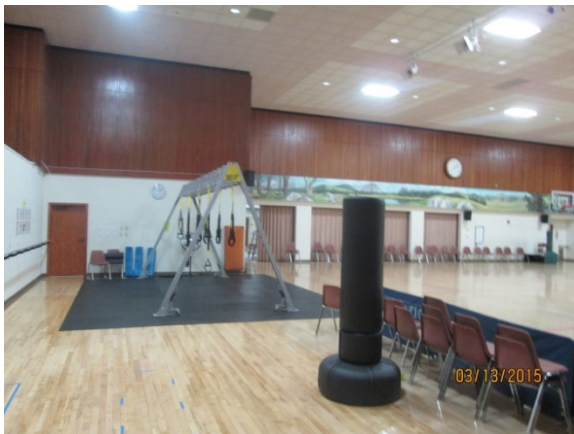
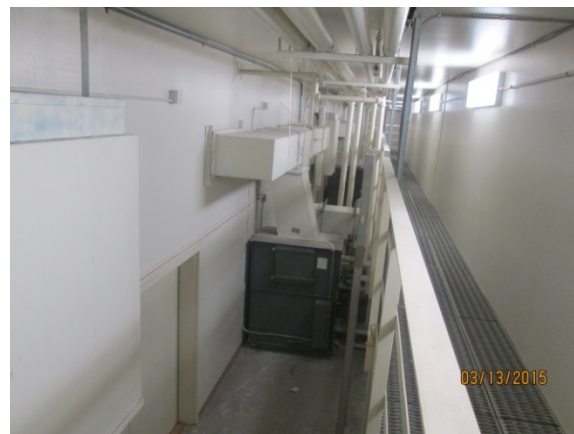
The first floor multi-use rooms are served by (2) constant volume rooftop air handling units (AHU-11 & AHU-12). (2) Rooftop exhaust fans (EF-7 & EF-8) are connected to the returns ducts of AHU-11 & AHU-12, respectively, for building relief. The mezzanine level multi-use room is served by a single constant volume rooftop air handling units (AHU-17). The clubhouse lobby is served by (2) constant volume rooftop air handling units (AHU-17 & AHU-18) which serve the lower portion of the lobby, while AHU-18 provides conditioned air above the lobby as well as the lobby stairwell up to the second floor mezzanine. (2) Rooftop exhaust fans (EF-10 & EF-11) are connected to the returns ducts of AHU-17 & AHU-18, respectively, for relief. The core of the kitchen contains (2) grease hoods which are exhausted by a single rooftop exhaust fan (EF-12). Make-up air is provided to the grease hood by a rooftop make-up air unit (MAU-1). Facilities noted the kitchen equipment is rarely used as food is most often catered. The women's shower, restrooms, and dressing rooms are served by a single rooftop air handling unit (AHU-1) and exhausted by a single rooftop exhaust fan (EF-1). The men's shower, restrooms, and dressing rooms are served by a single rooftop air handling unit (AHU-2) and exhausted by a single rooftop exhaust fan (EF-2). The fitness manager's office is served by an overhead ducted fan coil unit (AHU-5) connected to the building hot water/chilled water system. Single restrooms located throughout the facility contain typical ceiling exhaust fans (EF-13 & EF-14).

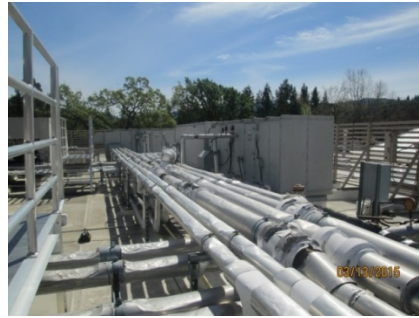
Space heating and cooling is provided to the aerobics room by a rooftop variable air volume (VAV) air handling unit (AHU-1A). The men and women's restroom, located near the lobby, is served by a terminal unit with reheat (VAV-1) connected to AHU-1A. The men and women's restrooms are exhausted by (2) existing rooftop exhaust fans (EF-4 & EF-9). The fitness center and vestibule are served by (2) VAV rooftop air handling units (AHU-1B & AHU-1C). The guard office, check-in, and lobby are served by an overhead ducted fan coil unit (AHU-1D), which is connected to the building hot water/chilled water system. The massage room is also served by an overhead ducted fan coil unit (AHU-1E) connected to the building hot water/chilled water system and exhausted by an inline ceiling exhaust fan (CEF-1).

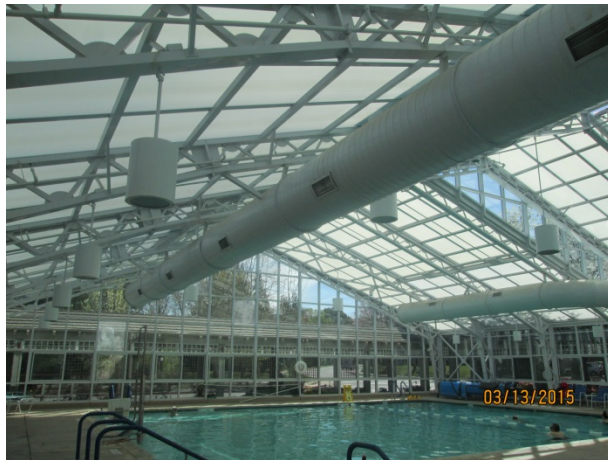
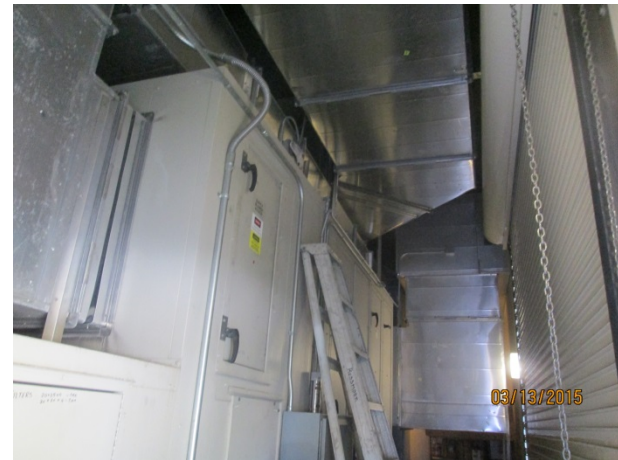
Ventilation is provided to the pool enclosure by a packaged energy recovery unit (AH-1) located in a mechanical room adjacent to the pool enclosure. AH-1 contains a heat recovery pipe which loops between the return air duct and exhaust air duct to pre-cool or pre-heat the incoming outside air. However, AH-1 does not have temperature control and cannot condition the supply air to a controlled set point. AH-1 was also designed to have a greater exhaust airflow than supply in order to negatively pressurize the pool enclosure and remove chlorine odors. The facilities engineer noted that AH-1 operates on a timer, which is overridden to turn off during pool class time due to noise propagation. A single restroom added to the clubhouse during the addition is exhausted by a rooftop exhaust fan (EF-1) and served by existing air fan coil AHU-1E. The pool storage room is exhausted by a rooftop exhaust fan (EF-2). The pool equipment room is served by an existing rooftop gravity hood (CAI) connected to a centrifugal inline ventilator (CIV-1), which was reversed to provide space exhaust. The pool enclosure contains overhead operable panels, controlled by a manual switch, which were designed to slide down the roof enclosure and provide an opening for hot air relief.
