**Assessment of
Civil, Architectural, Mechanical, Electrical, Plumbing and Fire Protection Systems**

**Belk and Graham-Hewlett Residence Halls
University of North Carolina Wilmington**

October 1, 2012
(DRAFT)

Sud Associates, P.A.

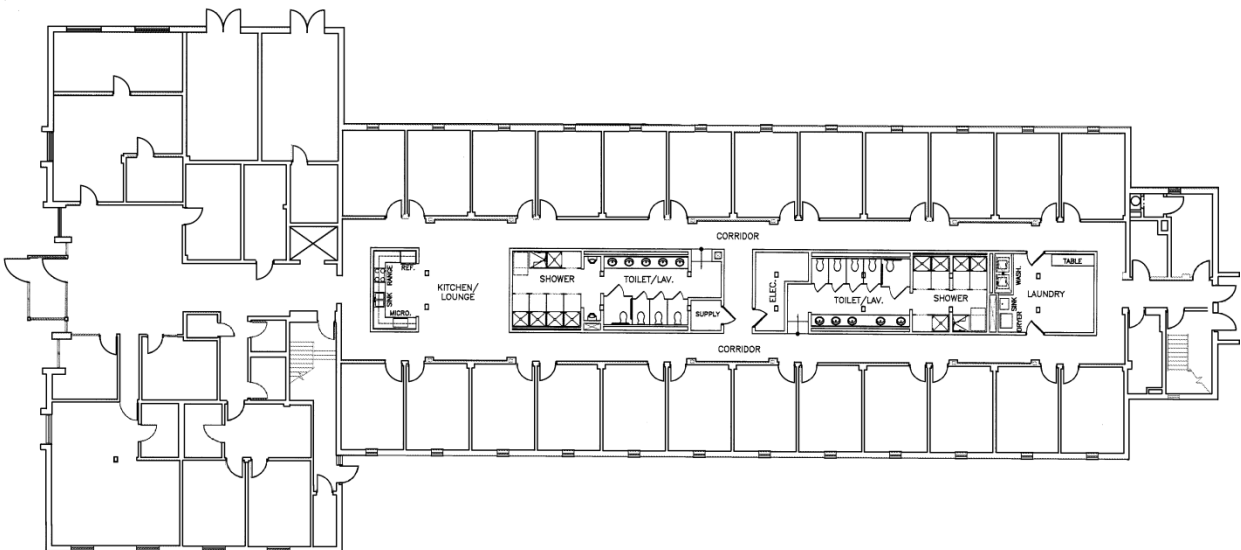
Figure 3.5: Proposed layout for Compliance with ADA.

The study architect prepared and reviewed alternative floor plans to comply with the present building code. After considerable effort, a proposed layout was developed to comply with the code requirements. The layout removes the Study Rooms and Baths and substitutes the Men's and Women's gang bath rooms in the center of the remaining space. Reference NCBC Section 1107.6.2.2. Proposed layout is provided as figure 3.5.

The reconfiguration of the space per Figure 3.5 meets the NC Accessibility code, reduces the amount of lighting intensive study areas and has the potential to meet NC Energy Code per the advantageous 'building area' method.

The building LPD would be reduced with the new proposed ADA layout per figure 3.5 due to its increased corridor areas and reduced energy intensive study areas, allowing the advantageous 'building area' method to be approached with the lighting design. The luminaire locations and underlying distribution system in the bedrooms and utility spaces may remain.

A new normal power layout and associated raceway system would be required if the center corridor was replaced with the gang bathrooms as described in the Accessibility Items in Architectural Chapter 3 per Figure 3.5.

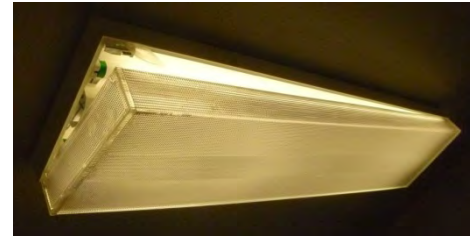
Figure 5.2 Belk Hall Fixture with T8 Lamp System

Most light fixtures in Belk Hall were replaced with T8 lamps and electronic ballasts in 2009. Some lenses and retainer clips of the surface mounted wrap-around prismatic lens type fixtures however seem to be failing prematurely.

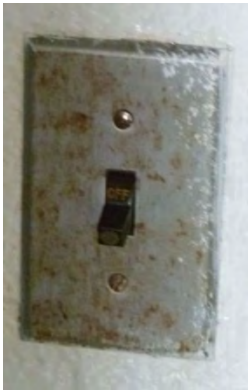
Figure 5.4 Light Switch

All lights except for the corridors and stairs are controlled via toggle switches. The switches are past their useful life of 20 years and are failing. The switches are not the non-teasable type and pose a fire hazard. The NC Energy Conservation code requirements for light reduction controls are not met for the study rooms and for some of the utility spaces that have more than 1 luminaire.

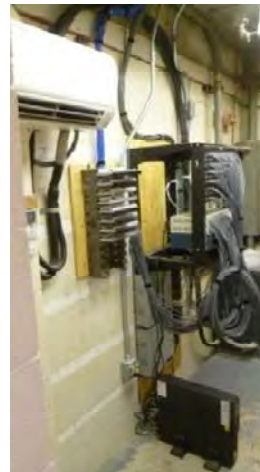
Figure 5.12 Typical MDF

The original building had no provisions for a data infrastructure. One of the early data system upgrades for the dorms was done in the early 2000s. It included an underground fiber optic cable to the mechanical spaces. The environmental conditions of the mechanical and boiler rooms are not suitable for active or passive data equipment or terminations. Graham and Hewlett Halls have a few switches and other active equipment mounted to a plywood data backboard and on plywood shelves in the mechanical spaces.

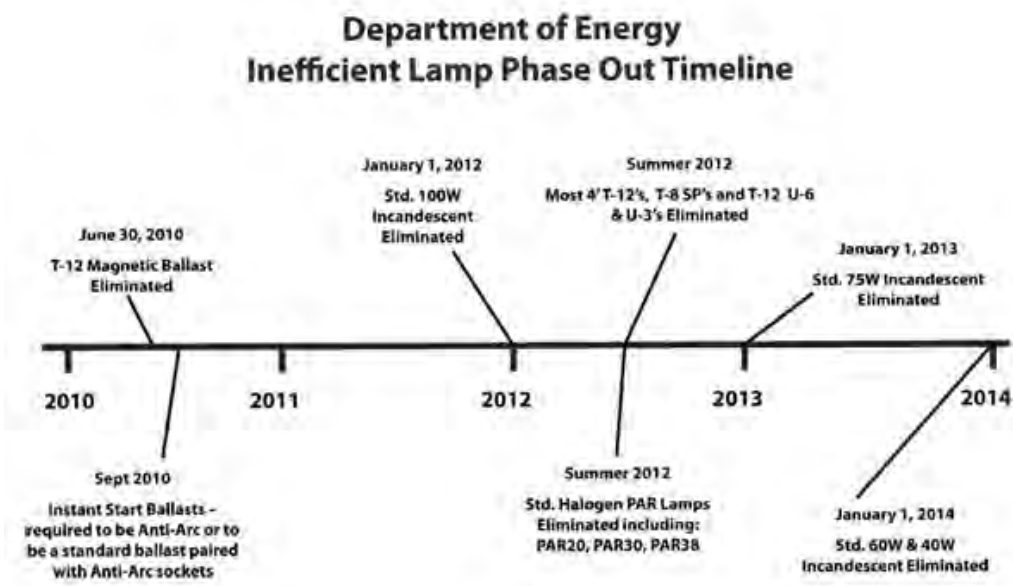
Figure 5.15 Insufficient Lamp Phase Out Timeline

Effective July 14, 2012, the production of most T12 florescent lamps are being phased out as mandated by the 2009 Department of Energy General Service Lamp legislation.

Replace all general and task light fixtures based on T12 lamp/ballast systems with fixtures based on efficient T8 or T5 lamp/ballast systems.
