SERVICE BULLETIN

APPLICABILITY: 2020-22MY Legacy and Outback Models **NUMBER:** 15-261-20R
SUBJECT: Reprogramming File Availability for Optimization of Gen 4 Denso CP1 Infotainment Systems **DATE:** 03/10/20
REVISED: 01/28/22

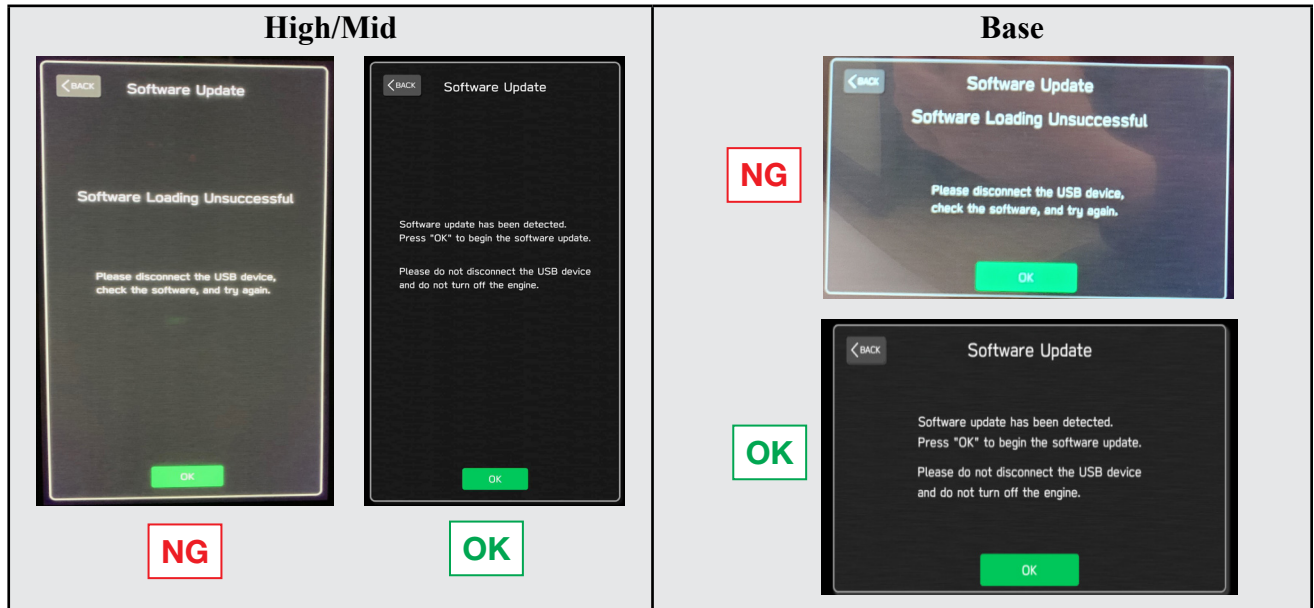
- 4e) Insert reprogramming USB into the USB port and press **OK**.
NOTE: If after plugging in the USB, the screen displays a **Software Loading Unsuccessful** message, confirm the USB device has been properly formatted and the the software on the device matches the **system** being reprogrammed (example: Base software is being used to update a Base **system**) and **retry**.

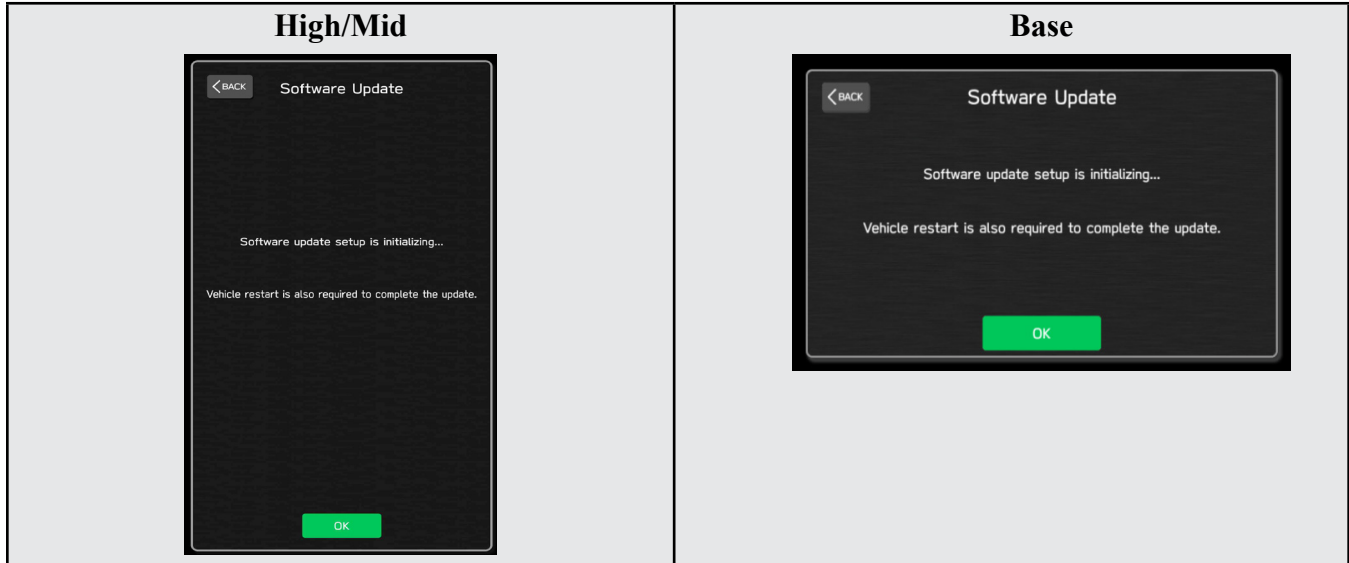
- If the screen shown below appears, **WAIT** for approximately 30 minutes or as long as necessary (waiting for longer than 60 minutes might indicate system malfunction). **In that case please perform recovery according to the instructions in “Appendix B”** to allow the Software update setup initialization process to complete.

1. Turn the ignition OFF, open the driver’s door, close the driver’s door and **WAIT** for 3 or more minutes before proceeding further.
2. Open the driver’s door again and either turn the ignition ON (if a charger is connected) or start the engine.
3. Go to Dealership Mode menu again (PRESS and HOLD the RIGHT-side temperature control buttons (both up and down) and press the Tune / Scroll knob 6 times then release all to display the Dealership Mode) and select Software Update as in **STEP 4c** beginning on **pg. 11**.

IMPORTANT NOTE: If this procedure is required, contact Techline as additional action may be necessary.

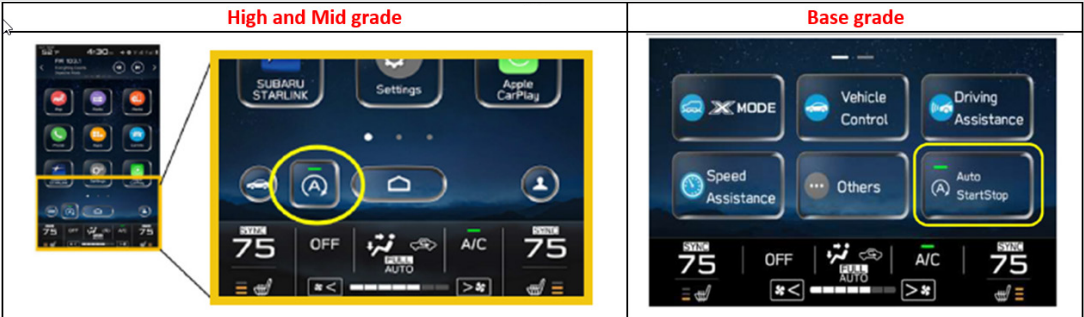
Number	Symptoms to be Improved:
4	A reduced (low) volume (-6db) concern during handsfree conversation when using CarPlay has been addressed to make the volume level consistent.
5	Voice recognition (VR) has been enhanced to improve recognition of short words (e.g. YES).
6	The program has been corrected to prevent repeated rebooting and system freeze-up immediately after activation of Android Auto.
7	Eliminate CP1 MOTA update error message “Something went wrong. The system is unable to install any map updates. Contact your dealer for more information.”
8	<p>The Auto Stop-Start On/Off function button has been moved from the bottom to top layer of the system for easier use. A screenshot of how the button will appear is shown below.</p>

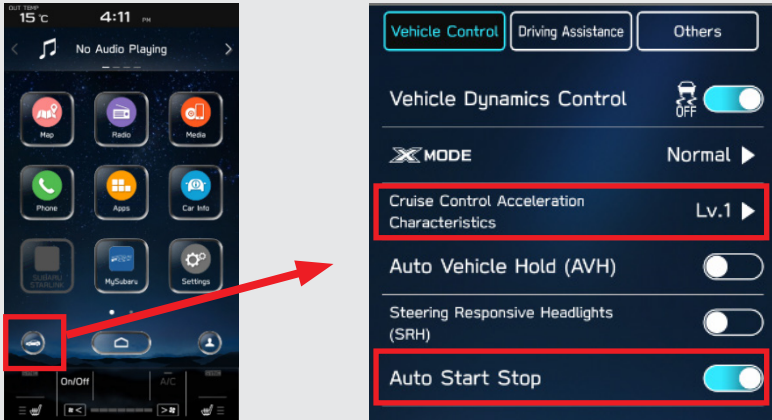
Number	New Functions and Improvements:
4	<p>The ISS (Auto Start Stop) button has been moved to the upper layer in the Car Setting menu. By touching the “Car Setting” icon, the Auto Start Stop and Cruise Control Acceleration Characteristics menus can be accessed immediately, whereas selecting “Others” in the Car Setting screen was required to access these menus.</p>

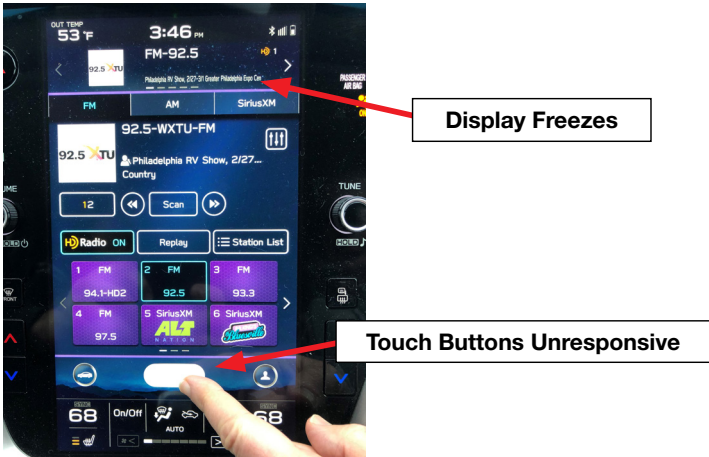
Symptom #	Description of Symptom:
1	<p>The CP1 display and/or center Combination Meter display freezes. No response from touch screen or voice guidance. After switching the ignition off and opening the driver’s door, the system does not recover**.</p>

<p>**NOTE: After switching the ignition off and leaving the driver’s door open more than 70 seconds, the system <i>may</i> recover after switching the ignition back on.</p>

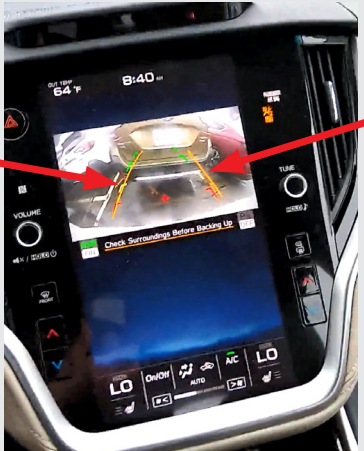
Symptom #	Description of Symptom:
2	<p>Delayed response of rear view camera guide lines. When the rear view camera is activated and the steering wheel is turned, there is a delay before the steering-responsive guide lines respond to the steering wheel input.</p>

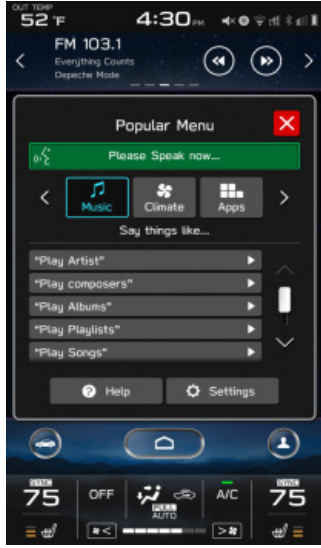
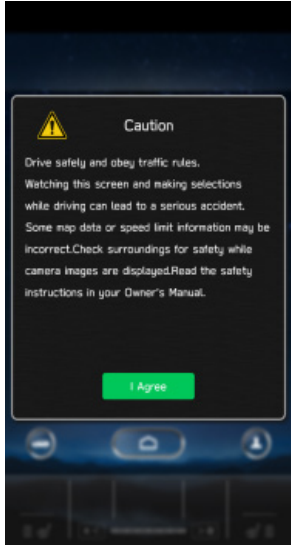
Symptom #	Description of Symptom:
5	<p>When using Voice Recognition to search for a 'Nearby POI' (Point of Interest) in Canada with FRENCH language selected, the CP1 display turns black and displays a Caution / disclaimer message.</p> <div style="display: flex; justify-content: space-around; align-items: center;">

</div> <div style="display: flex; justify-content: space-around; margin-top: 10px;"> <div style="border: 1px solid black; padding: 5px; text-align: center;">Voice Recognition</div> <div style="border: 1px solid black; padding: 5px; text-align: center;">Black Screen</div> <div style="border: 1px solid black; padding: 5px; text-align: center;">Caution / Disclaimer Message</div> </div>
