AXOD/AXODE (AX4S) UPDATE HANDBOOK

*Updated
October, 2002*

This updated version of the AXOD "Update Handbook" will also cover the changes that occurred in the 1991 model year, when electronic controls were adapted to the AXOD transaxle, making it an AXODE, and now called an AX4S transaxle. We have included the changes on the AX4S transaxle up through and including model year 2002.

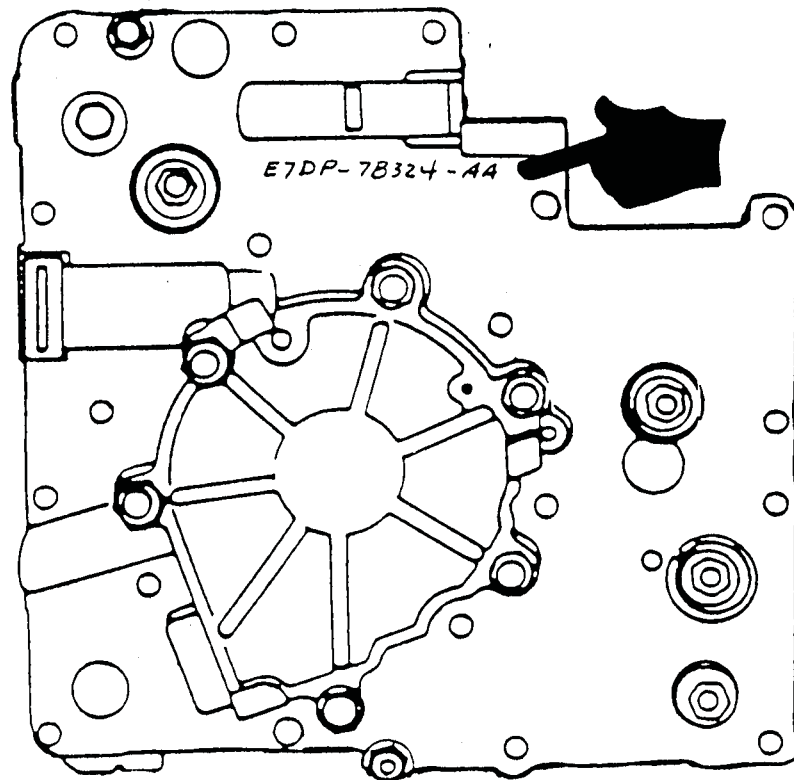
Figure 1

- (1) OIL PUMP CASTING - Must be identified by the casting number located on the pump as shown in Figure 1, and can be identified as follows:
 - E6SP-7B324-AA = 1986 Hydraulics.
 - E7DP-7B324-AA = 1987 Hydraulics.
 - E8DP-7B324-AA = 1988 Hydraulics.
 - E9OP-7B324-AA = 89/90 Hydraulics (10 Checkball Pump).

OIL PUMP
CASTING NUMBER LOCATION

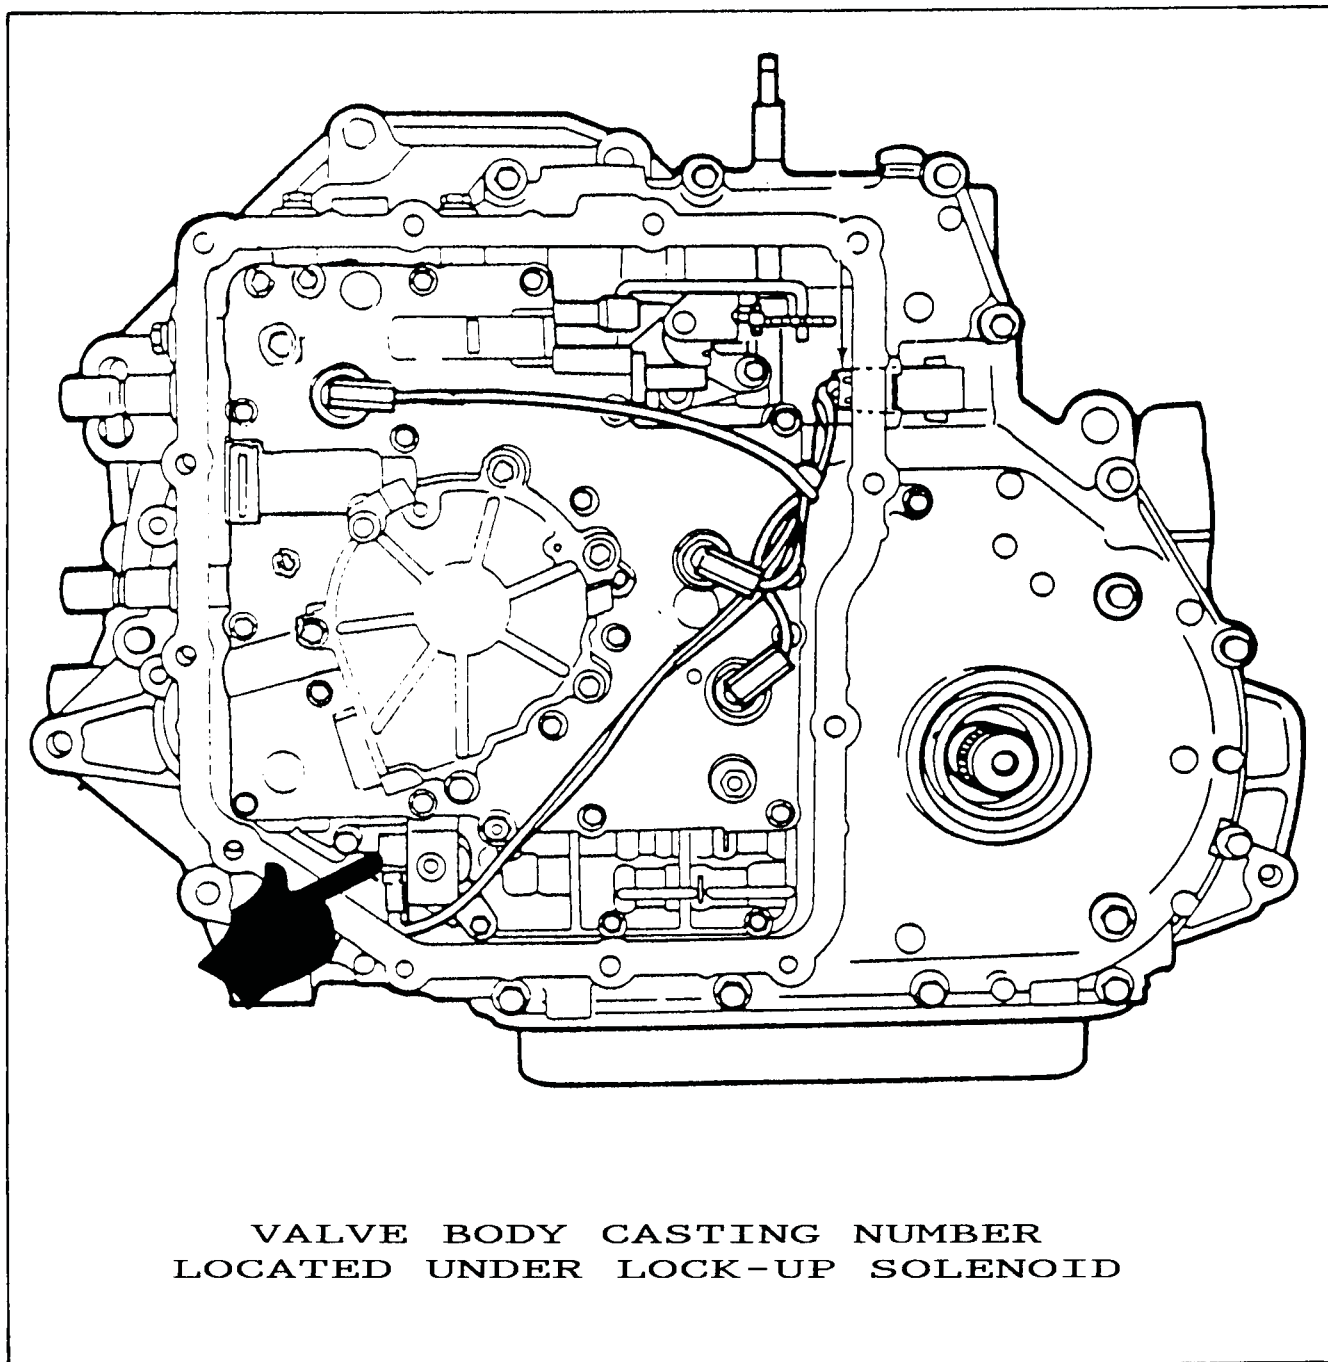
Figure 2

NOTE: Some 1987 models had 1986 pumps, but had 1987 spacer plate, and requires 1987 pump spacer plate gaskets.
- (4) VALVE BODY CASTING - Must be identified by the casting number located beneath the lock-up solenoid as shown in Figure 2, and can be identified as follows:
 - E6SP-7A092-AD = 1986 Hydraulics Only.
 - E7DP-7A092-BA = 1987 Hydraulics Only.
 - E8DP-AA = 88/90 Hydraulics Only.

VALVE BODY CASTING NUMBER
LOCATED UNDER LOCK-UP SOLENOID

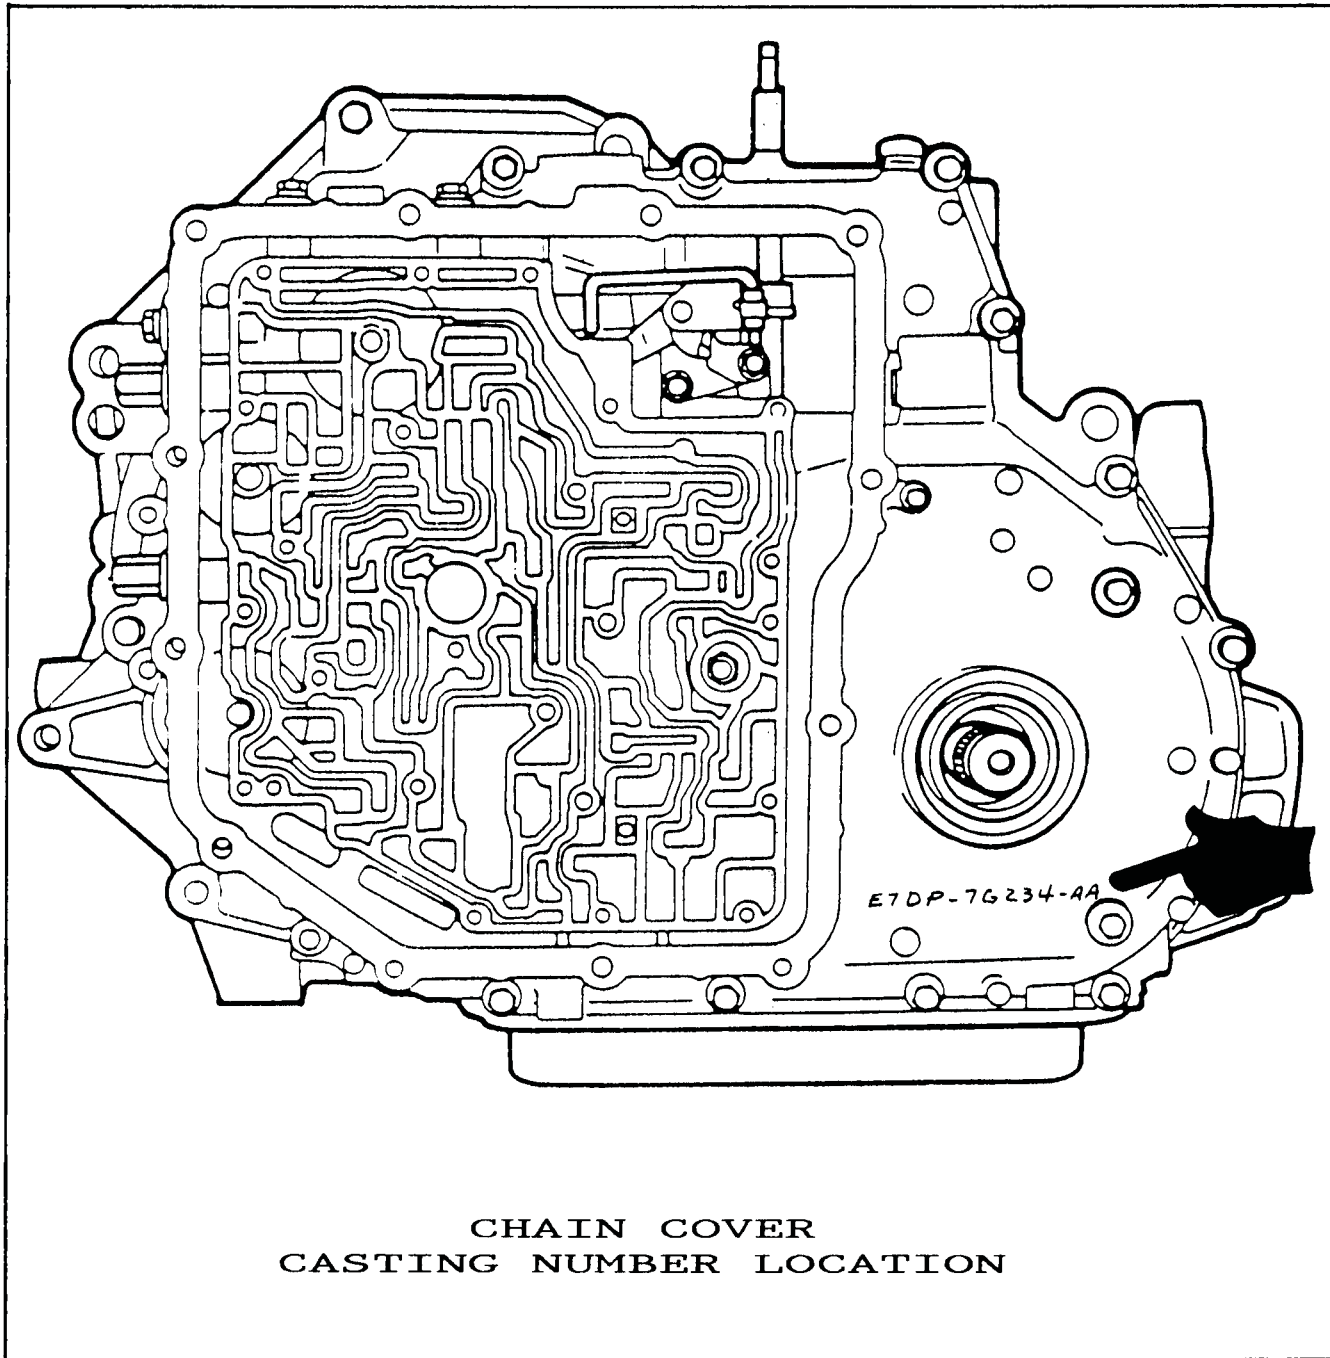
Figure 3

- (7) CHAIN COVER - Must be identified by the casting number located below the axle seal as shown in Figure 3, and can be identified as follows:
- E6SP-7G234-AA = 1986 Hydraulics Only.
 - E7DP-7G234-AA = 1987 Hydraulics Only.
 - E8DP-7G234-AA = 88/90 Hydraulics Only.
- (8) OIL PUMP CHECKBALL LOCATIONS - The 1986 through 1989 oil pumps have 9 checkballs, and locations are shown in Figure 16.
Some 1989 models and all 1990 model oil pumps have 10 checkballs, and locations are shown in Figure 17.

CHAIN COVER
CASTING NUMBER LOCATION

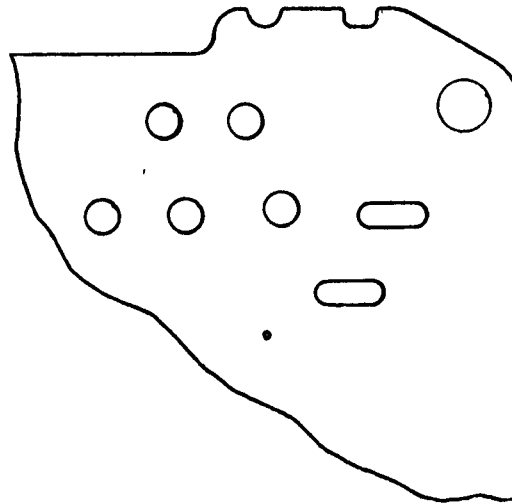
Figure 7

SPACER PLATES WILL NOT INTERCHANGE FROM MODEL TO MODEL

THIS SPACER PLATE FITS "ONLY" THE 10 CHECKBALL OIL PUMP.

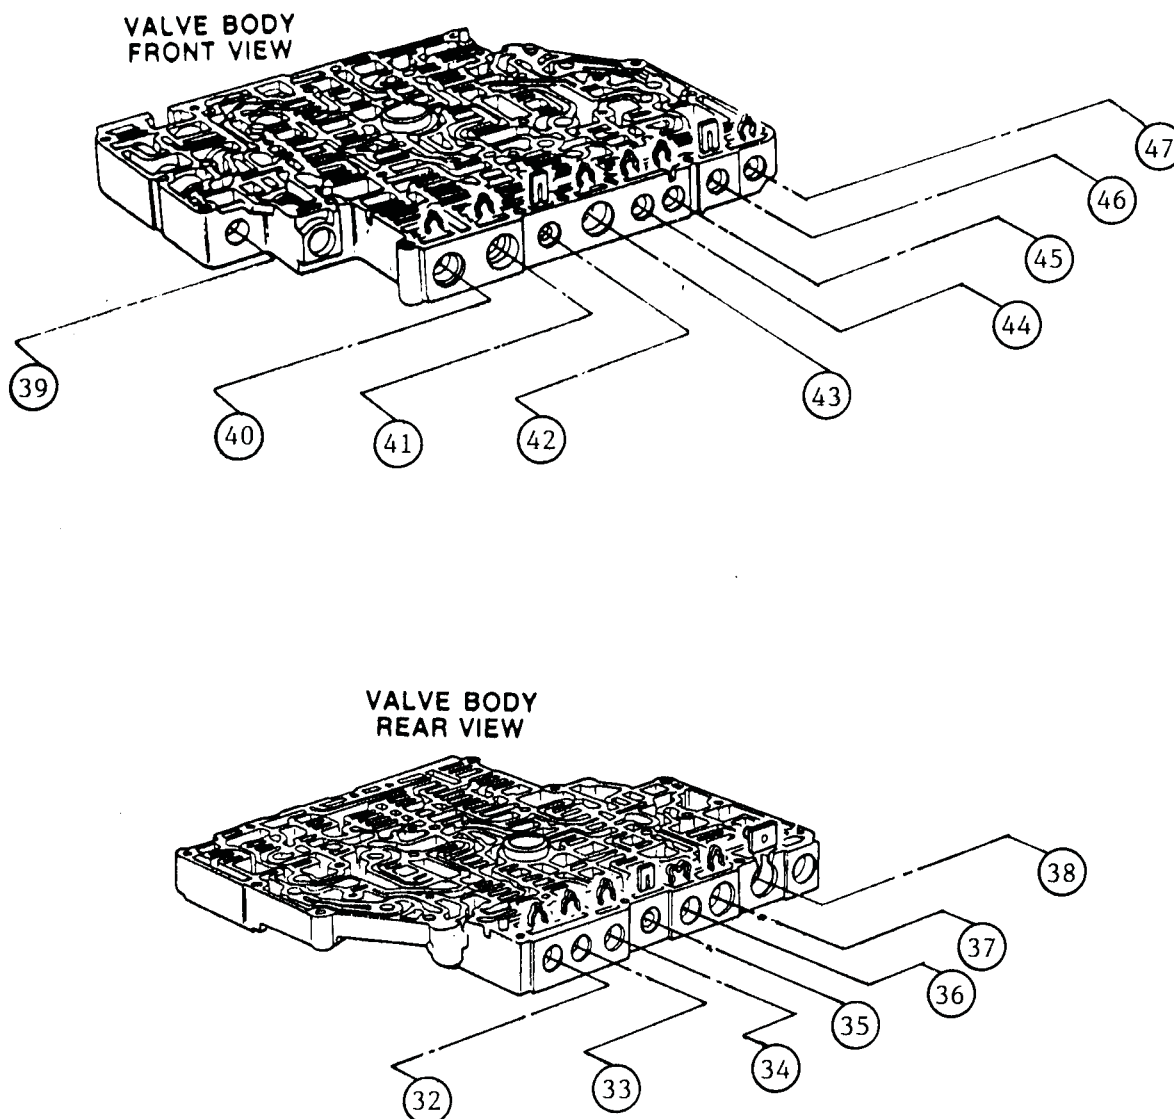
Figure 20

ON THIS PAGE WE HAVE ASSIGNED NUMBERS TO ALL OF THE VALVE BODY BORES AND RE-DRAWN THE VALVES AND SPRINGS IN THEIR PROPER LOCATIONS, WITH EACH VALVE ORIENTED PROPERLY, AND IDENTIFIED, AS SHOWN ON THE FOLLOWING PAGES. "ALL" OF THE MANUALS PRESENTLY IN PRINT ARE WRONG.

USE THIS MANUAL TO PROPERLY ASSEMBLE THE AXOD VALVE BODY.

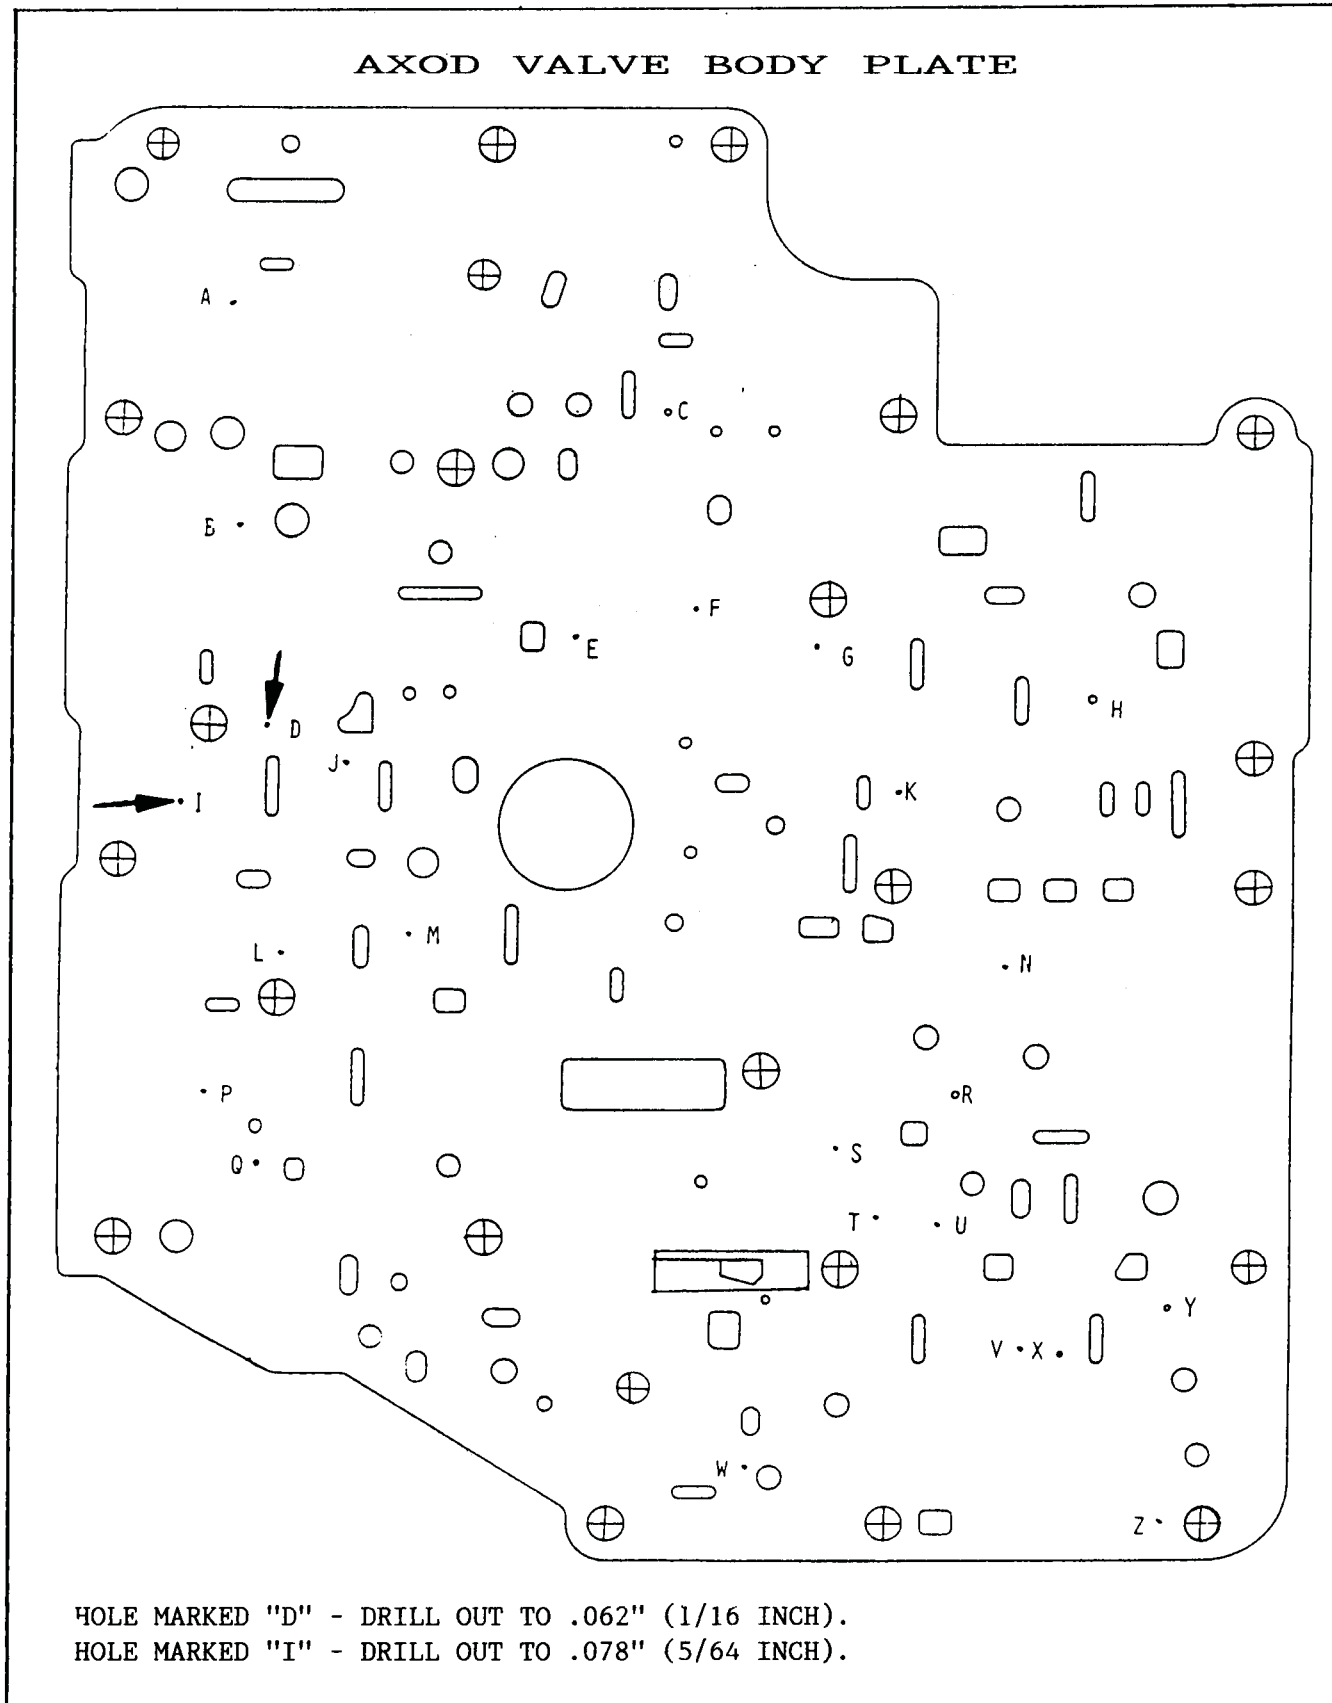
Figure 27

FORD AXOD PREMATURE PLANETARY FAILURE

1. Drill the torque converter fill hole in the valve body spacer plate out to .062" (1/16 Inch). This is the hole marked "D" as shown in Figure 27.
Drill the rear lube orifice in the valve body spacer plate out to .078" (5/64 Inch). This is the hole marked "I" as shown in Figure 27.

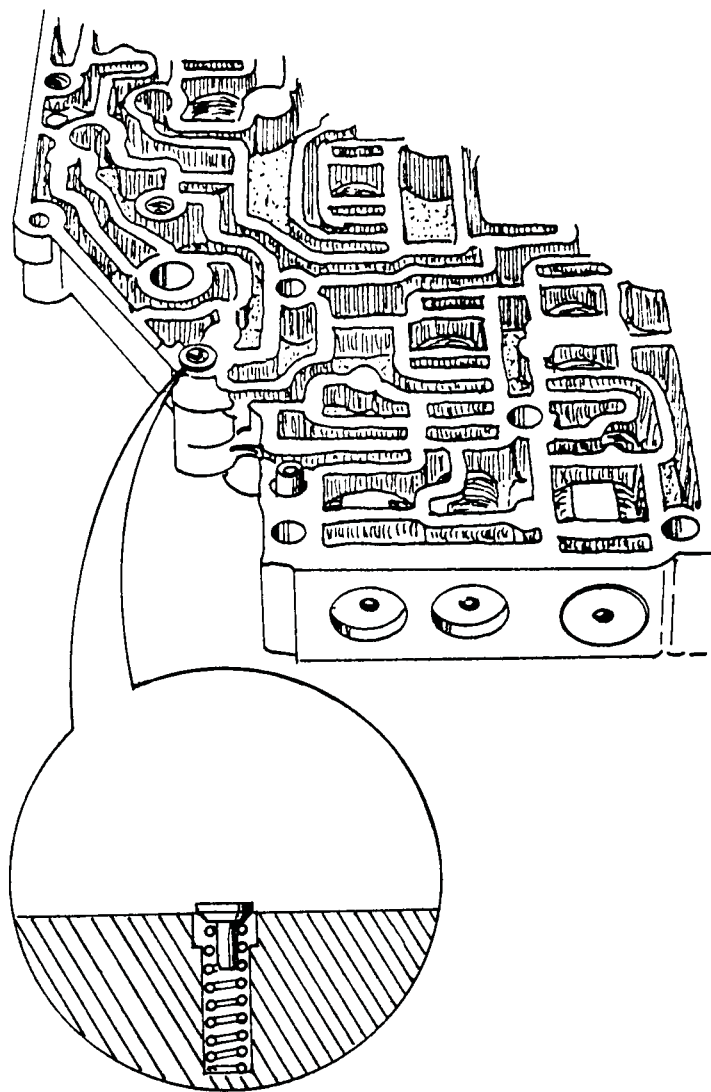
Figure 28

TRIM THE REAR LUBE CHECK VALVE SPRING, UNTIL THE CHECK VALVE SITS ABOUT 1/16" ABOVE THE MACHINED SURFACE OF VALVE BODY.

2. Trim the rear lube check valve spring, which is located in the valve body, until the check valve sits approximately 1/16" above the machined surface of the valve body (See Figure 28). This will require approximately 3 coils be removed from the spring, and always install the cut end of the spring back into the valve body first.

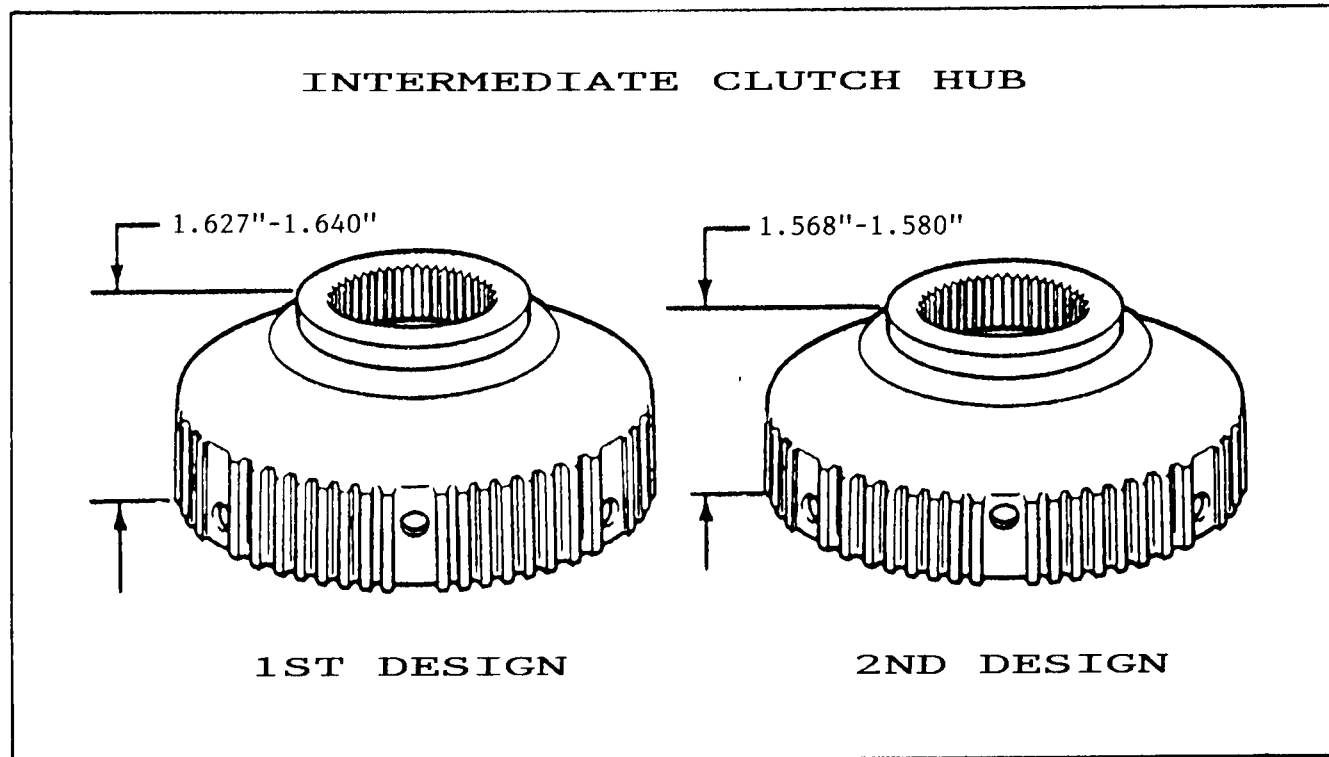
Figure 32

- (2) **INTERMEDIATE CLUTCH HUB** - Overall height was made shorter by approximately .060" with no identifying marks. The hub **MUST** be measured with a dial caliper or depth gage.
The 1st design hub will measure 1.627"-1.640", and the 2nd design hub will measure 1.568"-1.580" as shown in Figure 32.

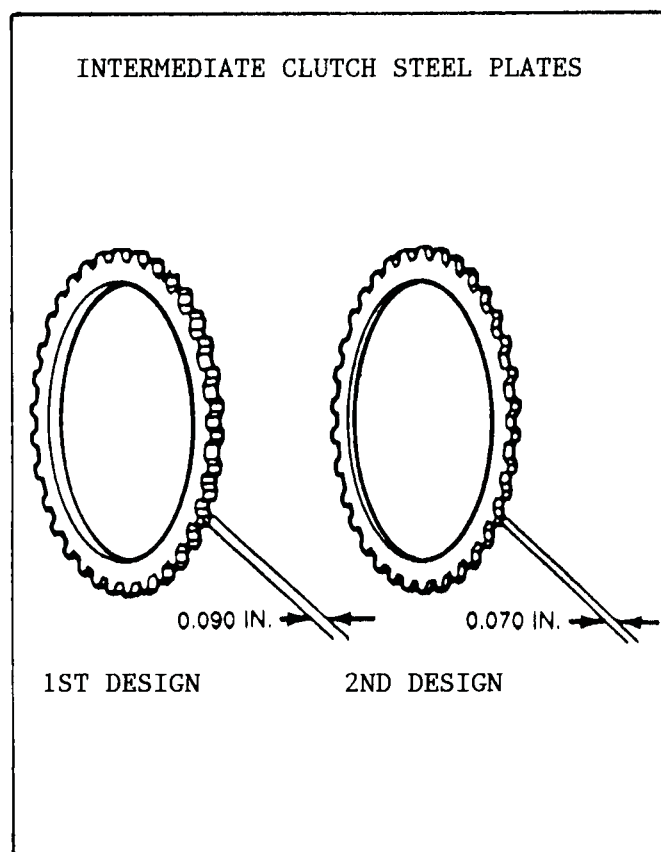
Figure 33

- (3) **INTERMEDIATE CLUTCH STEEL PLATES** - Thicknes was reduced by .020" to help accomodate the added wave plate on 3.8L models, or the added spacer plate on 3.0L models.
The 1st design steel plates are .090" thick, and the 2nd design steel plates are .070" thick as shown in Figure 33.

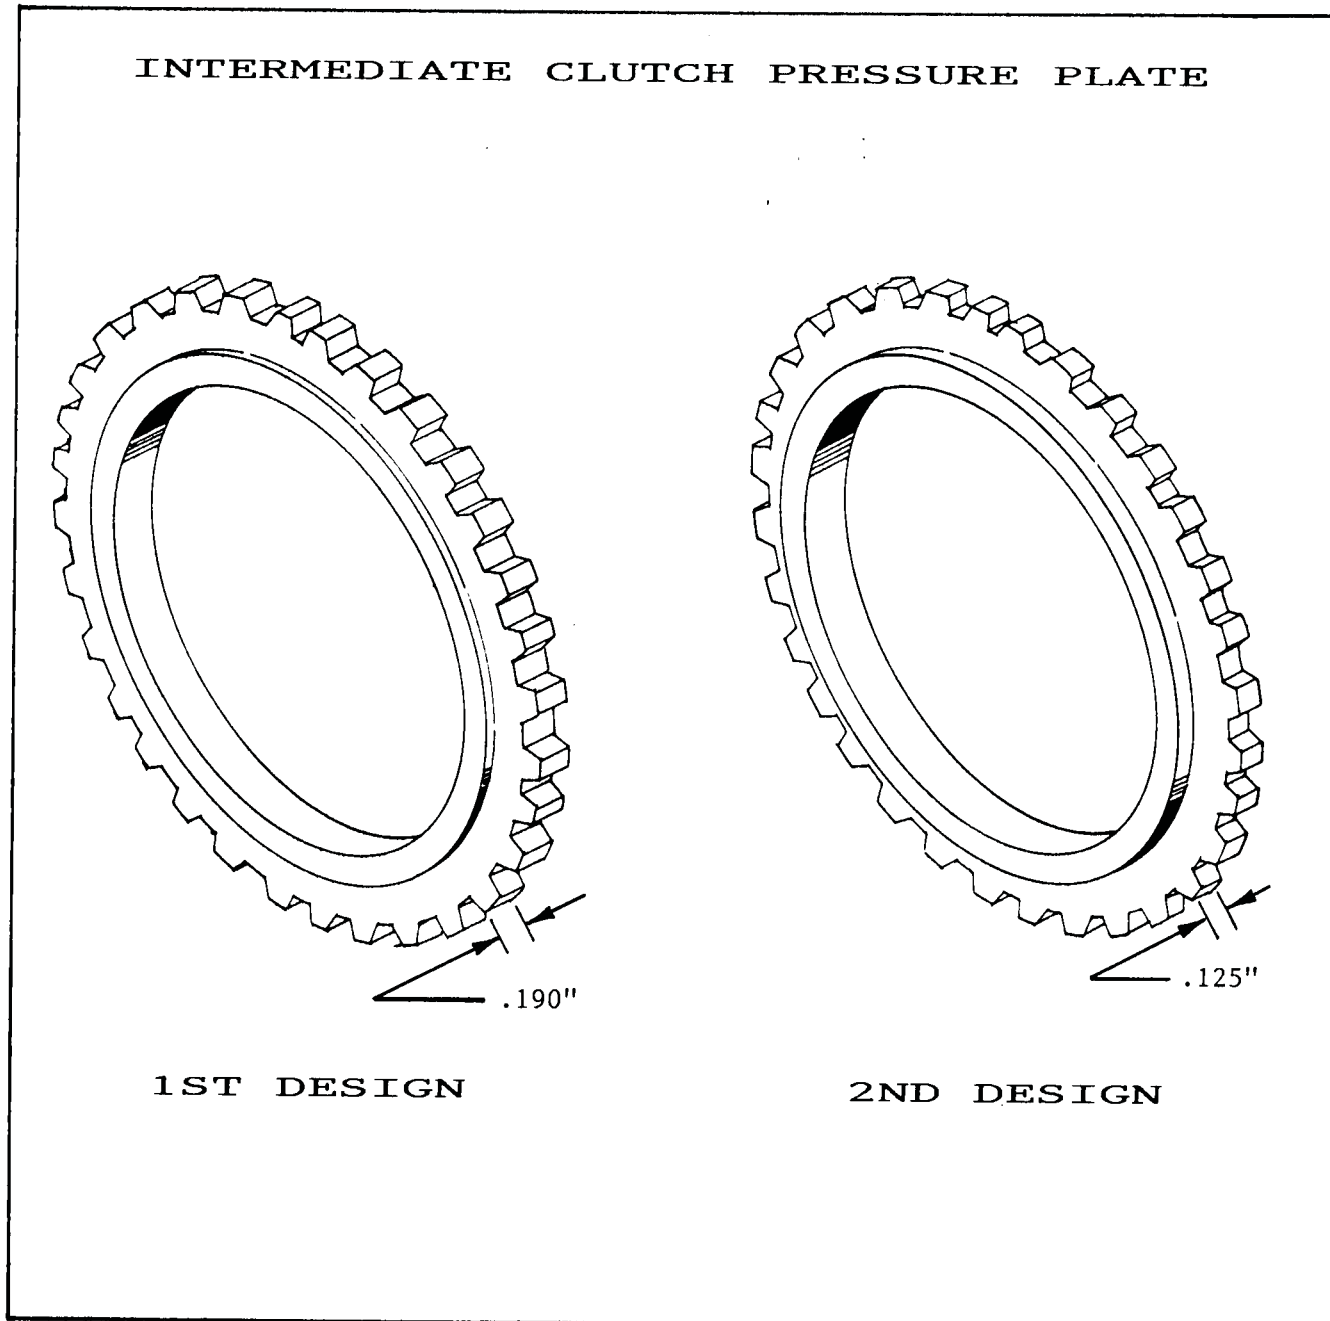
Figure 35

- (4) **INTERMEDIATE CLUTCH PRESSURE PLATE** - Thickness was reduced by .065" to help accomodate the added wave plate on 3.8L models, or the added spacer plate on 3.0L models.
The 1st design pressure plate is .190" thick, and the 2nd design pressure plate is .125" thick as shown in Figure 35.

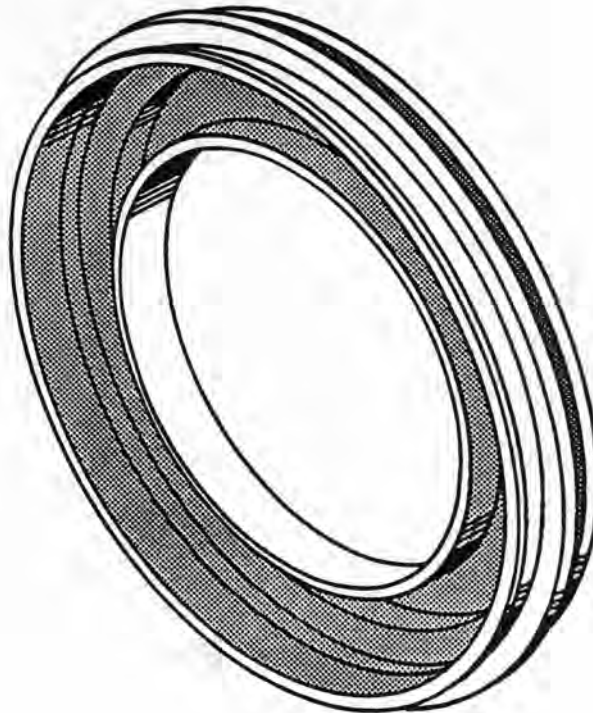
Figure 39

CHANGE: The Forward Clutch Piston material has now been changed to "Steel", instead of the previous design aluminum piston, as shown in Figure 39.

REASON: To eliminate cracks from occurring in the seal groove and greatly improve durability

- (1) FORWARD CLUTCH PISTON - Now manufactured out of steel, instead of aluminum, and there are no dimensional changes on the piston (See Figure 39).

Forward Clutch Piston (All Except "SHO" Models)	F4DZ-7A262-A
Forward Clutch Piston (3.2L "SHO" Models Only)	F4DZ-7A262-B

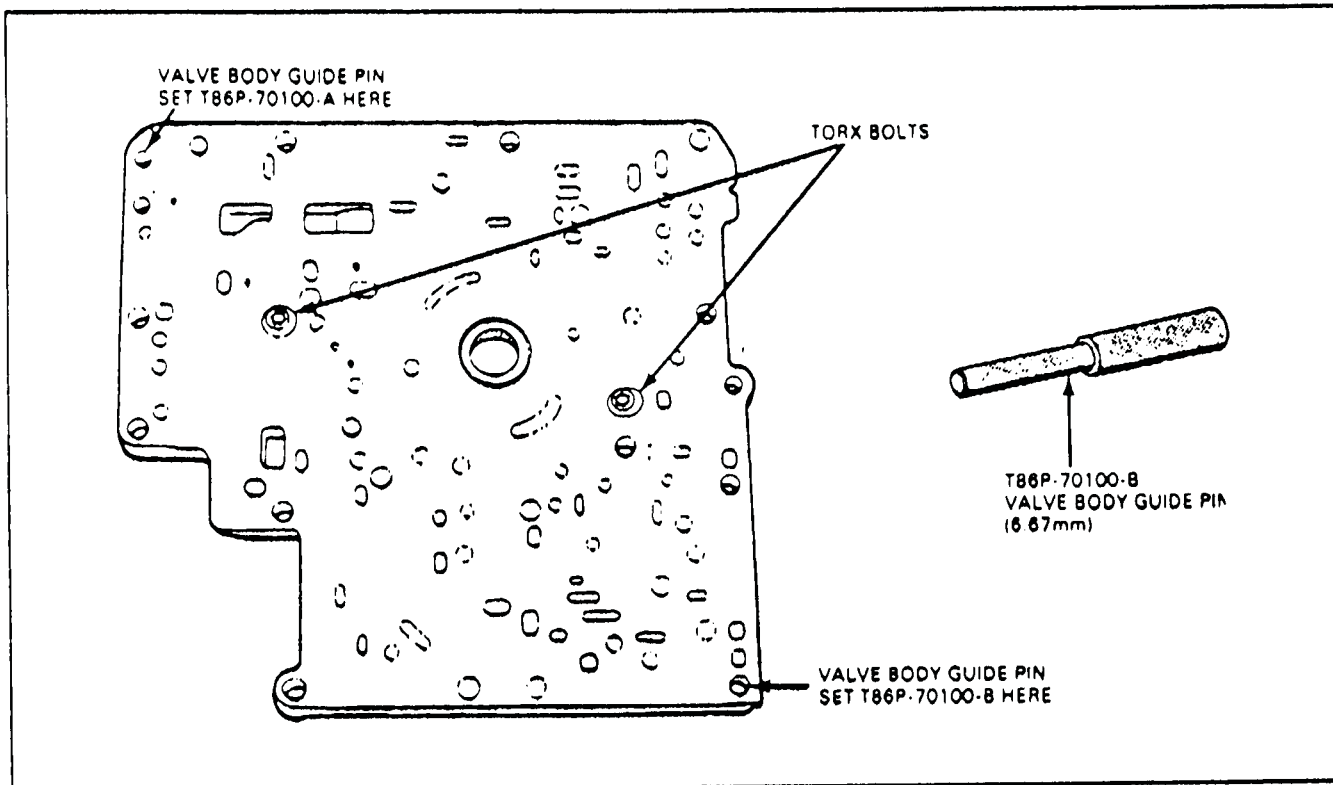
Figure 44

Proper alignment of the oil pump and the valve body are mandatory to prevent premature wear of the oil pump drive shaft and the bearing assembly located in the pump housing. When re-assembling the valve body and oil pump, use the guide pins to assure proper alignment.

1. Position the spacer plate on the pump housing, using a new gasket.
2. Insert valve body guide pin T86P-70100-A (.271" Diameter) and valve body guide pin T86P-70100-B (.262" Diameter), as shown in Figure 44.
3. Install two "Torx" bolts and torque to 7 to 9 ft.lb.
4. Remove both guide pins.
5. Position the spacer plate on the valve body using a new gasket.
6. Insert two valve body guide pins T86P-70100-A (.271" Diameter, as shown in Figure 45.
7. Install two "Torx" bolts and torque to 7 to 9 ft.lb.
8. Position the oil pump on the valve body using a new gasket.
9. Insert pump body guide pin T86P-70370-A and valve body guide pin T86P-70100-C which is .245" in Diameter.
10. Install two valve body to oil pump retaining bolts and torque to 7 to 9 ft.lb.

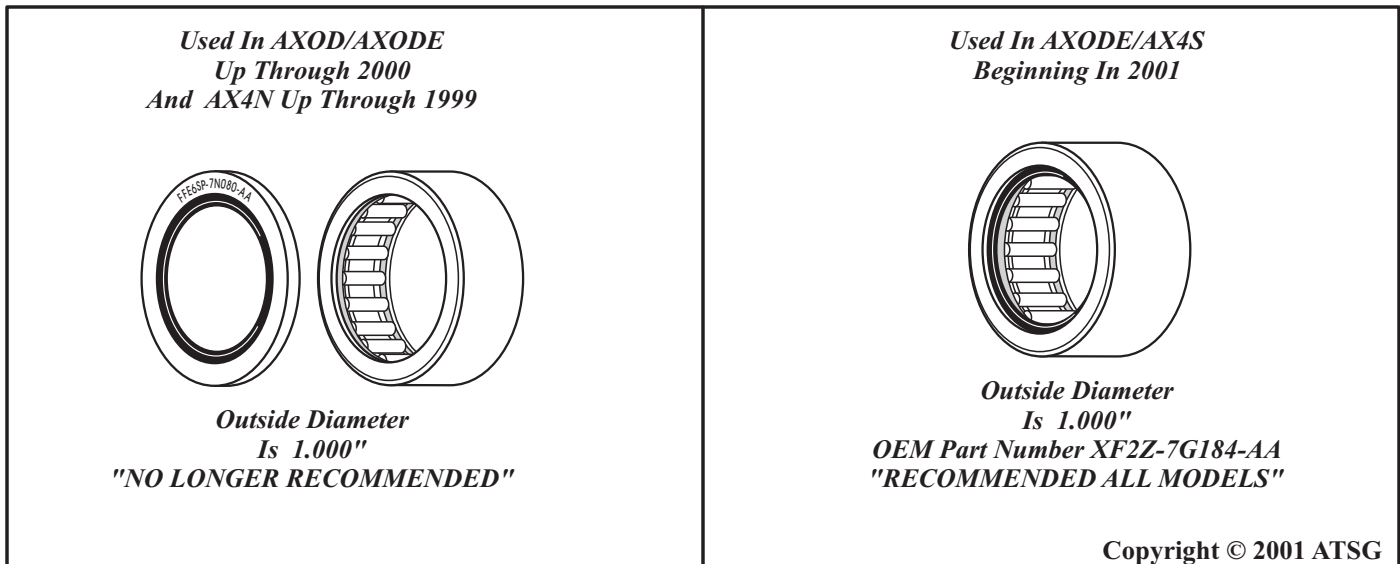
Figure 47

CHANGE: Beginning at the start of production for 2001 on all AX4S transaxles, Ford Motor Company introduced a new design pump bearing that includes an integrated seal, as shown in Figure 47. When this new design bearing and seal assembly went into production, it was installed with the *seal on the valve body side of the pump instead of the rotor side.*

REASON: Greatly reduced pump bearing, pump rotor and vane ring failure, for much improved durability and reliability.

AXOD/AXODE (AX4S) - When using the 1st Design bearing with the "Nickel" Seal, install the seal on the valve body side, with the part number facing up, as shown in Figure 48. When using the 2nd Design bearing with the integrated seal, *which is recommended*, install the bearing assembly with the integrated seal facing the valve body side. The 2nd Design Bearing and Seal assembly *will retro-fit back on all* AXOD, AXODE and the AX4N up through 1999.

Pump Bearing With Integral Seal XF2Z-7G184-AA

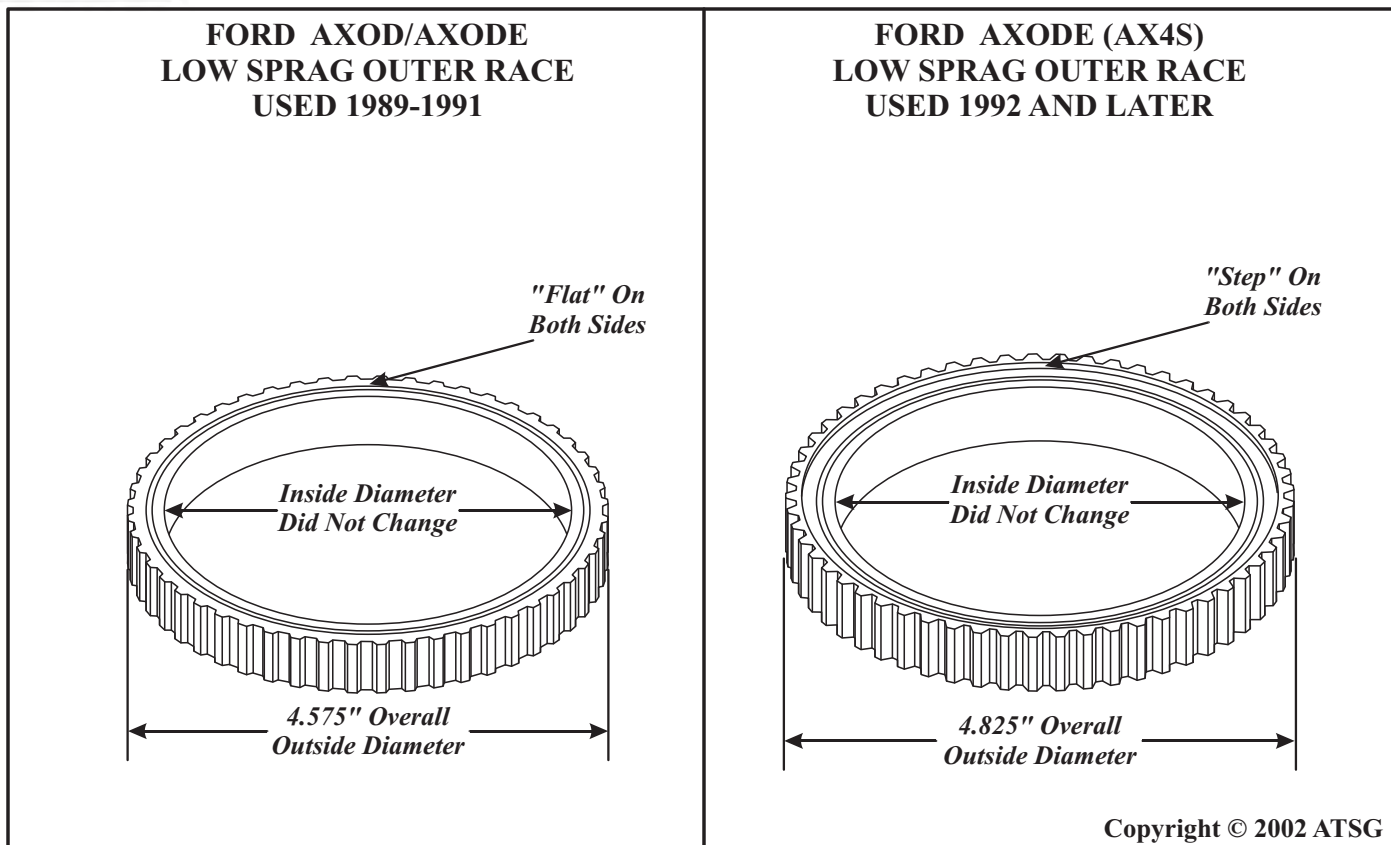
Figure 57

- (1) **LOW SPRAG OUTER RACE** - The outer diameter of the race was increased from 4.575" to 4.825", and the width of the race was increased from .600" to .725", as shown in Figure 57. *The Inside Diameter of the sprag race Did Not Change.*

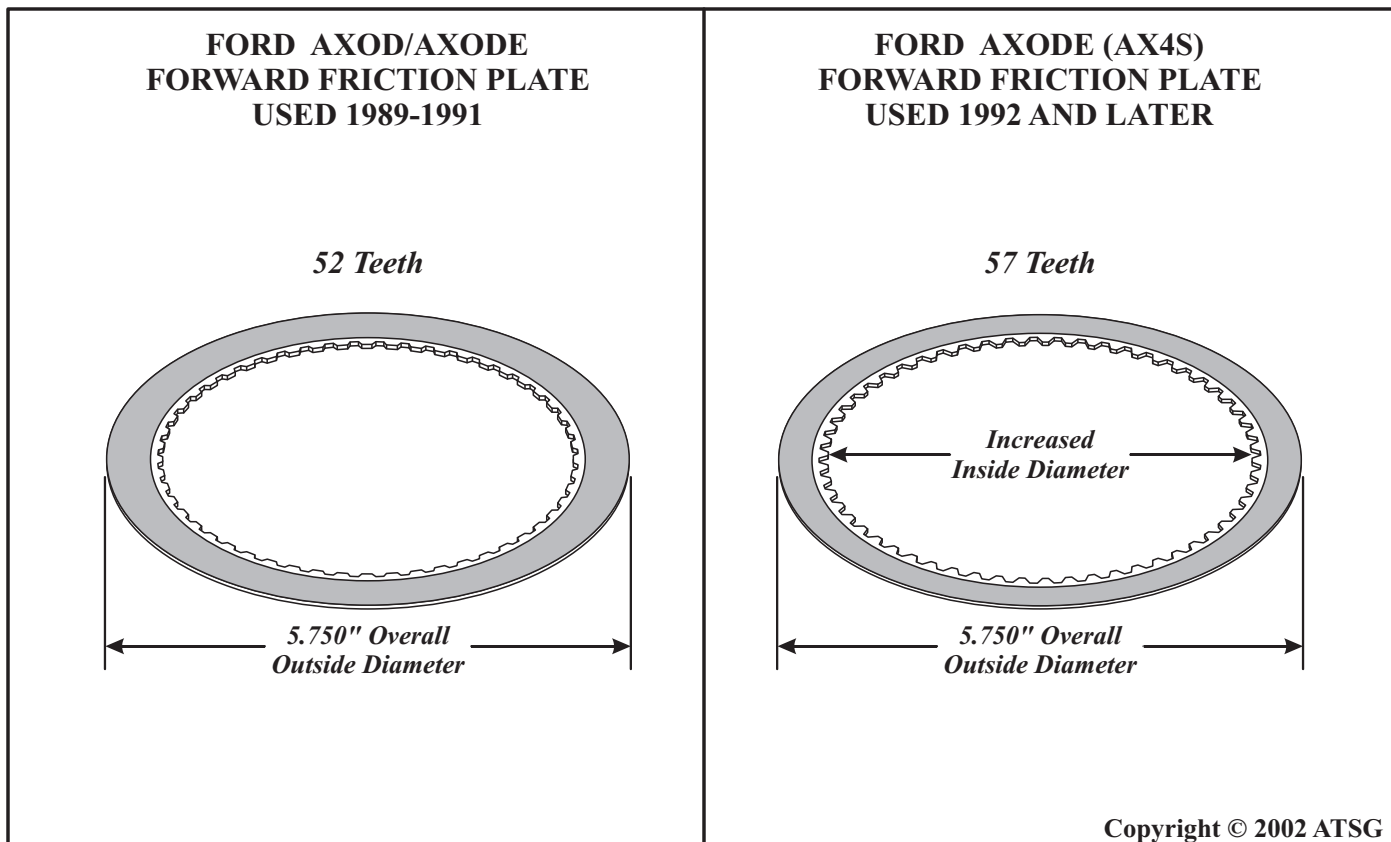
Figure 58

- (2) **FORWARD CLUTCH FRICTION PLATES** - Have an increased amount of teeth to 57 Teeth from the previous 52 Teeth, to accommodate the increased diameter of the sprag outer race, as shown in Figure 58.

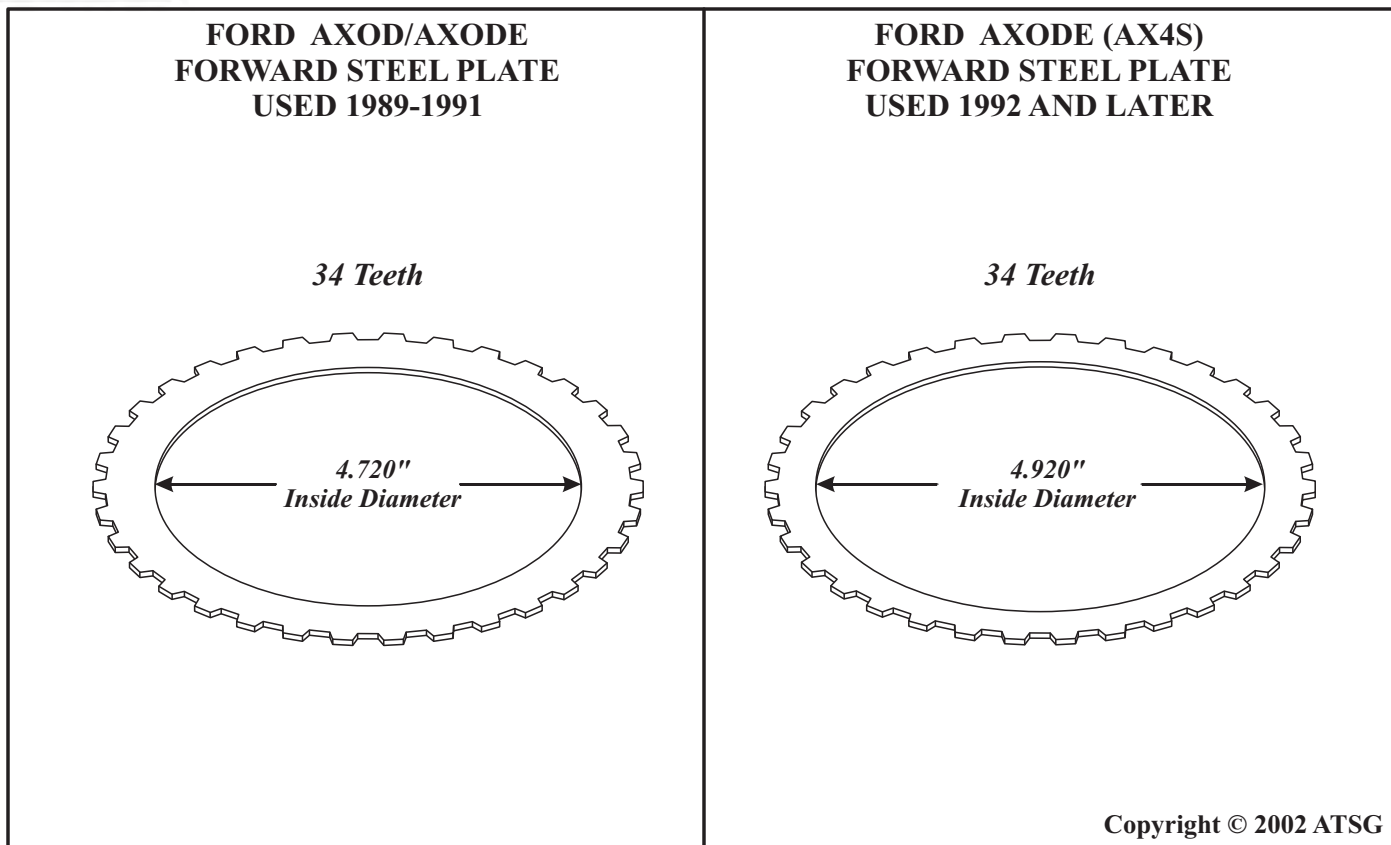
Figure 59

- (3) **FORWARD CLUTCH STEEL PLATES** - Have an increased inside diameter to 4.920" from the previous 4.720", to accommodate the increased diameter of the sprag outer race, as shown in Figure 59.

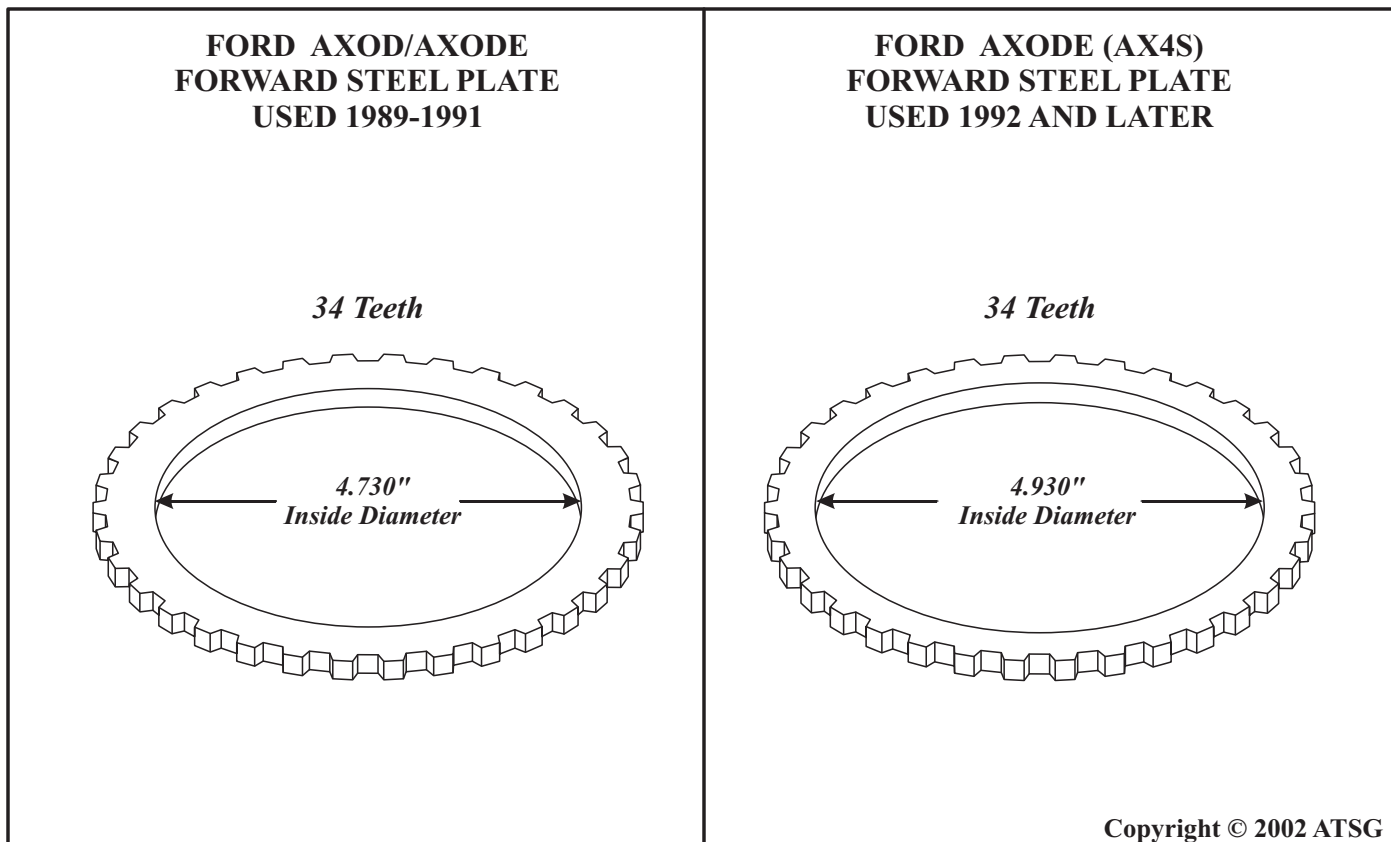
Figure 60

- (4) **FORWARD CLUTCH PRESSURE PLATE** - Has an increased inside diameter to 4.930" from the previous 4.730", to accommodate the increased diameter of the sprag outer race, as shown in Figure 60.

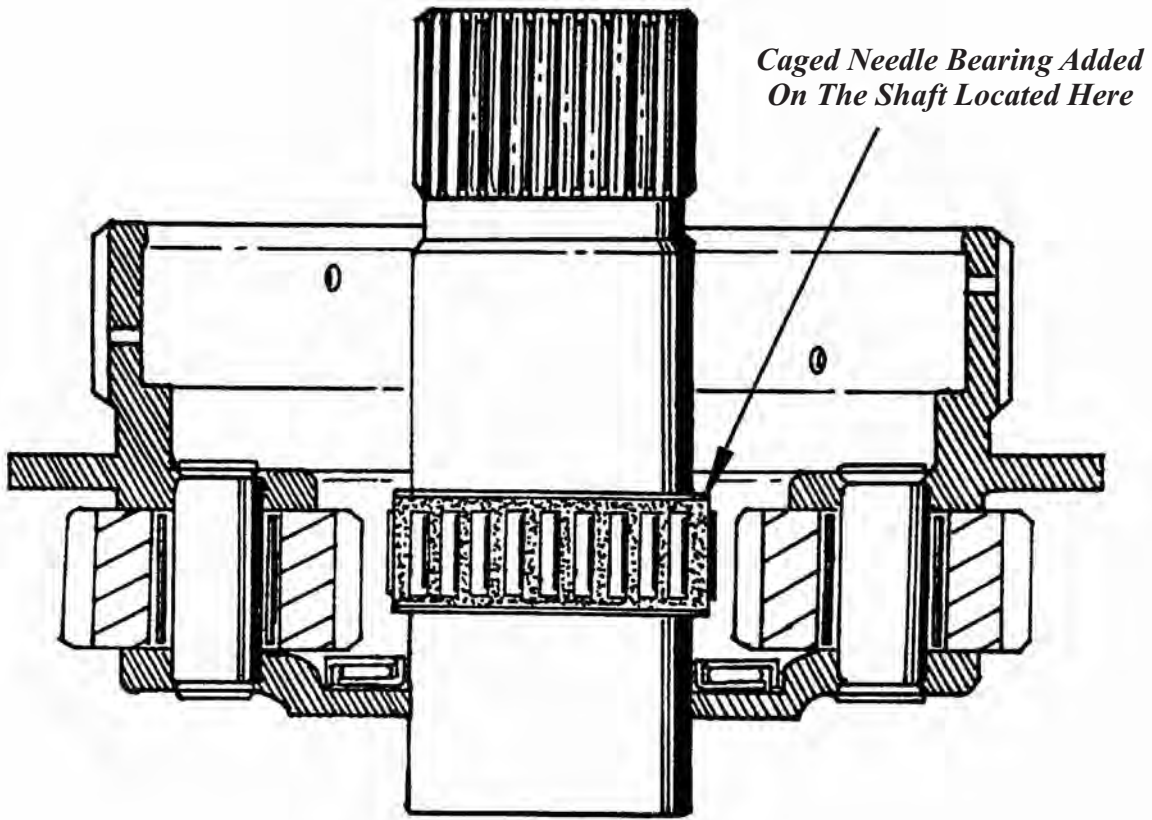
Figure 62

- (1) INPUT PLANETARY CARRIER - New caged needle Bearing added to the shaft on the Input Planetary Carrier, as shown in Figure 62.
- (2) SUN GEAR AND SHELL ASSEMBLY - Single bushing is now located in front of the lube holes in the sun gear, and the area behind is now machined to accommodate the new caged needle bearing, as shown in Figure 63.

When you order an Input Planetary Carrier and/or a Sun Gear and Shell assembly from OEM, they will automatically supercede to the new service package part number F4DZ-7A398-A, which includes both of the new design parts listed above.
