AXOD/AXODE (AX4S) UPDATE HANDBOOK

*Updated
October, 2002*

This updated version of the AXOD "Update Handbook" will also cover the changes that occurred in the 1991 model year, when electronic controls were adapted to the AXOD transaxle, making it an AXODE, and now called an AX4S transaxle. We have included the changes on the AX4S transaxle up through and including model year 2002.

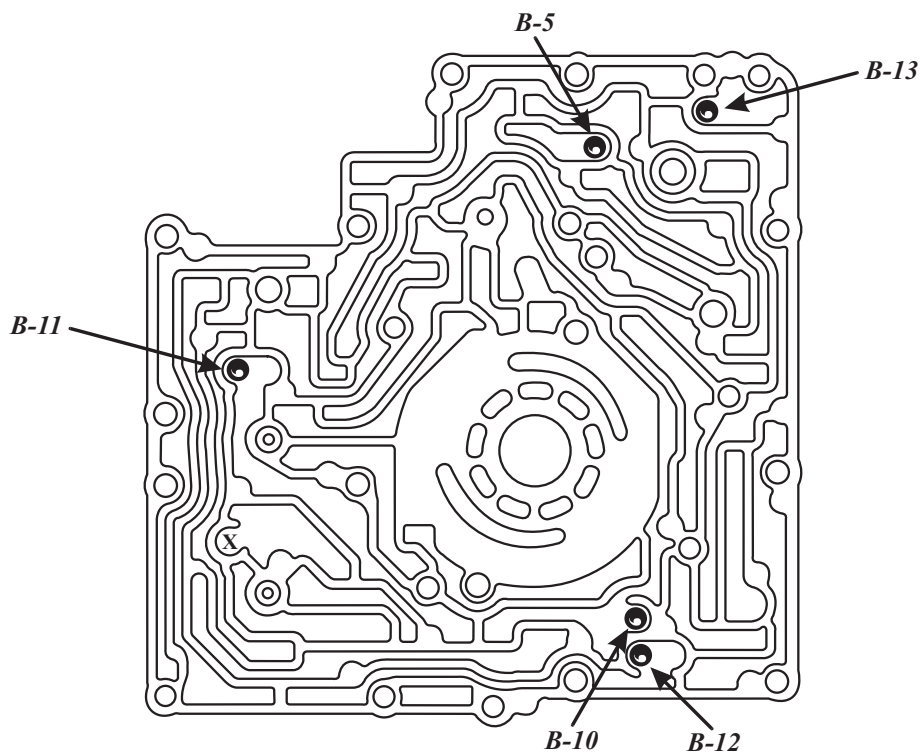
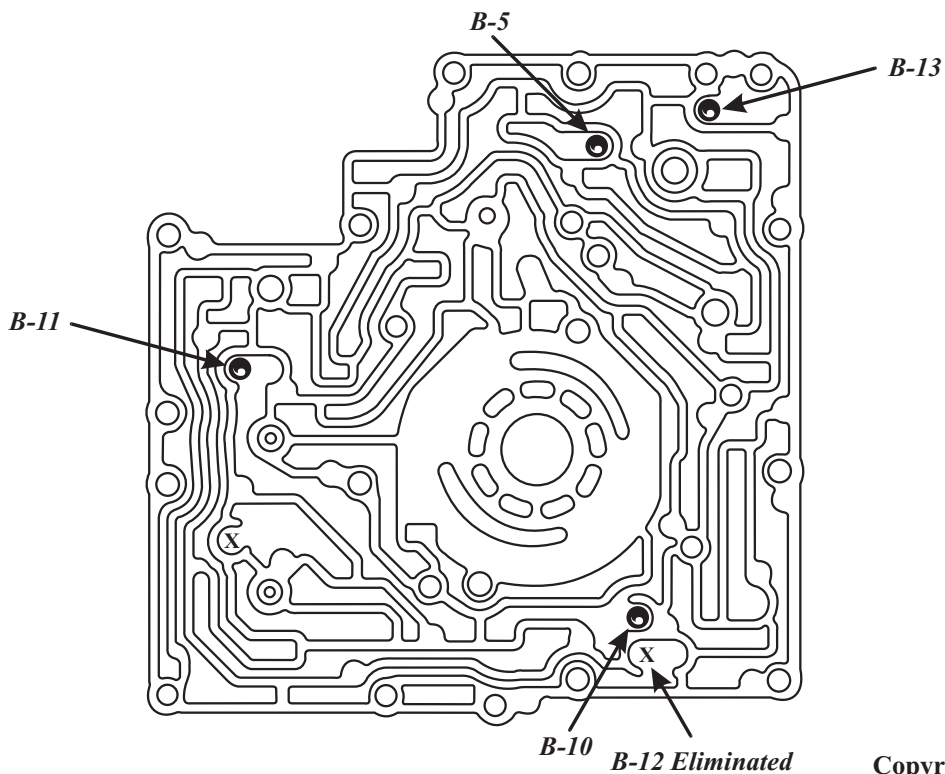
Figure 65

"Early" 1991 Only - Uses 5 checkballs in the locations shown in Figure 65. Use chart above to determine Early or Late transaxle by serial number.

"Late" 1991 Only - Uses 4 checkballs in the locations shown in Figure 65. Use chart above to determine Early or Late transaxle by serial number.

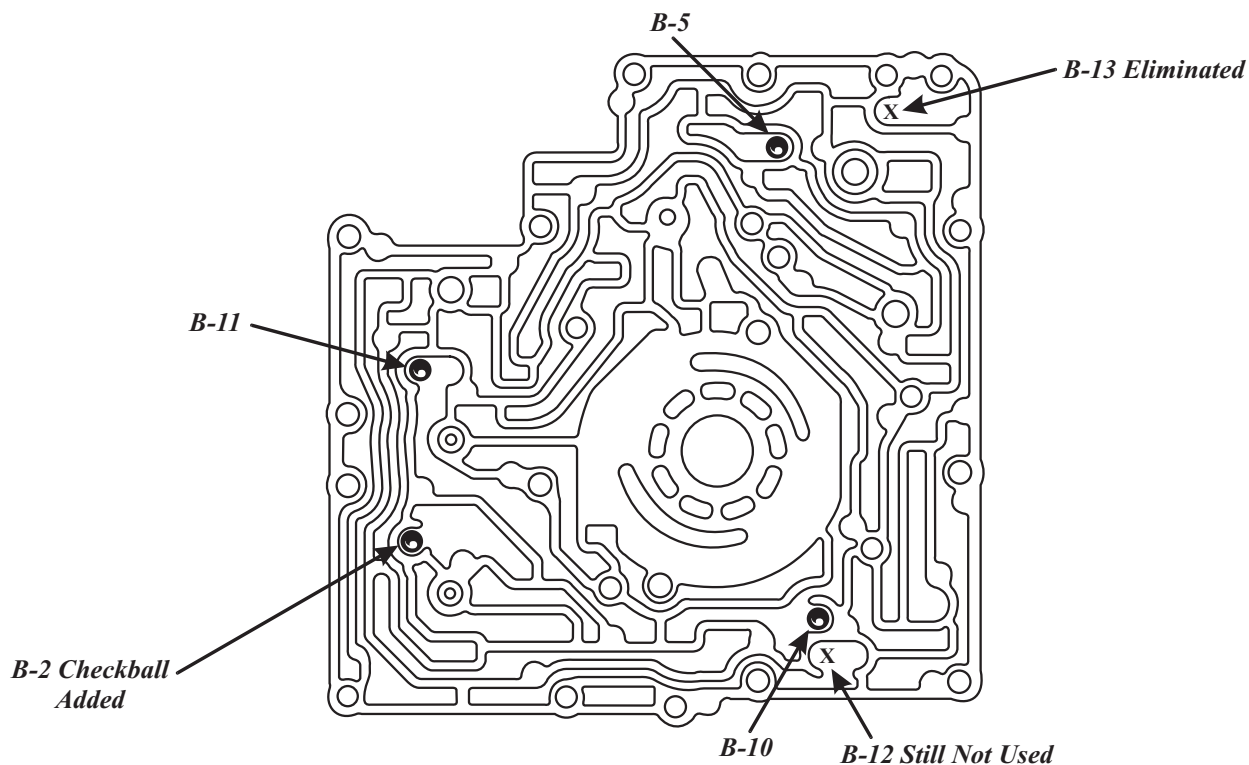
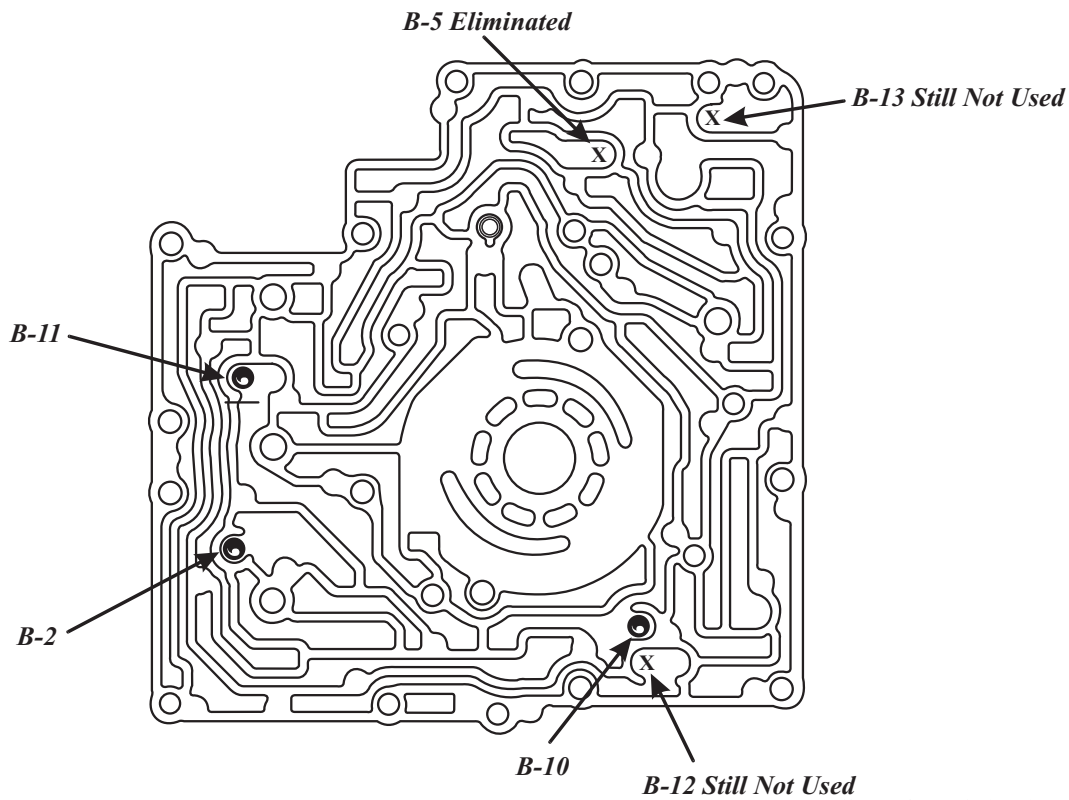
Figure 66

1992-1998 Only - Uses 4 checkballs but in different locations, as shown in Figure 66. B-13 checkball was eliminated and B-2 checkball was added.

1999-2002 Only - Uses 3 checkballs in the locations shown in Figure 66. B-5 checkball was eliminated.

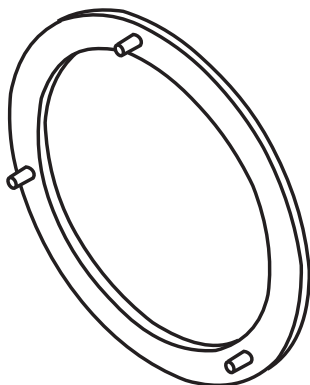
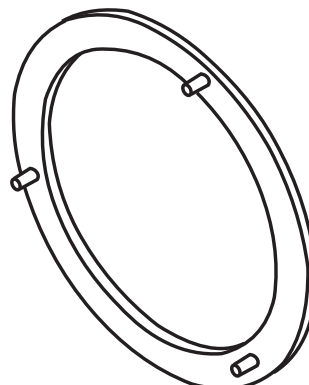
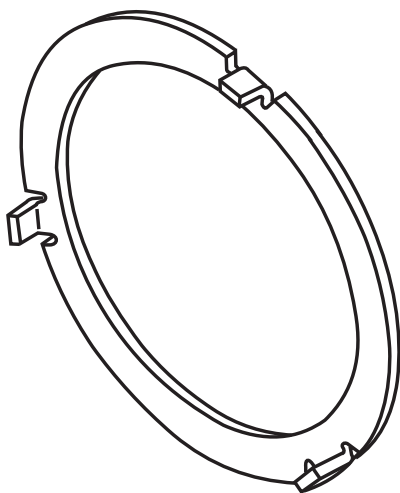
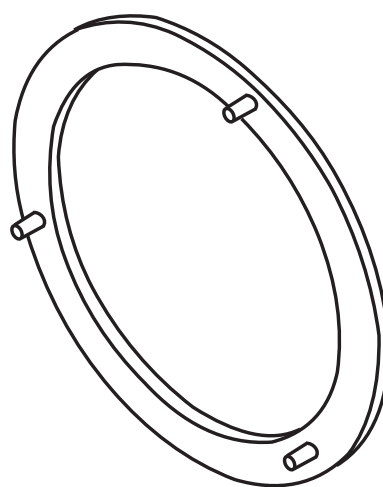
CHANGE: Beginning on October 13, 1995, introduced as a running change for 1996 models, the AX4S transaxles were built with new design Number 1 and Number 3 thrust washers (See Figure 84).

- (1) NUMBER 1 THRUST WASHER - New design washer has symmetrically located tabs for ease of assembly, as opposed to the previous design with non-symmetrically located tabs. Refer to Figure 84 for illustrations of both designs.

- (2) NUMBER 3 THRUST WASHER - New design washer is Black plastic with 3 symmetrically located tabs, as opposed to previous design bronze washer with tangs on the outside diameter. Refer to Figure 84 for illustrations of both designs.

**NUMBER 1 THRUST WASHER
WITH NON-SYMETRICALLY LOCATED TABS
PART NUMBER E6DZ-7G099-A**

**NUMBER 1 THRUST WASHER
WITH SYMETRICALLY LOCATED TABS
PART NUMBER F5DZ-7G099-A**

**NUMBER 3 BRONZE THRUST WASHER
WITH TANGS ON OUTSIDE DIAMETER
PART NUMBER E6DZ-7G096-A**

**NUMBER 3 PLASTIC THRUST WASHER
WITH SYMETRICALLY LOCATED TABS
PART NUMBER F5DZ-7G096-A**

If replacement of the number 1 and/or the number 3 thrust washer becomes necessary, inspect the chain cover in the thrust washer tab areas to determine the correct thrust washers required. Refer to Figures 85 and 86.

Number 1 Thrust Washer (Before 10/13/95)	E6DZ-7G099-A
Number 3 Thrust Washer (Before 10/13/95)	E6DZ-7G096-A
Number 1 Thrust Washer (On or After 10/13/95)	F5DZ-7G099-A
Number 3 Thrust Washer (On or After 10/13/95)	F5DZ-7G096-A

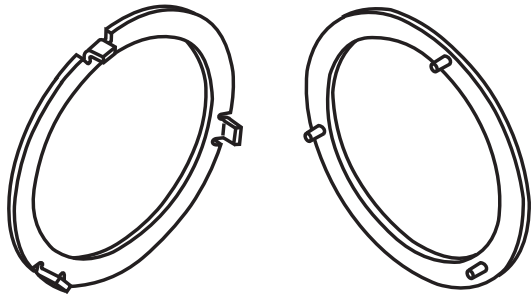
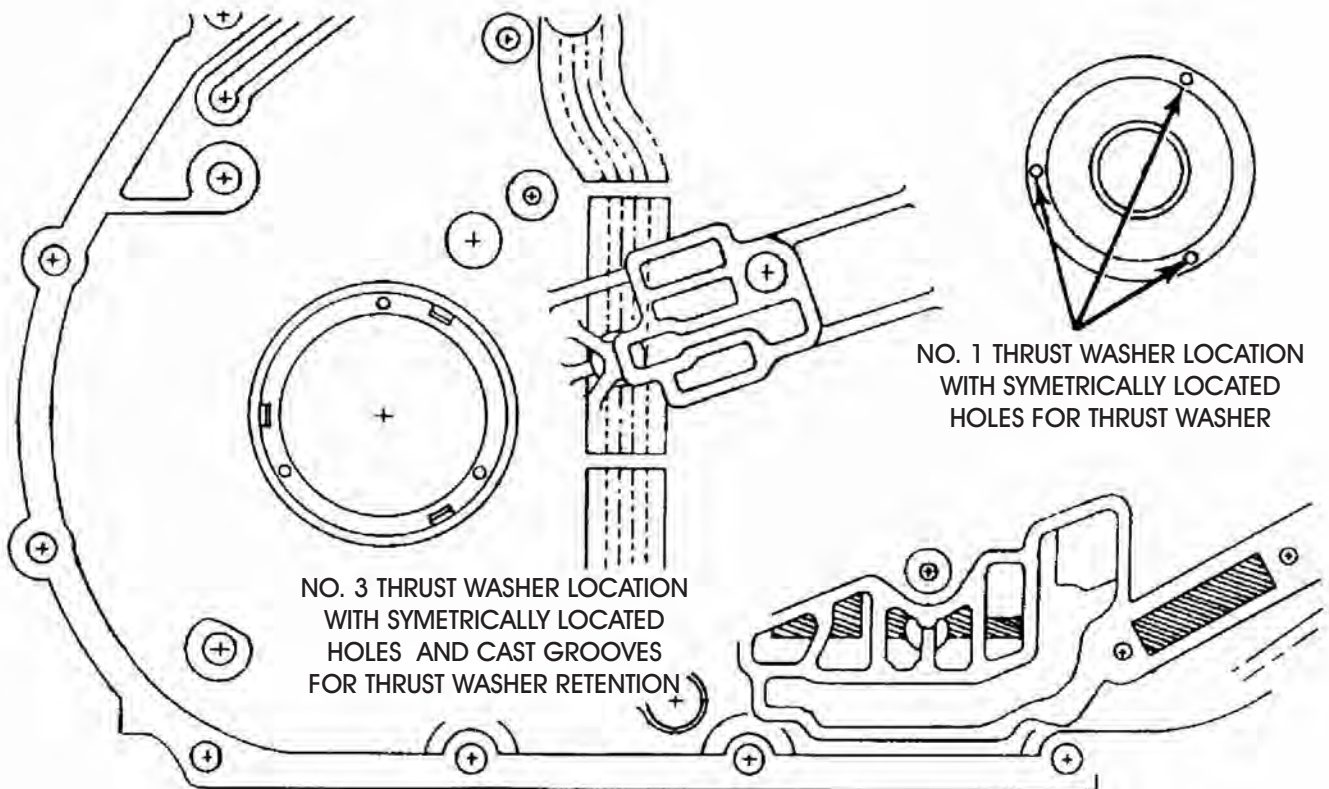
CHAIN COVER AND THRUST WASHERS OCTOBER 13, 1995 AND BEYOND

REQUIRES THE PLASTIC NO. 1
THRUST WASHER WITH TABS THAT
ARE SYMETRICALLY LOCATED
PART NUMBER F5DZ-7G099-A

NO. 1 THRUST WASHER LOCATION
WITH SYMETRICALLY LOCATED
HOLES FOR THRUST WASHER

NO. 3 THRUST WASHER LOCATION
WITH SYMETRICALLY LOCATED
HOLES AND CAST GROOVES
FOR THRUST WASHER RETENTION

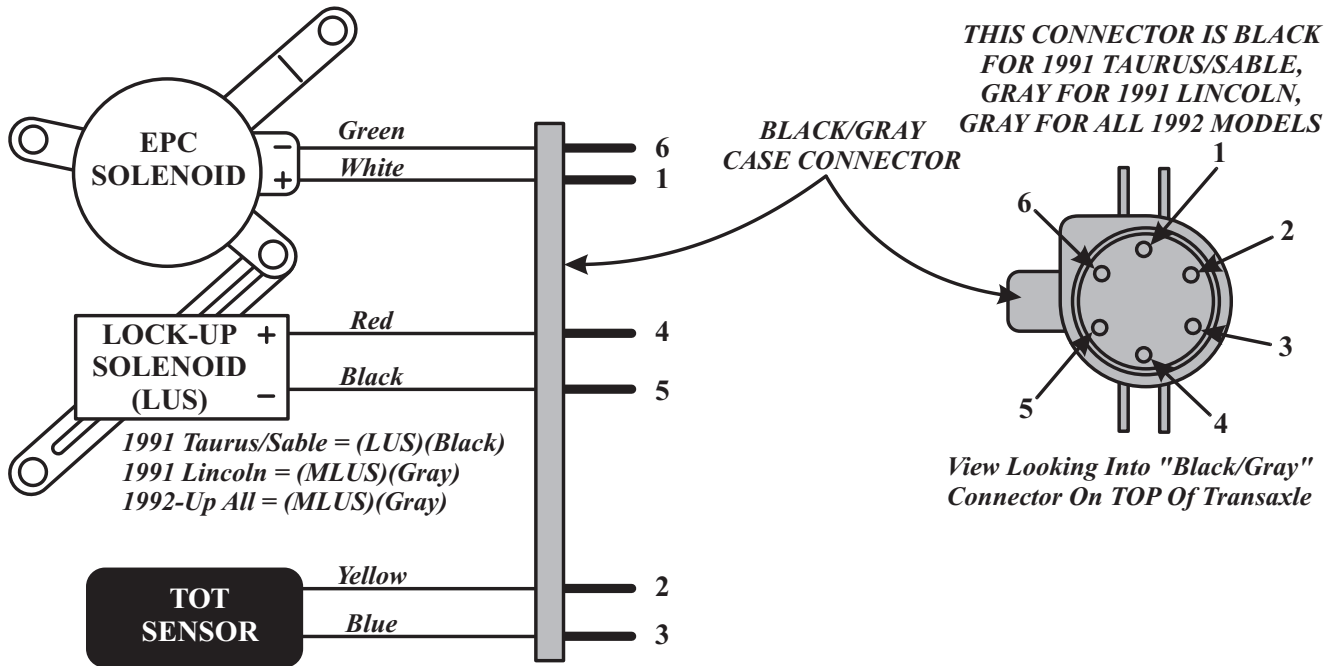
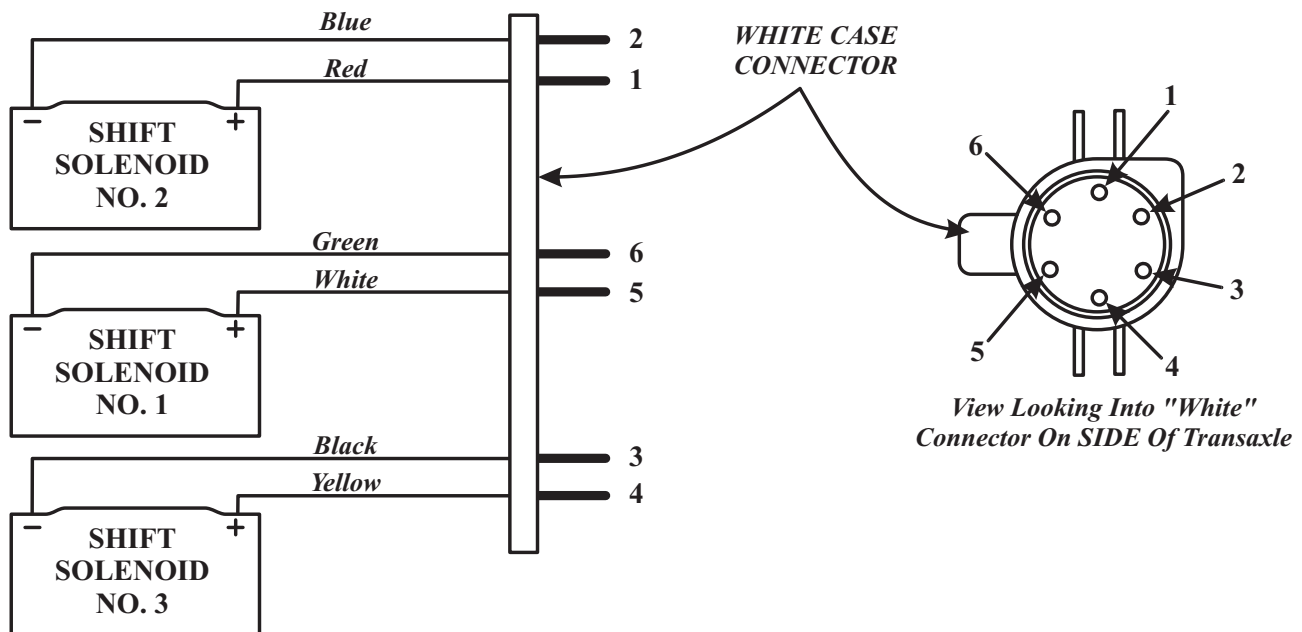
Figure 88

Wires for the Electronic Pressure Control solenoid are fed through pins 1 and 6 of the "Black/Gray" case connector, located on top of the transaxle (See Figure 88). Ohmmeter across terminals 1 and 6 should read 2.5-6.5 Ohms resistance.

Wires for the Modulated Lock-Up Solenoid (MLUS) are fed through pins 4 and 5 of the "Gray" case connector, located on top of the transaxle (See Figure 88). Ohmmeter across terminals 4 and 5 should read 0.75-2.0 Ohms resistance if you have MLUS. The Modulated Lock-Up Solenoid (MLUS) is found on the *Lincoln Only* for the 1991 model year. Taurus/Sable for 1991 are the regular Lock-Up Solenoid (LUS) that is described below. *All models for 1992 model year are MLUS.*

Wires for the Lock-Up Solenoid (LUS) are fed through pins 4 and 5 of the "Black" case connector, located on top of the transaxle (See Figure 88). Ohmmeter across terminals 4 and 5 should read 16-40 Ohms resistance if you have LUS. The Lock-Up Solenoid (LUS) is found on the *Taurus/Sable Only* for the 1991 model year. Lincoln for 1991 is the Modulated Lock-Up Solenoid (MLUS) that is described above. *All models for 1992 model year are MLUS.*

Wires for the Transaxle Oil Temperature (TOT) sensor are fed through pins 2 and 3 of the "Black/Gray" case connector, located on top of the transaxle (See Figure 88). Ohmmeter across terminals 2 and 3 should read the approximate resistance listed in the chart below. Resistance should decrease if transaxle is heated, and should increase if transaxle is allowed to cool. Oil pan that is warm to the touch is about 105°F-158°F.

Wires for Shift Solenoid 1 are fed through pins 5 and 6 of the "White" case connector, located on the side of transaxle (See Figure 88). Ohmmeter across terminals 5 and 6 should read 12-30 Ohms resistance.

Wires for Shift Solenoid 2 are fed through pins 1 and 2 of the "White" case connector, located on the side of transaxle (See Figure 88). Ohmmeter across terminals 1 and 2 should read 12-30 Ohms resistance.

Wires for Shift Solenoid 3 are fed through pins 3 and 4 of the "White" case connector, located on the side of transaxle (See Figure 88). Ohmmeter across terminals 3 and 4 should read 12-30 Ohms resistance.

The 1991-1992 AXOD-E transaxle has 2 case connectors, 1 Black or Gray in color on the top of the transaxle, and 1 White in color on the side of the transaxle.

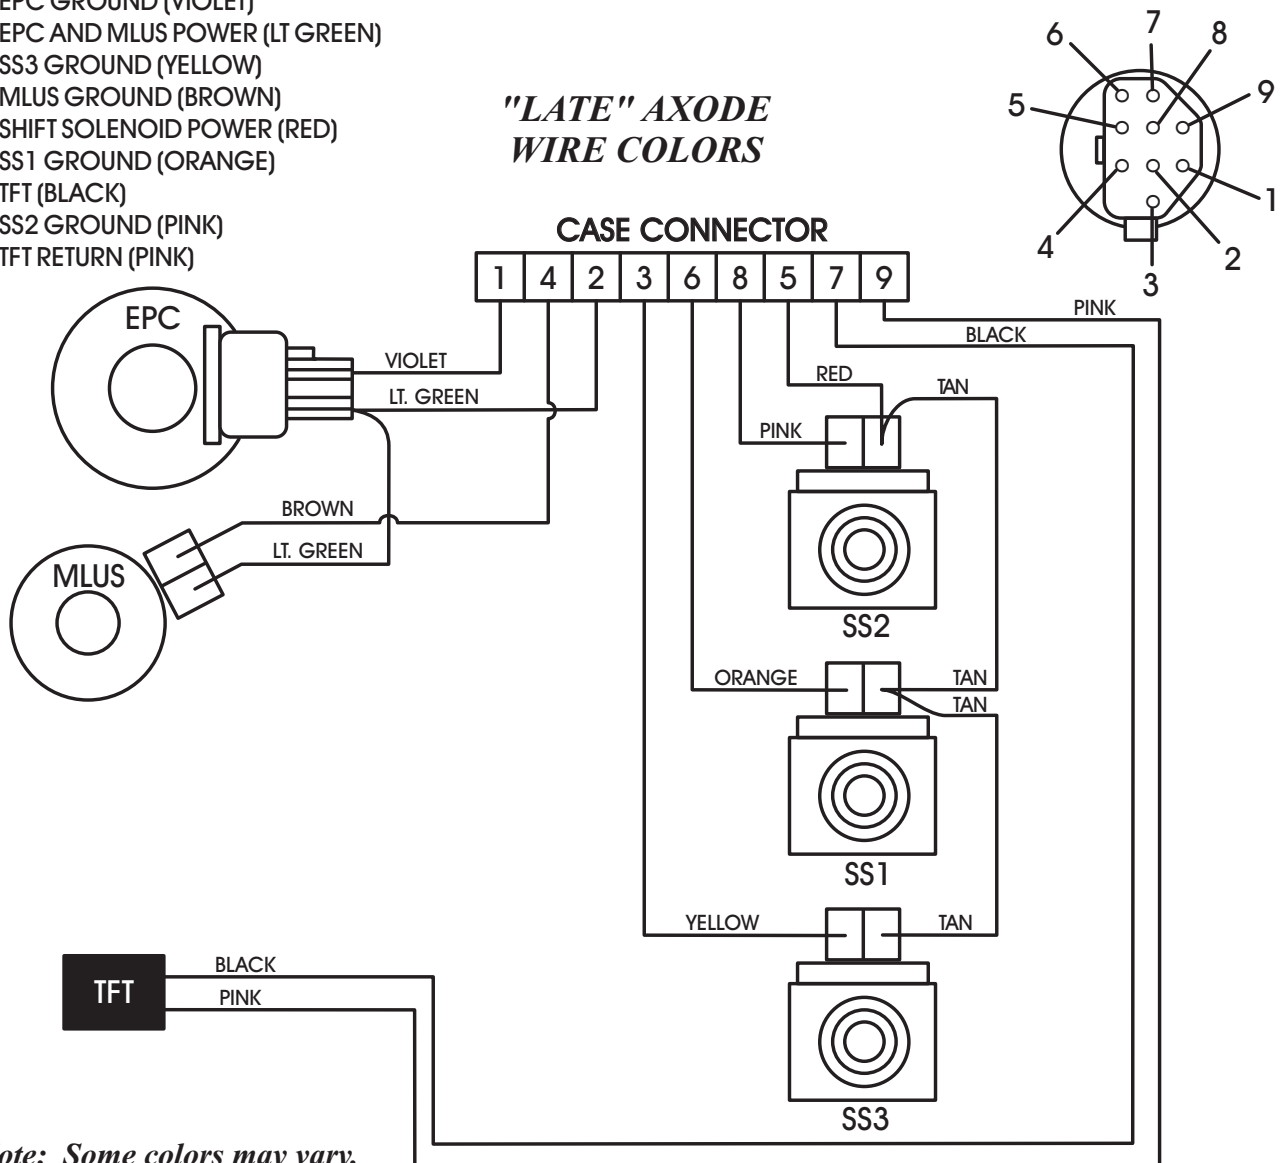
"LATE" AXODE WIRE COLORS

COMPLAINT: *After rebuild*, harsh shifts (High Line) and/or a "Clicking" or cycling noise may be heard from the side cover area, that is usually accompanied by an ON/OFF bind-up sensation that coincides with the "Clicking" noise. These symptoms may be accompanied with Diagnostic Trouble Code (DTC) 652 (MLUS Shorted or Open Circuit), DTC 624 (EPC Circuit Failure), and/or one Shift Solenoid DTC 621, 622, or 624.

CAUSE: The cause may be, solenoid wire connectors installed on the wrong solenoids.

NOTE: The internal wire harness normally is secured by wire-ties which would prevent improper connection of solenoids, however, not all wire harnesses have the wire ties necessary to prevent this problem and the chart must be used.

1. EPC GROUND (VIOLET)
2. EPC AND MLUS POWER (LT GREEN)
3. SS3 GROUND (YELLOW)
4. MLUS GROUND (BROWN)
5. SHIFT SOLENOID POWER (RED)
6. SS1 GROUND (ORANGE)
7. TFT (BLACK)
8. SS2 GROUND (PINK)
9. TFT RETURN (PINK)

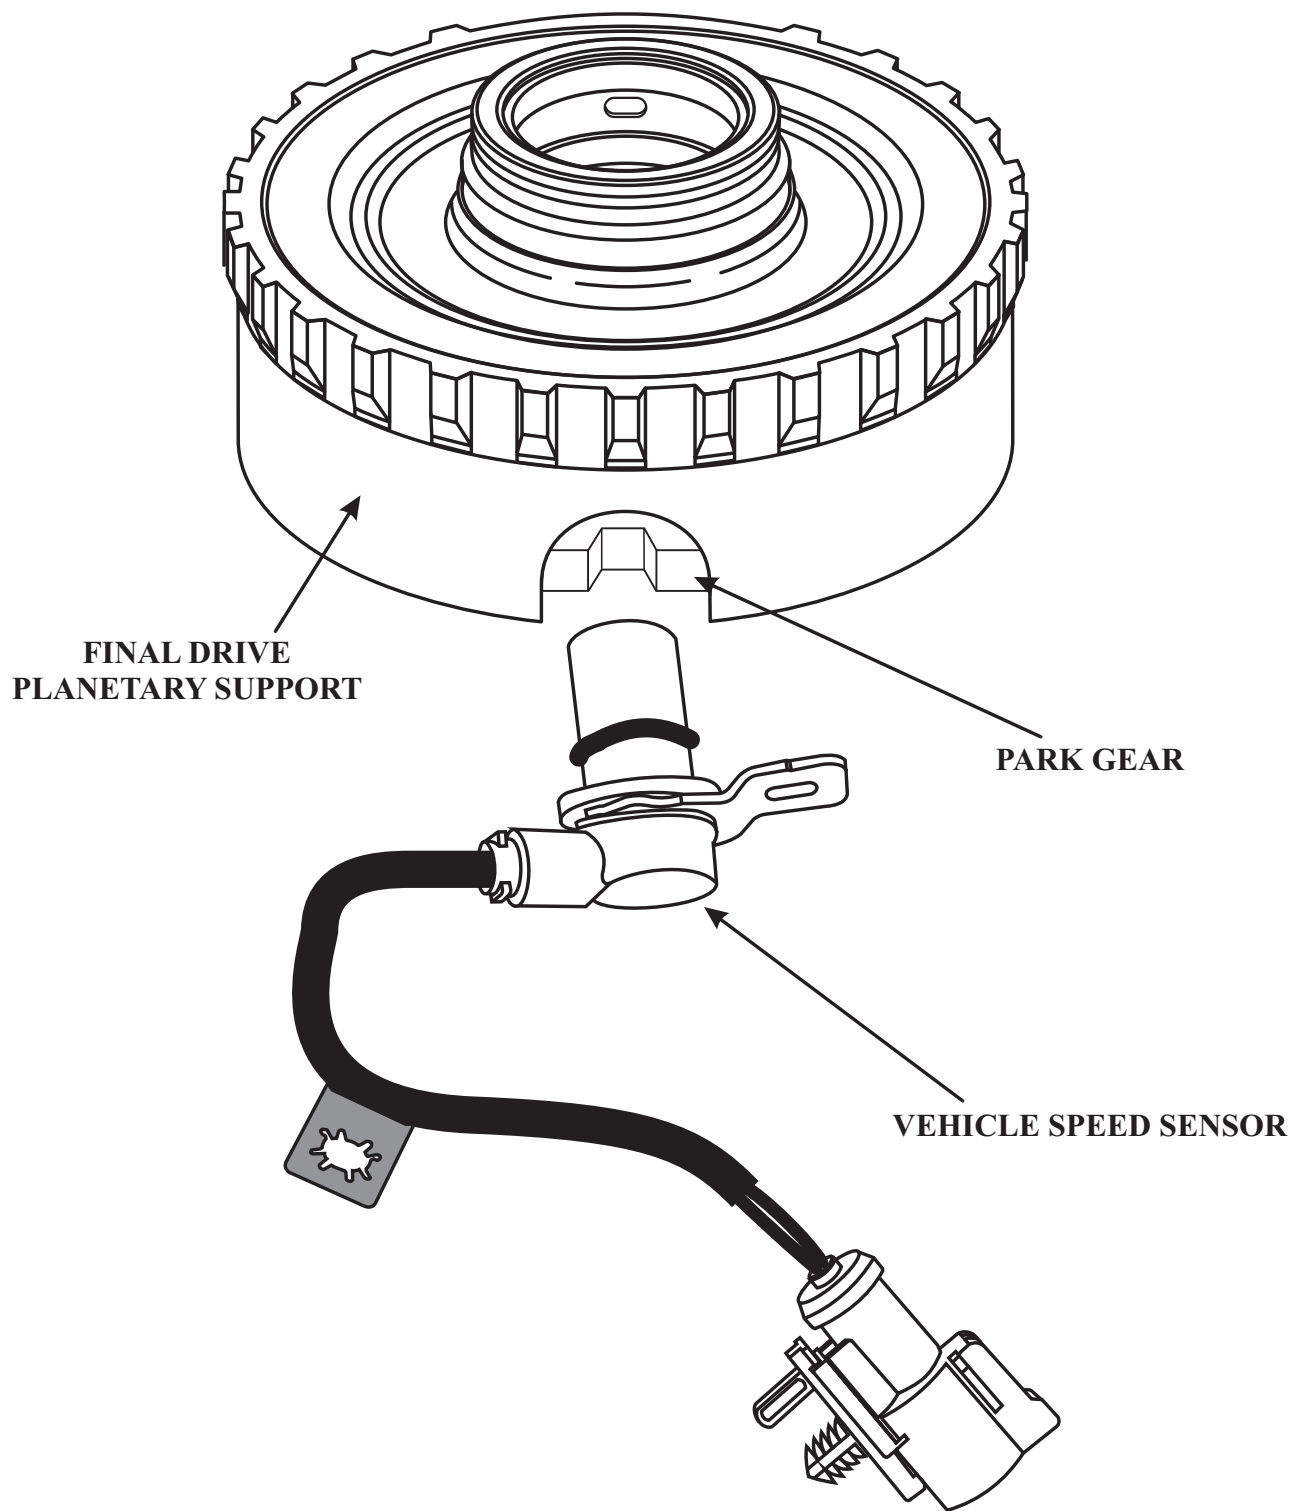
Figure 94

CHANGE: The gear driven vehicle speed sensor that has been in use in the AX4S and the AX4N since their inception will be replaced, as a running change during the 1999 model year beginning with the AX4S, and at the start of production for the 2000 model year for the AX4N, with a permanent magnet speed sensor. The PM Generator will be mounted in the barrel of the case and will be using the park gear teeth as an exciter wheel.

REASON: The possibility of the VSS drive or driven gear "apple coring" will be eliminated as well as the intermittent loss of vehicle speed signal due to the speed sensor sub harness damage that would occur as a result of exhaust system heat transferral.

- (1) TRANSAXLE CASE - Changed to accommodate mounting the new design speed sensor so that it is in line with the planetary support and the park gear.
- (2) FINAL DRIVE SUPPORT - Changed to accommodate mounting the new design speed sensor and now has a "cut out" for the speed sensor to look through at the park gear, as shown in Figure 94.

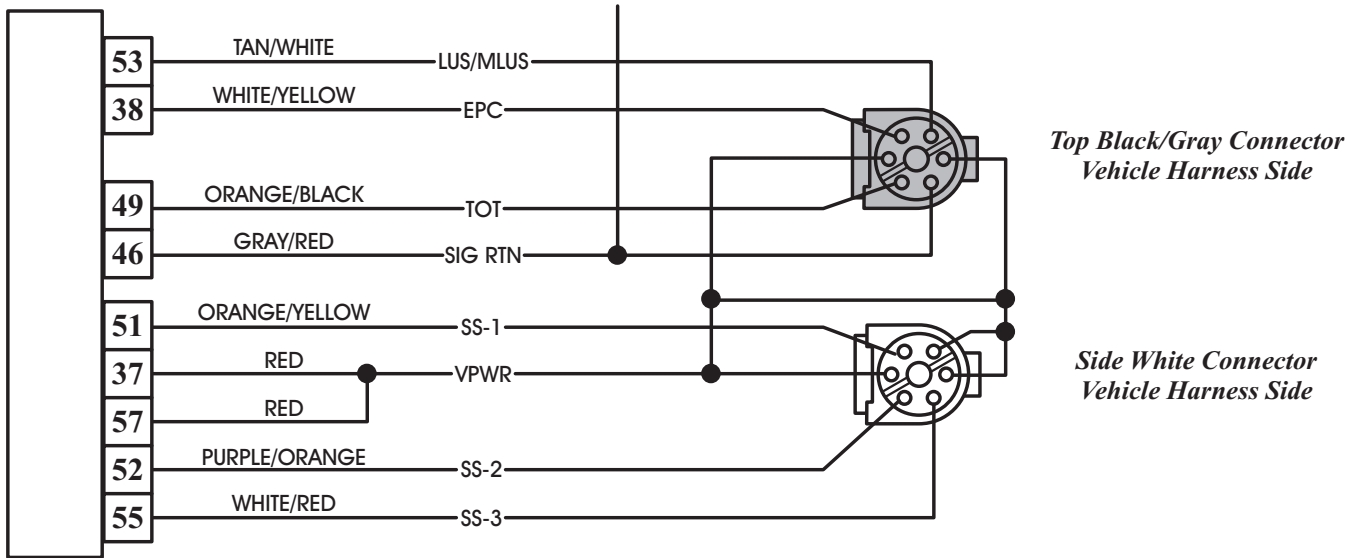
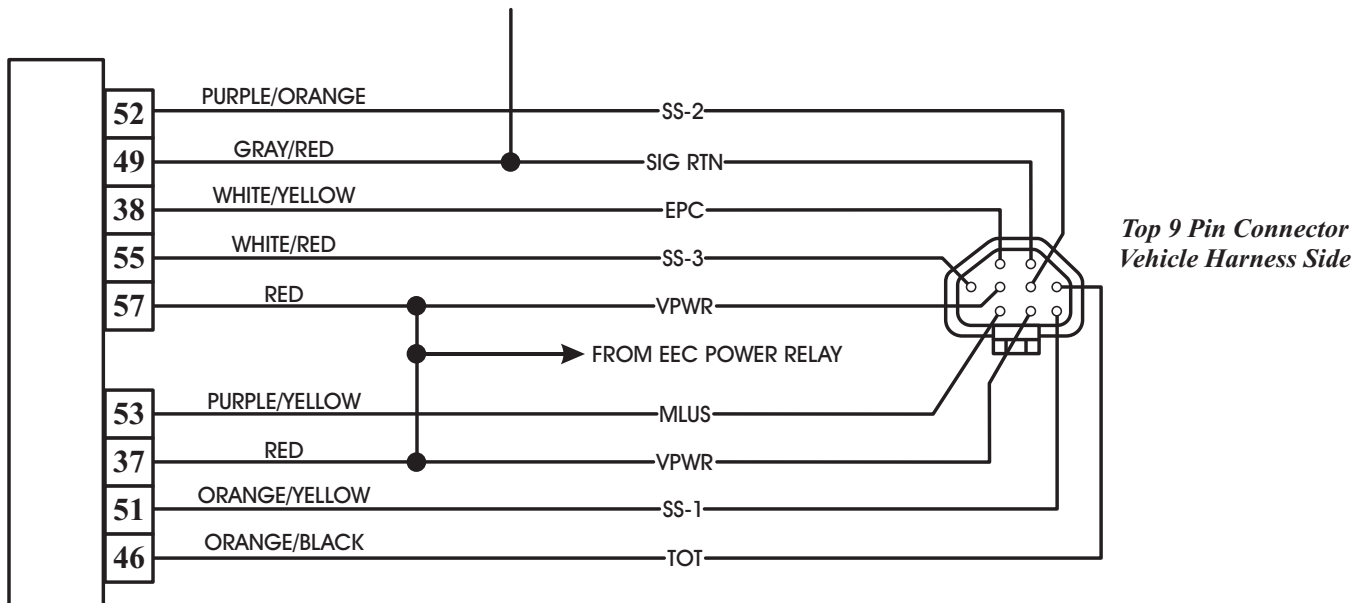
Figure 98

To begin the EPC circuit current draw test, the EPC ground wire that runs from the computer to the transaxle case connector must be located, and the external wire color will be White with a Yellow tracer on both versions, as shown in Figure 98. On 1991-1992 model vehicles the wire will be found in the top case connector and comes from pin number 38 on the computer. On 1993-UP vehicles there is only one case connector and the wire still comes from pin number 38 on the computer. Refer to Figure 98.

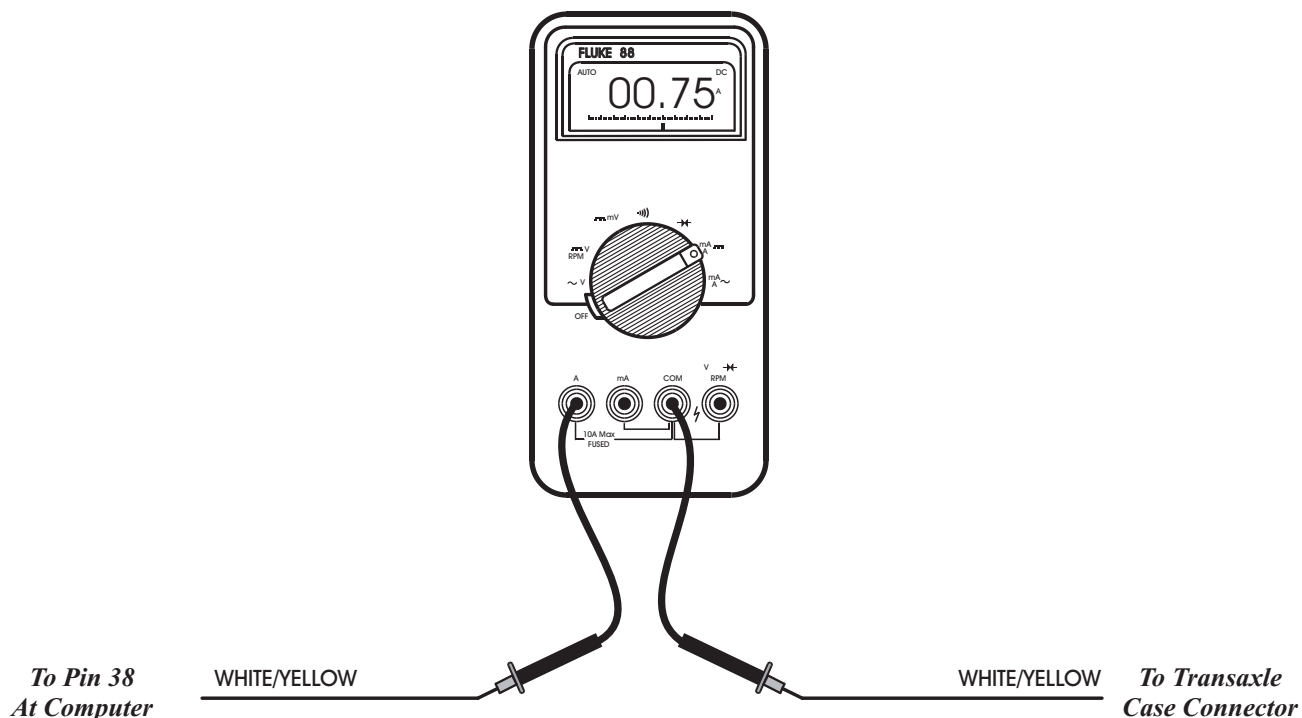
CONNECTING THE DVOM TO CHECK AMPS TO THE TRANSAXLE

Connect the 0-400 lb. pressure gauge to the mainline pressure tap, as shown in Figure 100. Cut the White wire with the Yellow tracer and hook the DVOM, **in series**, so that current flows **through** the DVOM, as shown in Figure 99. Start the engine and let it warm up until the pressure stabilizes between 48-77 PSI. The amperage reading at idle should be approximately 1 Amp. As the throttle is opened, amperage should begin to drop, and pressure should begin to rise. Refer to the chart in Figure 99.

Cut the White/Yellow wire from Pin No. 38 at the computer and connect the DVOM leads, as shown above, to perform this test. This is known as "connecting in series".

EPC AMPS	1.0	.90	.75	.70	.60	.50	.35	
EPC PSI	20	30	40	50	60	70	80	
* P psi	75	----	----	----	----	----	----	
R psi	90	145	175	200	225	275	310	
N psi	75	----	----	----	----	----	----	
OD psi	75	100	125	145	165	180	210	
D psi	75	100	125	145	165	180	210	
L psi	80	100	125	155	175	190	220

** With a normally functioning EPC circuit, you will see about 150 PSI on the pressure gauge while in Park, on "the initial start up", which is part of the computer strategy, "and is normal".*
